STAFF REPORT: JUNE 14, 2023 REGULAR MEETING
APPLICATION NUMBER: 23-8405
ADDRESS: 950 LONGFELLOW
HISTORIC DISTRICT: BOSTON-EDISON
APPLICANT/OWNER: CAROL DARGIN
DATE OF PROVISIONALLY COMPLETE APPLICATION: MAY 22, 2023
DATE OF STAFF SITE VISIT: MAY 30, 2023

SCOPE: REPLACE WOOD WINDOWS WITH COMPOSITE WINDOWS

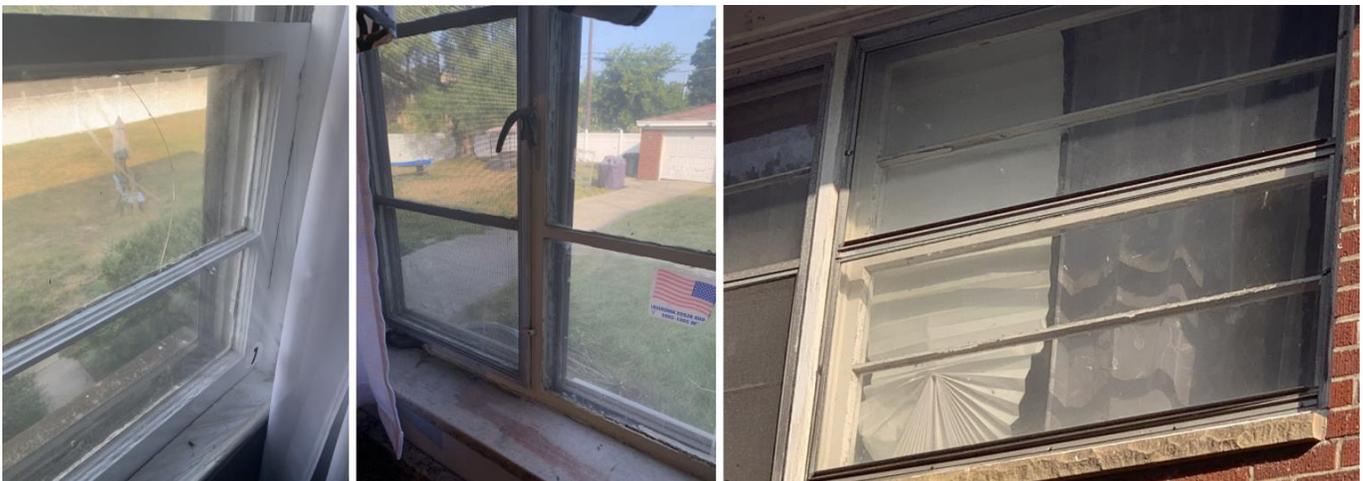
- The submitted application documents do not provide evidence that the windows have deteriorated beyond repair. The submitted photos show cracked glass and peeling paint, but these conditions are typical maintenance needs of old windows and are repairable.⁶

Example photos of windows proposed for replacement. Images from application; please see application for additional photos.

- Although the application documents discuss the value of sustainability and the importance of energy efficiency, staff notes that energy efficiency would more appropriately be accomplished with storm windows.
