ADDRESS: 15002 ASHTON

APPLICATION NO: #23-8399

HISTORIC DISTRICT: ROSEDALE PARK

SCOPE

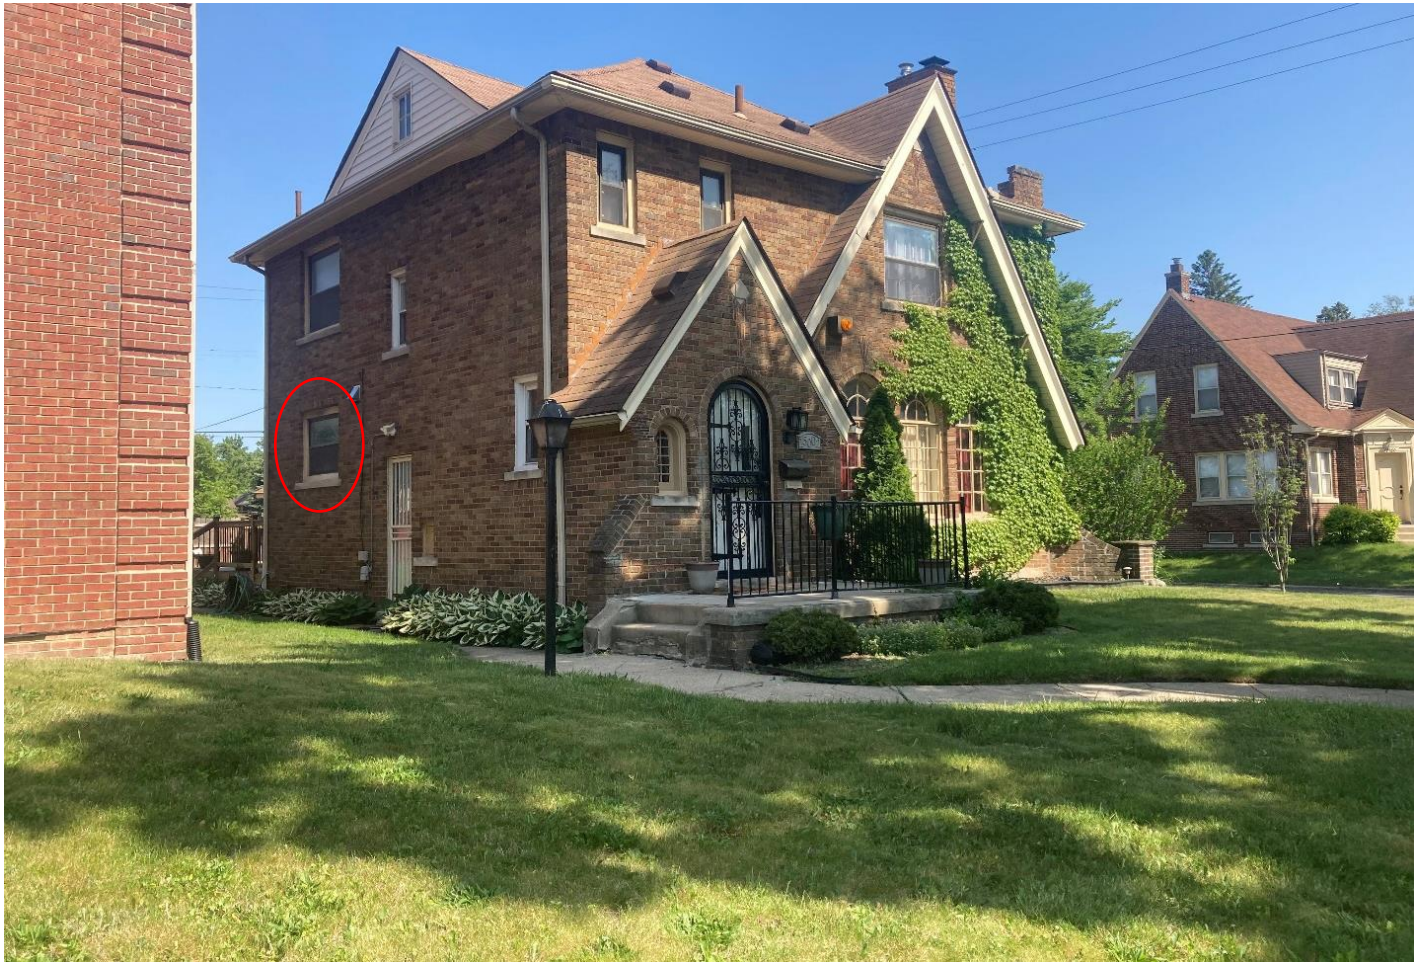
15002 Ashton, current appearance, staff photo taken 5/31/2023. The encircled window is proposed for replacement

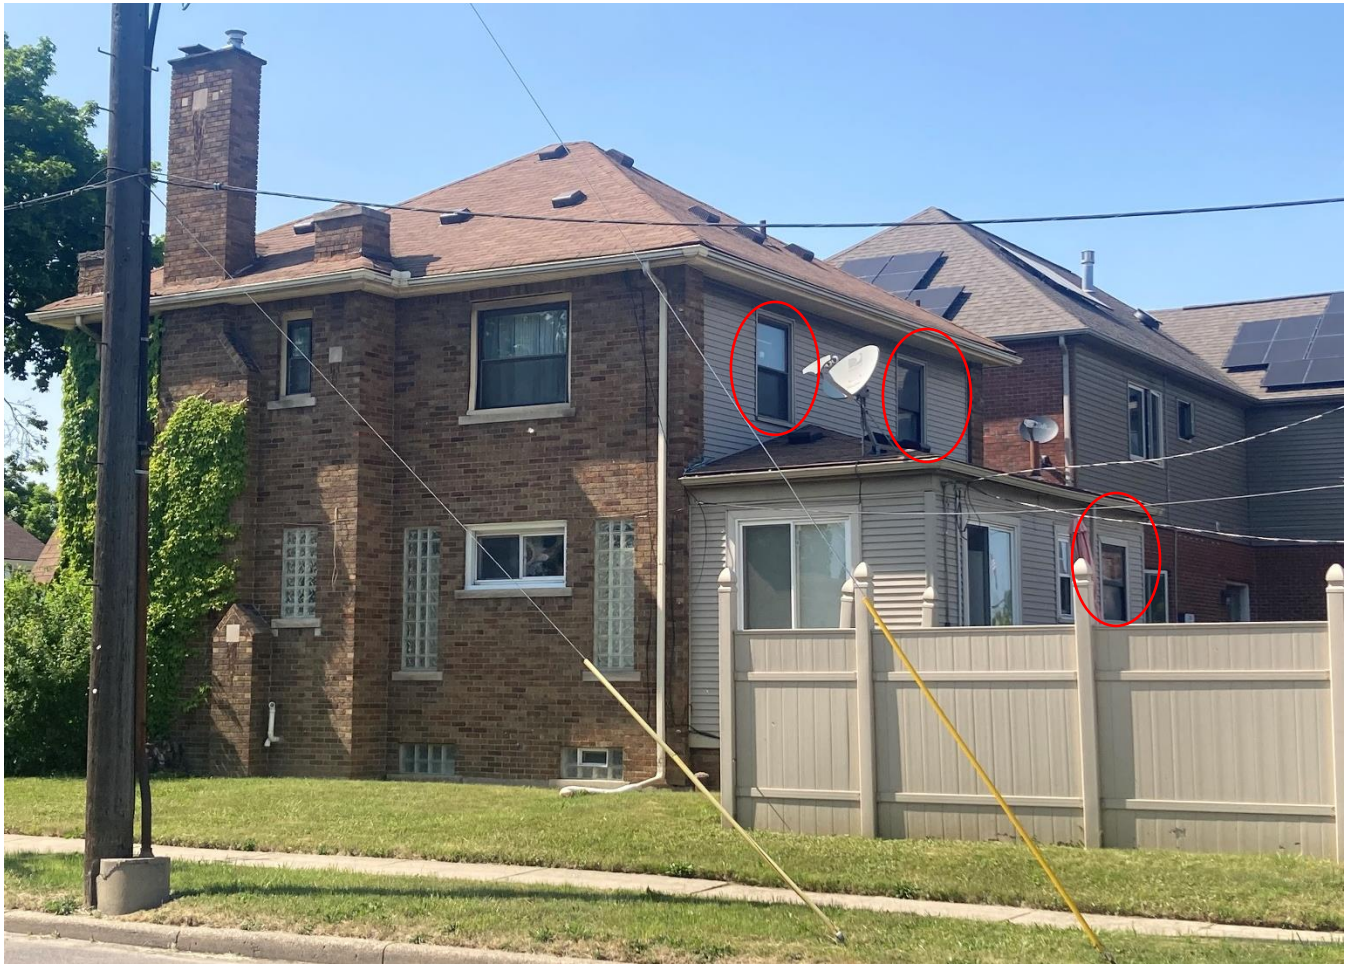
15002 Ashton, current appearance, staff photo taken 5/31/2023. The three encircled windows are proposed for replacement. Also note that the white vinyl windows were installed sometime between 2013 and 2015 before the current owner purchased the property. HDC did not approve this work.

- Original windows were replaced with the current vinyl units at the south elevation, north elevation, and rear, hipped roof wing. It is staff's opinion that these unapproved white vinyl units and associated trim are not compatible with the property's historic character/do not meet the Standards as they do not adequately replicate the historic windows that they replaced in material, operation, light configuration, design, color, or texture
- Historic-age metal double overhead garage doors were replaced with a single steel door
- Vinyl fencing erected at the rear yard
- Wood deck added to the rear, hipped-roof wing

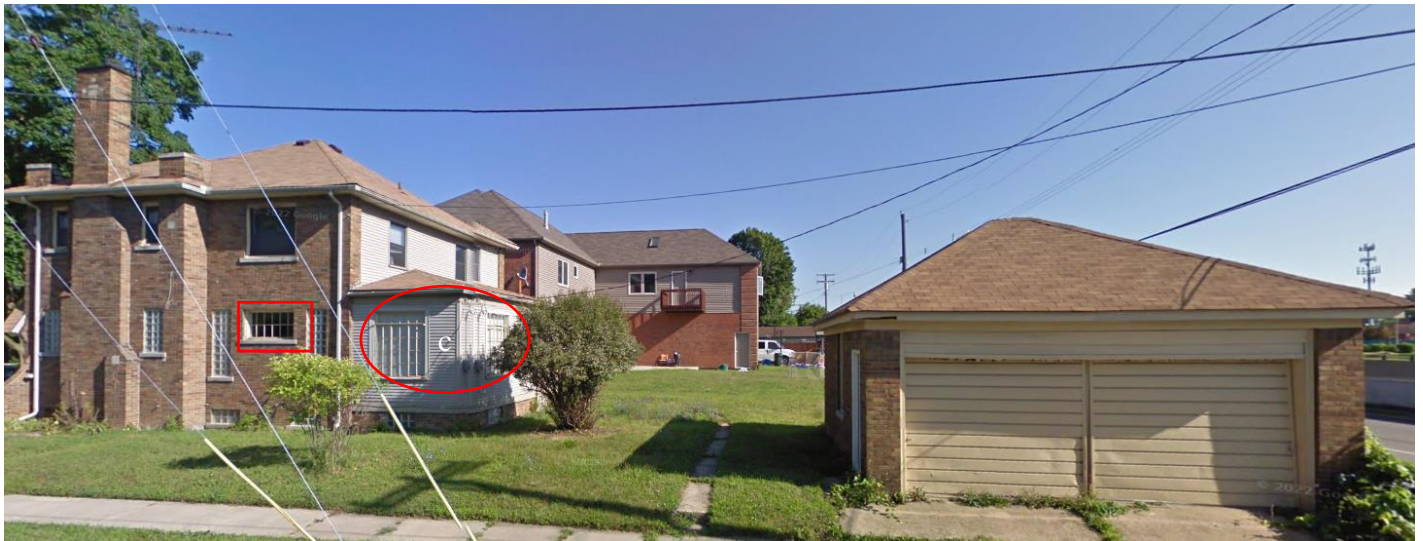
2009 Google Streetview image. Note the presence of steel casement windows at the casement windows at the rear wing's first story and the side elevation's first story. Also a rear deck and gate is not present in 2009 and the garage doors are different from the current single overhead door.

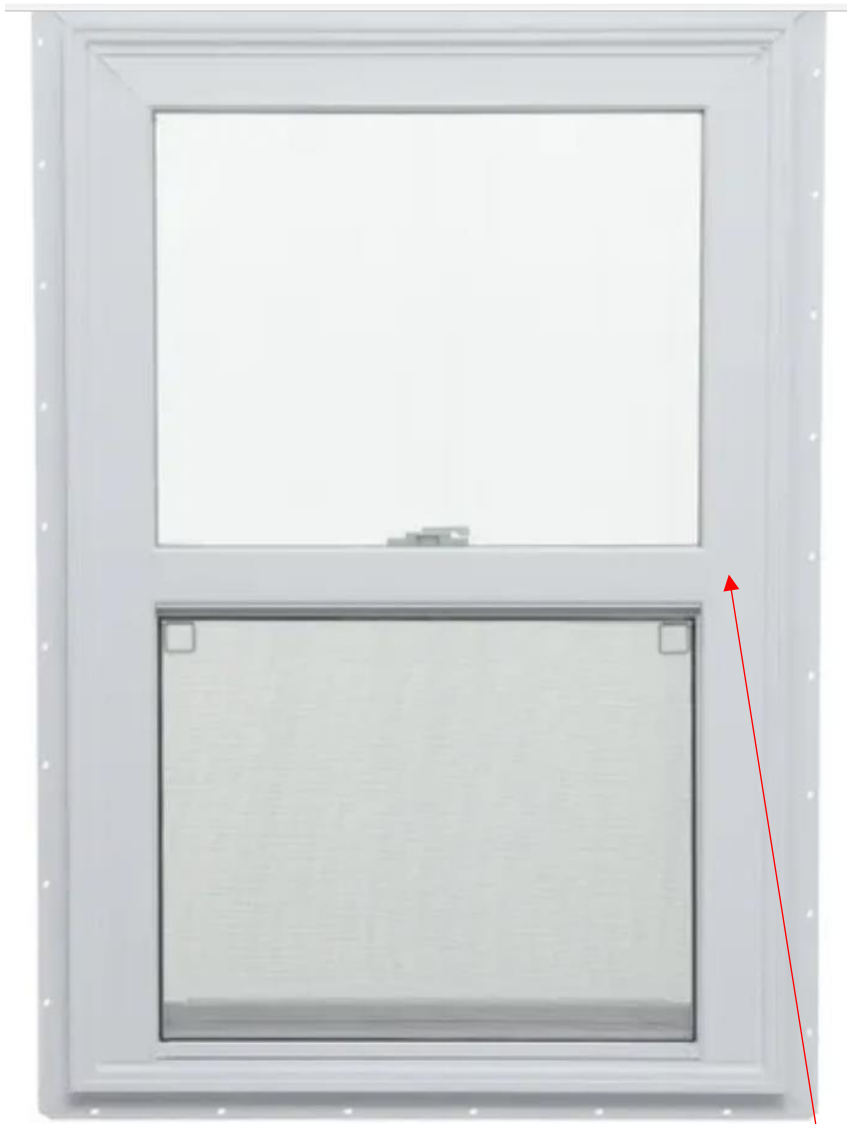
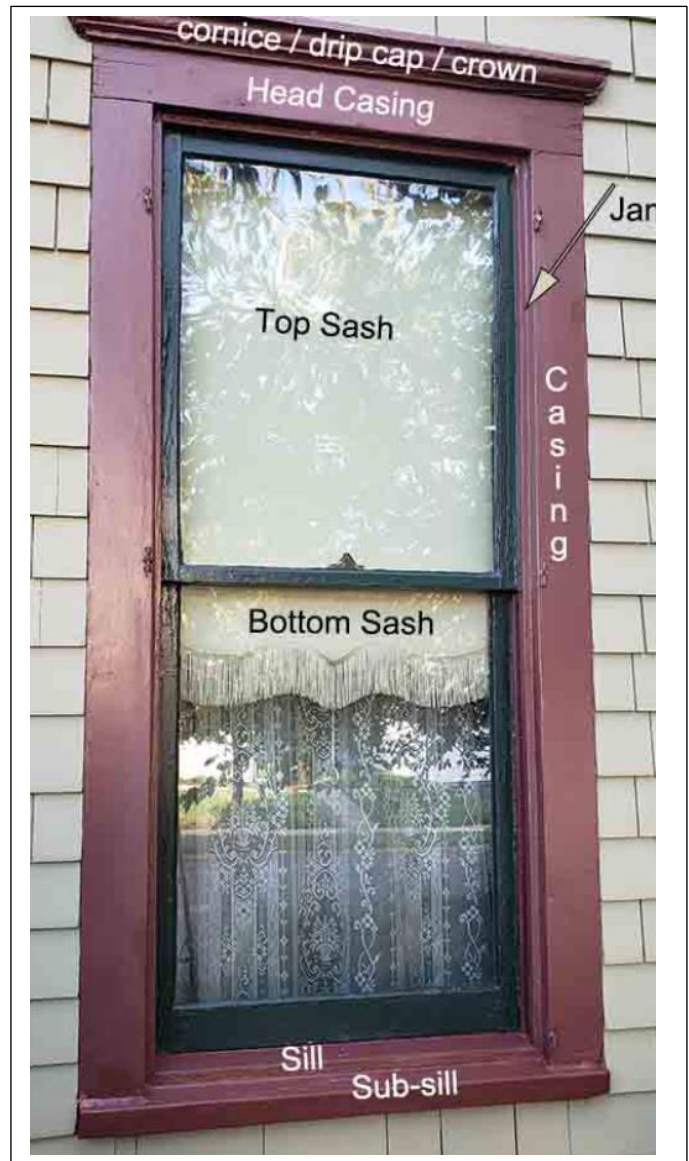
- Both proposed window unit types are single hung so that the top, fixed "sash" is integrated with the casing/brickmould. Therefore, a true jamb, sash channel, and blind stop is not visible from the exterior. As a result, the windows display a flat appearance which is wholly inappropriate to an historic property. A compatible replacement window should be double hung/display an independent upper sash, true jamb, sash channel, and blind stop. If single hung, the top sash of the unit should be independent of the brickmould/trim and the brickmould/trim should adequately display a true jamb, sash channel, and blind stop.

- The window unit casing/brickmould for both products is too flimsy and flat/lacks depth
 - The sill is minimal at both units
 - The sash top, side and bottom rails appear to be too wide/thick vs and historic-window (due to strength limitations of the material and each unit's accommodation of double paned glazing)

- The white finish color of the "American Standard" unit is not consistent with the color of the brick and/or the home's trim and does not conform to any of the colors outlined in the HDC's Color Systems.

See the proposed “American Craftsman” brand window [American Craftsman 24 in. x 36 in. 70 Series Single Hung White Vinyl Window with Nailing Flange 2030729 - The Home Depot](#). Note that the top sash appears to be integrated with trim vs presenting as an independent sash which is typical of historic windows. Also note the thickness of the top, bottom, and side rails of the sash casing (the part of the window that holds the glass) when compared to the historic window and the flimsiness of the trim.

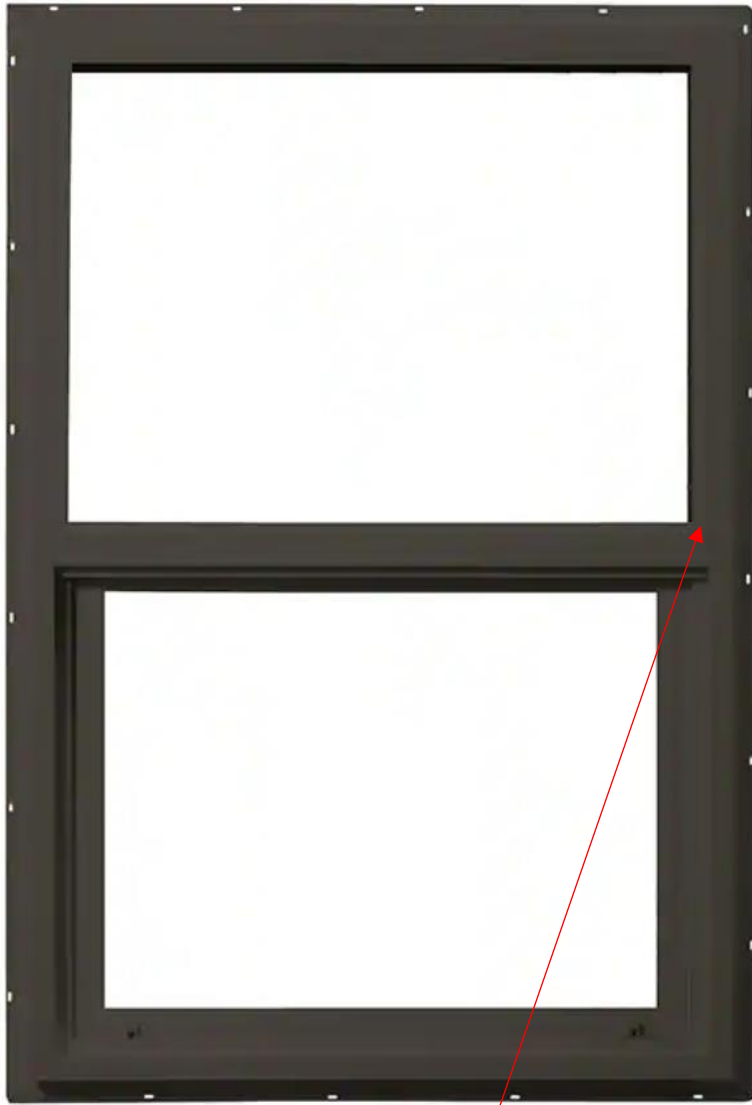
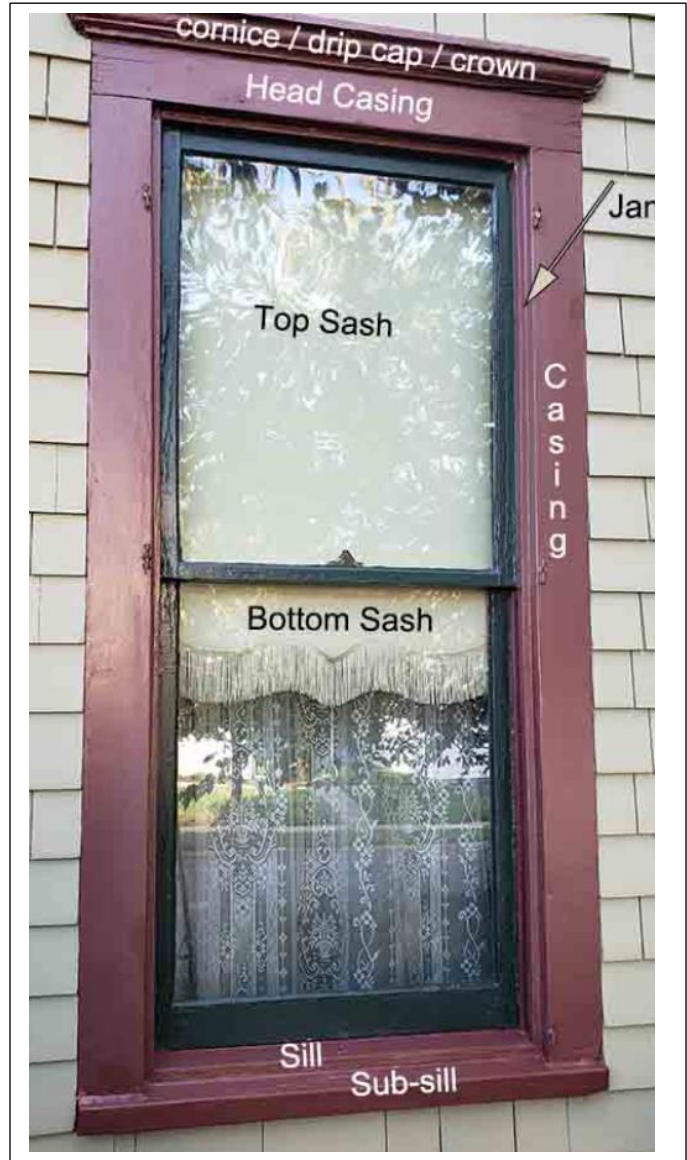
Similarly, see the proposed “Ply Gem” brand window [Ply Gem 23.5 in. x 35.5 in. Select Series Single Hung Vinyl Bronze Window with HPSC Glass and Screen Included 24x36SELSH - The Home Depot](#) and note that the top sash appears to be integrated with trim vs presenting as an independent sash which is typical of historic windows. Also note the Thickness of the top, bottom, and side rails of the sash casing (the part of the window that holds the glass) when compared to the historic window and the flimsiness of the trim.
