**STAFF REPORT: 7/12/2023 MEETING**

**APPLICATION NUMBER: #23-8434**

**ADDRESS: 1120 SEMINOLE**

**SCOPE: ERECT GREENHOUSE (WORK COMPLETED WITHOUT APPROVAL)**

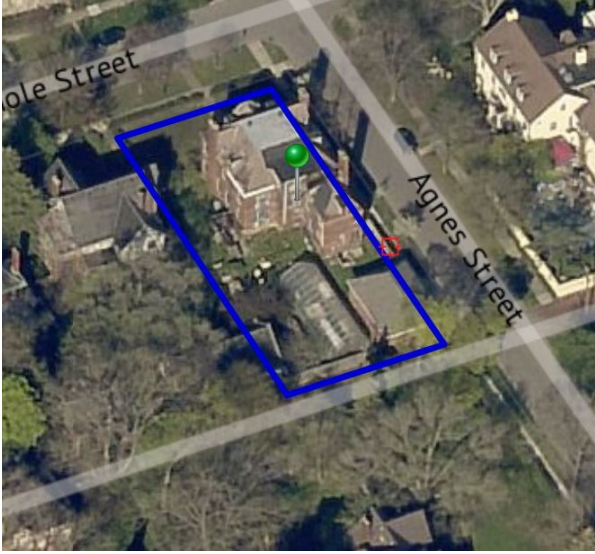
Aerial view, May 2020, showing hoophouse

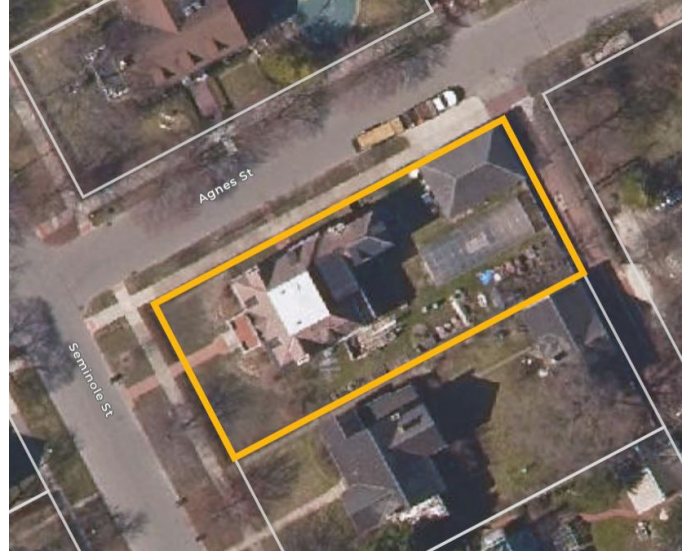
Aerial of Parcel 17007571, showing hoophouse

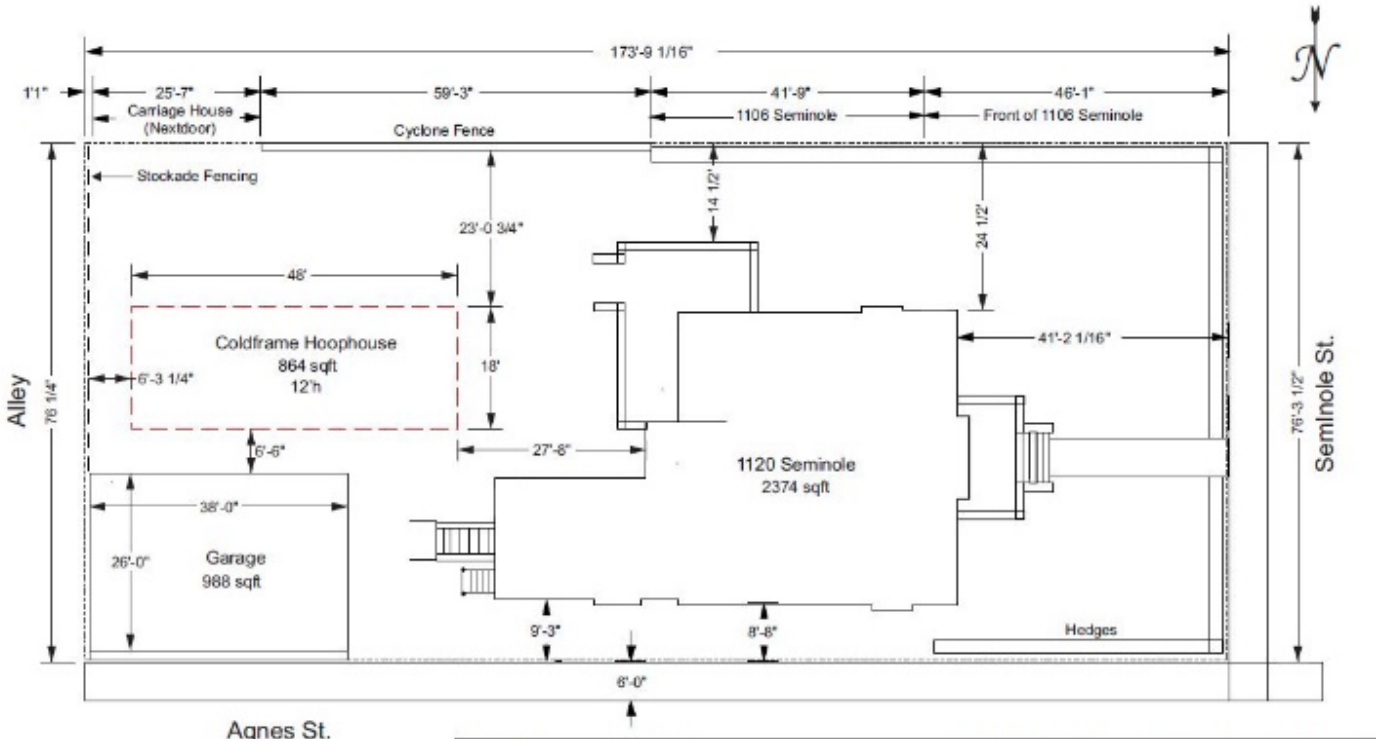
Figure 1 by Applicant (altered by staff for clarification), showing location of hoophouse in red.

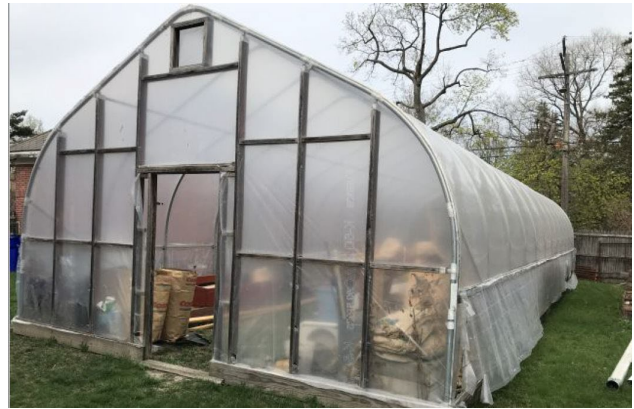
Site Photo 4, by Applicant, showing completed construction of hoophouse.

- Staff has the opinion that the 12’ height, gothic-style roof form and plastic materials are not appropriate as permanent materials as they conflict with the *Relationship of roof shapes* and *Relationship of materials* Elements of Design as listed above.

- Because of the structure’s height and massing, it is publicly visible from the front yard, as well as the side walkway and the rear, despite the surrounding privacy fence.

1. The applicant shall afford the Commission the opportunity to define an appropriate timeframe which the hoop house may remain as a temporary structure within the subject parcel.
2. The applicant shall remove the hoop house and restore the property to an appropriate condition, per staff review, upon the expiration of the Commission’s defined temporary period.
