STAFF REPORT: JULY 12, 2023 MEETING

APPLICATION NUMBER: 23-8397

ADDRESS: 14860 PIEDMONT

HISTORIC DISTRICT: ROSEDALE PARK

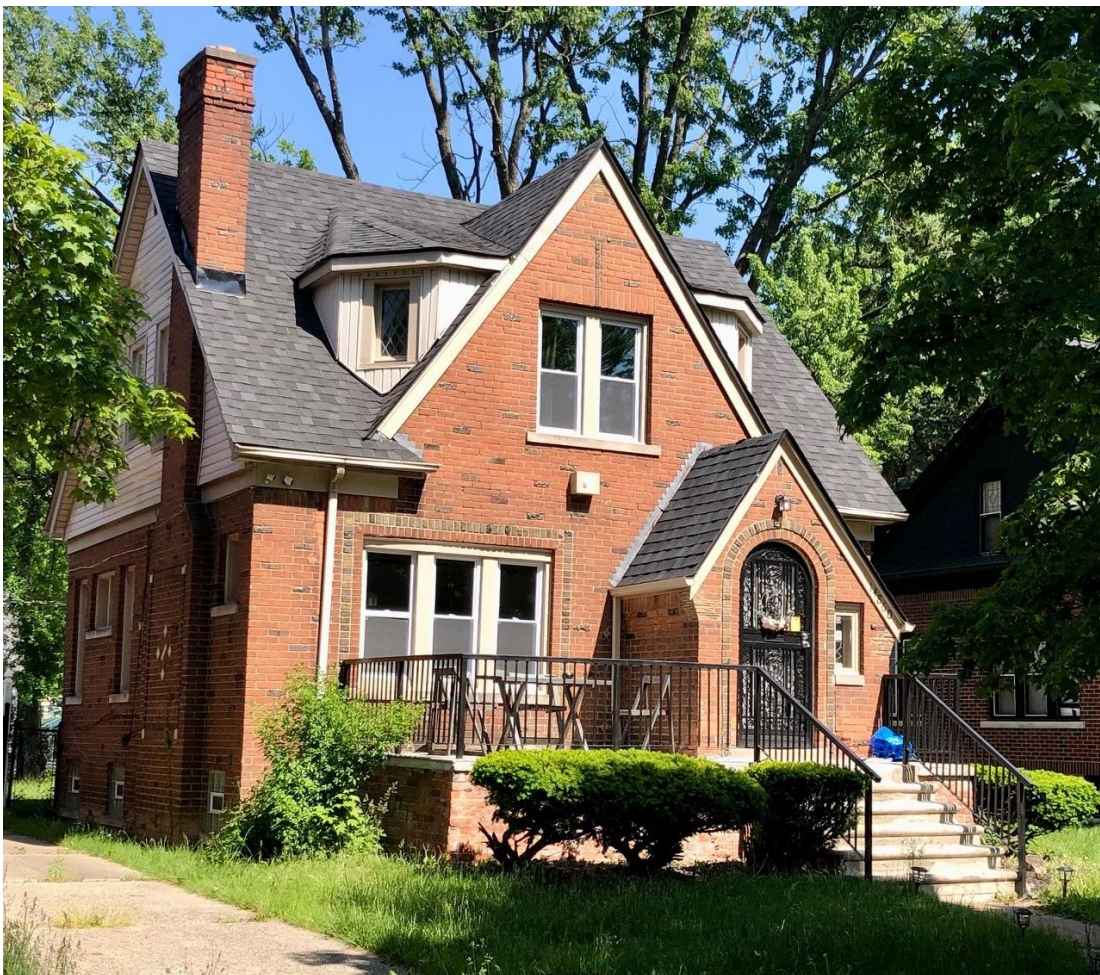
Staff photo, May 31, 2023.

The house at 14860 Piedmont is a 1-1/2 story English cottage-style dwelling. It features a reverse gable roof with an intersecting front gabled wall; small dormers fill the roof valleys. The extended front entrance has a catslide roof and arched door that is accessed by a raised porch. Roughhewn brown brick, contrasting the dominant reddish-orange brick, is used for decorative effect on every wall surface. The upper walls within the side gables and front dormers are covered with vinyl siding. The raised open porch is enclosed with a non-historic railing.

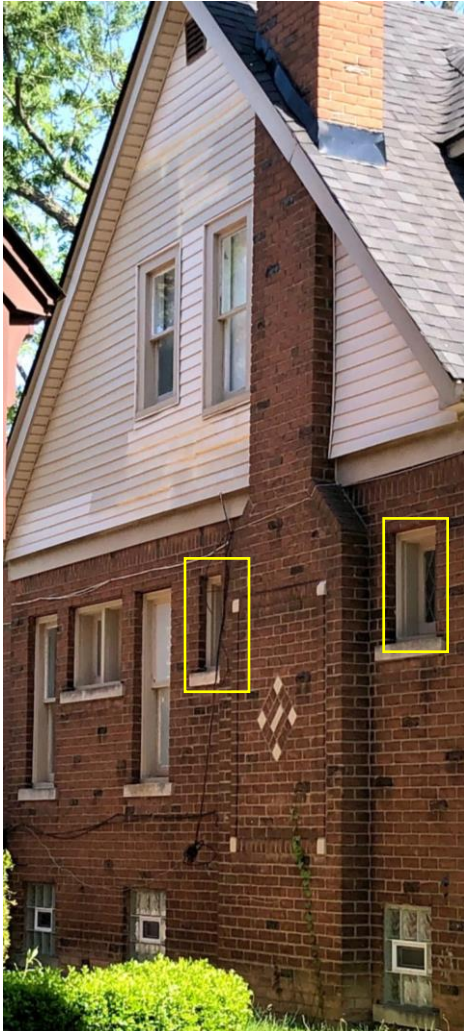
South-side elevation

The south side elevation has a combination of wood framed double-hung and small square fixed units. Diamond paned leaded glass fill the fixed openings adjacent the chimney, and the fixed mullied openings near the rear have clear glass. The north-side elevation consists of one small diamond paned leaded glass opening, three wood double-hung units and one wide vinyl replacement (single or double-hung) window. The basement windows on the side elevations have vented glass block. The rear elevation retains wood double-hung units and a multi-paned double casement.

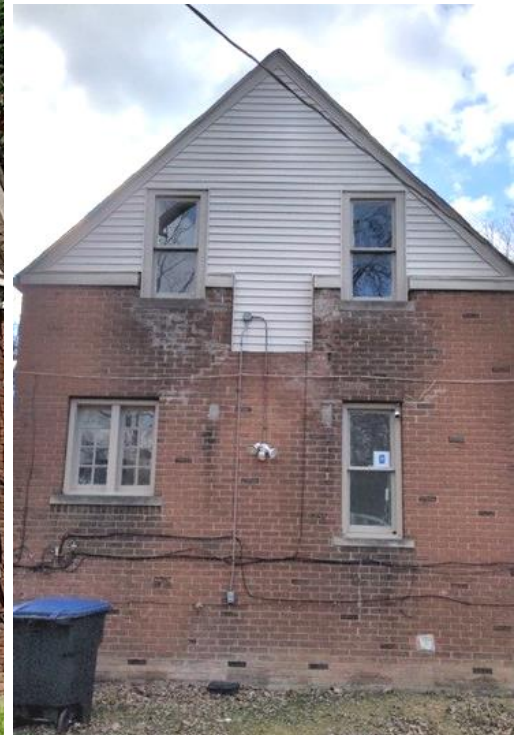
Rear Elevation, Applicant photo

*Window circled in red indicates vinyl window.
Windows within yellow squares indicate leaded glass windows.*

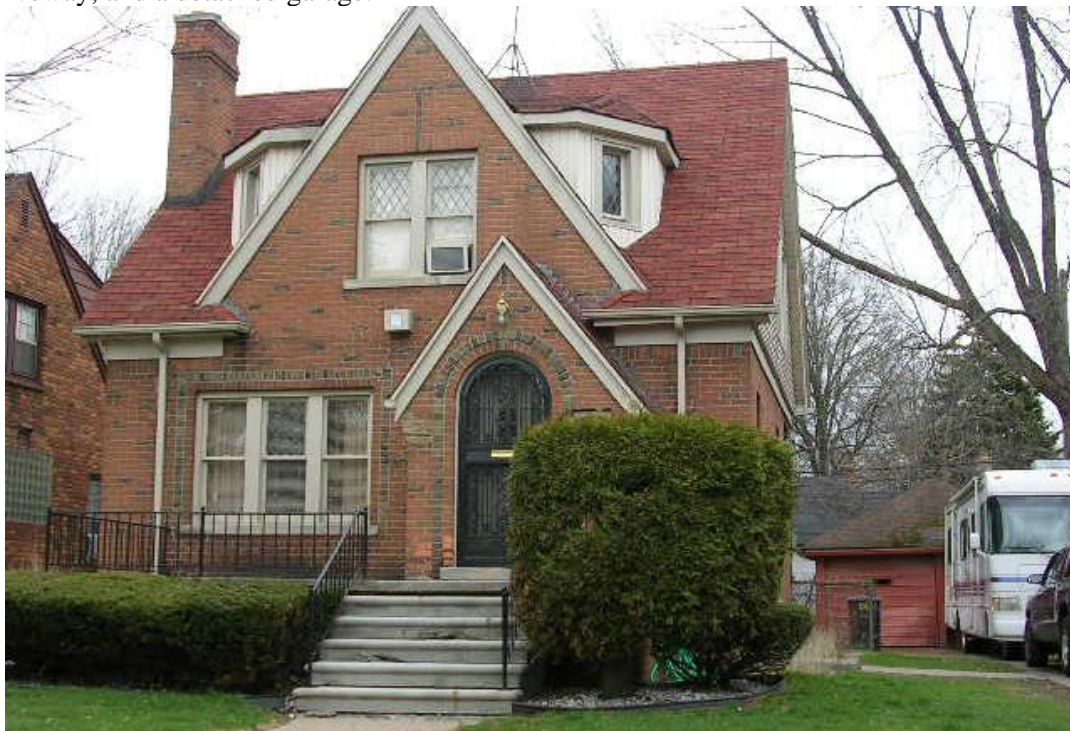
2007 Designation photo, HDAB

- The designation photograph shows wood framed leaded glass (upper sash) double-hung windows at the front elevation second story and the central window at the first story, which is flanked by one-over-one wood double-hung units. Other visible site components include a low metal porch and stair railing, chain link fence at the driveway, and a detached garage.

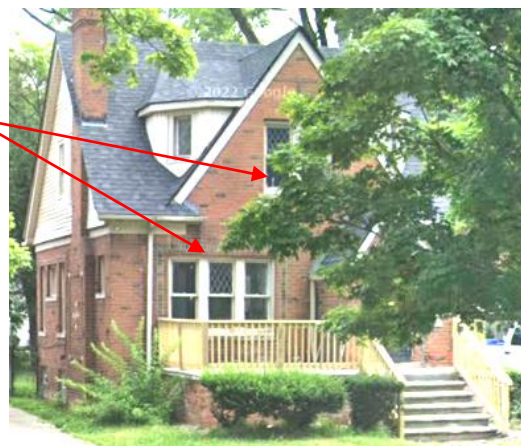
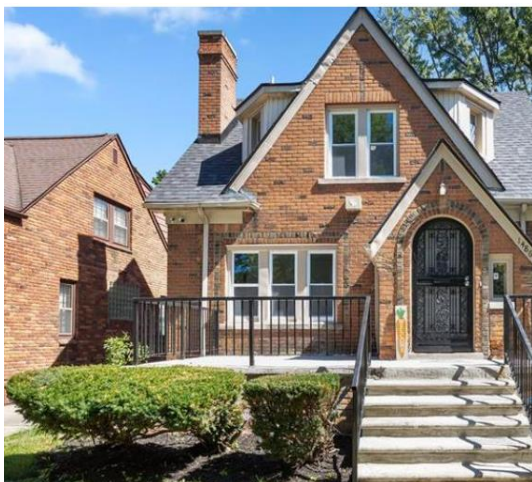
- The real estate listing image shows vinyl one-over-one windows in place at the front elevation.
- A tall, straight spindle/post metal railing replaced the non-approved wood railing.

*Above: Google street view, 2022, unfinished wood railing is highly visible.
Left: Real estate listing photo, 2023.*

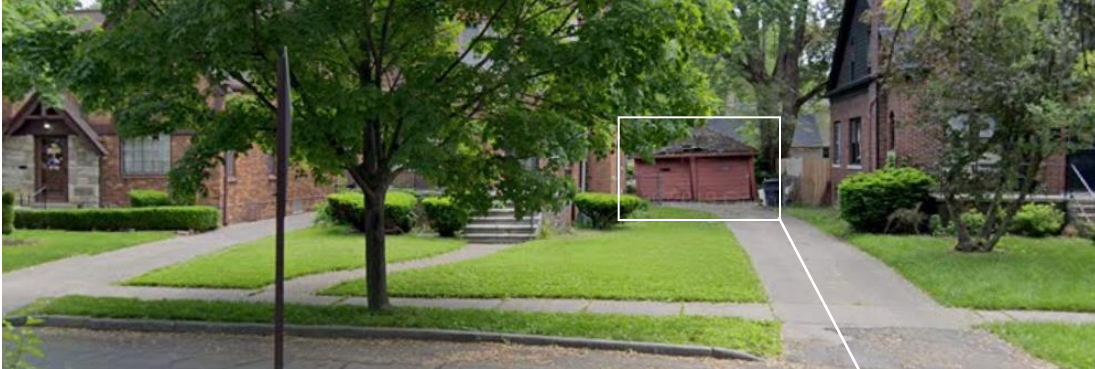
Google street view, 2019

- As seen in the photo to the right, the wood framed structure had a pyramidal hip roof and two individual car openings. The structure had a generalized historic massing, roof height and shape of garages built in the early 20th century. Staff considers the structure a contributing feature of the property, however, the garage didn't offer distinctive character-defining features such as masonry walls or a steeply sloped roof pitch and profile.
- The 2019 photo showed visible leaning of the entire building, along with a deteriorated roofing structure. It is staff's opinion the visual documentation is sufficient to confirm its severely deteriorated condition.

Staff finds that the proposal for the demolition of the garage will not alter the features and spaces that characterize the property and district and therefore recommends the Commission issue a Certificate of Appropriateness for the work as proposed as it meets the Secretary of the Interior’s Standards and the Elements of Design for the district.

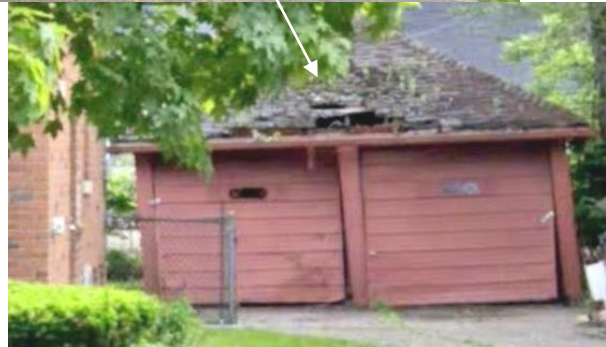
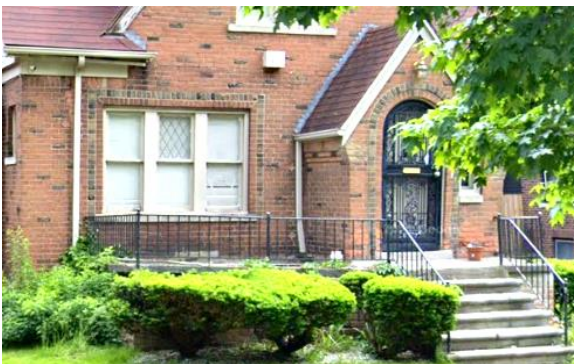
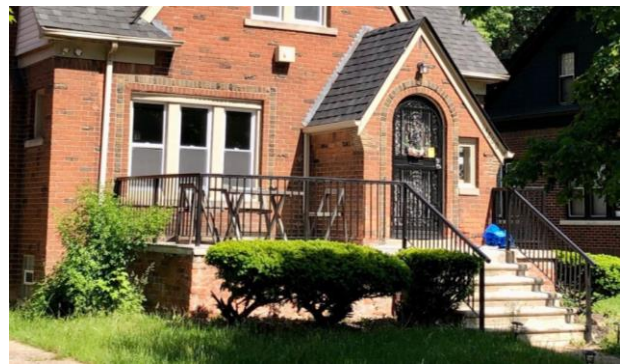
- The 2019 photo confirms the metal porch and stair railing was at a historic and appropriate height. By late 2022 a taller metal railing had been installed.

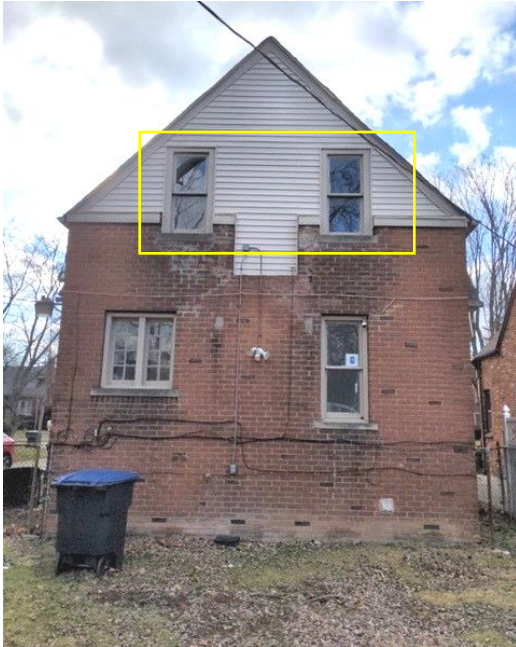
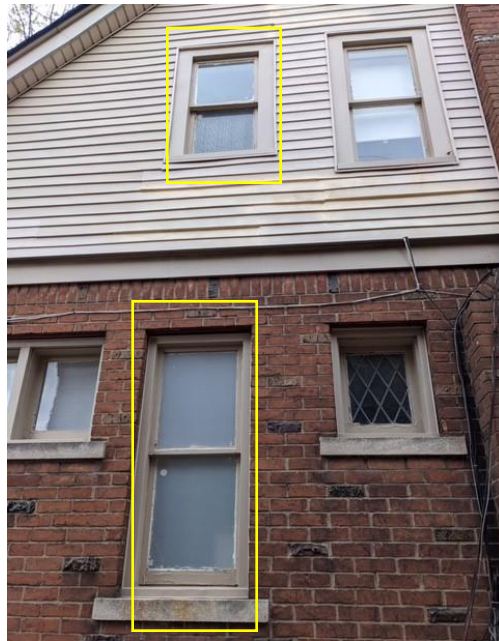
- The four windows the applicant is requesting to replace are located on the north-side elevation and the rear elevation.

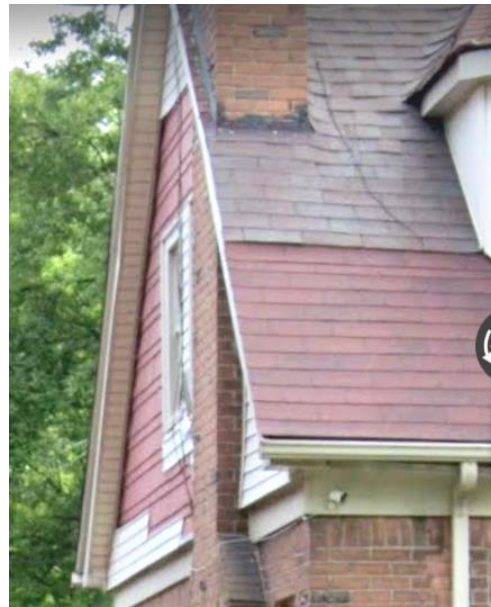
Google street view, 2019.

- The gable and dormer walls were covered with vinyl siding at the time of district designation. However, in June 2019, Google street view photographers captured a view of the north-side gable when some of the vinyl siding was not in place, exposing the original wood siding and window casing.

Note: As the other elevations remained covered with vinyl siding (confirmed through additional 2019 Google street view images), staff believes this section of vinyl was being replaced, which is allowed as this qualifies as a repair. (Current photos of this gable wall give evidence to a partial siding replacement.) Staff included this image to say that, while existing conditions (i.e., vinyl siding and aluminum window casing wrap) offer a flat appearance similar to the proposed vinyl windows, as long as historic material stays in place, the opportunity remains to uncover and repair character-defining features.

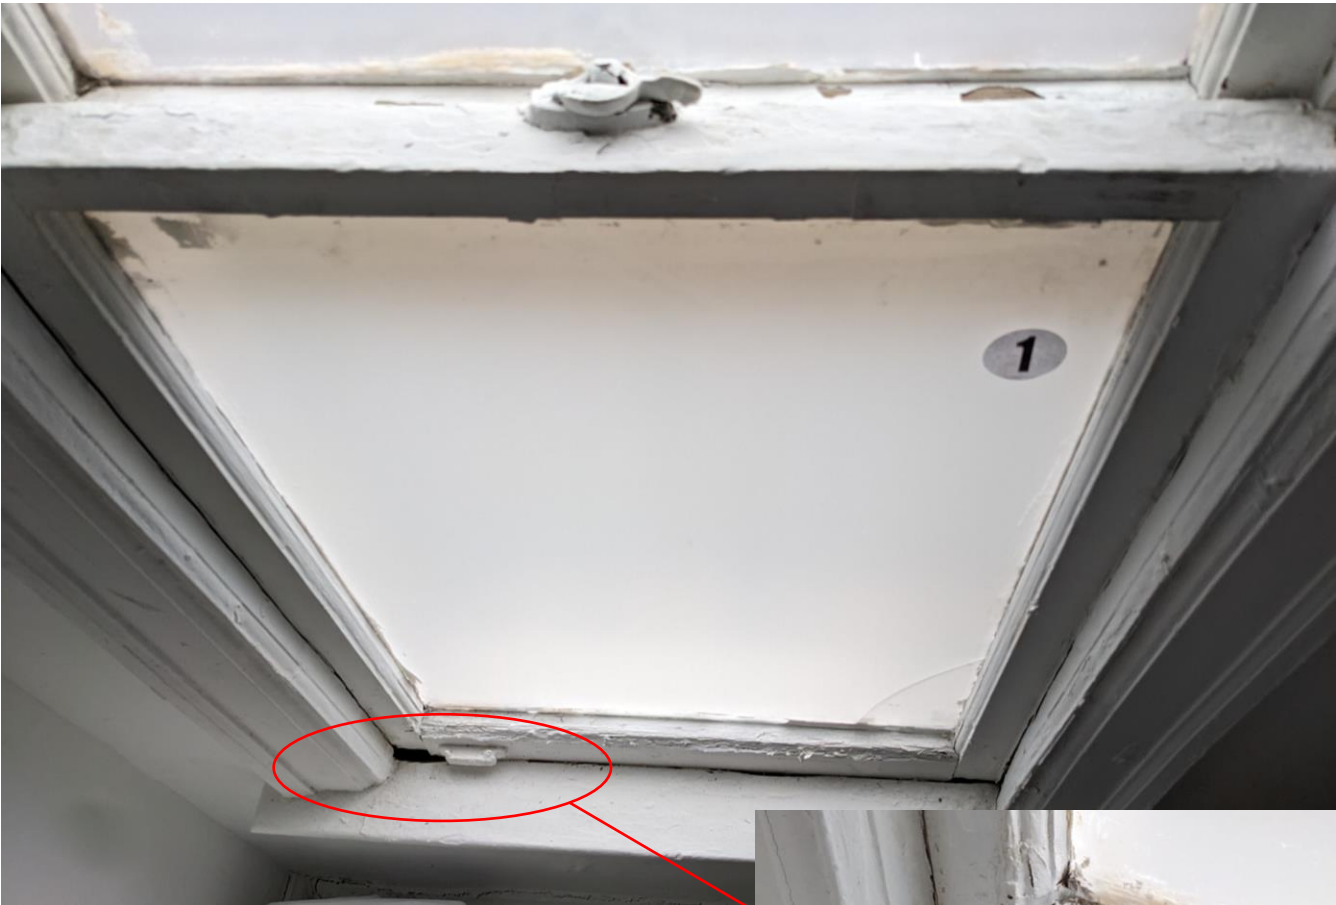
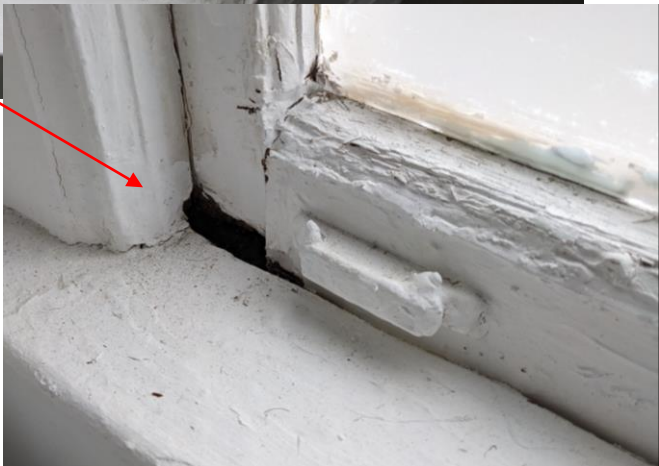
Applicant photos – Lower sash of window #1

- The applicant's description of existing conditions for the wood windows proposed for replacement confirms that repairs to the windows are needed. However, the interior and exterior photographs show intact window frames and solid window openings; the frames do not appear to be significantly deteriorated. Therefore, adding weatherstripping, caulk, wood filler and, at times, new glass would offer tremendous improvement in the efficiency of the existing windows; adding storm windows would help further reduce the infiltration of cold air and allow the air-conditioned air to stay inside during the summer months. Operation of the windows can likely be regained by removing layers of paint and repairing interior hardware.

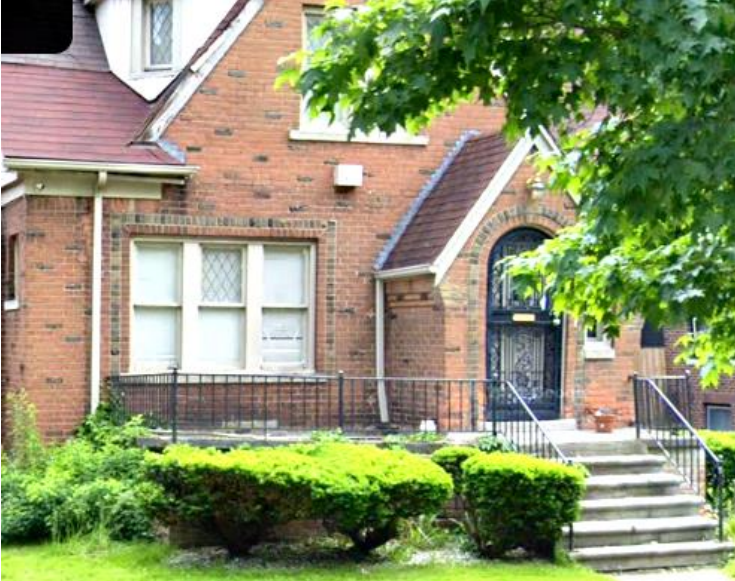
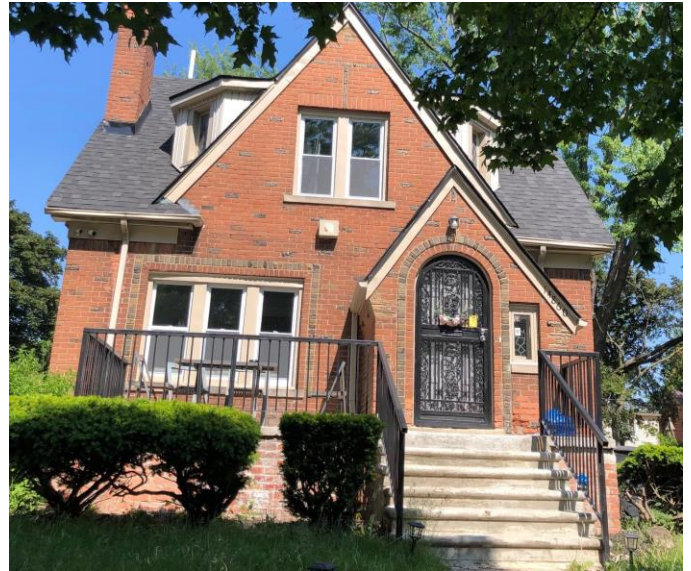
- As noted earlier, the historic metal porch railing was removed between 2019 and 2022. The height of the low railing was below the windows and enclosed the raised porch without conflicting with the architectural detailing of the first floor window opening. The height of the current railing is out of scale with the historic structure. It is a bold, dominant form against the front elevation. The straight spindles are similar to the previous design; however, the lack of defined center and corner posts, and increased height, causes this component to appear less like a railing and more like a barrier against the front elevation.
