STAFF REPORT: JULY 12, 2022 REGULAR MEETING

APPLICATION NUMBER: 23-8439

ADDRESS: 14910 STAHELIN

SCOPE: REMOVE WOOD PATIO DOOR, INSTALL VINYL PATIO DOOR

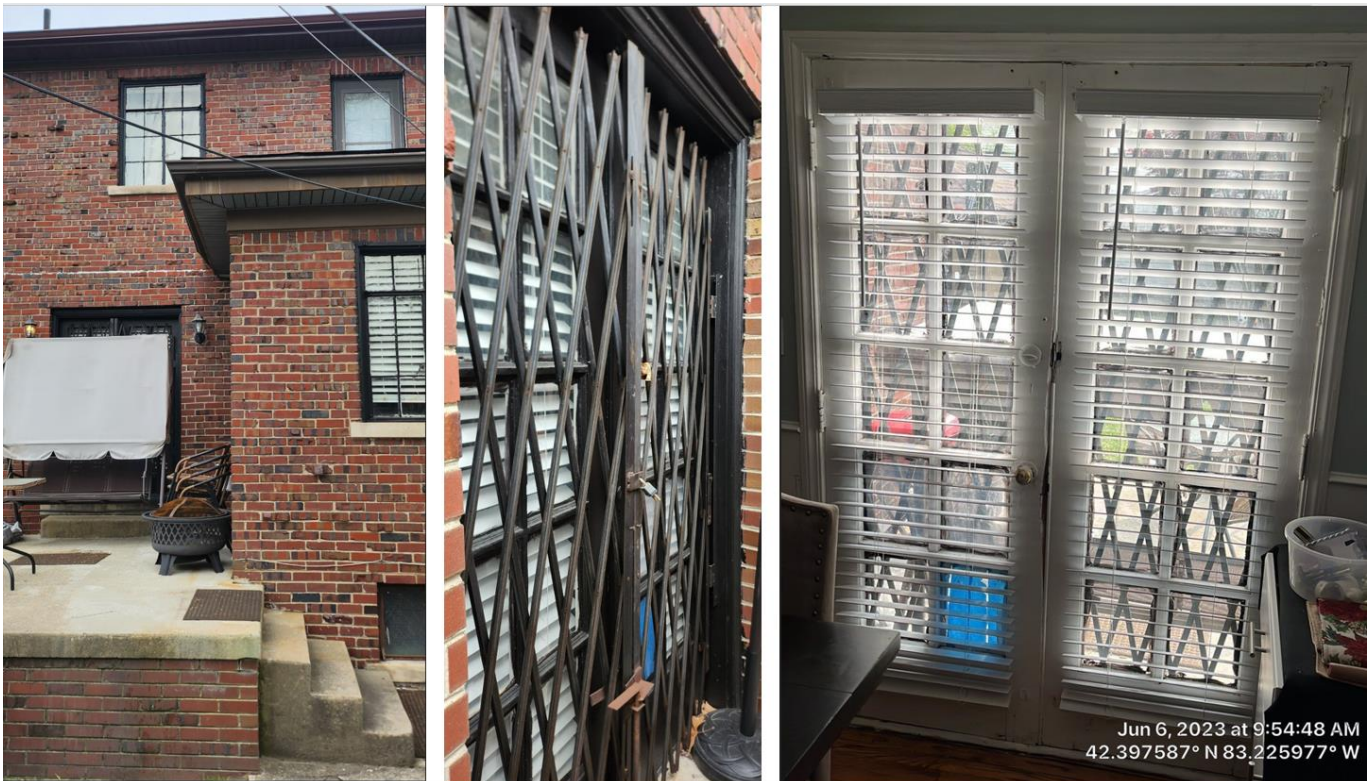
Existing door. Photos provided by applicant.

The existing door consists of a pair of ten-light, glazed wood doors, as seen in the photos above.

The applicant states that the existing door is damaged: “The current door is missing part of the door by the door handle and deadbolt. The molding on the interior is non-existent by the deadbolt area.” The applicant also states that the new door will be more energy efficient.

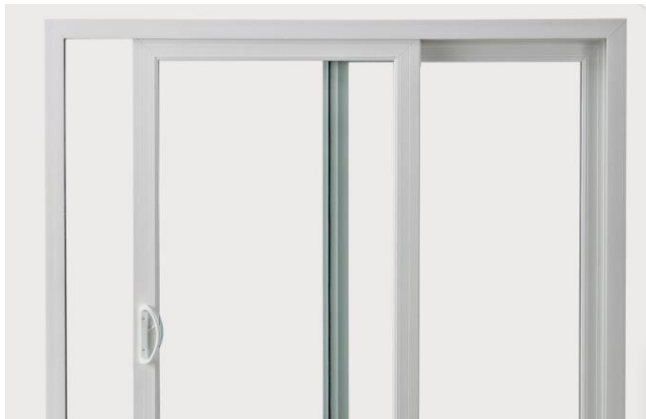
WeatherGard sliding patio door, interior view. Image from website. The website does not provide an exterior view. Also note that the proposed door is black, not white.

- The proposed door approaches compatibility in that it is a double, patio door with grids to mimic a divided light, and is in an appropriate color. However, a truly compatible door would "match the old in design, color, texture, and other visual qualities and, where possible, materials," (Standard #6); that is, it would be of metal or wood rather than vinyl and have true muntins or simulated divided lights (Regardless of compatibility, the replacement of historic material would still not be appropriate unless the existing door were beyond repair).

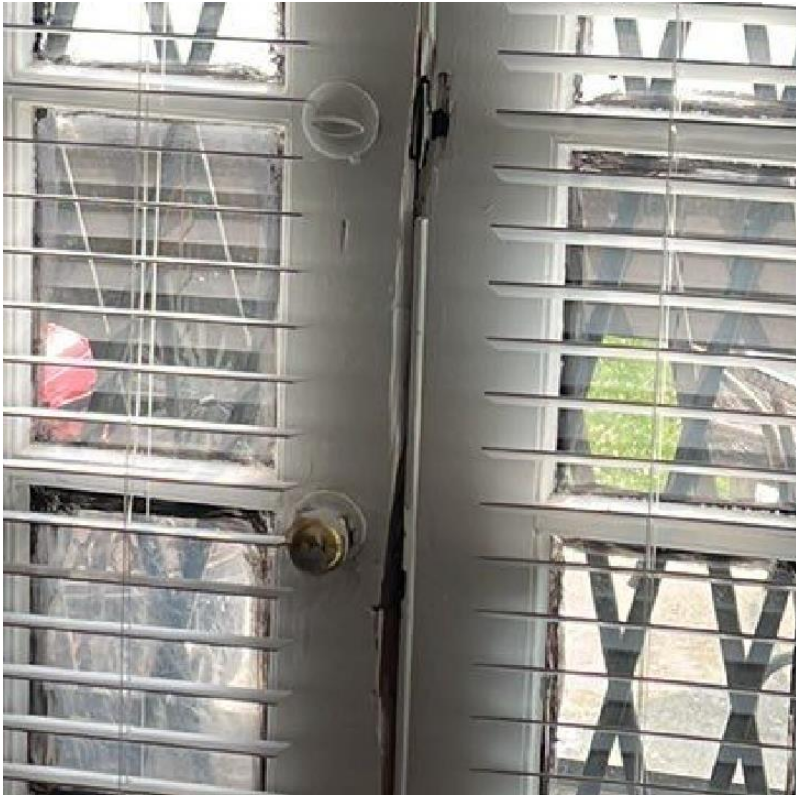
- The applicant has noted damage to the door, as described above.

Close-up of damaged area. Photo provided by applicant and cropped by staff.

- If the door has deteriorated beyond repair, its in-kind replacement is acceptable, according to the Standards. However, the photos provided do not suggest that the door has deteriorated beyond repair.

- If the applicant wishes to have increased security and energy efficiency, a more appropriate intervention would be the installation of a storm door or security door. The existing opening appears to have adequate depth to accommodate such a door. To be appropriate, the storm door or security door must be of a compatible material and include sufficient transparency to avoid concealing the historic door.
