STAFF REPORT: AUGUST 9, 2023 REGULAR MEETING **PREPARED BY:** T. BOSCARINO
APPLICATION NUMBER: 23-8482
ADDRESS: 630 VIRGINIA PARK
HISTORIC DISTRICT: NEW CENTER AREA
APPLICANT/OWNER: JOE GUADAGNINO
DATE OF PROVISIONALLY COMPLETE APPLICATION: JULY 17, 2023
DATE OF STAFF SITE VISIT: JULY 19, 2023

SCOPE: REPLACE FRONT DOOR, TRANSOM, AND SIDELIGHTS

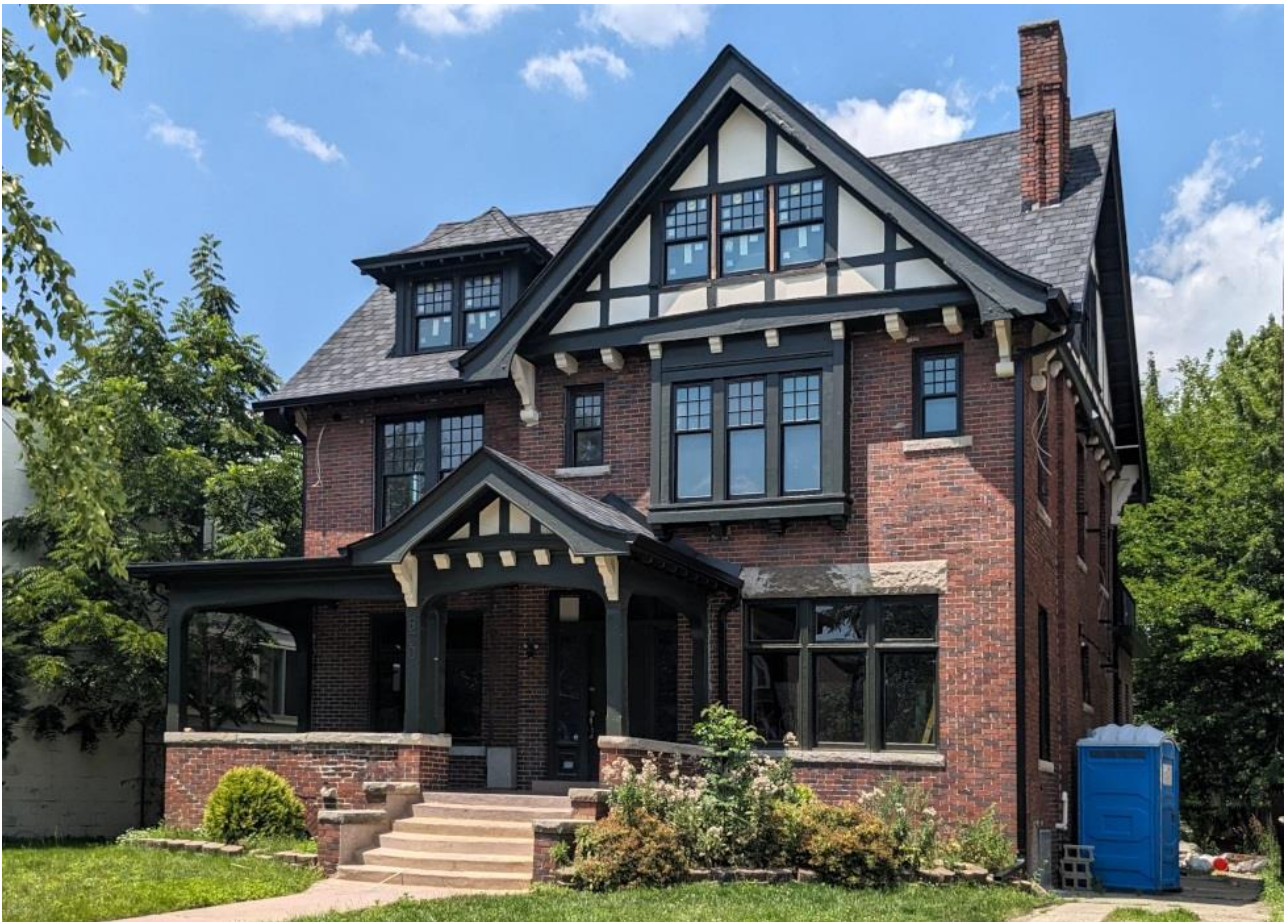
Built in 1906, the property at 630 Virginia Park is a two-and-one-half story building, located midblock and facing south towards the street. It is an English Revival or Tudor Revival house, clad in brown brick. Character-defining features include the asymmetrical façade with a dominant Tudor-style gable that projects forward from the east side of the front façade. On the west side of the front façade, a covered porch with a limestone cap also projects from the centrally located front entrance. Above, expressive fascia boards and half-timbering in the upper portion of the gables are supported by decorative dentils. An articulated gable aligned with the front door projects past the rest of the porch canopy and balances the composition of the front façade. Within the doorway, a door surround (subject of this application) with transom and sidelights is also a defining feature. Windows were replaced in 2020 or 2021.

July 2023 photo by staff.

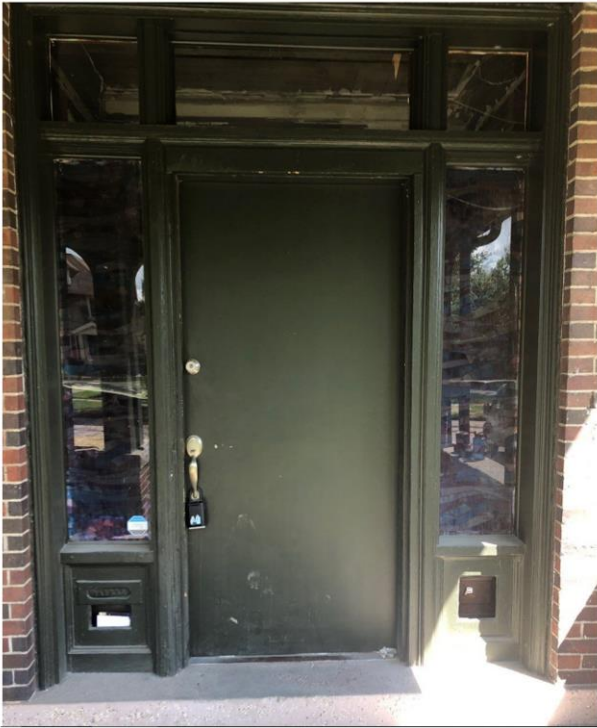
Left: Current front entrance. Right: Proposed new front entrance. Images from application materials.

- Based on the photo provided by the applicant and a staff site visit, the header and jambs of the door frame appear to be composed of dimensional lumber and are likely recent, non-historic elements. The glass in the sidelights and, potentially, the transom, is also likely to be non-historic as fixed, non-subdivided windows were historically very uncommon.

- The current door is non-historic as it was installed sometime between 1982, when the historic district was established, and 2009, when it is visible in a Google Street View photo. There is no record of Historic District Commission approval.

- Inferred by staff from the age and style of the building, the remaining wood components appear to be historic or original. They also appear, from photos, to be in good condition. Staff has asked the applicant for additional clarification regarding any elements that are believed to be non-historic or damaged.

- Replacing the sidelight and transom panes, themselves (but not the wood surrounds), would potentially be appropriate, as they appear to be non-historic features. The replacement should be a pane of a compatible design, such as one subdivided by metal came or wood muntins.
- The proposed black paint color is potentially appropriate, depending on a plan for painting the rest of the building. If the building continues its current color scheme, black is appropriate for window sashes only (see Color System D, as adopted by the Historic District Commission, for additional guidance).

- The doorway surround, still in place, should also be retained unless it is shown to have deteriorated beyond repair, according to Standard #6. If deteriorated beyond repair, it should be replaced in kind.

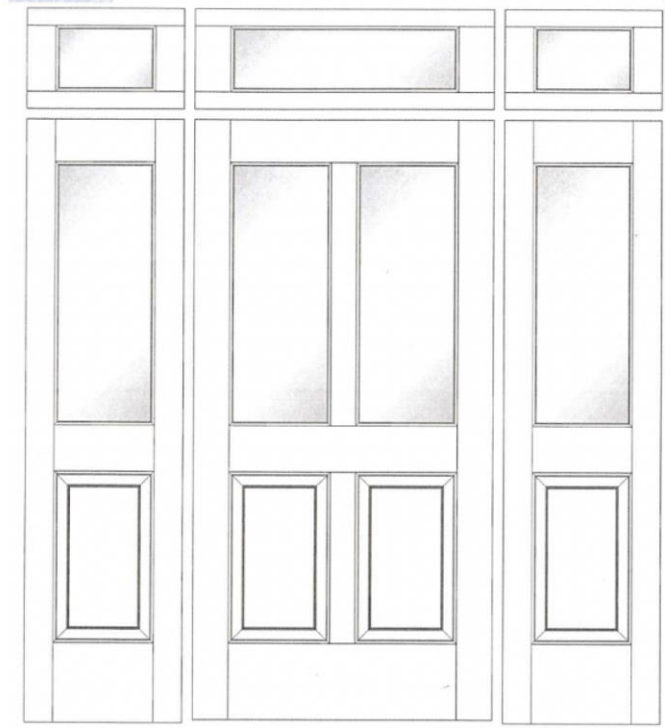
The proposed replacement is a Sampson Door Company custom unit. It would be wood, painted black, with brass and bronze hardware.

- Even if the door and surround were to be deteriorated beyond repair, the proposed new unit is not appropriate, as it does not match the old, as noted above.

- Staff further suggests that the overall configuration of the door and sidelights, consisting of tall, glazed areas above much shorter wood panels, is a “feature and space that characterize[s] the property” that should be “retained and preserved” (Standard #2). The proposed doorway, by reducing the glazed area and incorporating larger wood panels below, disrupts this character.

Therefore, staff recommends that the Commission issue a Denial as the proposed work fails to meet the Secretary of the Interior’s Standards for Rehabilitation, in particular:

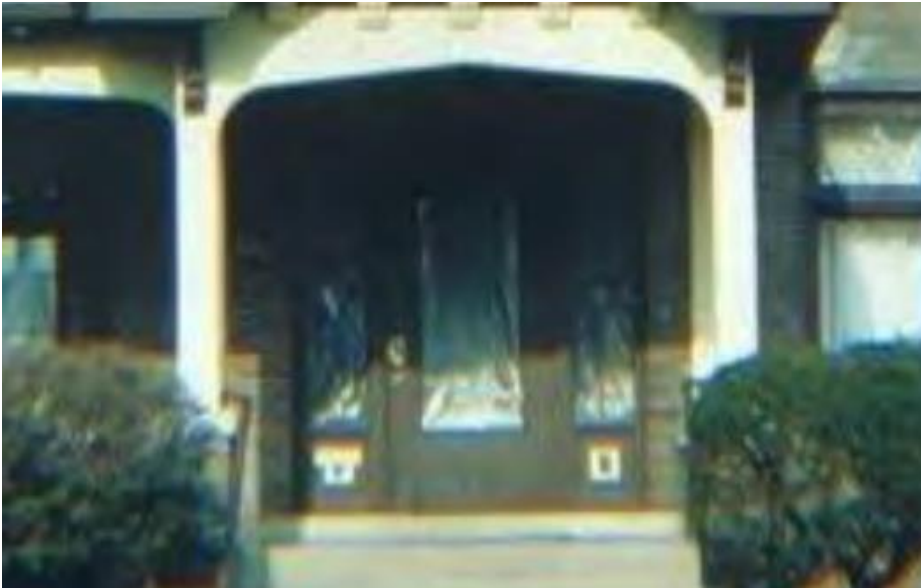
1982 Historic Designation Advisory Board photo (cropped) depicting previous door.

- Staff notes that the door has already been replaced without evidence that it has deteriorated beyond repair. Further, the proposed new door does not match the historic door, as seen in the above 1982 photo. These issues are contrary to the Secretary of the Interior’s Standards for Rehabilitation, particularly Standard #6: “Deteriorated historic features shall be repaired rather than replaced.” If the feature has deteriorated beyond repair, “the new feature shall match the old . . . replacement of missing features shall be substantiated by documentary, physical, or pictorial evidence.”

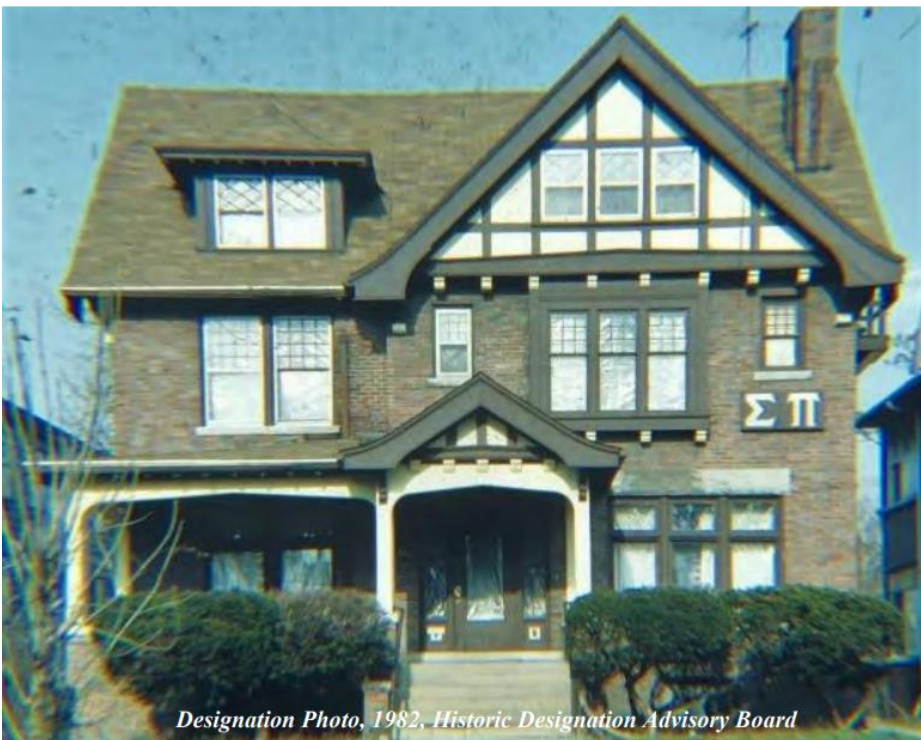
Designation Photo, 1982, Historic Designation Advisory Board

1982 Historic Designation Advisory Board photo.
