**ADDRESS: 3964 W. LAFAYETTE**

**APPLICATION NO: #23-8475**

**HISTORIC DISTRICT: HUBBARD FARMS**

**SCOPE: DEMOLISH WING, CONSTUCT NEW WING**

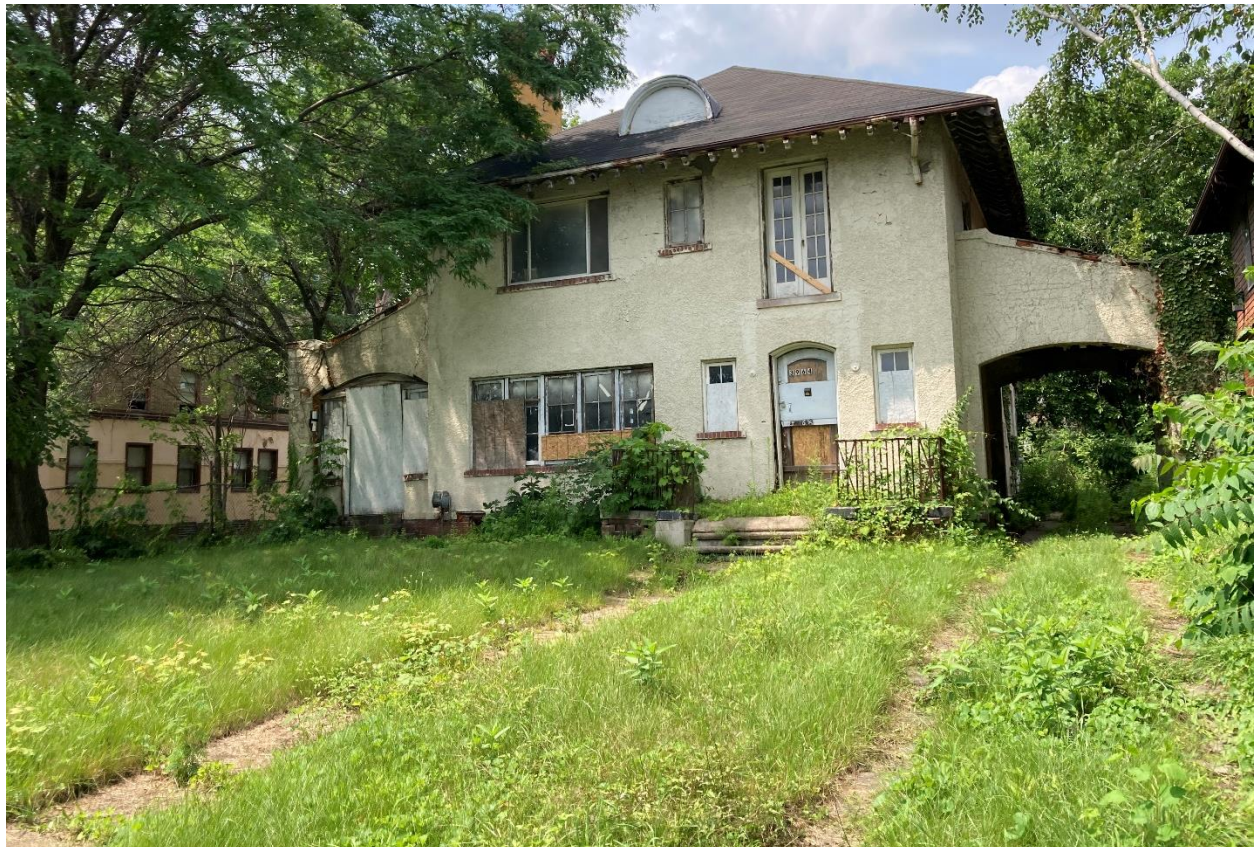
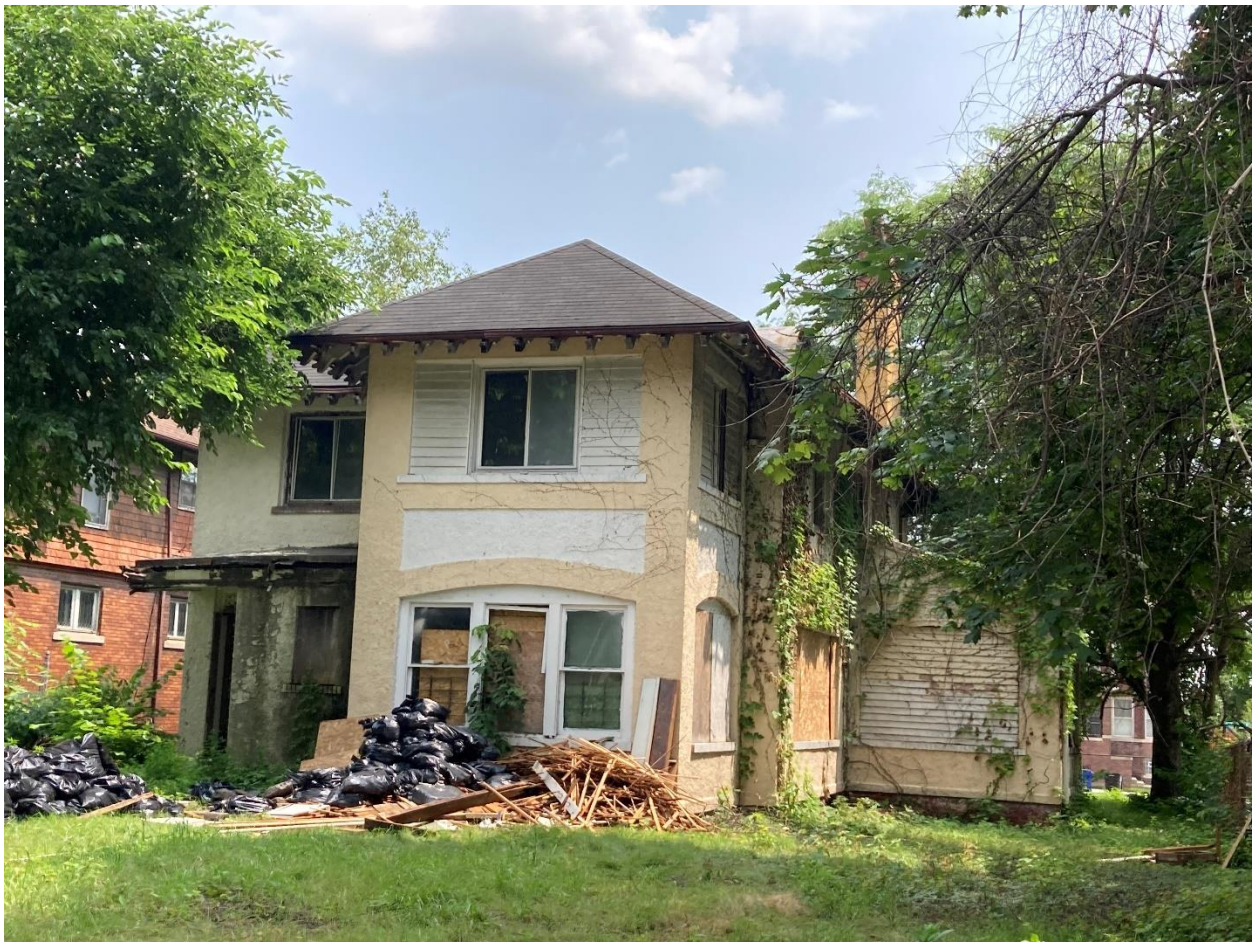
The building located 3964 W. Lafayette is structural clay tile dwelling that was erected ca. 1915. The home features a two-story, hipped-roof central/main mass with a projecting, two-story, hipped-roof wing at the rear. Arched and shed-roof dormers and a prominent stucco clad chimney top the building's main roof. The roof's deep, overhanging eaves include wood beadboard soffits and decorative jigsawn wood rafter tails. A shed-roof wing is located at the west side while a shed-roof porte cochere is at the building's facade elevation. The west side wing and the east side porte cochere both display decorative jigsawn wood rafter tails within their eaves and distinctive clay tile parapets which are clad with stucco. Stucco clads the building's exterior walls while red brick is present at the foundation and windowsills. Lapped wood siding is located within several window openings and a door opening at the front of the west wing. Historic double-hung and casement wood windows with wood trim/brickmould remain at all facades, although some have been covered with plywood. Also, a small number of non-historic vinyl slider windows are visible. A review of files maintained by the HDC indicate that these non-historic windows were present at the time of designation. A partial width, brick and concrete porch with stone steps and historic-age iron railing is located at the building's primary facade. A 6'-0" high, metal chain-link fence encloses the property.

**3964 W. Lafayette, current appearance. Staff photos taken 7/13/2023**

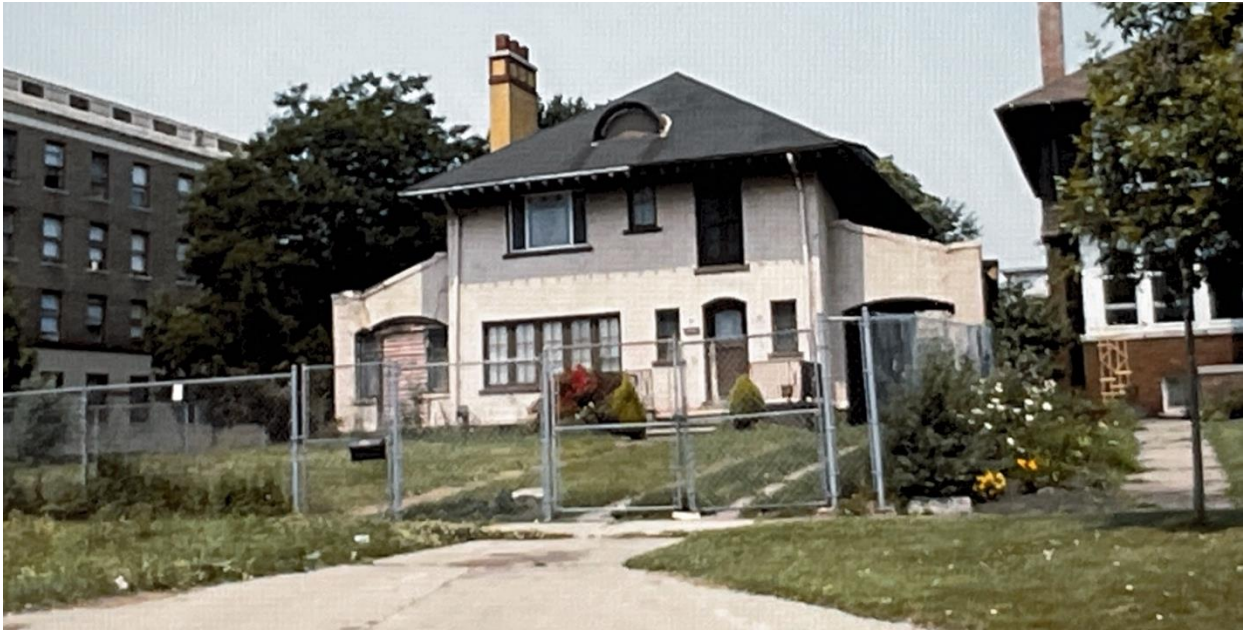
**3964 W. Lafayette, designation slide**

- Per the previous point, the wing proposed for demolition has been extant as an enclosed space since at least 1921. See the below designation slide which demonstrates that the wing mirrors the appearance of the porte cohere and provides a distinct sense of symmetry when viewing the home's primary elevation from Lafayette Street. The wing also includes a number of distinctive architectural details which are associated with the Spanish Colonial style to include arched window openings, stucco cladding, and deep overhanging eaves with decorative jigsawn wood rafter tails at its roof. The wing also retains its original wood windows and trim (see below photos). For these reasons, the wing is a distinctive character-defining element of the building, in staff's opinion.

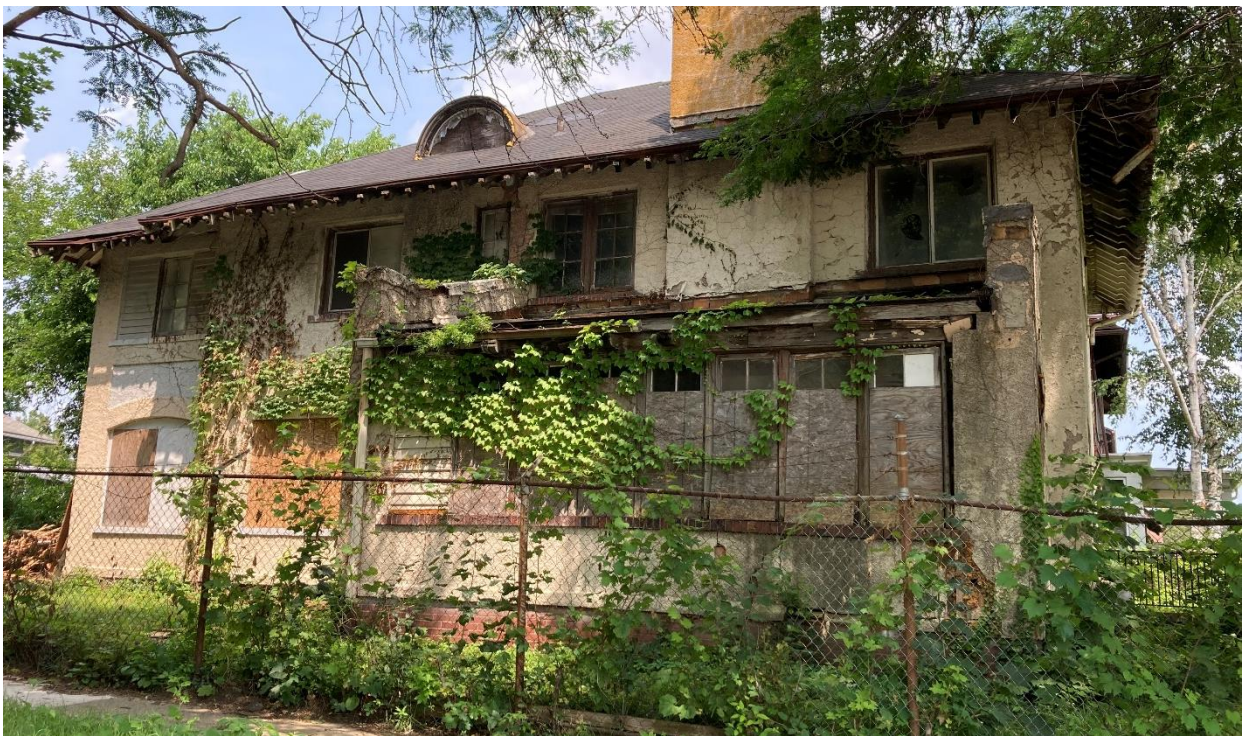
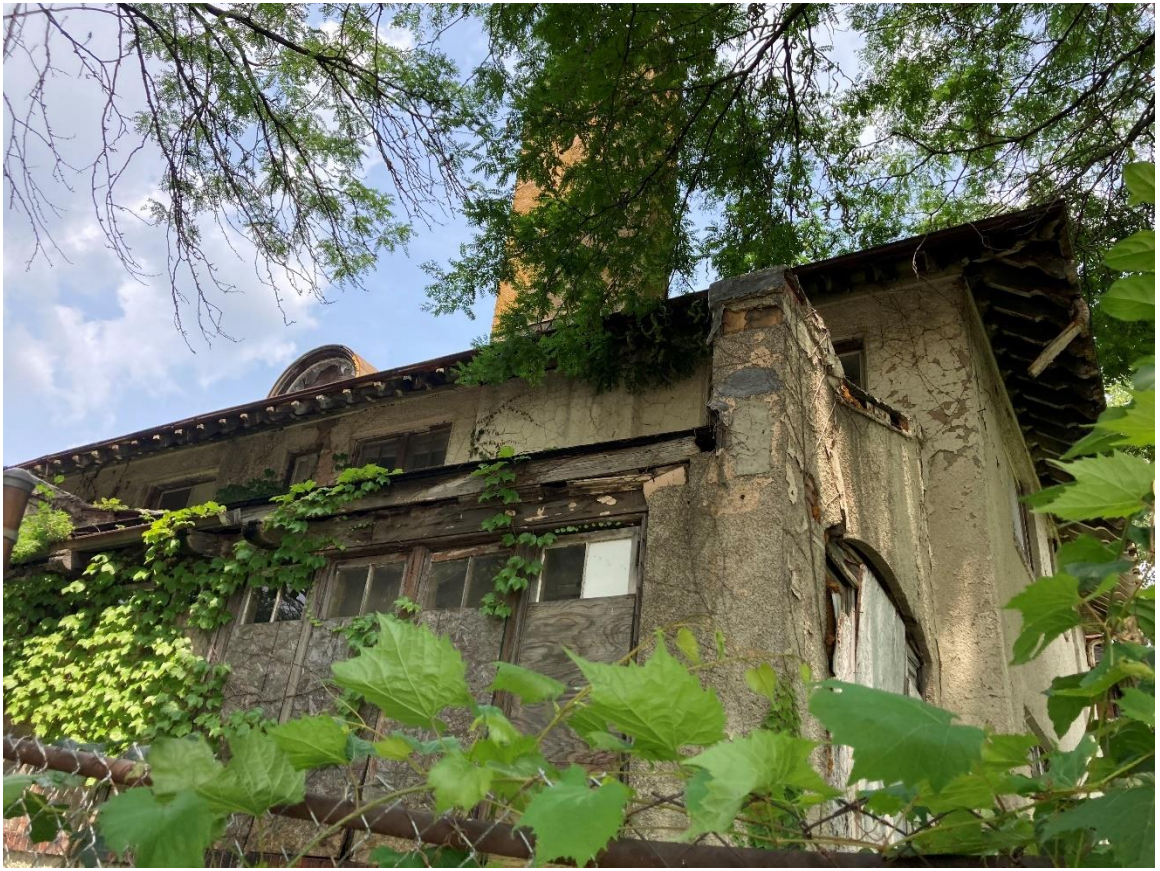
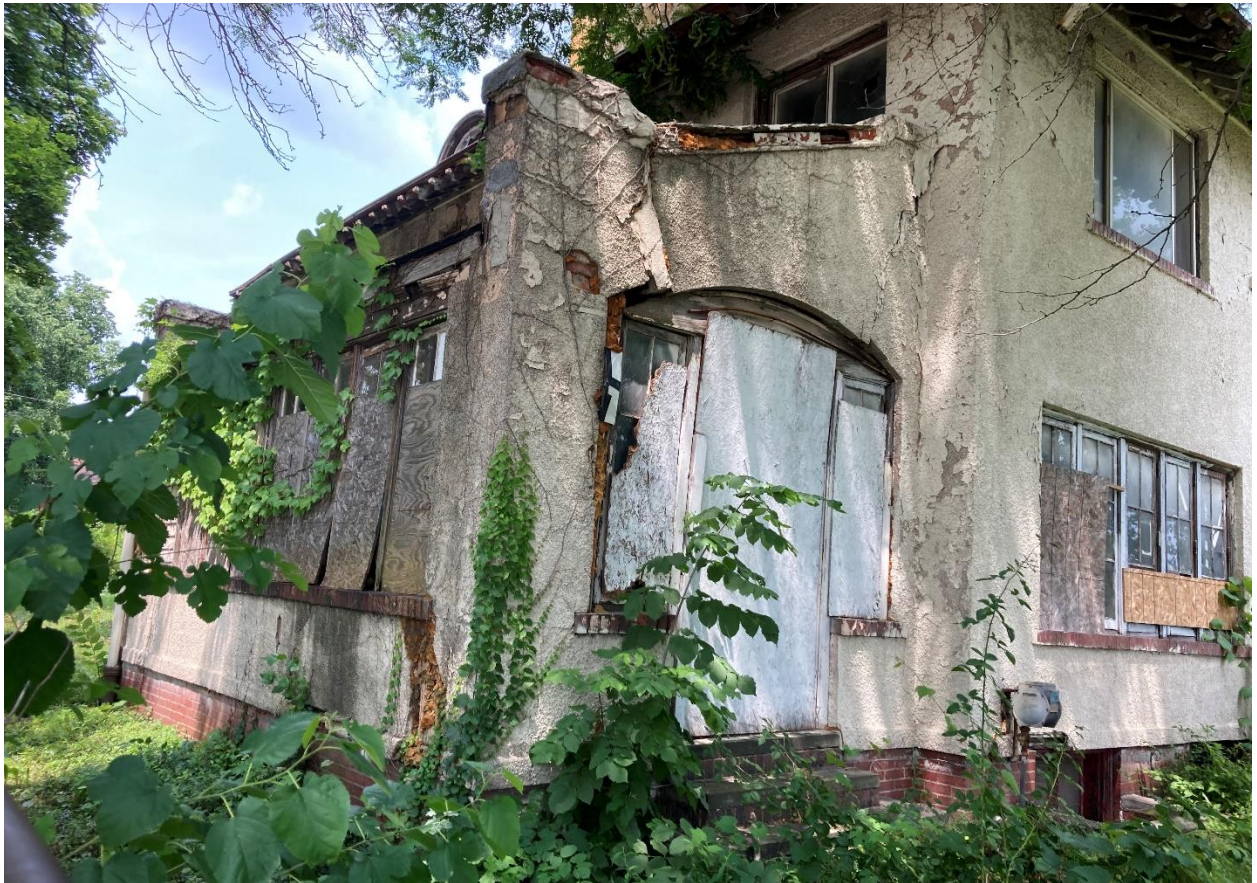
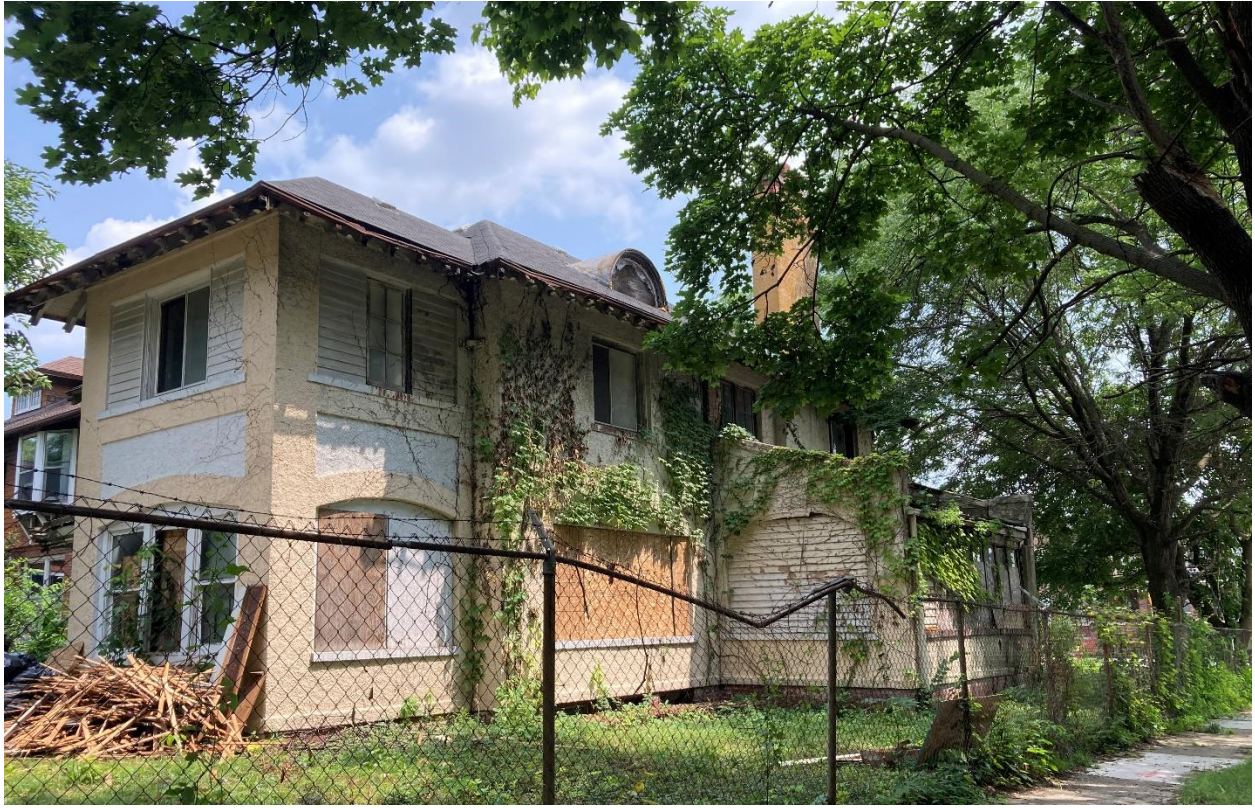
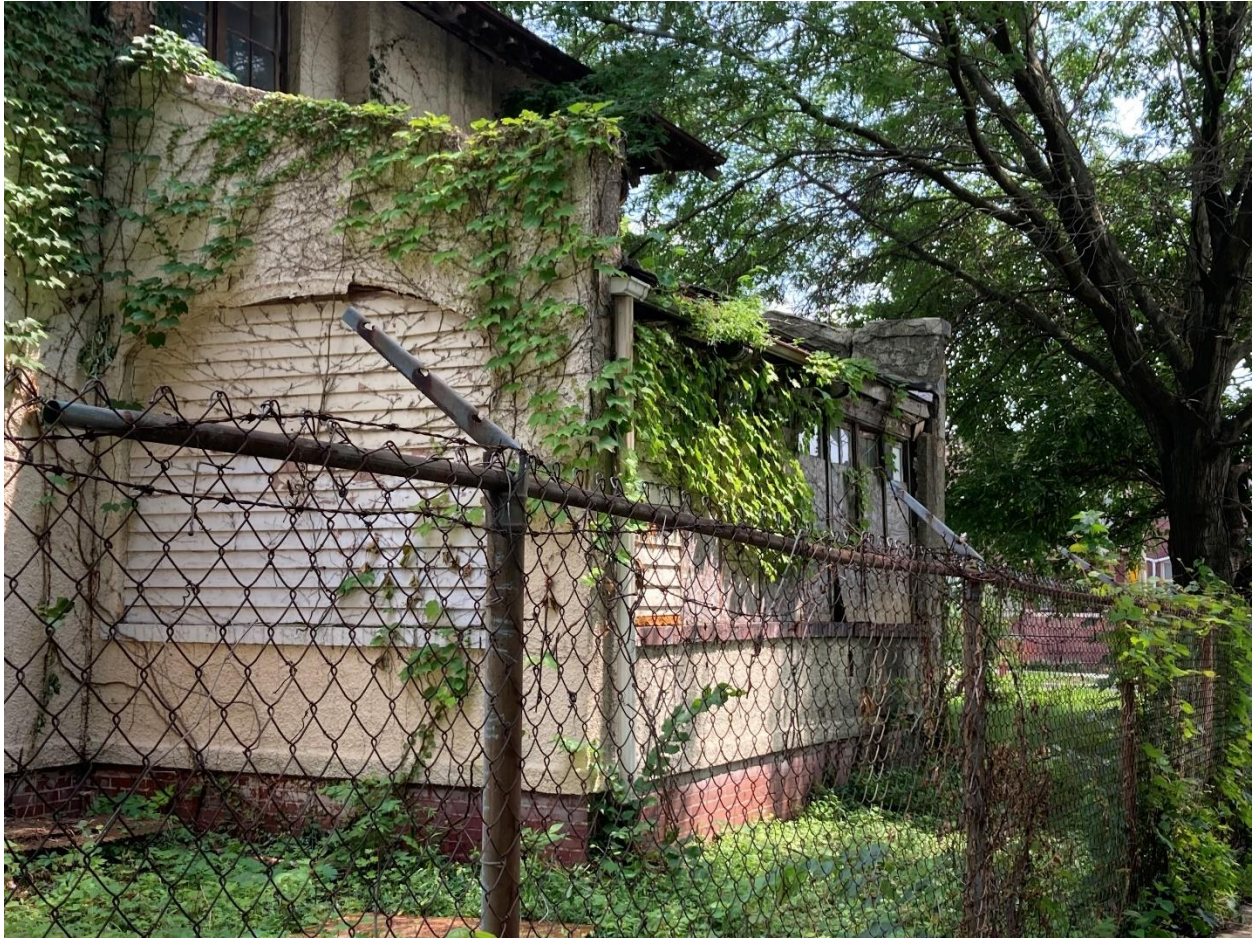
**3964 W. Lafayette, current appearance. Staff photos taken 7/13/2023**

- Per the narrative included with the current submission, the applicant is seeking to demolish the west wing because it “has fallen into a state of disrepair and presents a dangerous work environment in it’s condition.” His narrative further outlines the level of deterioration at the wing. While the wing appears to have some condition issues, it is staff’s opinion that the current application does not provide sufficient documentation that the current deteriorated conditions could not be successfully addressed via repair versus demolition. Please note that staff did reach out to the applicant via email and stated the following:

- Per the Secretary of the Interior's (SOI) Standards, Standard # 6 "Deteriorated historic features will be repaired rather than replaced." It is staff's opinion that the work does not meet SOI Standard #6 because it is not clear that the wing is deteriorated beyond repair.

Staff therefore recommends that the Commission issue a Denial for the current proposal because the work does not conform to the district's Elements of Design and does not meet the Secretary of the Interior's Standards for Rehabilitation. In particular, SOI Standards#:
