STAFF REPORT: 9/13/2023 REGULAR MEETING

APPLICATION NUMBER: #23-8520

ADDRESS: 1490 IROQUOIS

SCOPE: REPLACE CLAY TILE ON CARRIAGE HOUSE ROOF WITH ASPHALT SHINGLES, REMOVE EVERGREEN TREE (WORK COMPLETED WITHOUT APPROVAL)

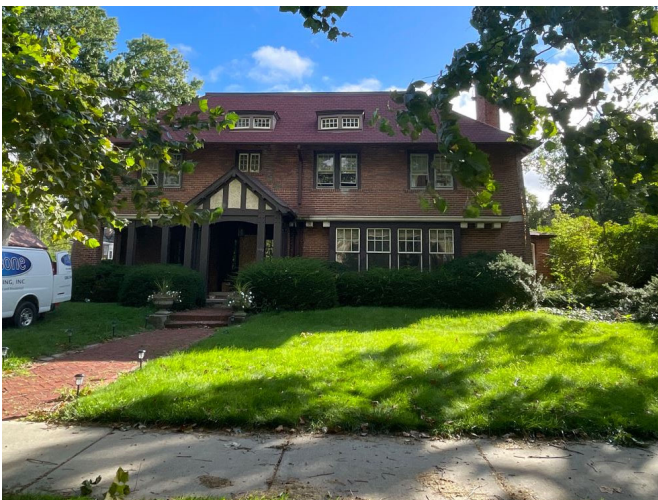
Site Photo 1, by Staff August 30, 2023: (West) front elevation of house, showing location of removed evergreen at southwest corner of the house, work completed without approval.

- Remove large evergreen tree, identified as a juniper, by a certified arborist.
- The tree was identified as diseased and planted too close to the house by the certified arborist.

- Staff requested the applicant to provide a statement from a certified arborist regarding the removal of the evergreen tree at the front yard, which was completed without approval. The applicant supplied a note from a certified arborist at Singing Tree LLC, who stated that the 40+ year juniper was planted very close to the house and had evidence of a foliar fungal disease. Staff would recommend approval for this removal and agrees with the arborist recommendation to plant an appropriate replacement.

- The applicant provides HDC staff with a paint or solid stain color for the railing.
- The applicant provides HDC staff with a replacement tree species and location for the property.
- The applicant provides HDC staff with a review of the above items before installation.

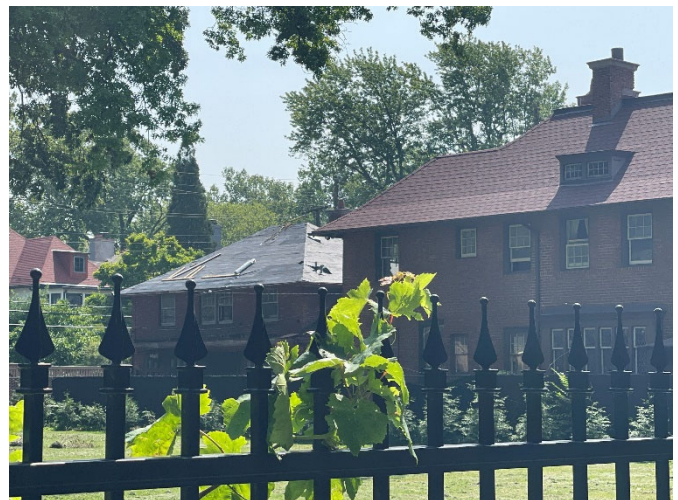
Site Photo 2, by Staff August 3, 2023: (North) side elevation of house and carriage house at rear, showing removed roof materials, work completed without approval.

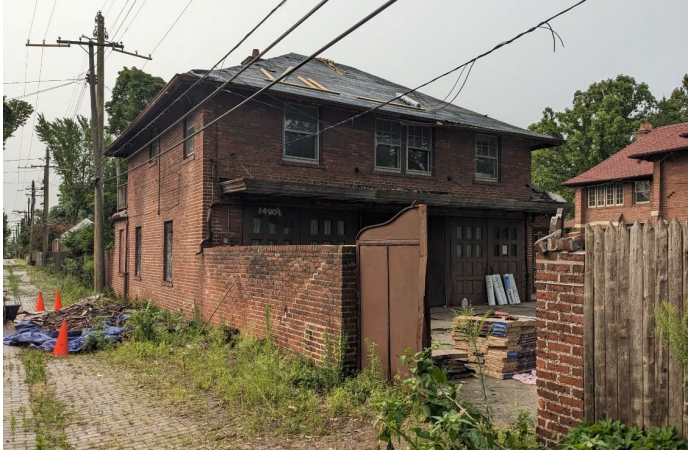
Site Photo 3, by Staff August 1, 2023: East elevation of carriage house, showing removed roof materials.

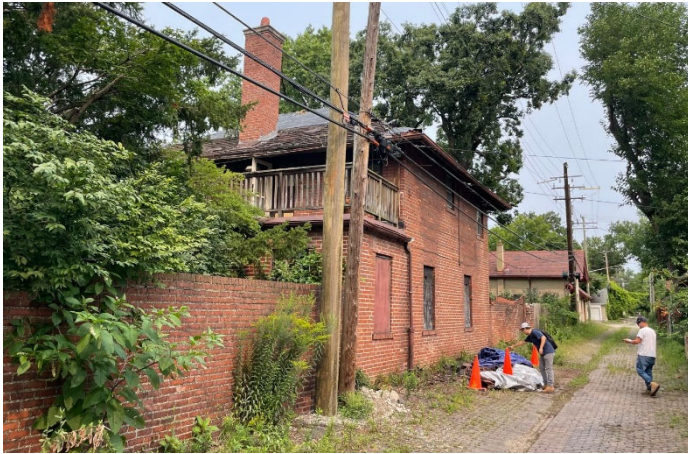
Site Photo 4, by Staff, August 1, 2023: Southeast elevation of carriage house, showing removed roof materials and balcony railing.

- Staff received an excerpt from an inspection report regarding the safety concerns for the balcony railing on the carriage house. Staff has no issues with the initial proposal but offers the opinion that the wood railing must be painted or solid stained so as not to create a “deck” impression of this feature.

Staff recommends the COA be issued with following conditions:

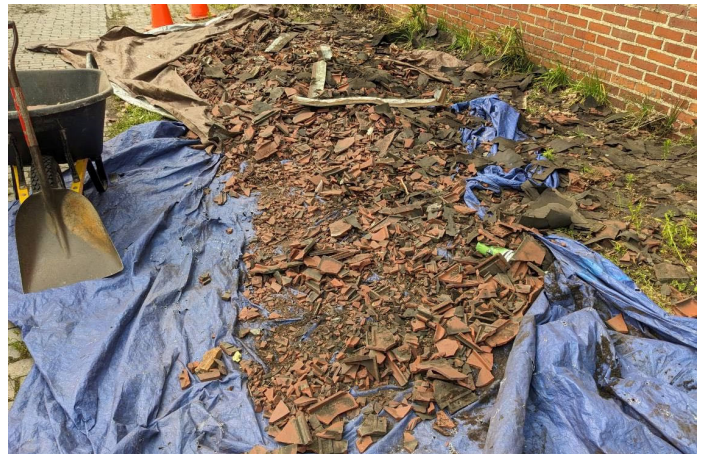
Site Photo 5, by Staff, August 1, 2023: Showing clay tile shattered on the ground in the alley.

- No documentation establishing that the original conditions of the clay tile units themselves were beyond repair was submitted or available. It is staff’s opinion that the roof’s repair could have been performed by removing the clay tile to repair the roof where required and replacing the tile. The condition of the clay tile with new individual pieces has not yet been shown clearly as “unrepairable”.

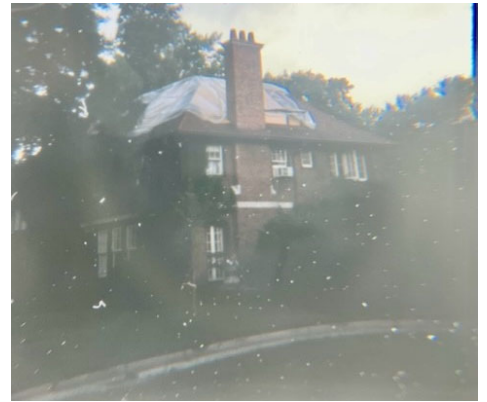
Site Photo 6, by HDC Staff, 1983: Showing damaged roof of main house at south elevation.

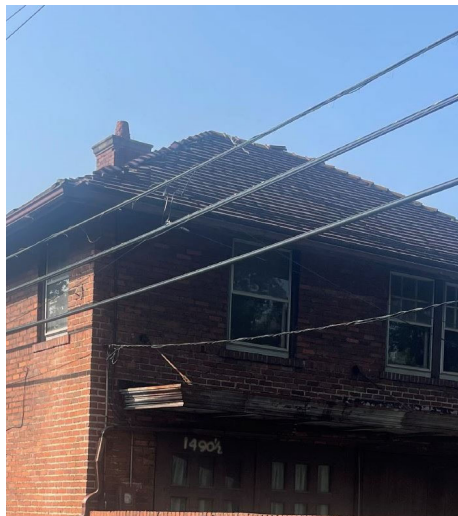
Site Photo 6, by Applicant, date unknown: Showing clay tile roof prior to removal.

- Staff requested the applicant to provide any evidence of roof damage prior to the removal of the clay tile roof, including a professional estimate, photos, and a description of the conditions. Some photos were provided that showed roof conditions after the tiles were removed, one showed prior conditions (*See Photo 6*). Staff did not receive an expert opinion on the ability to carefully remove the tiles for replacement, but staff did receive an estimate for this cost, which is \$135,000 by Detroit Cornice & Slate Co., dated August 31, 2023, which is after the tiles have been already removed. The counter proposal presented by the applicant is from the applicant’s company, Detroit Build, dated July 20, 2023, at \$15,461. Staff found that these estimates are comparable to other roof work projects of this size. However, staff has the opinion that sufficient evidence of saving the clay tile units themselves for reuse was not demonstrated.

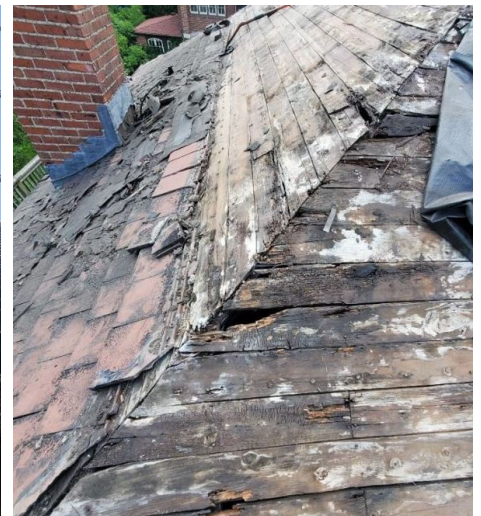
Site Photo 7, by Applicant, August 1, 2023: Showing some clay tile roof in place and damaged roof conditions.

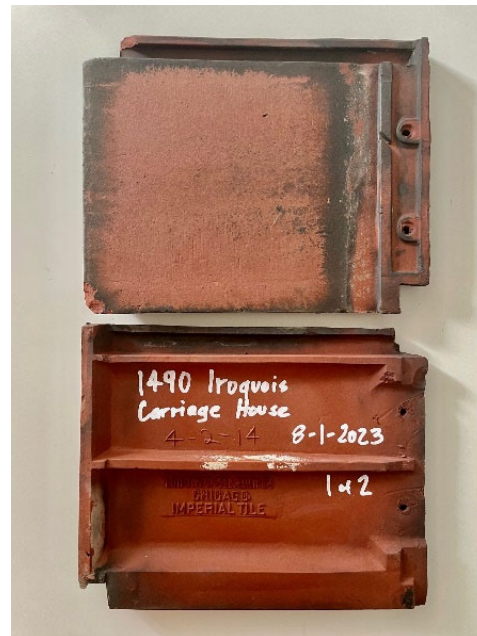
- The Indian Village Historic District was established in 1970.
- The main dwelling, built in 1913, had a clay tile roof and the carriage house, built in 1922, had matching clay tile, whose manufacturer was Ludowici Celadon Co. (*see detail photo 1*).
- From HDC staff hard files, photos and documents show that damage had occurred to the main house's roof in 1983, with what appears to be a fire. (*See site photo 6.*) In 1986, the City issued an interdepartmental complaint about the city-owned property being vacant and subject to vandalism, requesting the property to be securely boarded. Also in 1986, City and HDC COA records show a permit to replace the main house clay tile roof with asphalt shingles. The main house's roof was then replaced again in 2016 with asphalt shingles. During this period, no mention of the carriage house roof was found.

Detail Photo 1, by Staff August 1 2023, showing original clay tile recovered from the carriage house, laying in the alley.

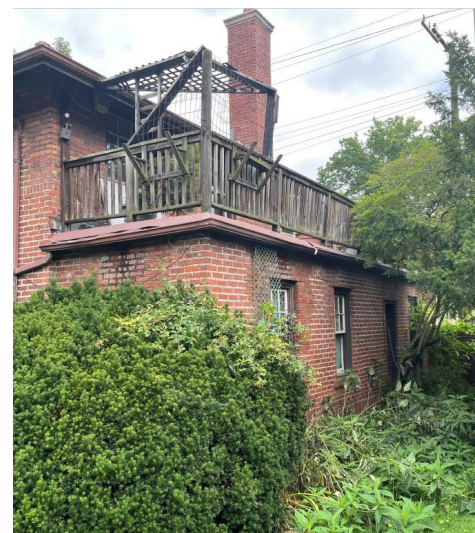
Site Photo 8, by Applicant, date unknown, south elevation: Showing existing carriage house railing.
