STAFF REPORT: 10/11/2023 REGULAR MEETING
APPLICATION NUMBER: HDC2023-00052
ADDRESS: 14811 ROSEMONT
HISTORIC DISTRICT: ROSEDALE PARK
APPLICANT/PROPERTY OWNER: DANNELL WILKERSON
DATE OF PROVISIONALLY COMPLETE APPLICATION: 9/18/23
DATE OF STAFF SITE VISIT: 9/21/23

SCOPE: REMOVE TREE

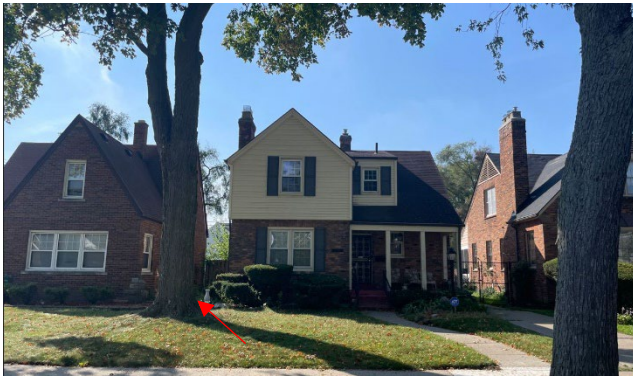
Site Photo 1, by Staff September 21, 2023: (East) front elevation, showing maple tree to the left of the house (arrow).

- Staff observed the condition of the maple tree, its proximity to the house and any other historic structures, and the proximity to the public right of way. (See site photos 1-2.) The tree’s main trunk has no lean, branches are pruned clear of the roofline of the house, and the tree appears to be balanced in its overall structure and appears to be good health. Photos show that most branches are still green with life.

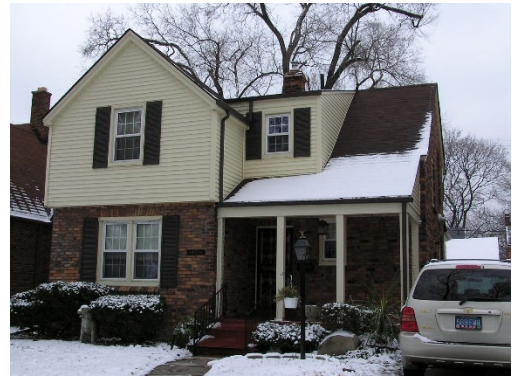
Designation photo 2007: (east) front elevation. Front yard maple tree is not visible in this or adjacent designation photos.

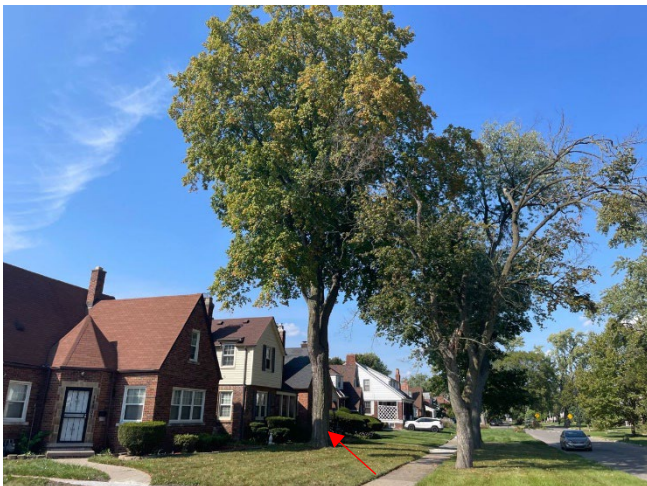
Site Photo 2, by Staff September 21, 2023: Looking north from the corner of Eaton Street and Rosemont, showing the maple tree that is proposed for removal on the left (arrow).

- The house is positioned one property away from the corner at Eaton Street exposing the front yard and this tree to public views from the corner and along Rosemont Street. (See site photo 2)

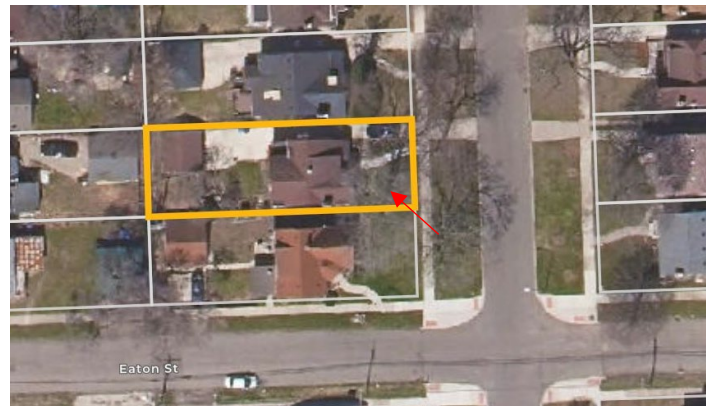
Aerial#1 of Parcel # 22077020, showing location of maple tree (arrow).

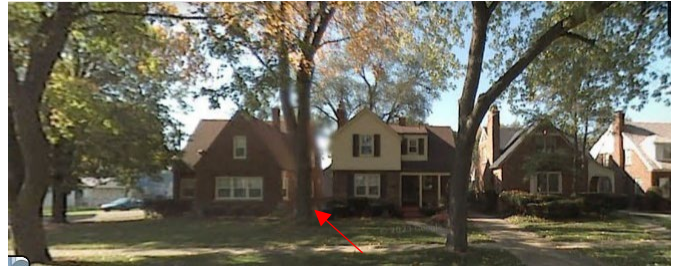
- The designation photos for both this and adjacent properties do not show the maple tree as the photos are cropped from view of the tree’s location. However, Google Street View shows the tree is in full maturity as far back as October 2007, which is the same year as the historic designation of Rosedale Park. (See site photo 3)

Site Photo 3, by Google Street View Oct 2007: (East) front elevation, showing maple tree, left of house (arrow).

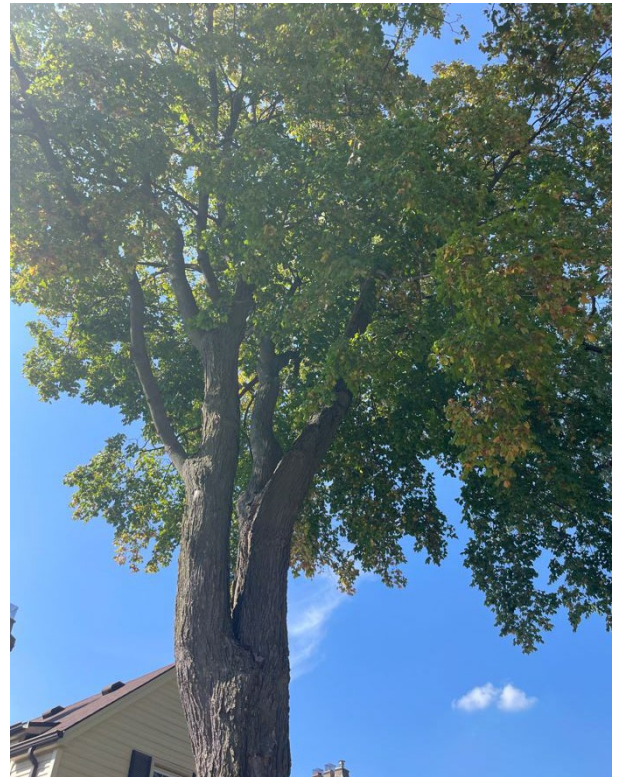
Site Photo 4, by Staff September 21, 2023 (front elevation): showing healthy tree canopy.

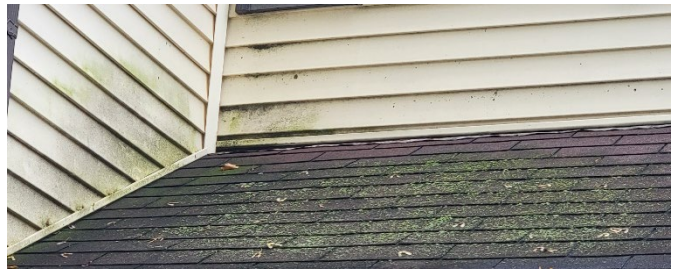
Site Photo 5, by Applicant: (East) front elevation, showing roof condition.

“...the moss that is currently growing on the roof as a result of it not being able to completely dry because of the overhanging branches that drop in the gutters and on the roof. As mentioned in my previous email the gutter becomes clogged which causes the gutter to overflow which leads to more water on the roof and water infiltration behind the siding in that area. We have already discovered rotted wood on the exterior wall where most of the debris from the tree lands in the gutters and on our roof. Moss significantly shortens the lifespan of roofs by trapping water and moisture that leads to rot. You can see the moss on the pictures provided with our initial application.” (From Applicant, September 28, 2023)

- It is staff’s opinion that the condition of the roof is a result of maintenance and not due to any direct damage by the maple tree. No evidence was provided that shows the tree is in ill-health by a certified arborist.
