**STAFF REPORT:** 9/13/2023 MEETING

**APPLICATION NUMBER:** HDC2023-00054

**ADDRESS:** 400 FISKE

**SCOPE OF WORK:** REPLACE SLATE ROOF WITH ASPHALT SHINGLES (WORK PARTIALLY COMPLETE)

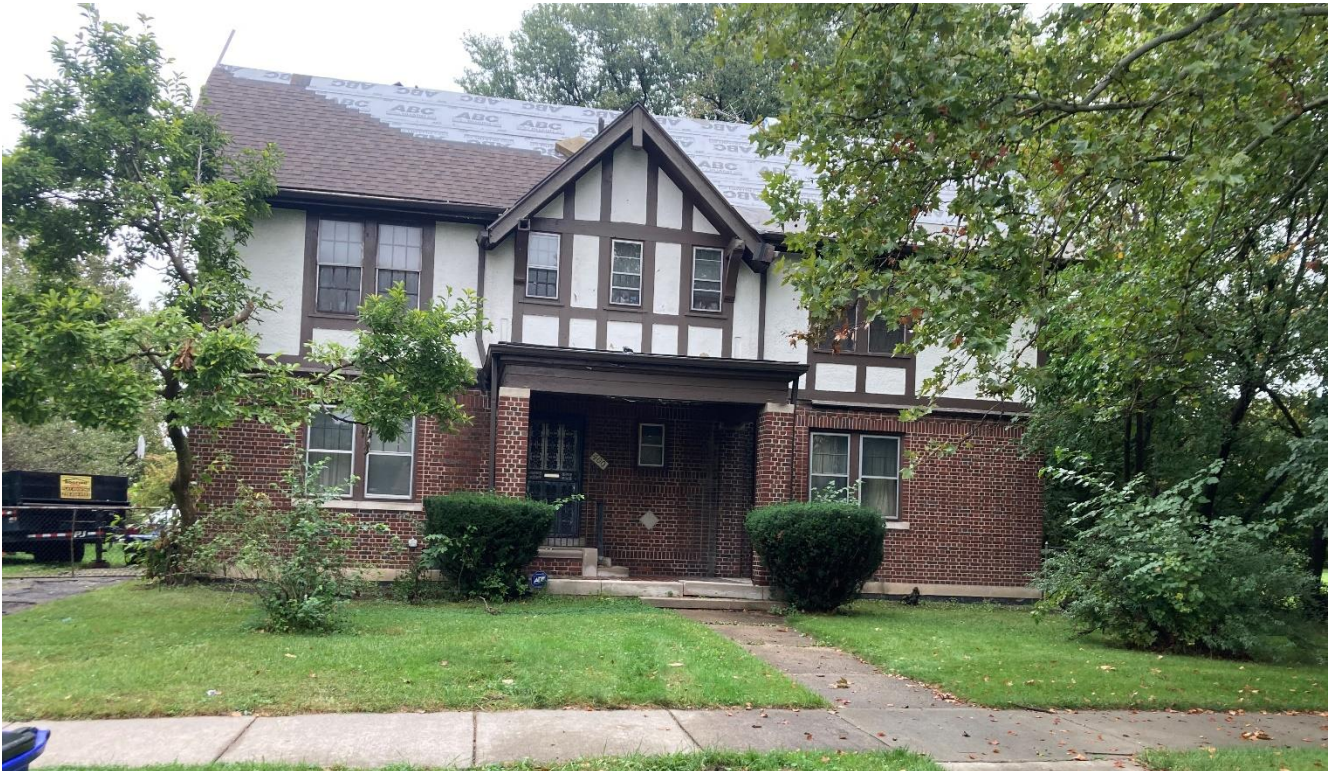
**400 Fiske, current appearance of front facade. Staff photo taken 9/28/2023**

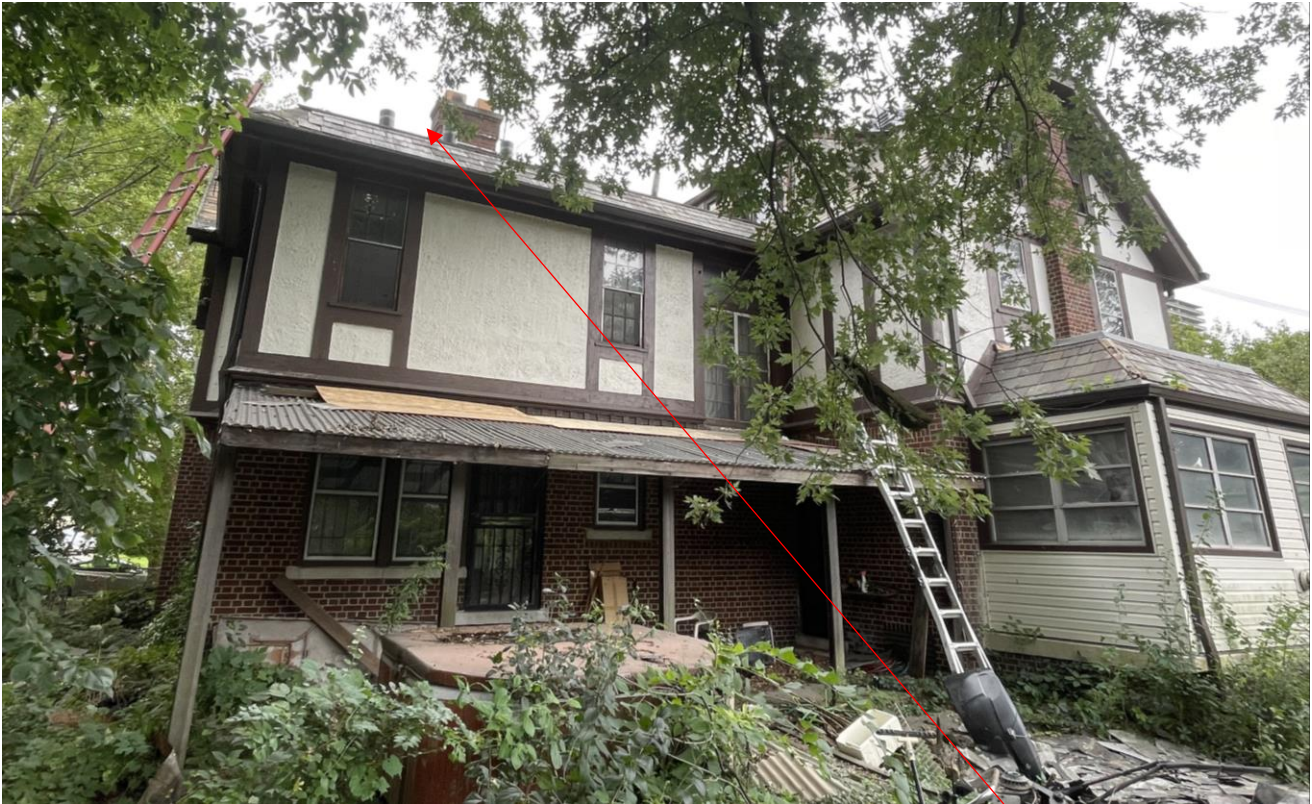
**400 Fiske, current appearance of rear wall/roof. Staff photo taken 9/8/2023. Note that a new rubberized roof membrane is proposed for installation at the flat portion of the mansard roof at this location.**

- The current scope of work calls for the addition of a new rubberized roof membrane on the flat portion of the rear mansard roof. Staff supports approval of this portion of the project

It is staff’s opinion that the proposal to install a new rubberized roof membrane at the flat portion of the rear mansard roof conforms to the district’s Elements of Design and meets the SOI standards. Staff therefore recommends that the Commission approve this scope item with the condition that the existing slate at the rear mansard roof be retained.

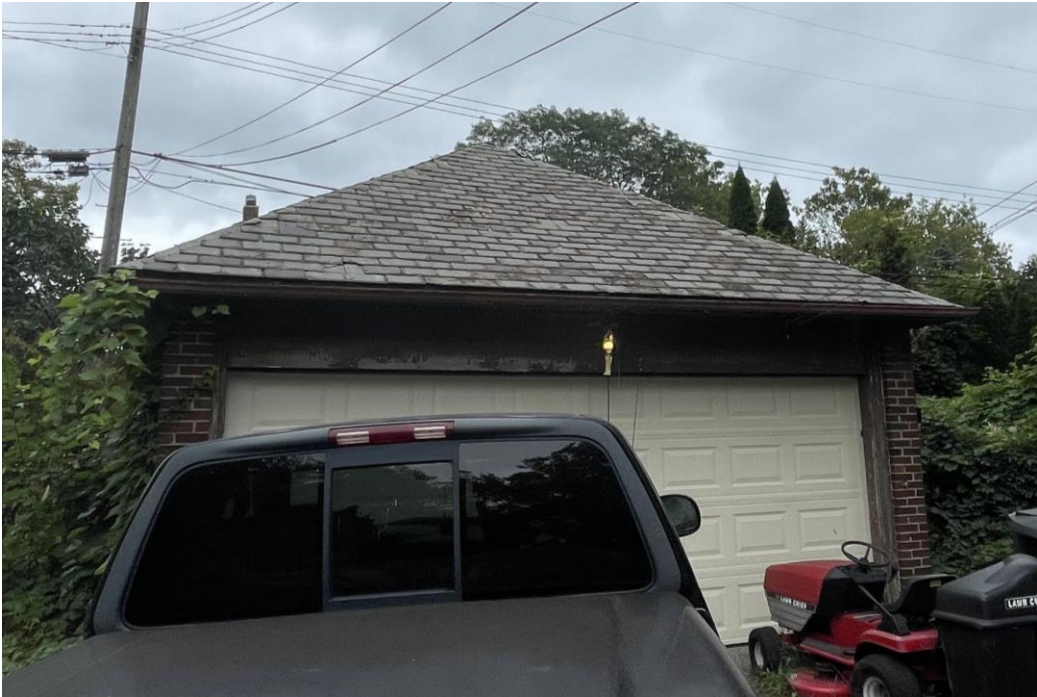
**400 Fiske, current appearance. Staff photo taken 9/8/2023**

the site on 9/28/2023 and noted that much of the slate has been removed from the front, side-gabled portion of the roof. This work was undertaken without HDC approval and/or permit.

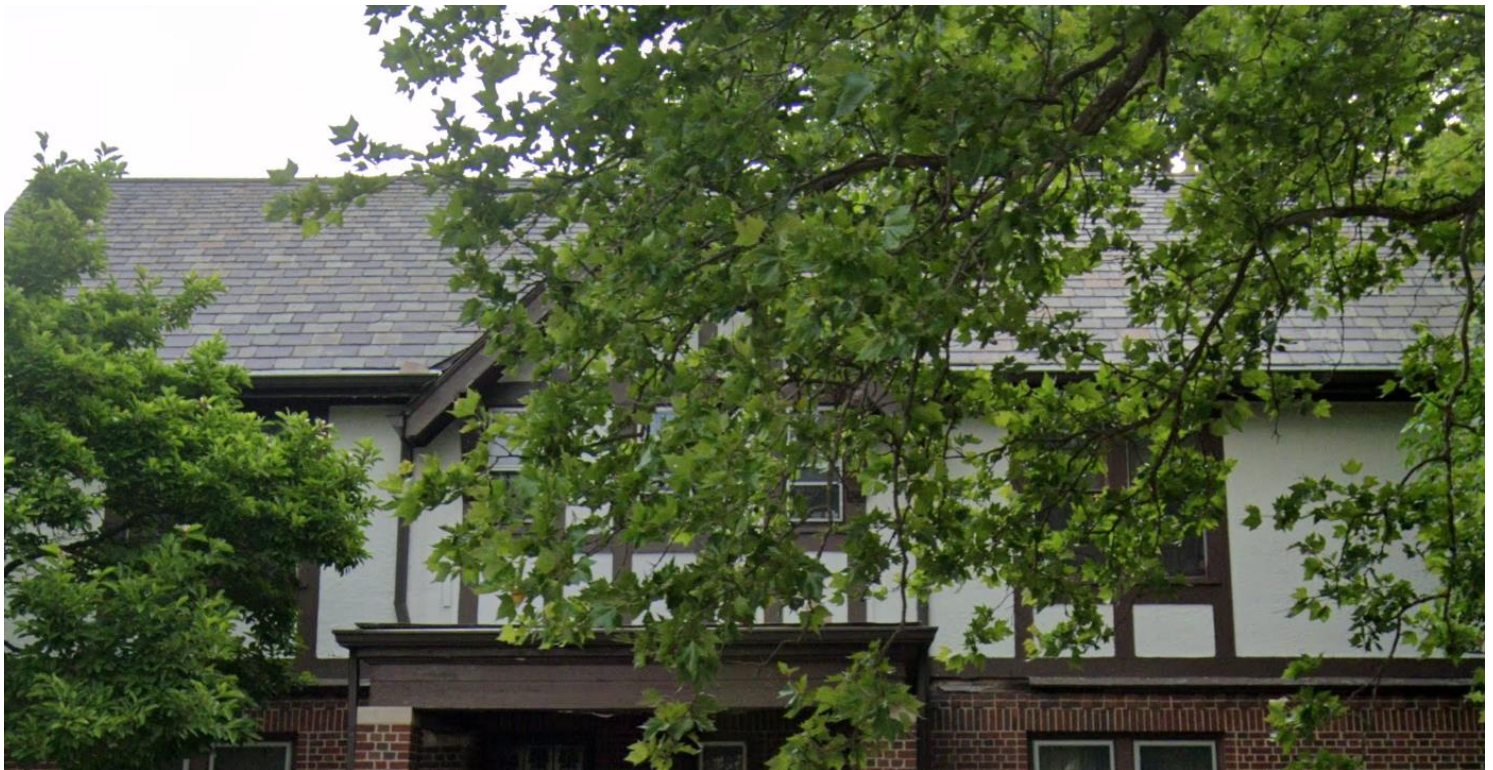
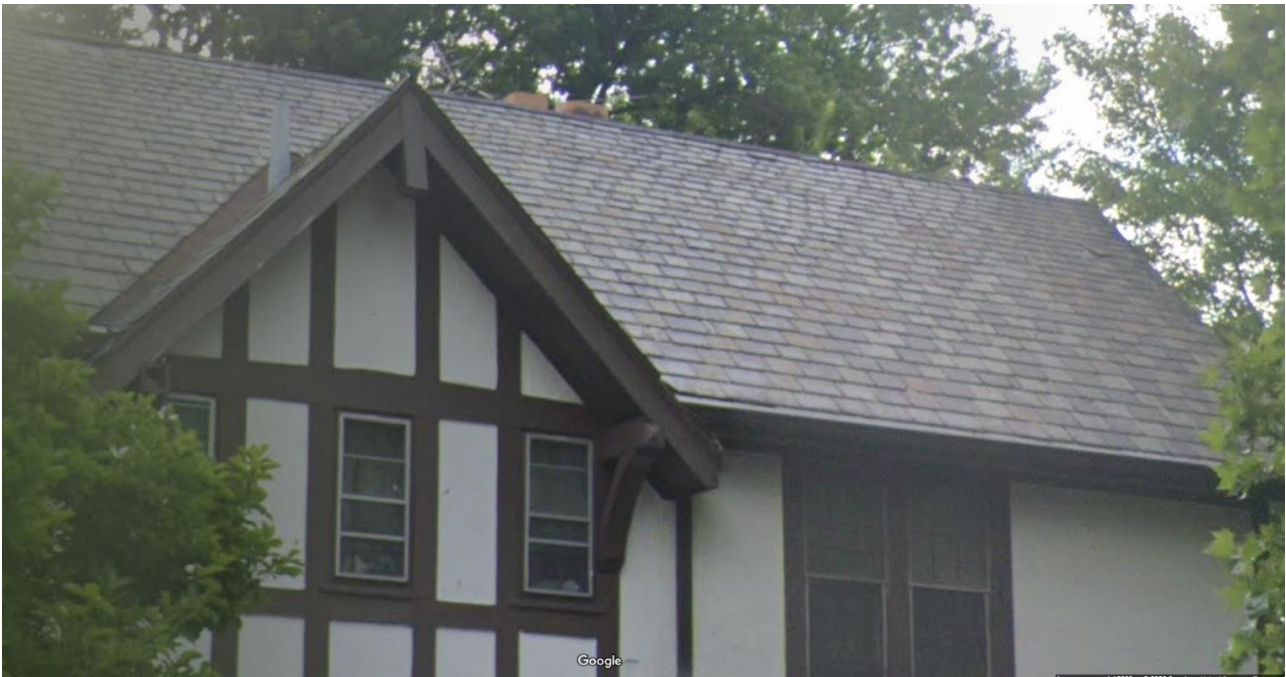
Google Streetview images, 2022

- Staff did view the designation photo of the home, the remaining portions of the slate on the property's roof, and recent Google Streetview images which were taken prior to the current unapproved roof removal. It is staff's opinion that the slate roof was a distinctive, character-defining feature of the home. A review of the below Google Streetview images, which date from 2022, indicated that the slate tiles generally appeared to be in repairable condition at that time. It does not appear that any of the tiles have dislodged, slid out of place, nor do they appear to be delaminated or cracked.

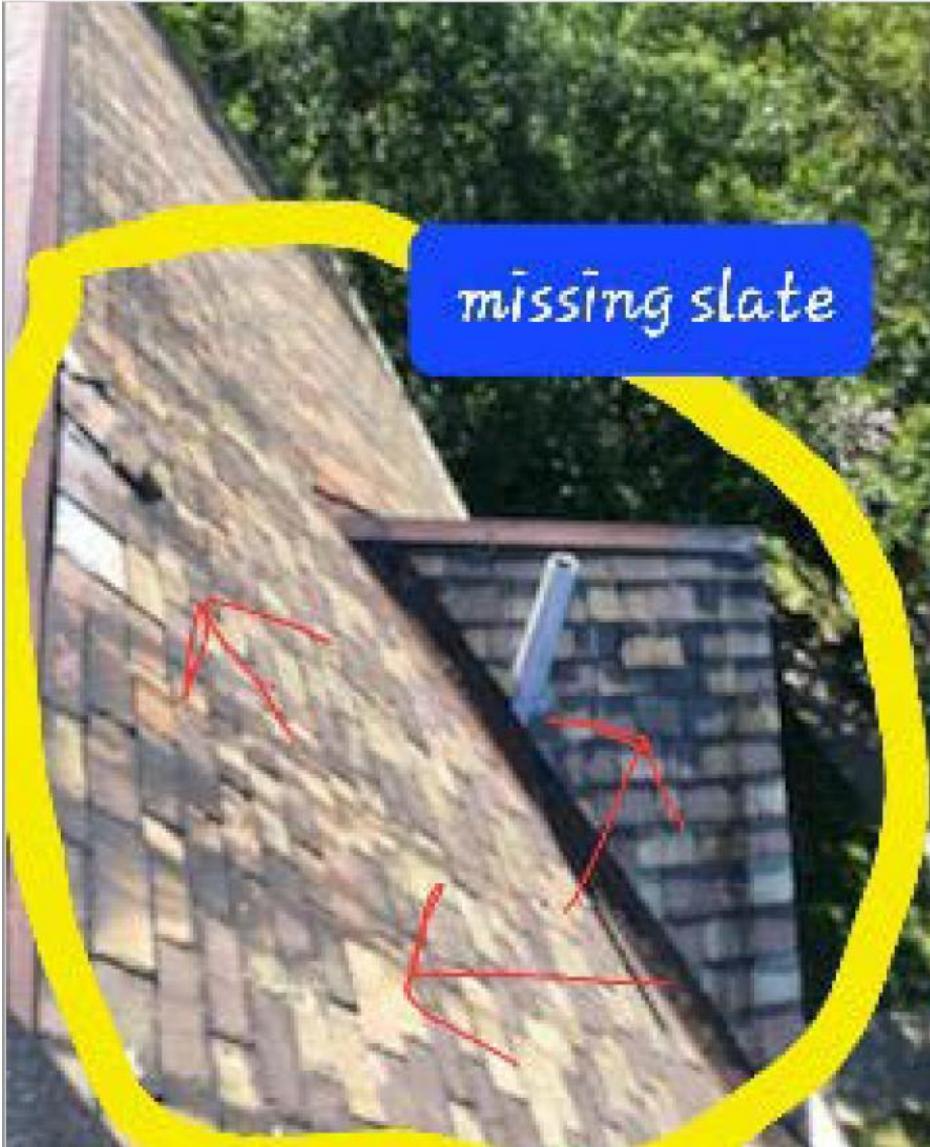
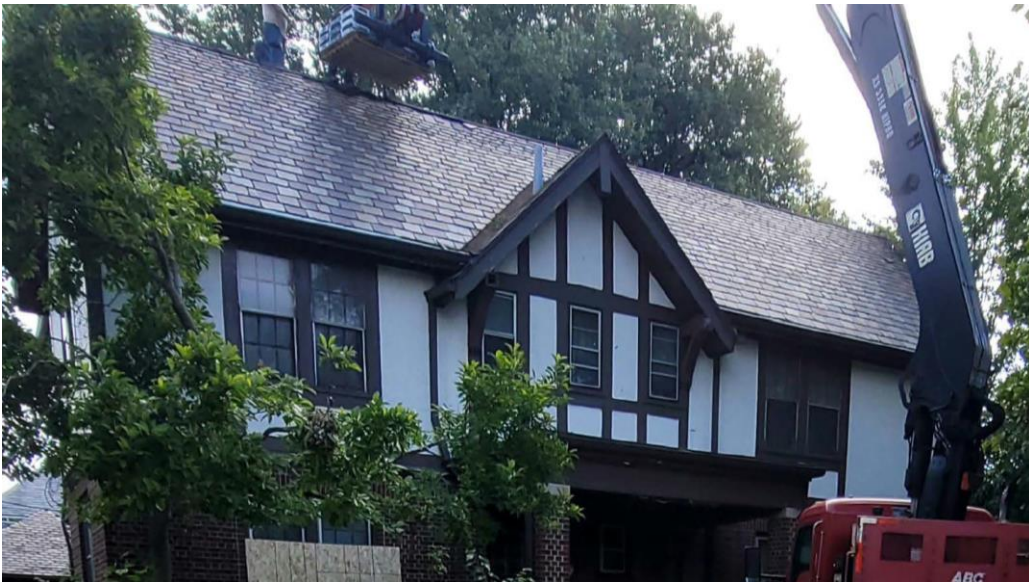
Photos of the roof submitted by applicant

- Note that the applicant did not provide a narrative description/condition assessment of the roof prior to the unapproved work or currently, nor did he provide photo documentation which outlined the slate roof's level of deterioration outside of one photo indicating an area where a small number of individual tiles were missing and a photo of the roof taken from the front lawn (see below). Also, a quote for in-kind repair of the slate roof was not included with the current submission. Staff did request that the applicant provide this information. However, staff has yet to receive the requested information as of the date of this report's completion. Therefore, staff has relied on Google Streetview images of the home from 2022, the above-referenced 9/8/2023 staff assessment of the slate tiles which had been removed from the roof, and a 9/28/20023 field assessment of the remaining slate tiles from the public right of way (see attached photos) and concluded that the slate roof does/did not appear to be deteriorated beyond repair. Per the Secretary of the Interior's (SOI) Standards, Standard # 6 "Deteriorated historic features will be repaired rather than replaced." It is staff's opinion that the work does not meet SOI Standard #6 because it is not clear that the slate roof is deteriorated beyond repair.

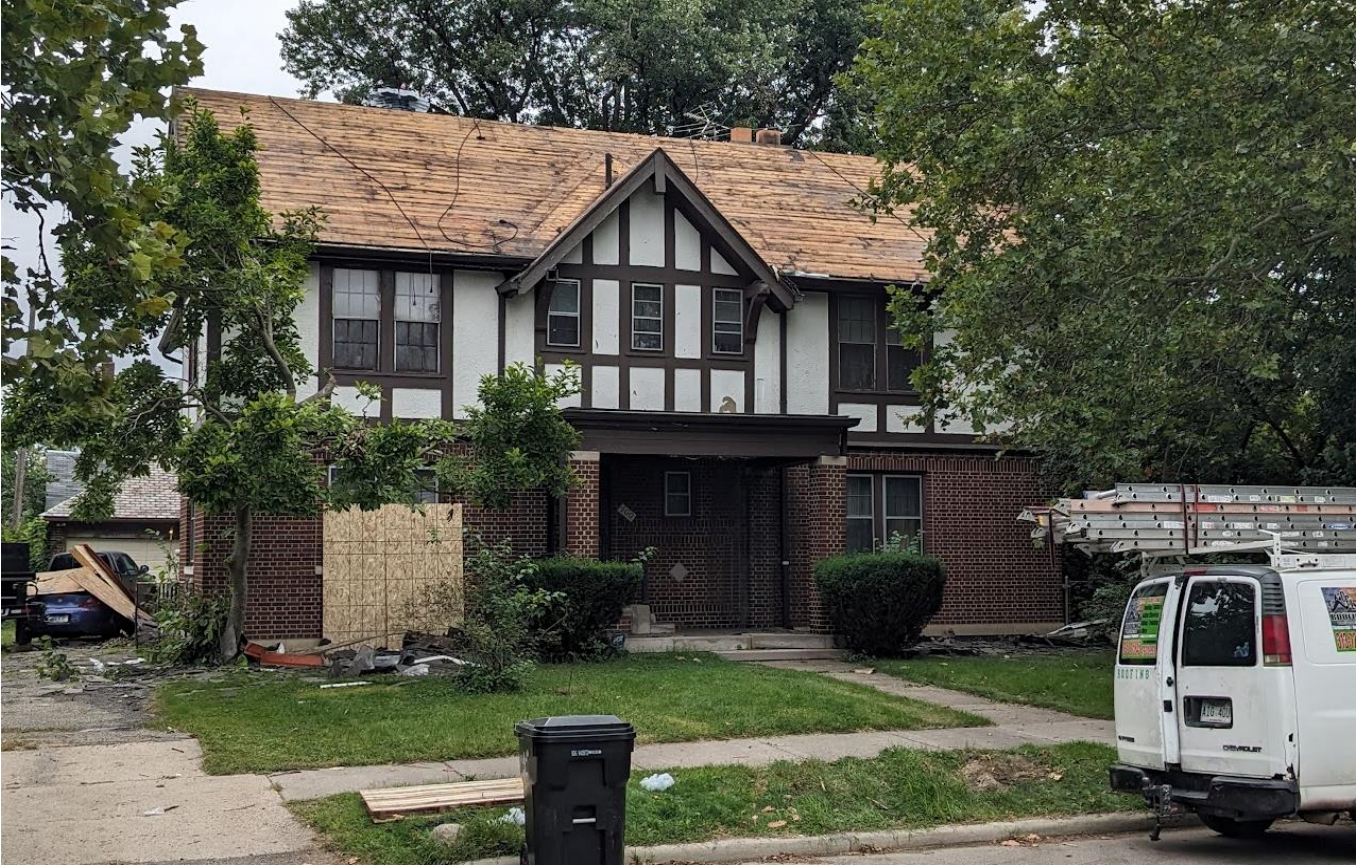
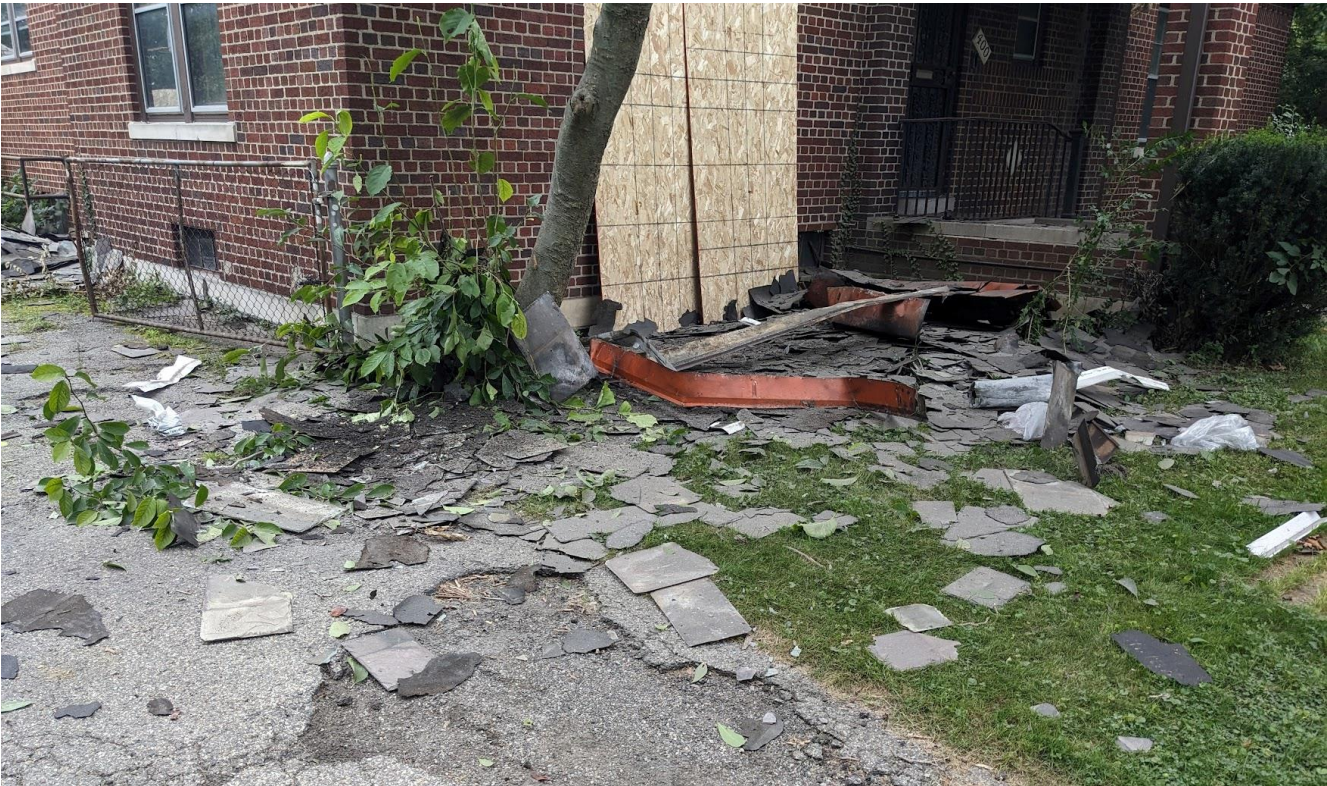
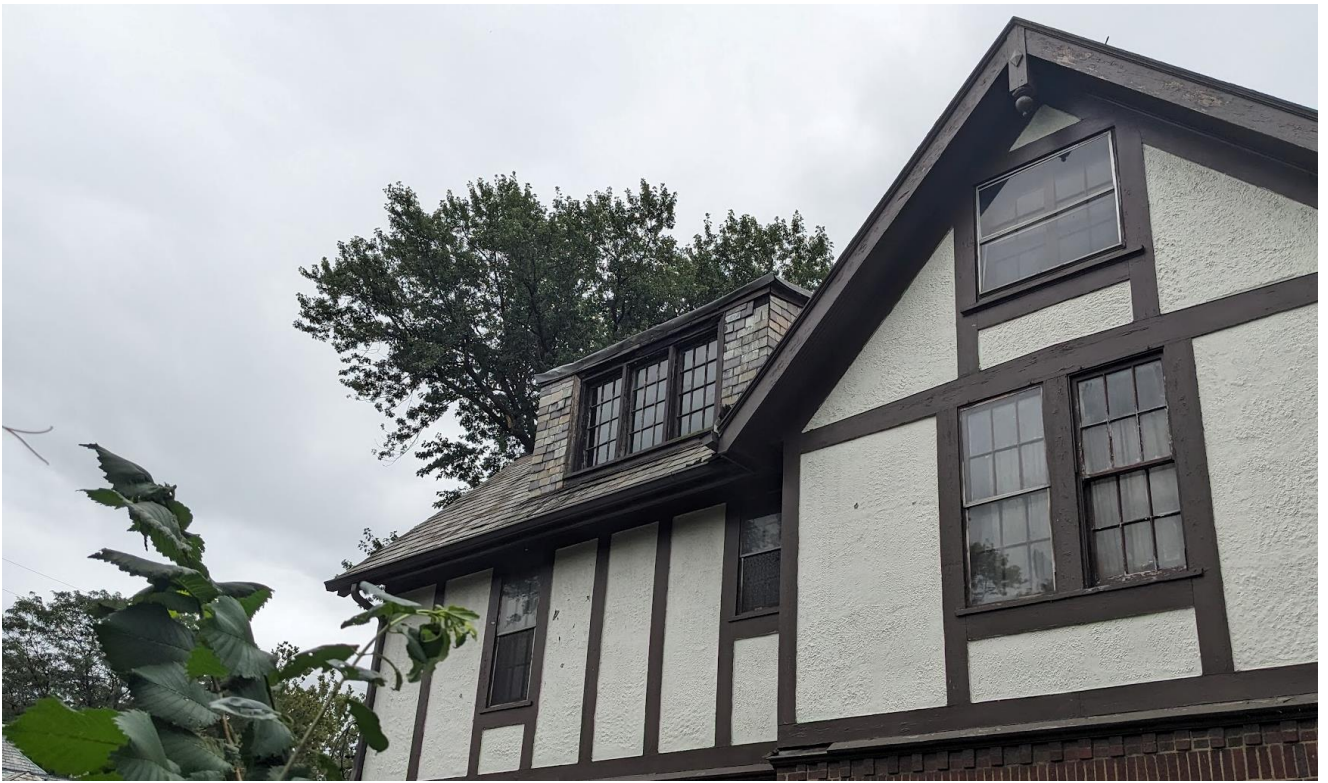
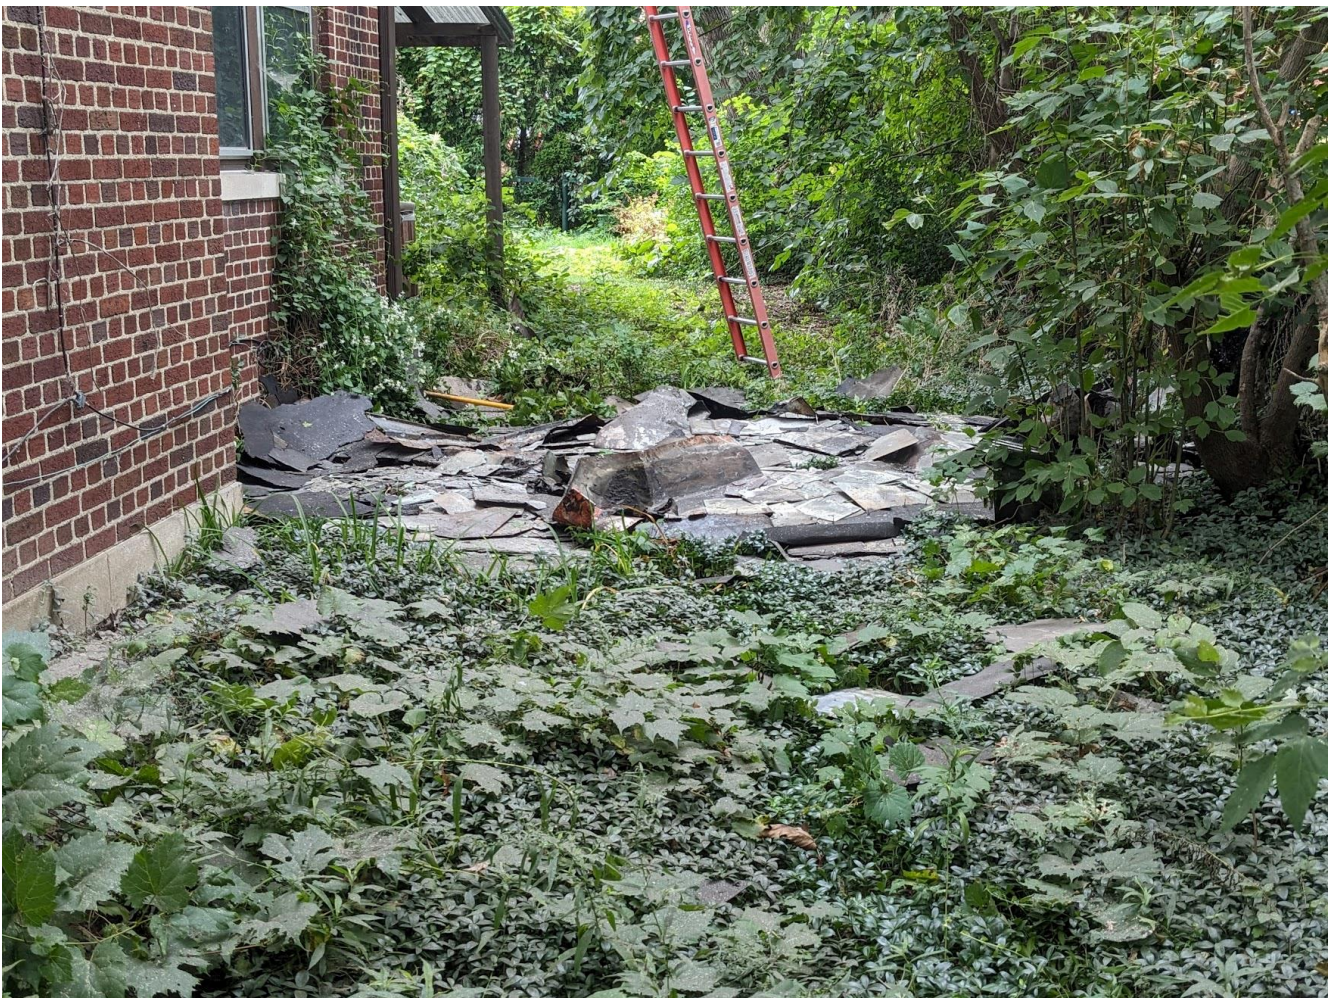
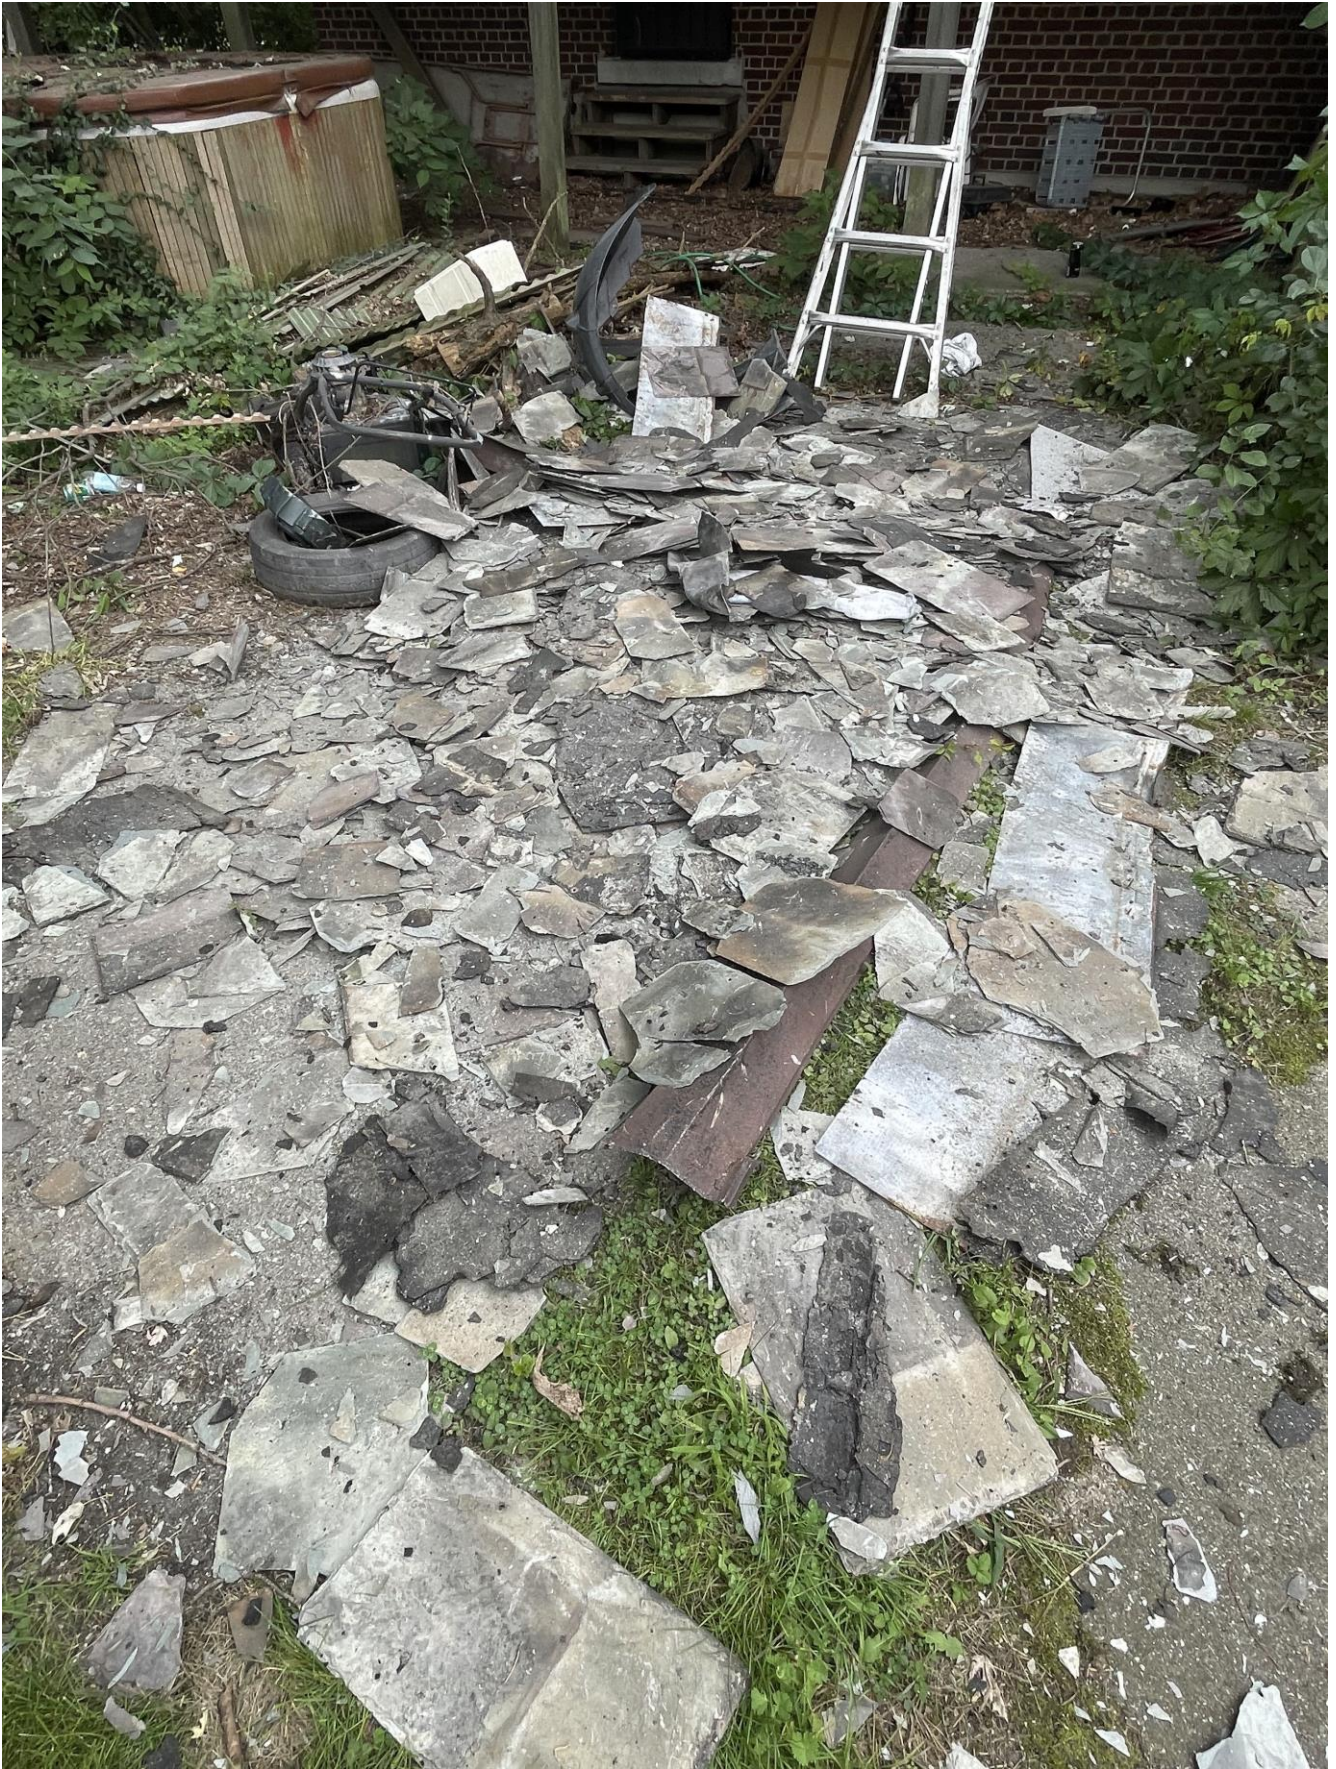
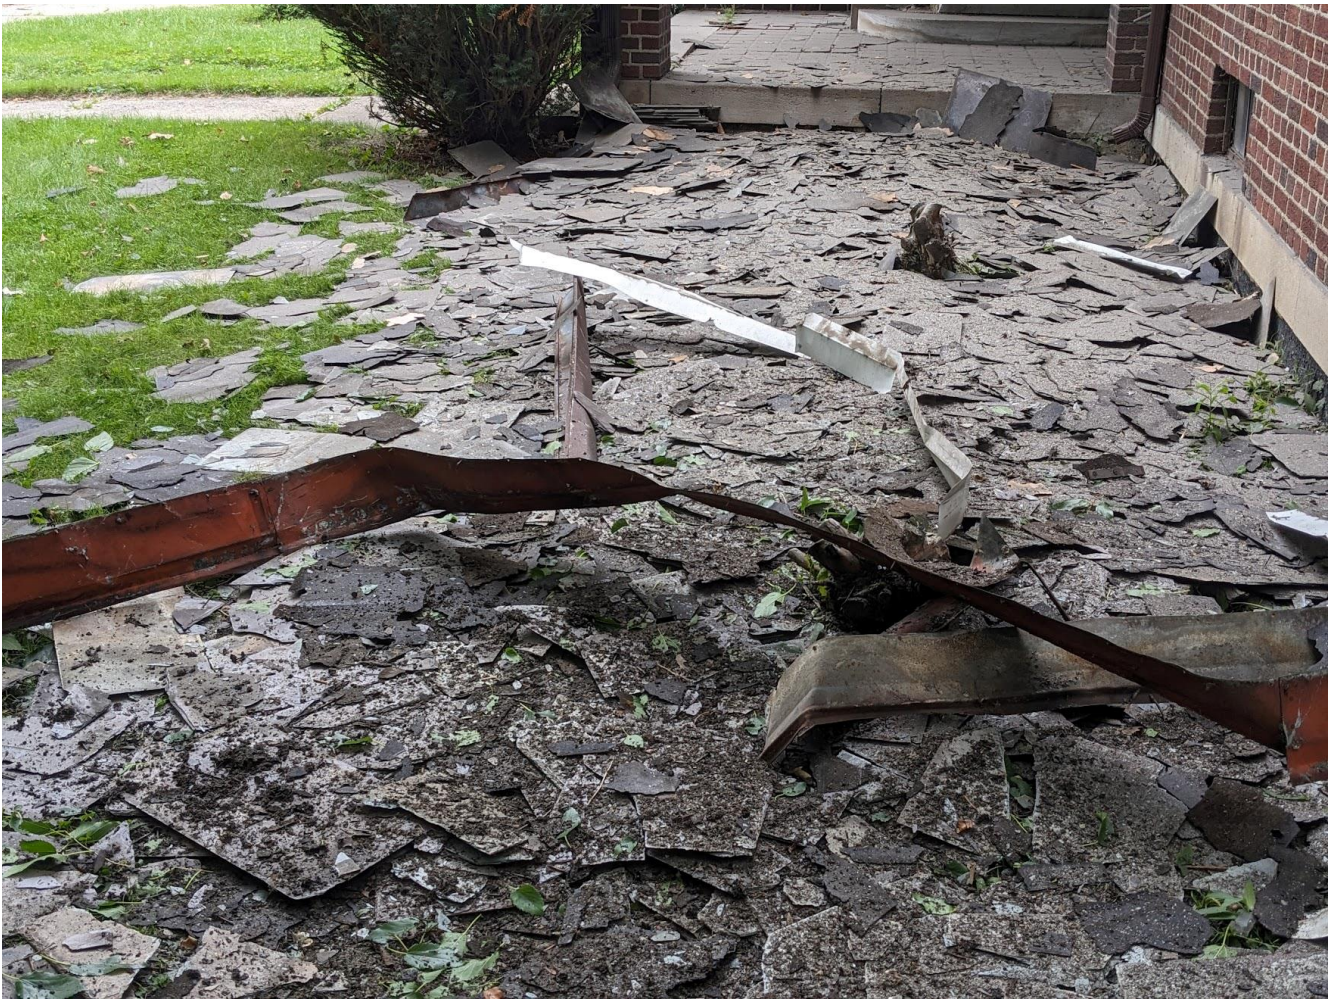
Staff photos, taken on 9/8/2023 during unapproved slate roof removal

- During the initial 9/8/2023 site visit, staff observed the condition of slate tiles which had been removed from the roof and dropped to the ground. Staff noted that the slate roof tiles did vary in size and that many appeared to have been in good condition. See below photos taken during the 9/8/2023 field visit.
