STAFF REPORT: OCTOBER 11, 2023 MEETING

APPLICATION NUMBER: HDC2023-00024

ADDRESS: 2244 WABASH

**SCOPE: DEMOLISH REAR OF HOUSE* (WORK COMPLETED WITHOUT APPROVAL);
ERECT REAR ADDITION**

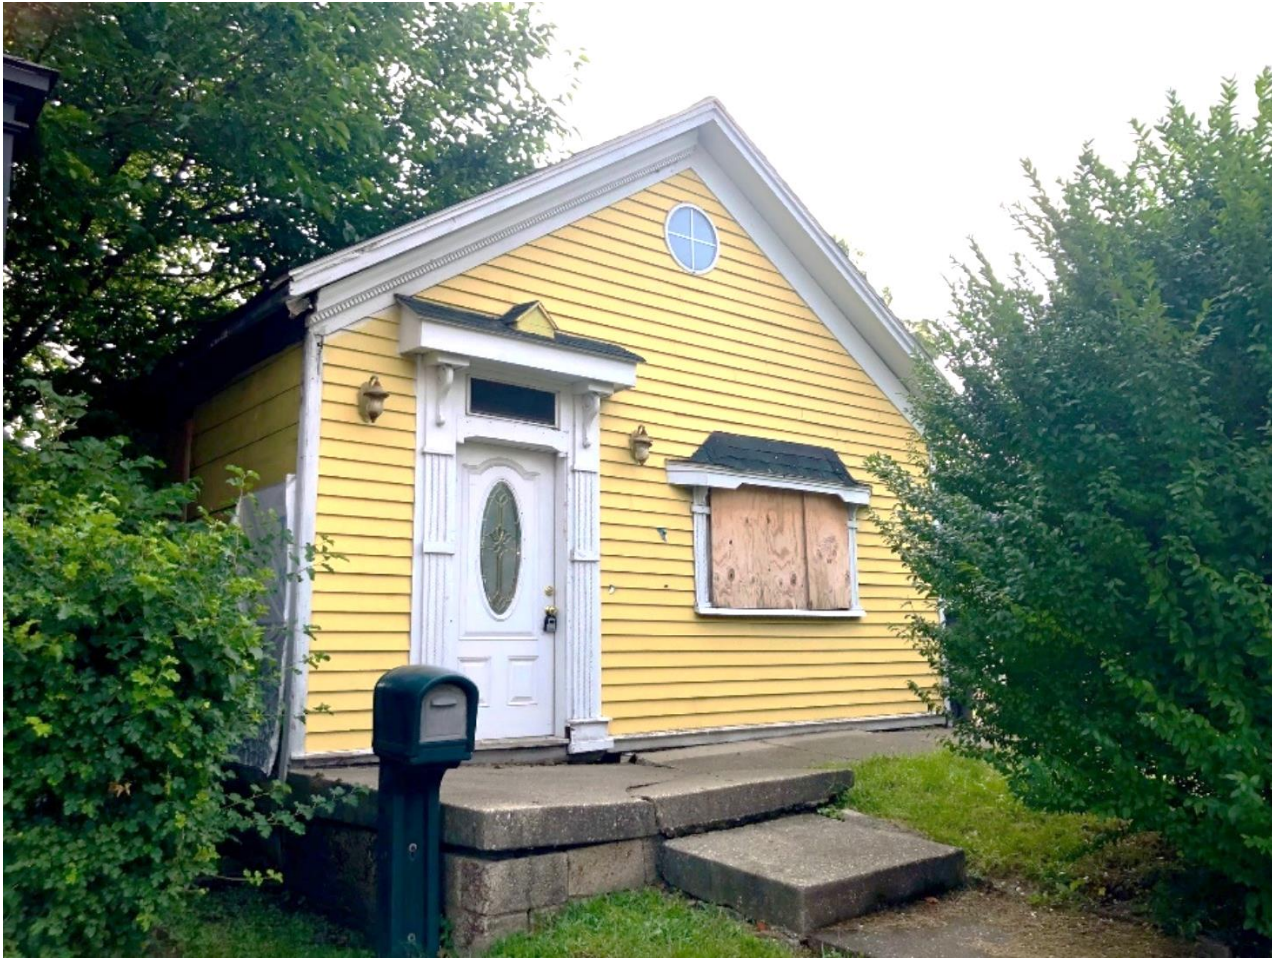
The front elevation at Wabash. Staff photo, September 12, 2023.

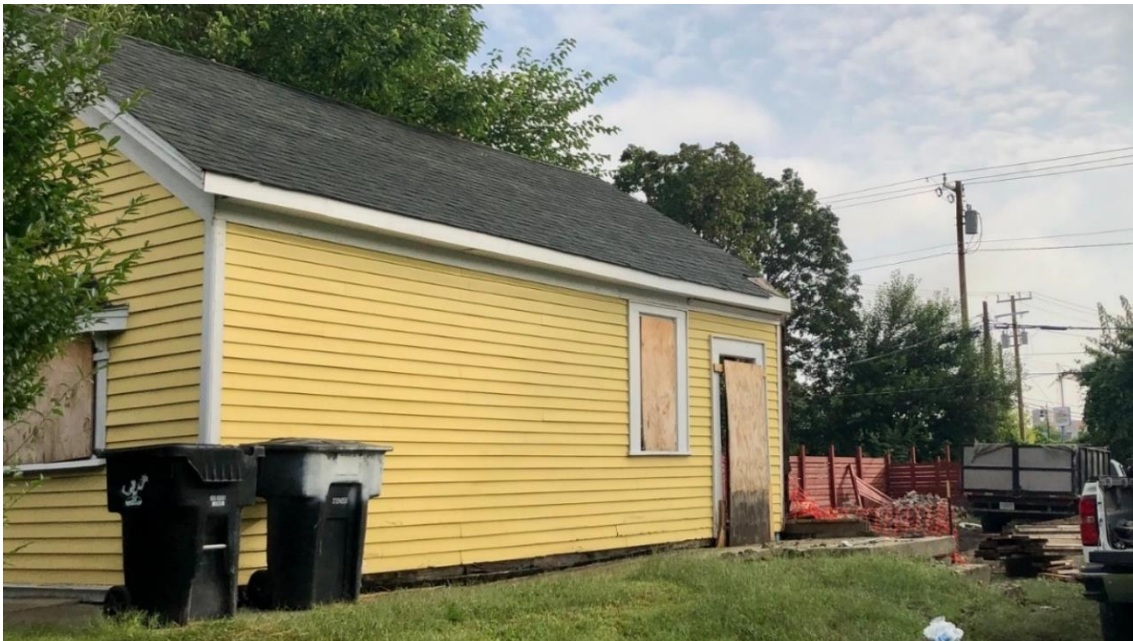
The south-side elevation. Staff photo, September 12, 2023.

The rear extensions of the house and side wing were recently demolished without HDC approval; a large deep hole currently covers this area of the lot.

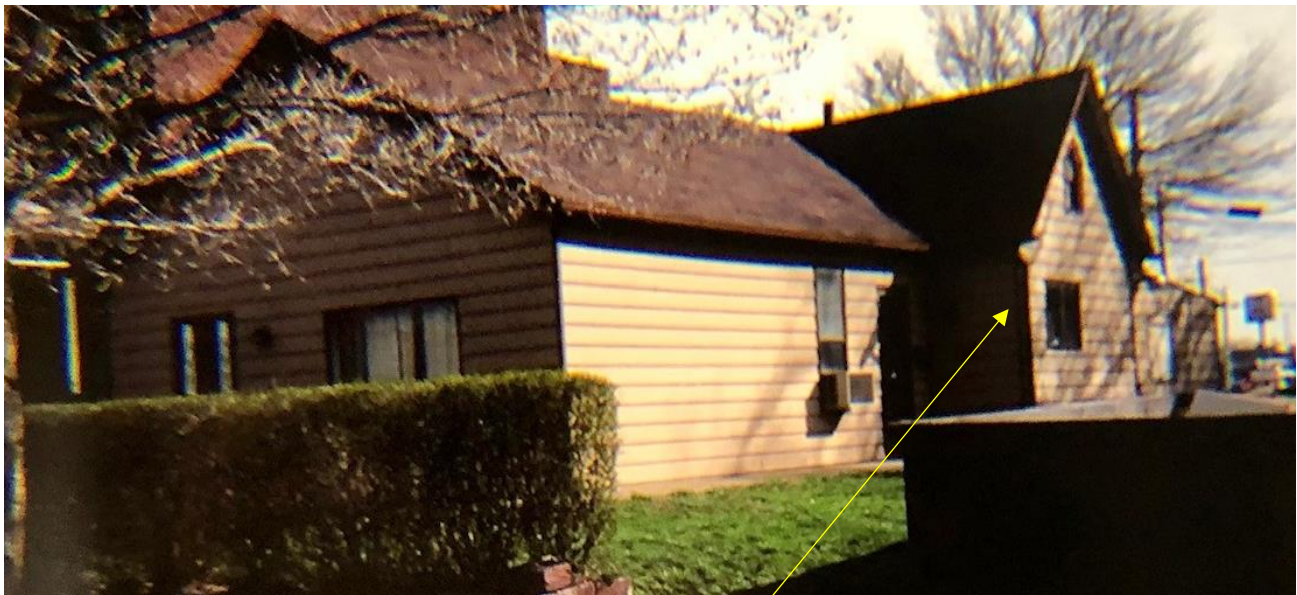
Designation photo – view from Wabash showing front and south-side elevations, 1984. HDAB.

No changes to the footprint of the pre-1884 addition are present (i.e., bay window).

Pre-1921 rear addition is visible and has a shed roof.

- Aluminum siding covered the house at time of designation. The front elevation's window opening appears to have a non-historic window. The pointed window in the side gable is a shape that was common on Gothic Revival structures. Staff doesn't know when this window was removed and replaced with a rectangular fixed window.

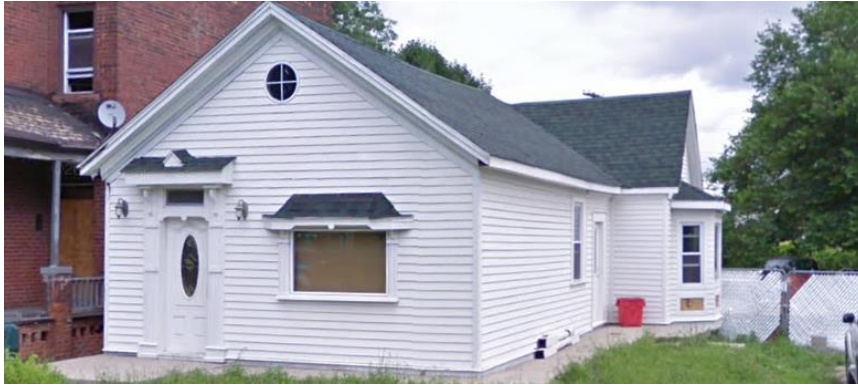
Google street view, July 2009.

- The 2009 image shows the property as exterior work was nearing completion (note: the boards in the bay walls are not yet painted). Staff doesn't know if the bay window was part of the 2008 scope of work, or if the front façade's window/door hoods matched the Commission's approval. It is clear, however, that the bay window is not a historic feature.
- Staff doesn't know when the shed roof rear extension was demolished; however, it was gone prior to June 2009 based on the below photo.

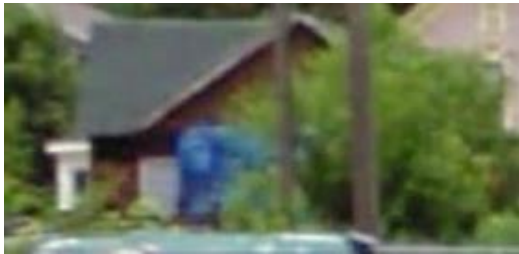
*Google street view, June 2009.
The blue tarp covers the area where the rear extension had been located.*

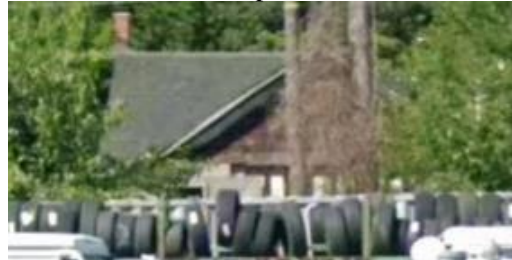
*July 2018.
Although hard to see, it appears as though a wall was erected (and windows installed) to enclose the space where the extension had been.*

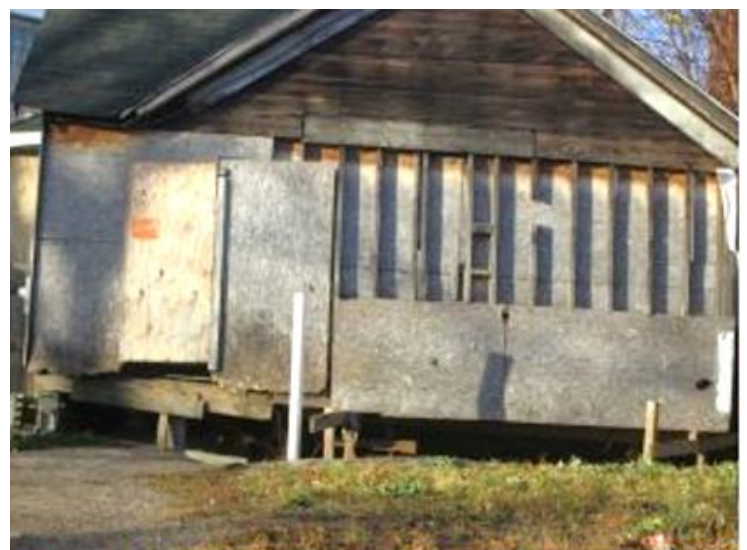
CC 2244 Wabash5 11-14-22 Jaafar.JPG

- The demolished side wing was part of the 1884 structure and a distinctive character-defining feature of the house. The applicant didn't submit sufficient visual or physical information to substantiate that the side wing was so deteriorated that it necessitated its entire removal, rather than completing repairs to the foundation and internal structural supports.

Staff obtained photos from BSEED's Dangerous Buildings Division that show the condition of the rear wall prior to the recent demolition of the rear section of the house. This view shows the historic gable's wood sheathing and rake board were intact. Staff believes this section of the house could have had temporary support while the structural issues were corrected.

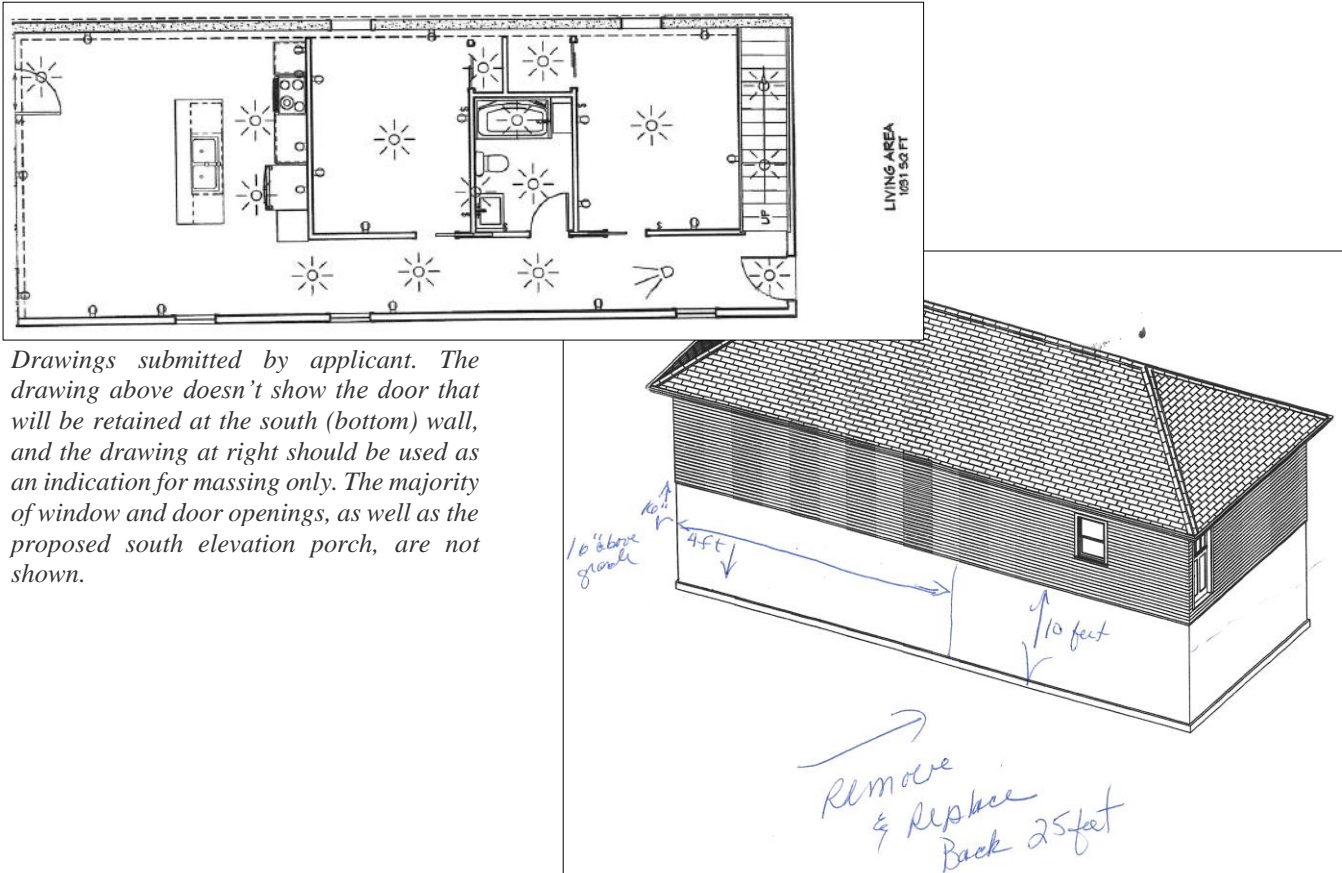
Drawings submitted by applicant. The drawing above doesn't show the door that will be retained at the south (bottom) wall, and the drawing at right should be used as an indication for massing only. The majority of window and door openings, as well as the proposed south elevation porch, are not shown.

- The submitted documents do not clearly show how the house and lot will look with the proposed rehabilitation and new construction, and different dimensions for the addition are mentioned in the varying documents. A landscape plan, dimensioned site plan, and dimensioned elevations are necessary to review the proposal for its placement on the site as well as showing how the walls, window and door openings, new porches, exterior siding and trim and landscaping will be articulated. Staff sent multiple requests for detailed documents but only received additional hand drawings and marked-up photos.

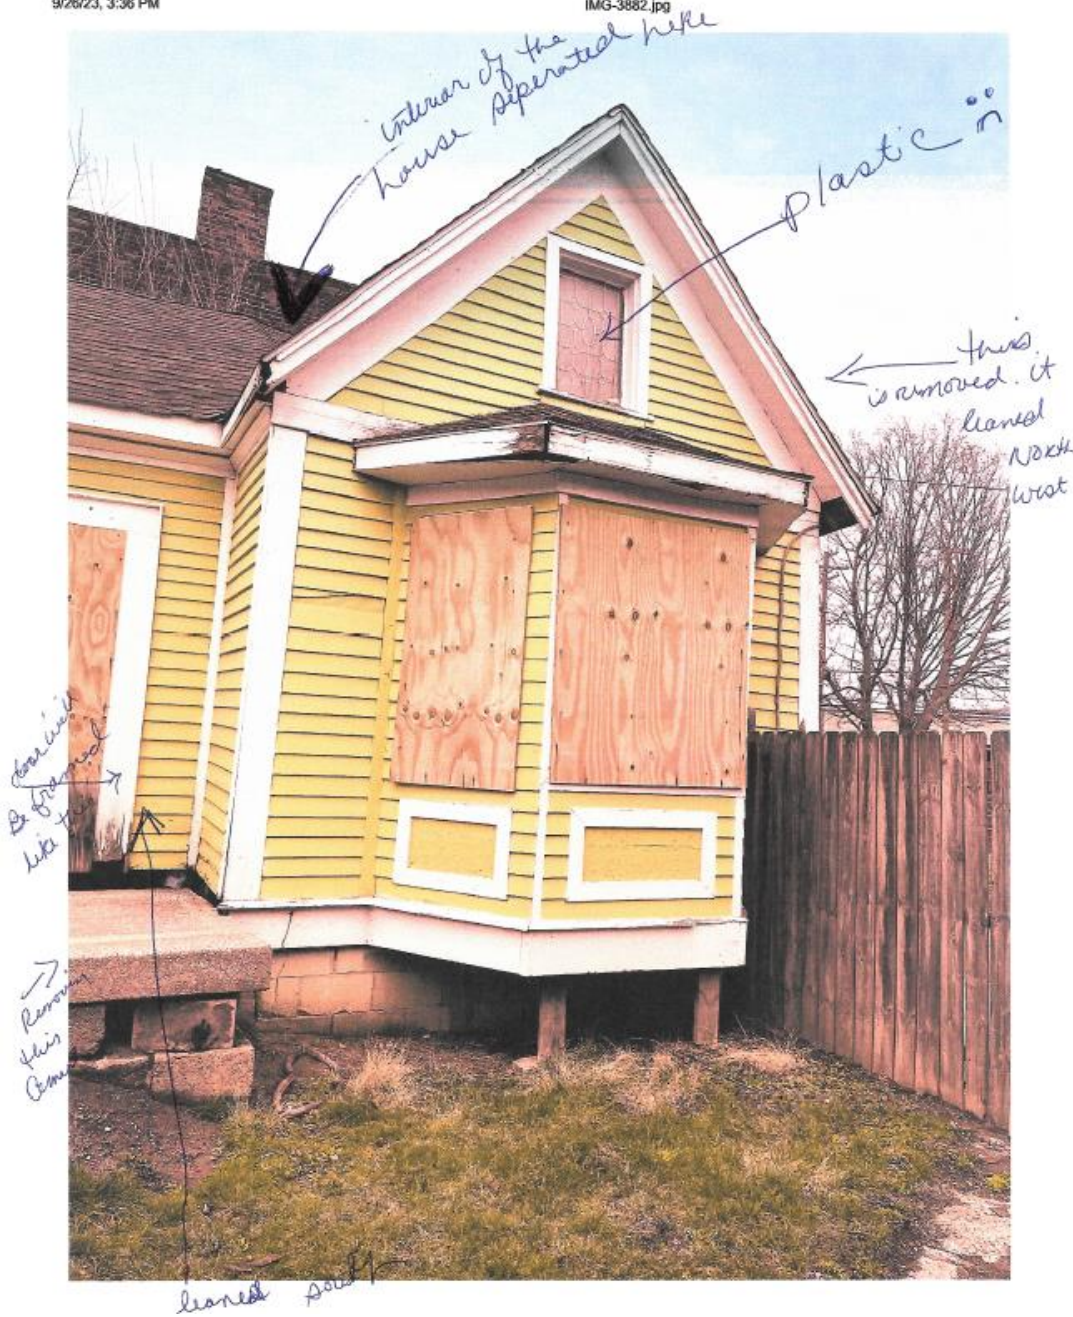
IMG-3882.jpg

- While the rear portion of the house, shown in the below photo, may have had structural issues, this section of the dwelling could have been stabilized or rebuilt to retain the historic footprint. It is staff's opinion that the smaller pre-1921 extension that had a lower shed roof (as seen in the designation photo on page 3) was not a distinctive character-defining feature of the dwelling. Therefore, erecting a rear addition in that location might meet the Standards and achieve the additional square footage desired by the applicant while retaining the distinctive character-defining footprint of the 1884 dwelling.

Applicant photo, showing rear section that was recently demolished.

- The applicant states the new design is to duplicate the neighboring homes as a style and size reference. The Standards do not allow for a house to be changed to match other houses; a house must remain a product of its time and its individual architectural design. Beyond that, the previous footprint did match most neighboring homes that were built within the same 19th century time period. The side wing should be reconstructed as part of a new construction proposal.
