**STAFF REPORT:** OCTOBER 11, 2023, REGULAR MEETING

**APPLICATION NUMBER:** HDC2023-00056

**ADDRESS:** 226 MACK

**SCOPE:** REPLACE WOOD AND VINYL WINDOWS WITH ALUMINUM-CLAD WOOD WINDOWS

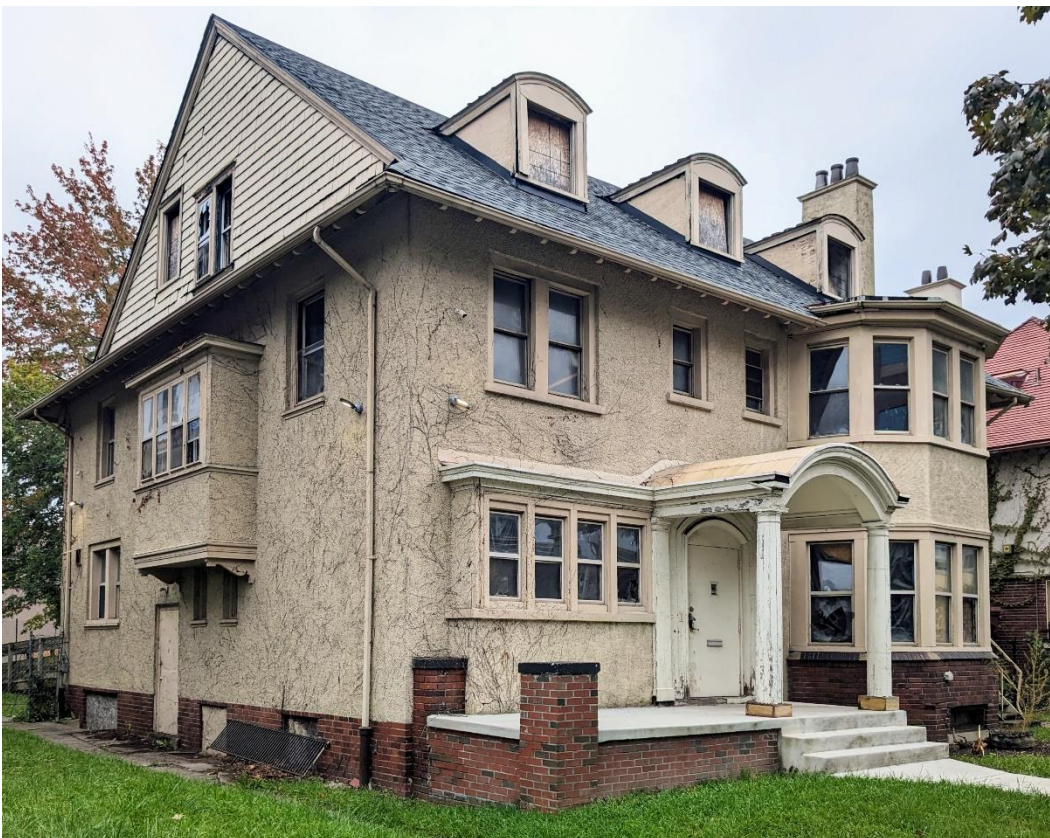
226 Mack is a two-and-one-half-story, side-gabled house, built in 1927. The irregular placement of window openings adds interest to all facades; this includes a dominant, five-faceted bay window on the primary (north) façade, box bay windows on the primary façade and east elevations, and segmental dormers on the front-facing roof slope. The only remaining historic wood windows are a row of four, one-over-one sash windows on the box bay window that projects from the east wall, and two small windows on the west elevation. All other windows are either vinyl replacements or are missing entirely.

*September 2023 photo by staff.*

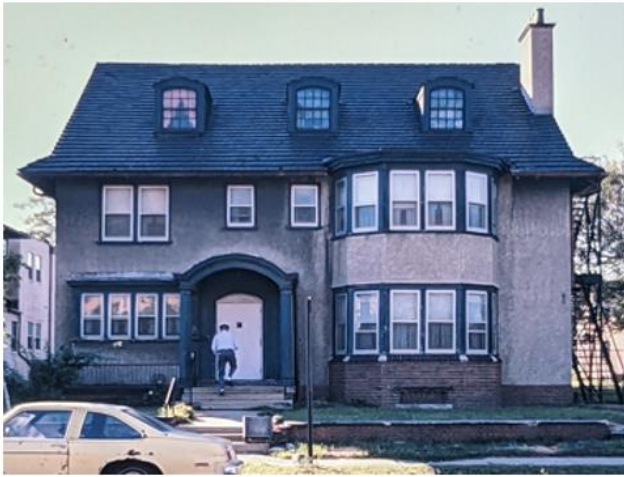
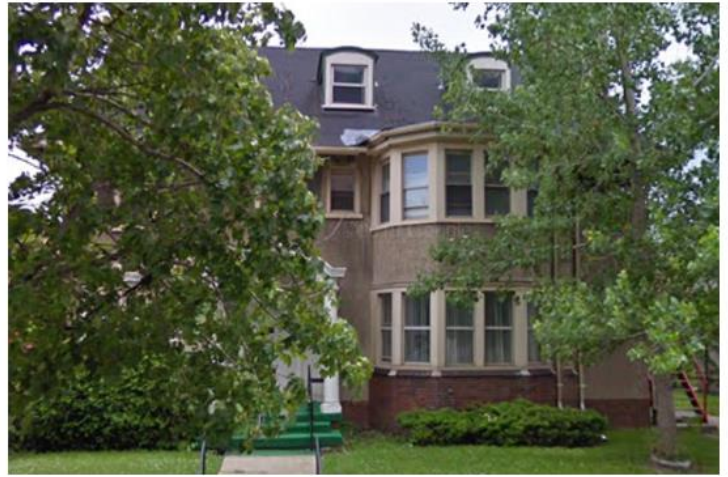
- The windows on the three, north-facing dormers were replaced sometime between 1980, when the historic district was established, and 2009, when newer windows are visible in a Google photo. There is no record of Historic District Commission approval for this work. The original windows were eight-over-eight sash windows with a curved upper sash. The original casing has also been clad in aluminum. **An undated historic photo clearly shows the original window casing. Comparison with current photos suggests that the aluminum stock has been applied over the historic casing, and that the**

historic casing remains encapsulated beneath. Original dentil trim, visible at the top of the front (north-facing) bay window, is also likely enclosed beneath the aluminum stuck.

Subject property in 1980 Historic Designation Advisory Board photo (left) and 2009 Google photo (right).

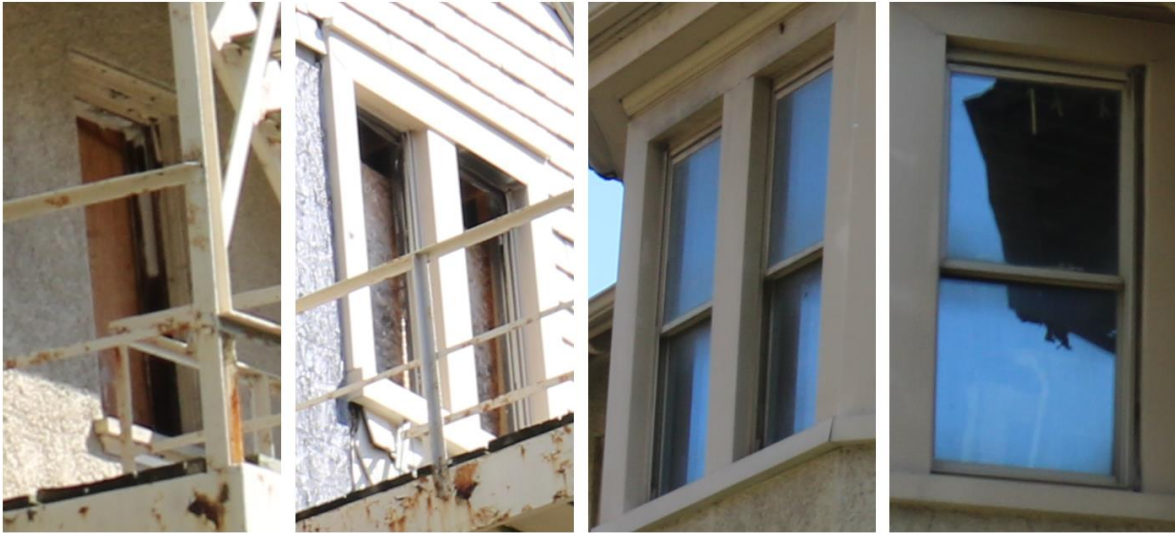
- Most other windows on the house have also been removed. Some of these openings now contain vinyl windows; others are missing windows. There is no record of ~~the prior appearance of~~ **when** the original windows ~~or when they~~ were removed, as they are concealed behind storm windows in the 1980 photo.

*Examples of missing windows and vinyl windows on the property. October 2023 photos by staff.*

Staff recommends that the Commission issue a Certificate of Appropriateness for the proposed replacement of missing windows and vinyl windows as these work items meet the Secretary of the Interior’s Standards for Rehabilitation, with the following conditions:

- Existing historic window casing will be retained (it may be replaced with matching wood casing if missing or deteriorated beyond repair) and will not be obscured by aluminum cladding.
- ~~The color of the windows will be a color selected from Color System C or D, or another color approved by staff.~~

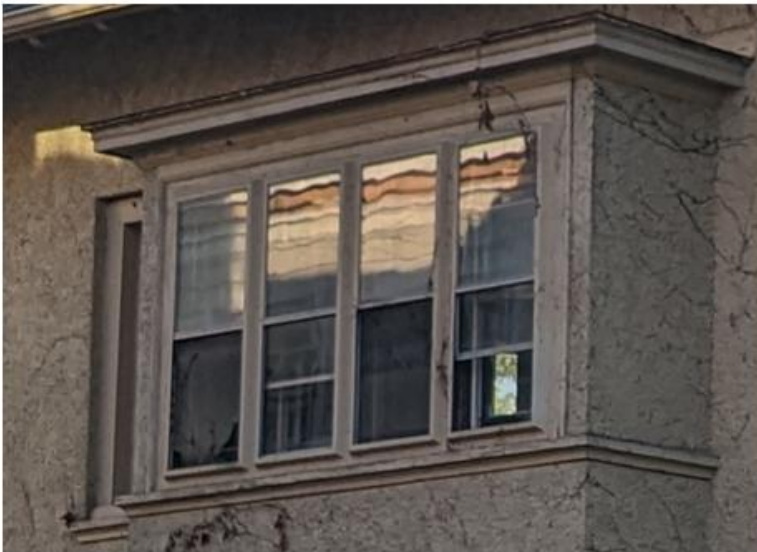
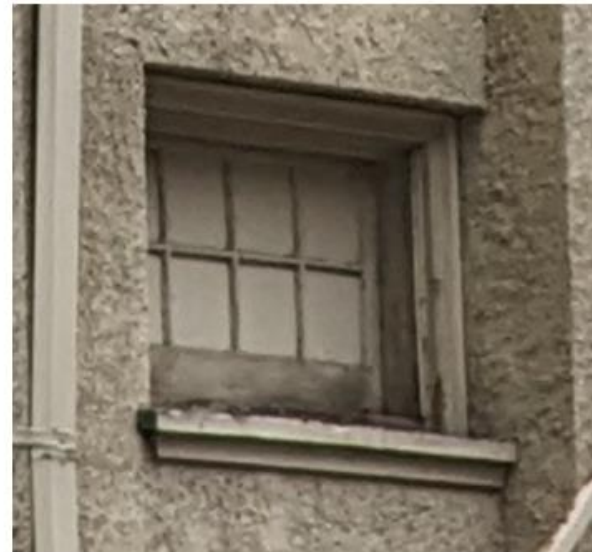
- A box bay window on the east elevation contains four wood sash windows that appear to be historic or original. Two small, eight-light rectangular windows on the west elevation, first floor, appear to be original wood windows. These six windows are the only remaining historic windows on the building.

*Left: Box bay with wood, one-over-one sash windows (not readily visible due to glare from storm windows). Right: Wood window, possibly a fixed or hopper window (typical of both). October 2023 photos by staff.*

- Likewise, the four windows on the east-facing box bay and the eight-lite windows on the west elevation are historic features that have not been shown to be deteriorated beyond repair. The Standards require that they be preserved.

Staff concludes that the proposed replacement of the three, north-facing, arch-top dormer windows (already done without approval), the four wood sash windows on the east elevation, and the ~~one~~ **two** wood windows on the west elevation does not meet the Secretary of the Interior’s Standards for the following reasons:

Therefore, staff recommends that the Commission issue a Denial for the proposed replacement the three, north-facing, dormer windows, the four wood sash windows on the east elevation, and the one wood window on the west elevation as the proposed work fails to meet the Secretary of the Interior’s Standards for Rehabilitation, in particular:

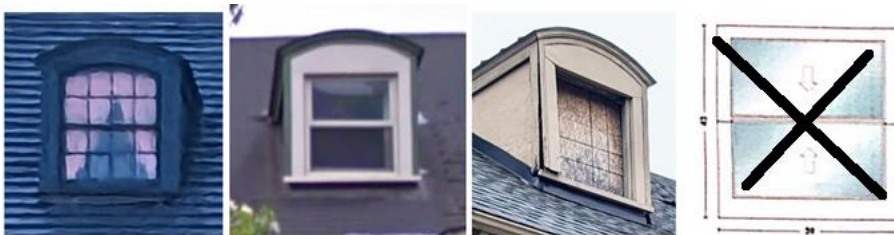
- The arch-top windows on the three, north-facing dormers, previously replaced without approval, were original or historic windows. There is no evidence that they were deteriorated beyond repair. The Secretary of the Interior’s Standards require that historic materials and features be retained and preserved (Standard #2, quoted below). If deteriorated beyond repair, historic features may be replaced with matching features (Standard #6, quoted below).
- The windows on the three, north-facing dormers formerly had curved upper sashes and both sashes were subdivided by muntins into eight panes each. Neither the current vinyl windows, installed without approval, nor the proposed replacement windows, match these characteristics, contrary to Standard #6.

North-facing dormers, left to right: 1980 (Historic Designation Advisory Board), 2007 (Google Maps), existing condition (photo by staff), ~~proposed replacement (from submitted window schedule).~~

- The windows are historic materials that have not been shown to be deteriorated beyond repair.
- For the north-facing dormer windows, the proposed work replaces nonrectangular, eight-over-eight windows (already removed without approval) with rectangular, one-over-one windows.
