**STAFF REPORT:** 11/8/2023 REGULAR MEETING  
**APPLICATION NUMBER:** HDC2023-00091  
**VIOLATION NUMBER:** 790  
**ADDRESS:** 14833 STAHELIN  
**HISTORIC DISTRICT:** ROSEDALE PARK  
**APPLICANT/ PROPERTY OWNER:** TAMEKKA COLMAN  
**DATE OF PROVISIONALLY COMPLETE APPLICATION:** 10/16/2023  
**DATE OF STAFF SITE VISITS:** 9/21/2023, 10/19/2023

**SCOPE:** DEMOLISH GARAGE, ERECT GARAGE, ALTER DRIVEWAY/PAVING (WORK COMPLETED WITHOUT APPROVAL)

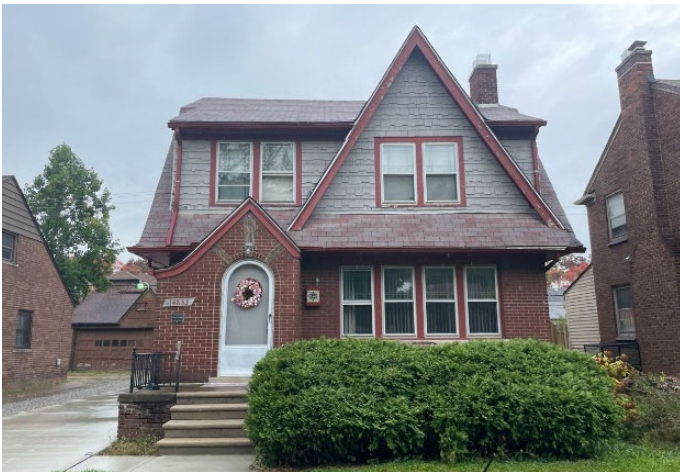
*Site Photo 1, by Staff October 10, 2023: (East) front elevation.*

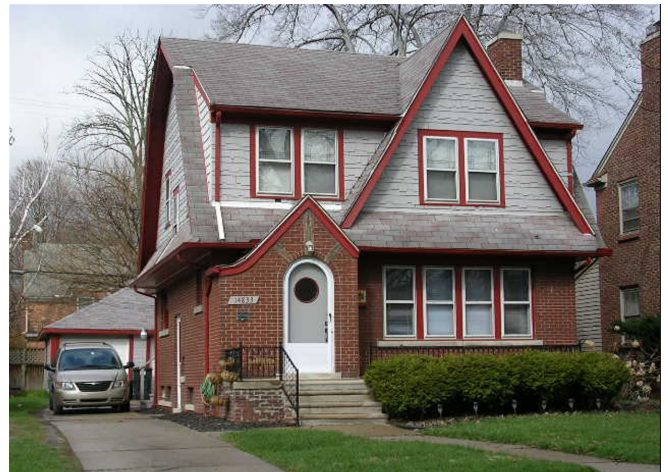
*Designation photo 2007: (east) front elevation, showing existing garage in the backyard.*

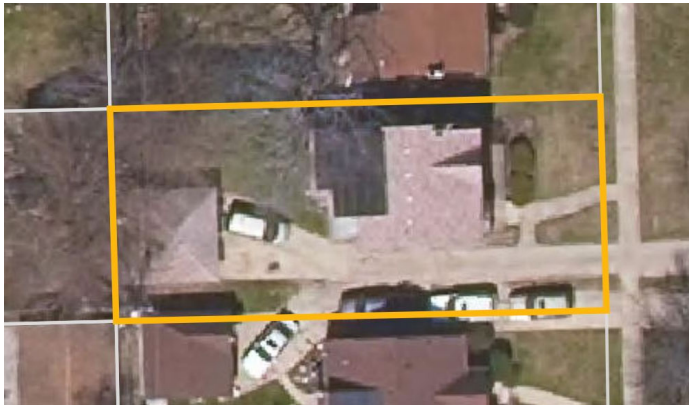
*Aerial#1 of Parcel # 22083667, showing original garage and driveway behind the house.*

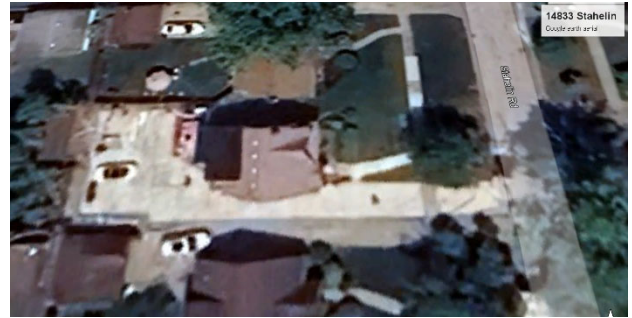
*Aerial#2 by Google Earth June 2023, showing original garage demolished existing driveway expanded along with new rear deck.*

- Staff initially received an application for only the removal of the original garage and installation of the new driveway, but upon further engagement with the applicant, there appears to be additional work completed without approval, the installation of a rear deck, which is visible in Google Earth imagery and confirmed by the applicant. Staff, however, did not receive any further information from the applicant and so this work is not included in this application. (See aerial #1&2)

- Although site photos of the rear were not obtained by the completion of this report, staff observed that the rear yard appears to be nearly covered in concrete from aerial images (*See Aerial #2*). This and the garage leaves only 3' to 7' margin of grass around the garage but eliminates the backyard lawn.

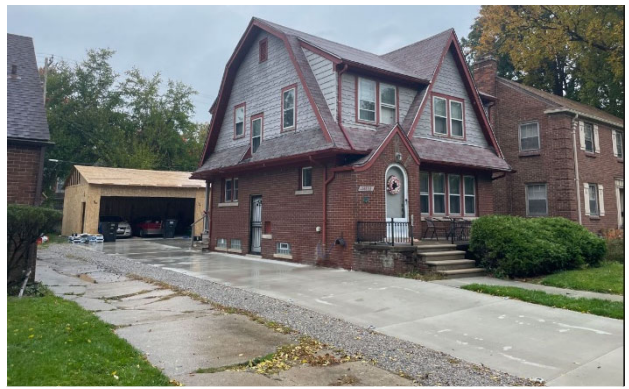
- Staff visited the site on September 21 and October 19, 2023 and observed that the applicant's newly built garage's size nearly takes up the width of the rear yard. The roof pitch and height are at a scale that closely matches or under the size of the neighbors' garage.

- While the height and roof pitch may be appropriate, it is staff's opinion that the proposed massing and scale for this garage are inappropriate as they do not meet the Elements of Design nor "relate to the main dwelling".

- Staff offers the opinion that the proposed garage does not share in *Relationship of Materials*, ie., the brick masonry, cedar shake siding, wood doors/windows of the house does not match with the vinyl siding and vinyl materials of the new garage. The proposed newly constructed garage with non-matching materials, conflicts with the Rosedale Park Historic District's Elements of Design by removing this relationship. Vinyl siding and windows are not an appropriate material for this historic district.

Site Photo 2, by Staff October 19, 2023 showing new garage and driveway.

Staff therefore recommends that the Commission issue a Denial for the above work items, as it do not meet the Secretary of the Interior's Standards for Rehabilitation, specifically Standards:

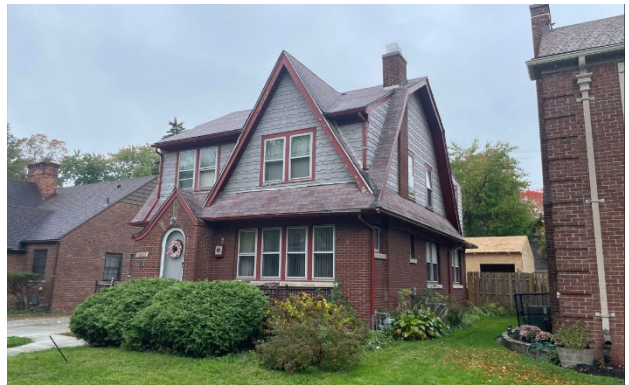
Site Photo 3, by Staff October 19, 2023 showing new garage at the rear.

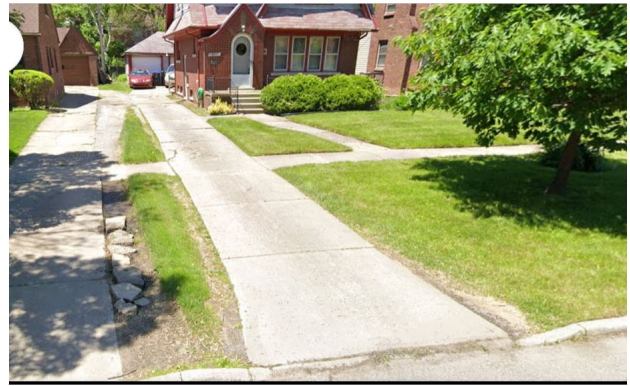
- Staff observed that the new driveway, constructed without approval, is approximately 2 feet wider than the original driveway, which overlays on top of the previously present green space between the house and the driveway, thus creating a continuous hard surface that nearly joins the neighbor’s driveway to the rear. Staff has the opinion that the width of the new driveway is not appropriate because it conflicts with the Elements of Design’s Relationship of Significant Landscape Features and Surface Treatments, *“The front lawn area is generally covered with grass turf, subdivided by a straight or curving concrete or brick walk leading to the front entrance and a single-width side driveway leading to a garage.”* (See site photo 4)

Site Photo 4, by Google Street View June 2019, showing original driveway width and planting beds next to the house.

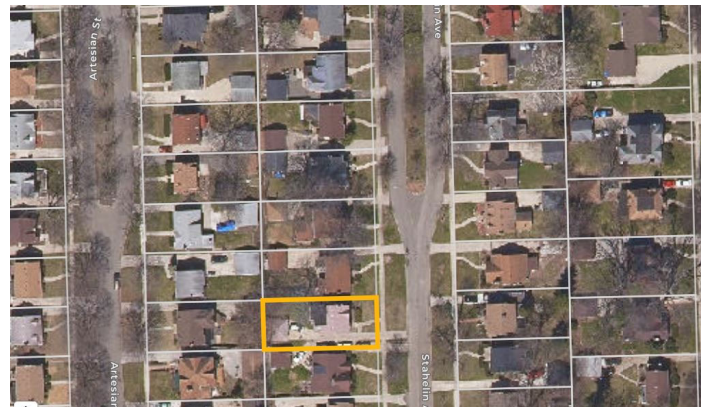
- A review of aerial images of the district revealed that most of the space within rear yards is typically dedicated to grass turf/landscaped open lawns with minimal hardscape intrusions to include walkways, patio, and narrow driveways. (See Aerial #3) When detached garages are present within the district, staff noted that parcels typically include a structure of a footprint/scale that is minimal in relationship to the home, leaving ample open green space in the rear yard. The current project will result in the erection of a large garage and expansion of the driveway that results in the near complete removal of the open lawn space within the rear yard. It is staff’s opinion that these conditions are incompatible with the house’s and the district’s historic character.

Aerial #3 of Rosedale Park HD, showing applicant’s location in the context of other resident’s back yards.
