STAFF REPORT: 12/13/2023 REGULAR MEETING
APPLICATION NUMBER: HDC2023-00146

ADDRESS: 1515 SEYBURN

HISTORIC DISTRICT: WEST VILLAGE

SCOPE: REPLACE 2 REAR WINDOWS, REPAIR EXISTING WINDOWS

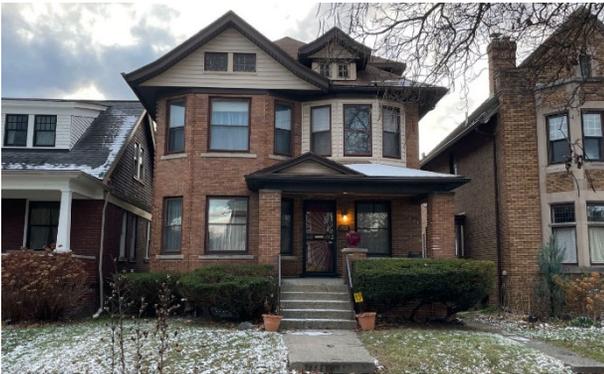
Site Photo 1, by Staff November 28, 2023: (East) front side

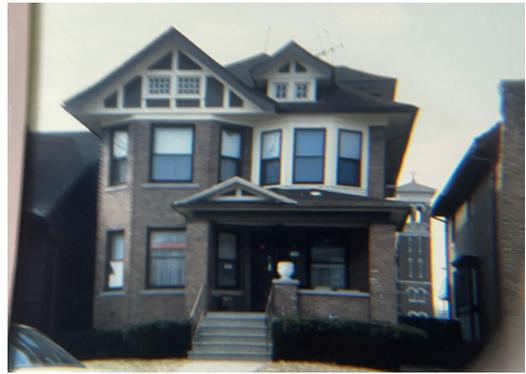
Site Photo 2, Designation Photo March 1983: (east) front elevation.

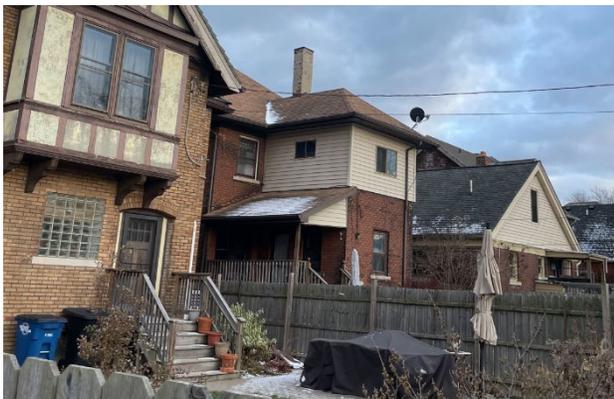
Site Photo 3, by Staff November 28, 2023: rear yard, looking south from public sidewalk towards rear porch.

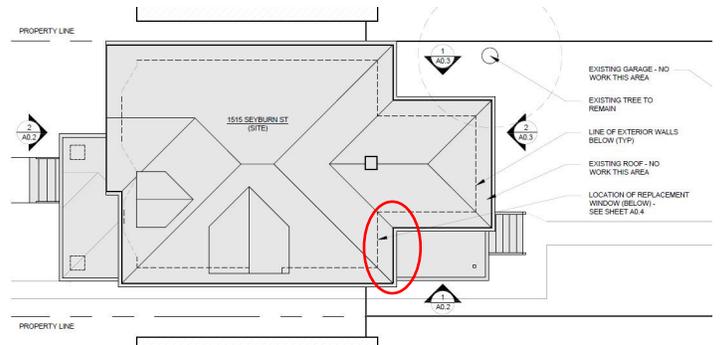
Figures 1 by Applicant: showing location of proposed modified window (see red circle above).

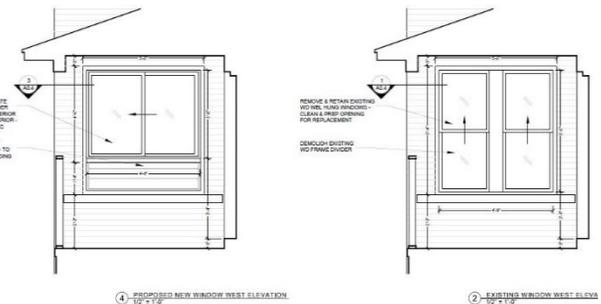
Figures 2&3, by Applicant: showing existing conditions (right) and proposed condition (left). Note that the applicant has now modified the application so that previously proposed slider window would be replaced with a pair of casements and the proposed vinyl siding, would instead be wood panel below the new set of casements. The center mullion is still proposed for removal.

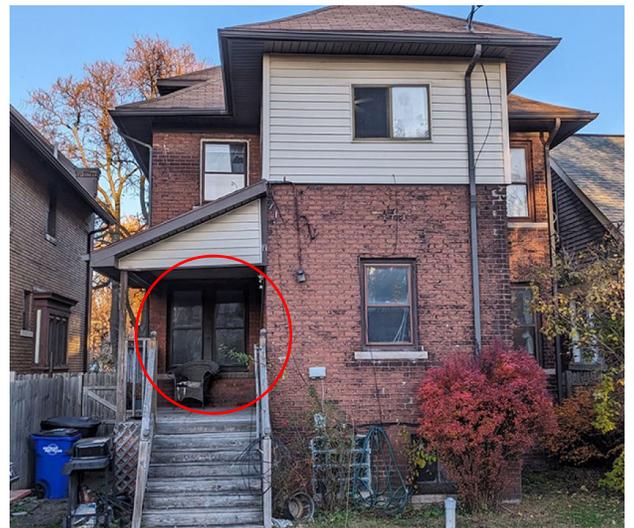
Site Photo 4, by applicant showing location of rear window proposed to be replaced by casements.

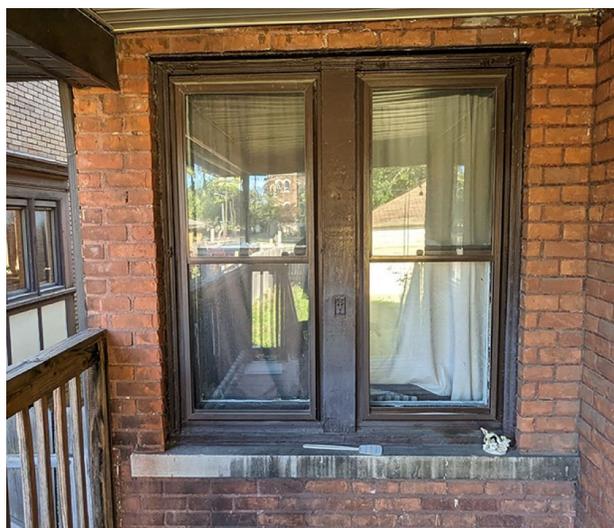
- Staff has the opinion that the original wood windows at the rear porch are character-defining features of the house, including the stone still and the wood mullion that divides the pair of double-hung wood windows. (See photo 5) Staff observed that this secondary elevation location is obscured from public view and that this proposal retains the brick opening and stone sill. Per the applicant's drawings, it also appears the wood framing the historic sash, including the brick molds, will be preserved *in situ*. However, the center mullion is proposed for removal. Staff suggests that the goal of the interior elective work can still be achieved by retaining the center mullion as well as replacing only the historic sash, on either side with a shorter new window over a wood infill, all within the historic sash opening.

Site Photo 5, by applicant showing original pair of double-hung windows and mullion proposed to be replaced by casements.

- Staff has the opinion that some alteration of the rear sash may be appropriate at this secondary elevation. However, the proposed removal of the center mullion does not appear to be necessary to reasonably achieve the desired interior conditions and thus should be preserved. It should be noted that interior reconfigurations of historically protected buildings cannot compel the alteration of distinctive exterior features under the Standards. Staff believes the robust vertical mullion is distinctive and important to the overall historic character.

- The alteration to the rear windows shall be redesigned to retain all exterior woodwork, (excepting the sashes), including the center mullion, stone sill and brick opening in their current position, while allowing infill of the new windows over wood panels in the resulting two openings. The removed sash shall be stored in the building for future reinstallation.
- The two separate infill windows shall be of casement or double-hung operation and made of wood or aluminum-clad wood materials.
- The two separate infills below the two new windows shall be designed in wood and painted according to HDC guidelines.
- The applicant provides HDC staff with an updated proposal drawing for review and approval of these conditions before work begins.
