**ADDRESS: 3964 W. LAFAYETTE**

**APPLICATION NO: HDC2023-00141**

**HISTORIC DISTRICT: HUBBARD FARMS**

**SCOPE: REBUILD WING**

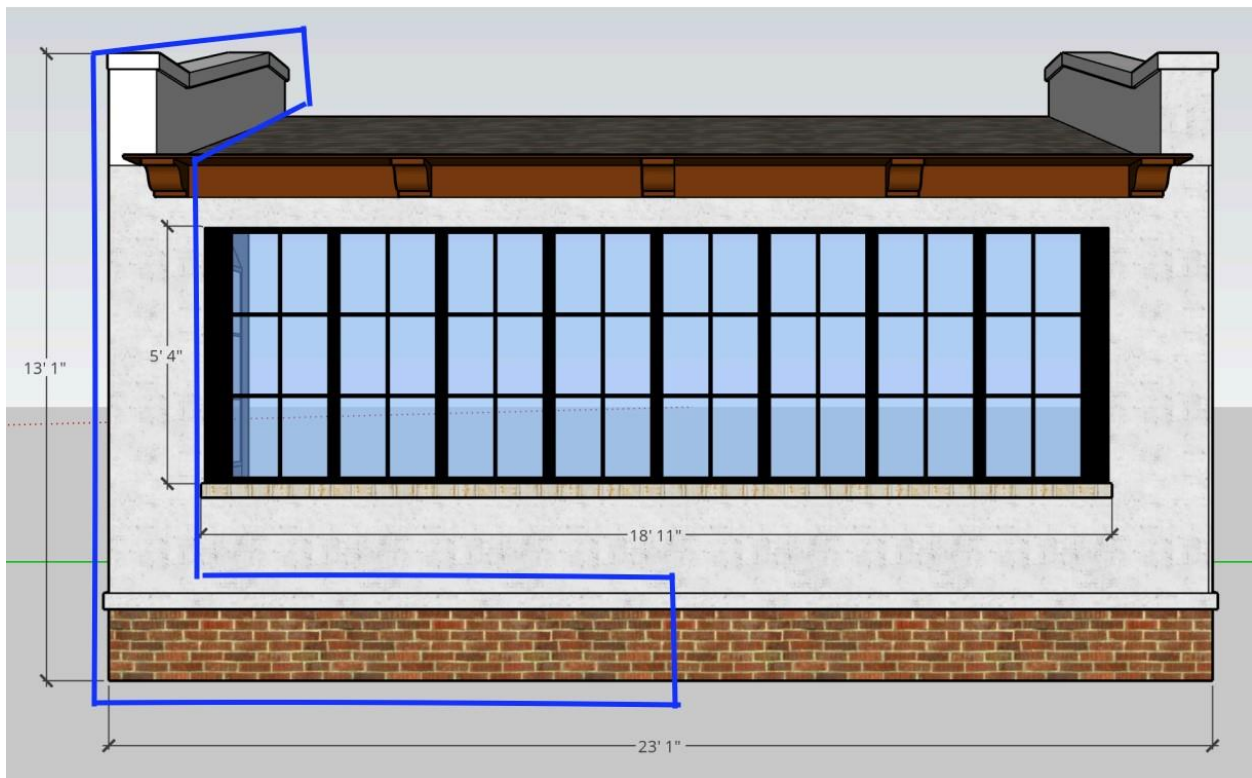
Area outlined in blue indicates the portions of the walls that will be replaced in kind (entire south wall and parapet and bottom portion of the west wall)

- Remove and rebuild the southern front wall (to include the removal of the existing historic doors and windows). The new southern wall will match the existing in in dimension, cladding and detailing. However the current door opening will not be replicated. Instead, the wall will include four milled, aluminum-clad, wood casement windows (Andersen E Series), topped with arched trim.

- Remove bottom portion of the west wall per the below graphic and rebuild with in-kind materials to match existing in dimension, cladding, and detailing

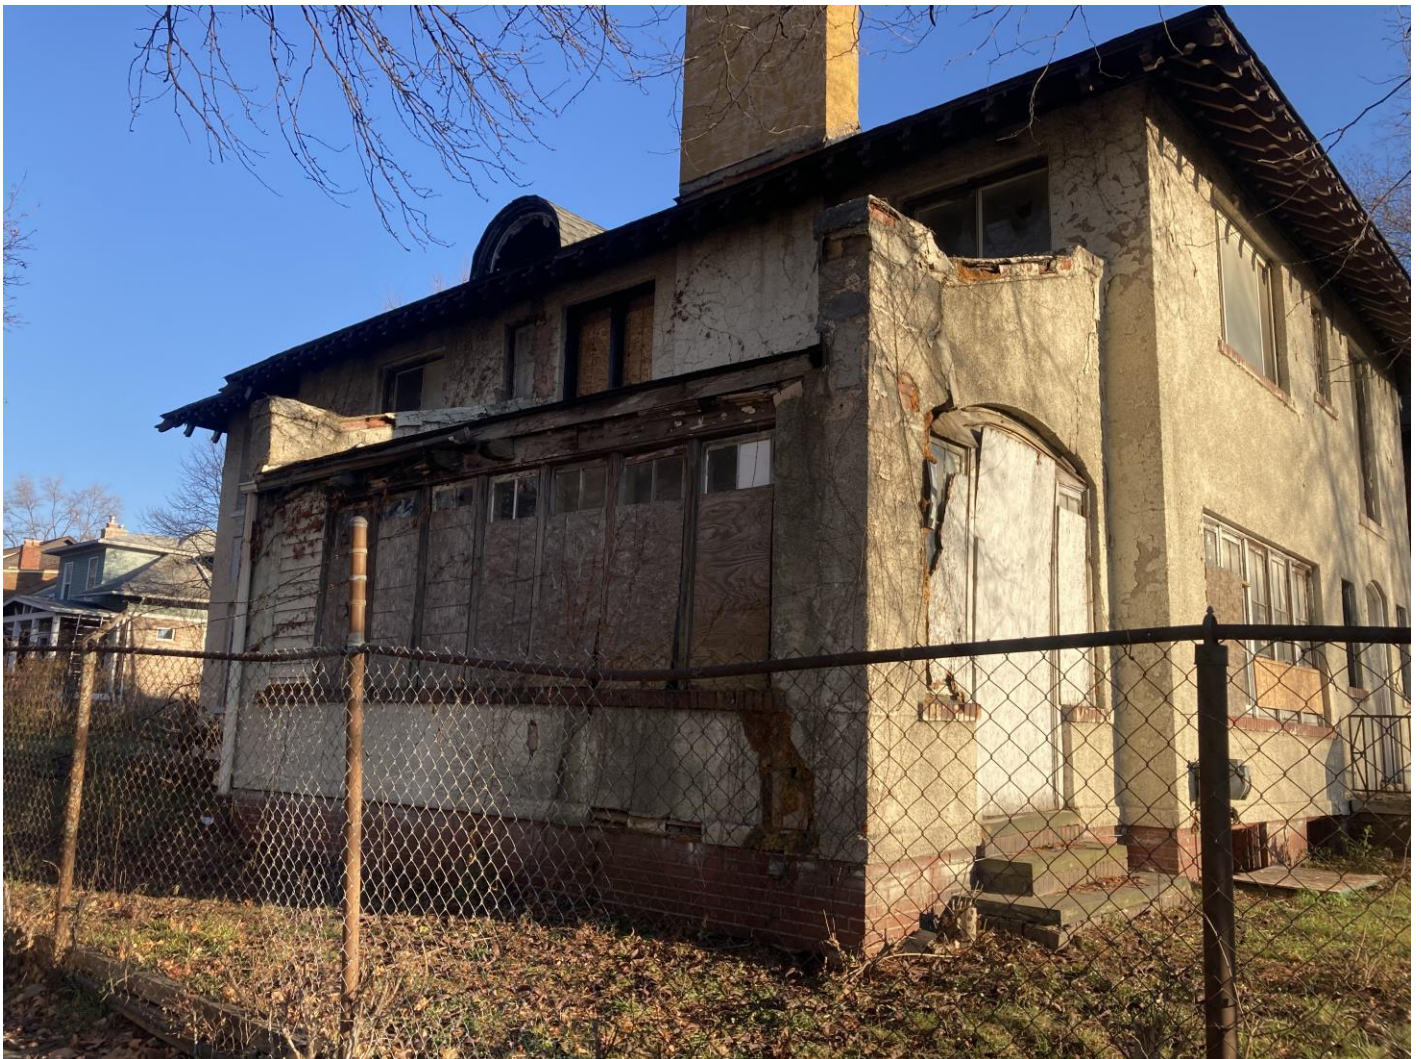
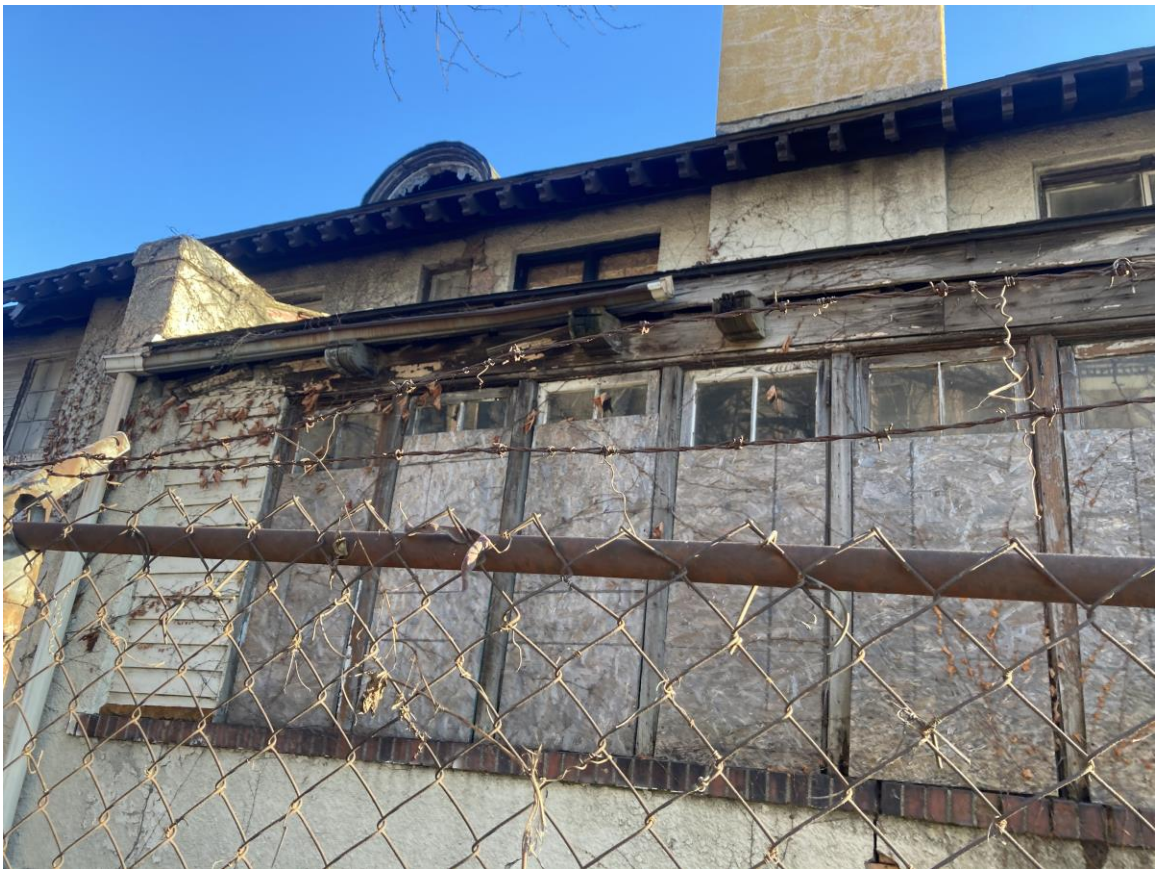
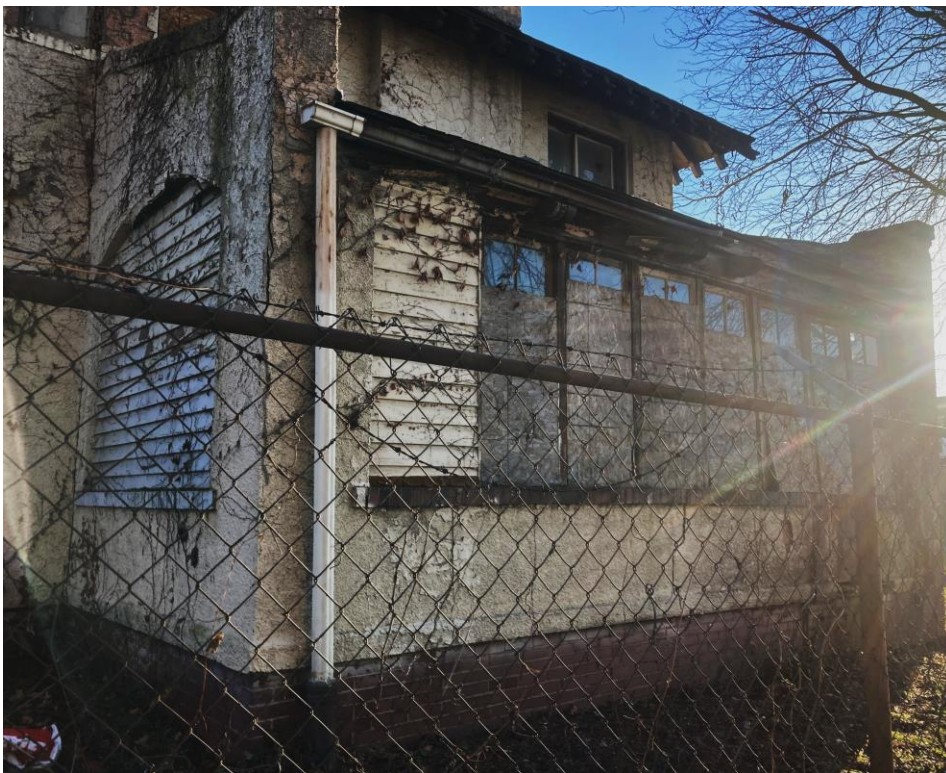
- The applicant has stated that he wishes to replace the wing’s roof, south wall and character-defining windows and associated exterior woodwork (frame, mullions, and arched lintels) due to their level of deterioration. Please see the submitted documentation which highlights the wing’s areas of structural failure. Re: the wing’s fenestration, structural failures at the walls and roof have caused bucking and racking of the windows and trim requiring

replacement throughout. Also, see the below photos which indicate the high level of wood rot/deterioration of the roof's soffit and decorative rafter tails. It is staff's opinion that the submission has supplied the level of documentation necessary to establish that the elements which the application is seeking to replace and replicate are deteriorated beyond repair.

**Staff photo, facing northeast showing wing proposed for rehabilitation, taken 12/8/2023**

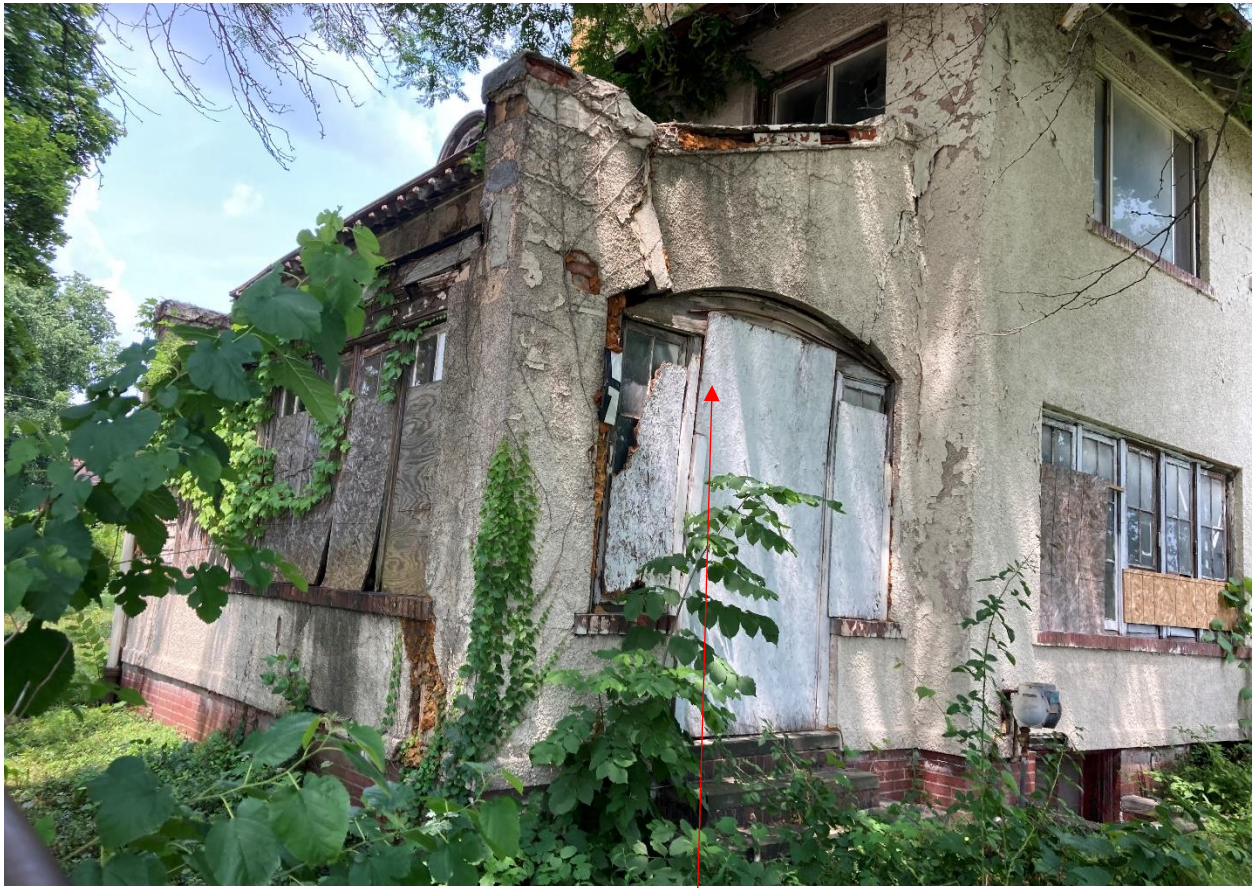
**Facing northeast. The south wall shown here will be rebuilt to match the existing in materials and design with the exception that it will only include window openings**

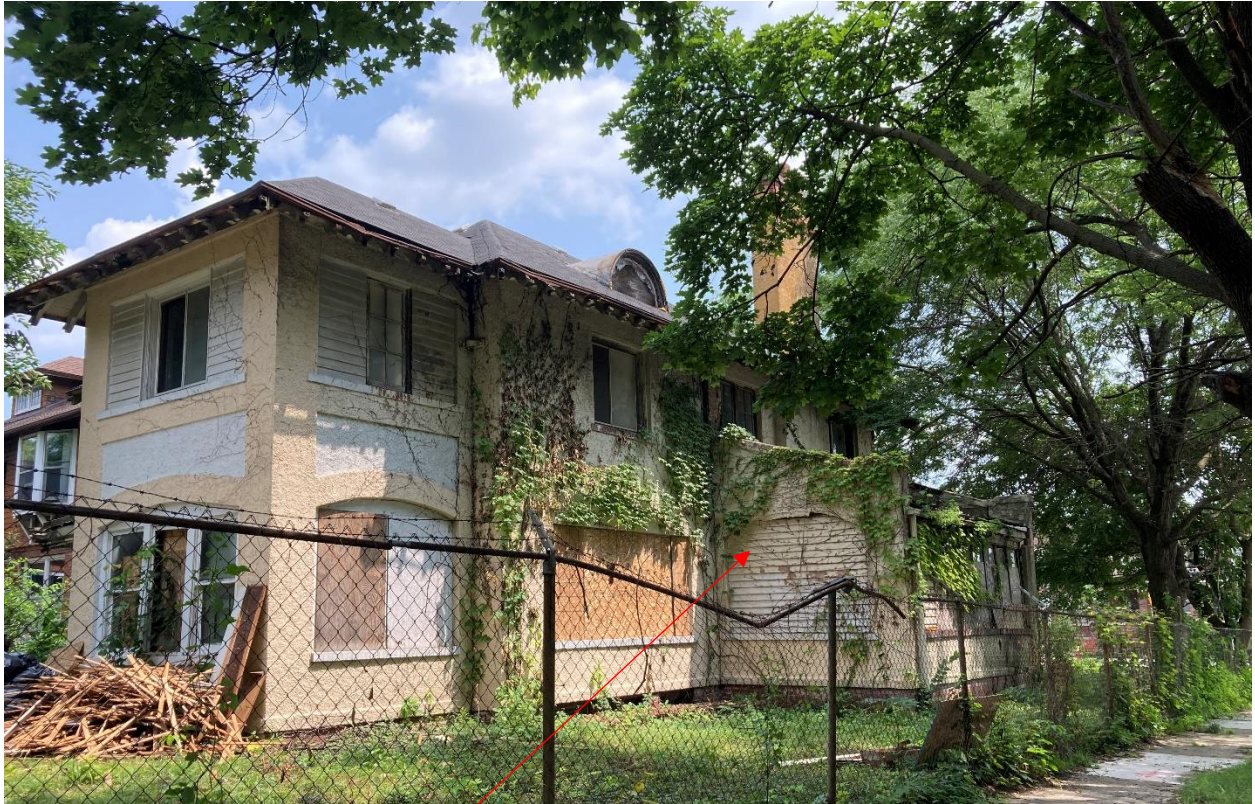
**Facing southeast. The north wall shown here will be retained**

- Repair deteriorated areas at the north wall with in-kind materials where necessary
- Remove existing wood windows and wood trim to rough opening throughout and replace with new aluminum-clad, wood casement windows (Andersen E Series)

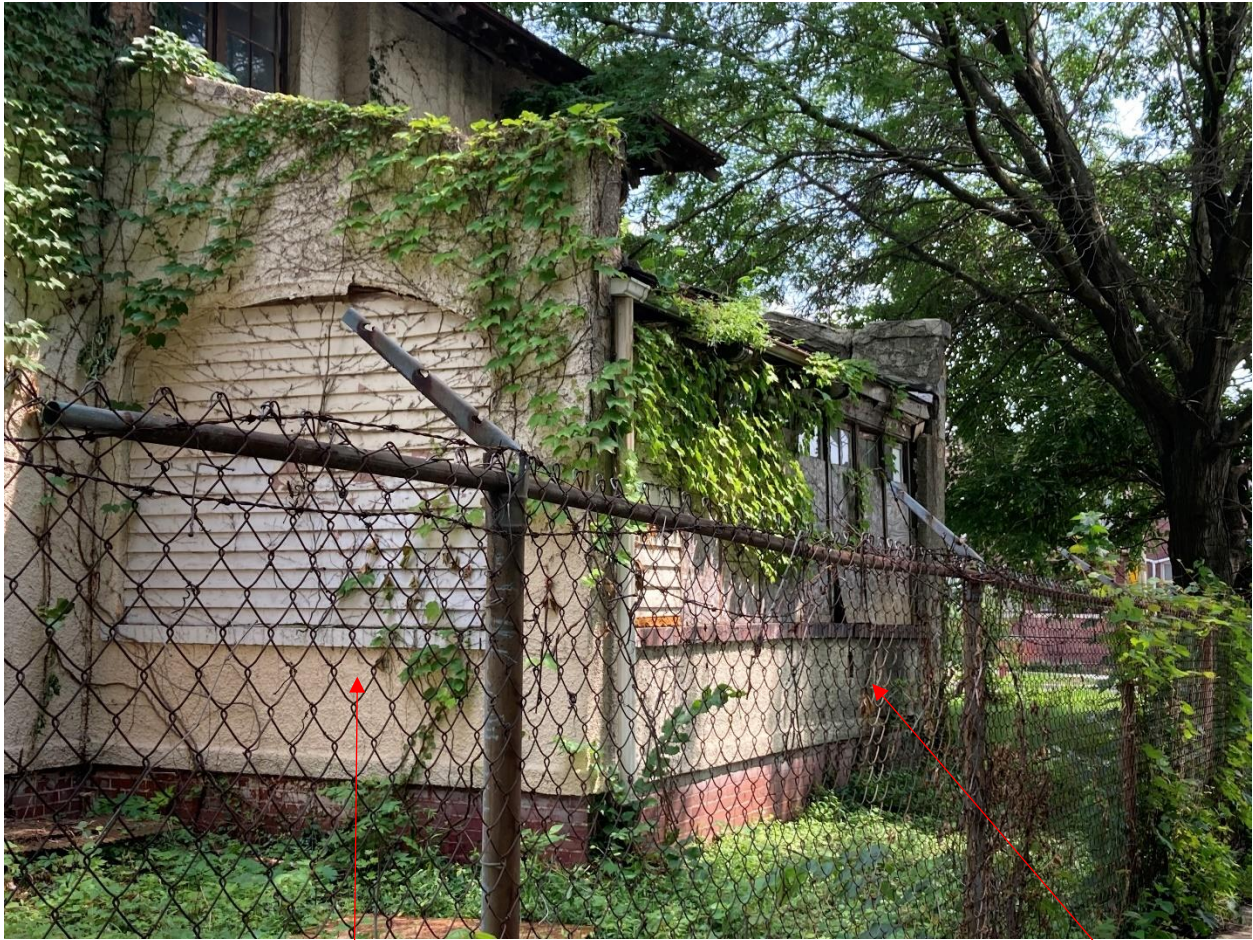
Facing southeast. The north wall shown here will be retained. The lower portion of the west wall will also be replaced to match existing in material, dimension, and detailing
