STAFF REPORT: DECEMBER 13, 2023, REGULAR MEETING PREPARED BY: T. BOSCARINO
APPLICATION NUMBER: HDC2023-00065
ADDRESS: 859 EDISON
HISTORIC DISTRICT: BOSTON-EDISON
APPLICANT/OWNER: NICHOLAS SEHY
DATE OF PROVISIONALLY COMPLETE APPLICATION: OCTOBER 10, 2023
DATE OF STAFF SITE VISIT: NOVEMBER 30, 2023

SCOPE: REPLACE PORCH ROOF, REHABILITATE GARAGE

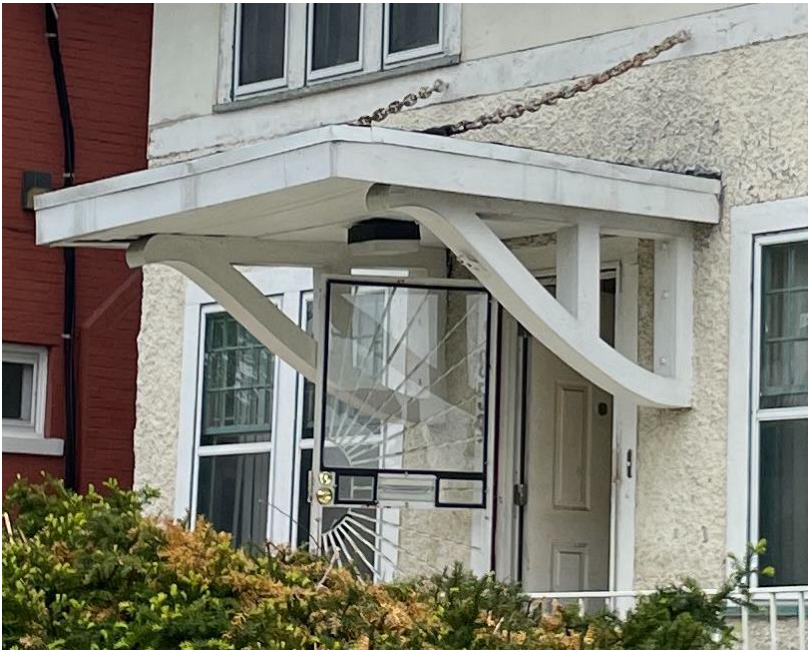
“Before” photo of porch roof. May 2022 photo by staff. (Photo was taken during a site visit pertaining to the security light, a separate scope item described below.)

- The (former) projecting, bracketed porch is a historic and distinctive feature that defines the character of the house and original design, which combined elements from two architectural styles that were popular at the time. The removal of historic and distinctive features is contrary to the Secretary of the Interior’s Standards for Rehabilitation, namely Standard #2 and Standard #5, respectively (quoted below).

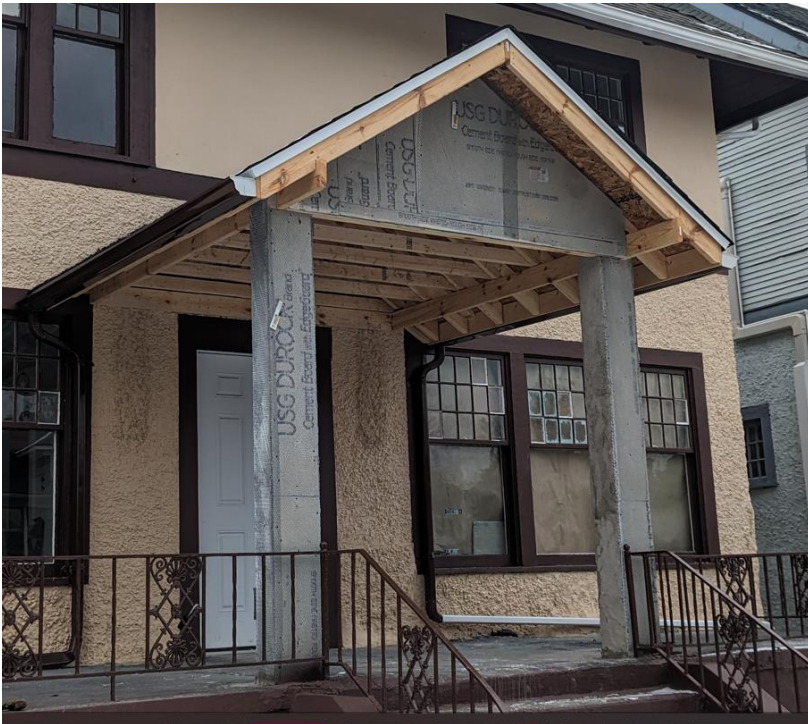
“After” photo of porch roof. November 2023 photo by staff.

- The proposed (already mostly complete) porch is compatible with the house. The application scope of work states that the porch was inspired by the next-door house at 867 Edison. The two houses were both built at the

- The work removes a historic and character-defining porch overhang, projecting rafter ends on the garage, and a garage window. According to the Secretary of the Interior’s Standards, such distinctive elements should not be removed unless they have deteriorated beyond repair. Even if they are beyond repair, they should be replaced with matching elements.
- The new garage windows, due to their lack of depth and texture, are not compatible replacements.

Therefore, staff recommends that the Commission issue a *Denial* of the proposed work as it does not meet the Secretary of the Interior's Standards for Rehabilitation, in particular:

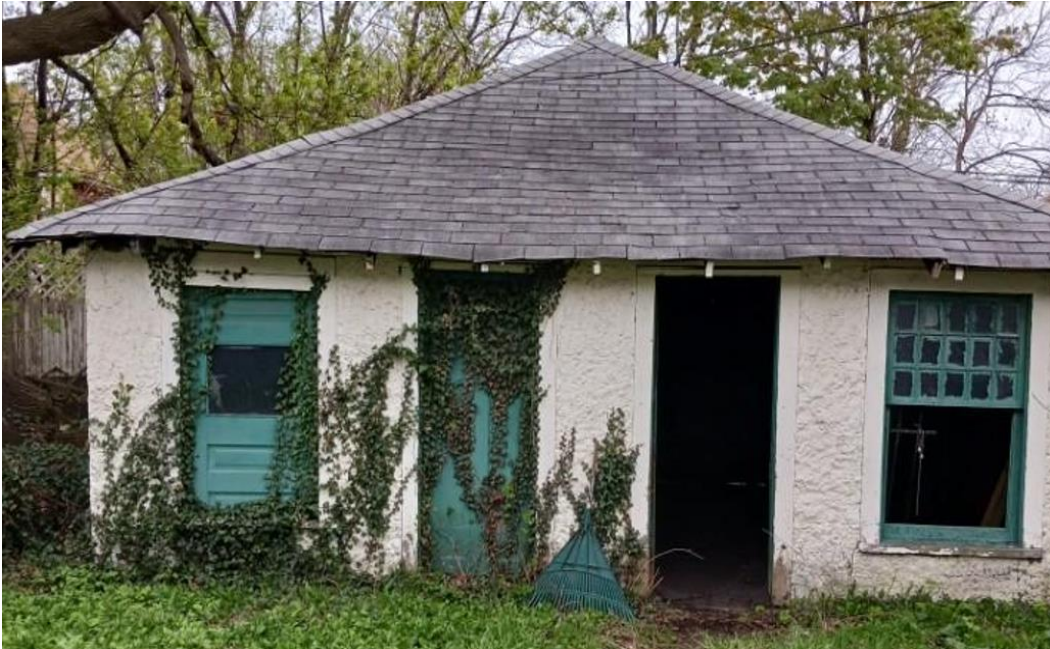
“Before” photo of garage, from April 22, 2022, garage repair application by previous owner.

- The four, north-facing garage openings consisted of (from left/east to right/west, as seen in the “before” photo on page 3):
 - A non-historic, makeshift window created by repurposing an old, glazed wood door. Replacement of this opening with a compatible window would be appropriate.

- A non-historic, inoperable wood panel enclosing a former door opening. Replacement of this with a compatible door would be appropriate.
 - A door opening with missing door. Installation of a compatible door at this location would be appropriate.

- A historic, fifteen-over-one wood sash window that appears to have been in good or repairable condition. The upper sash and surrounding frame and casing appear to have been intact. The applicant states that the lower sash was missing, but staff notes that this can be replicated. Replacement of this window is not appropriate.

- The proposed (already completed) garage roof work eliminates projecting rafter ends that were a distinctive and character-defining feature. Although deterioration of the garage rafters is visible in 2022 photos, likely requiring replacement of much or all of the structure, Standard #6 (quoted below) requires that replacement materials match the historic materials that were removed.

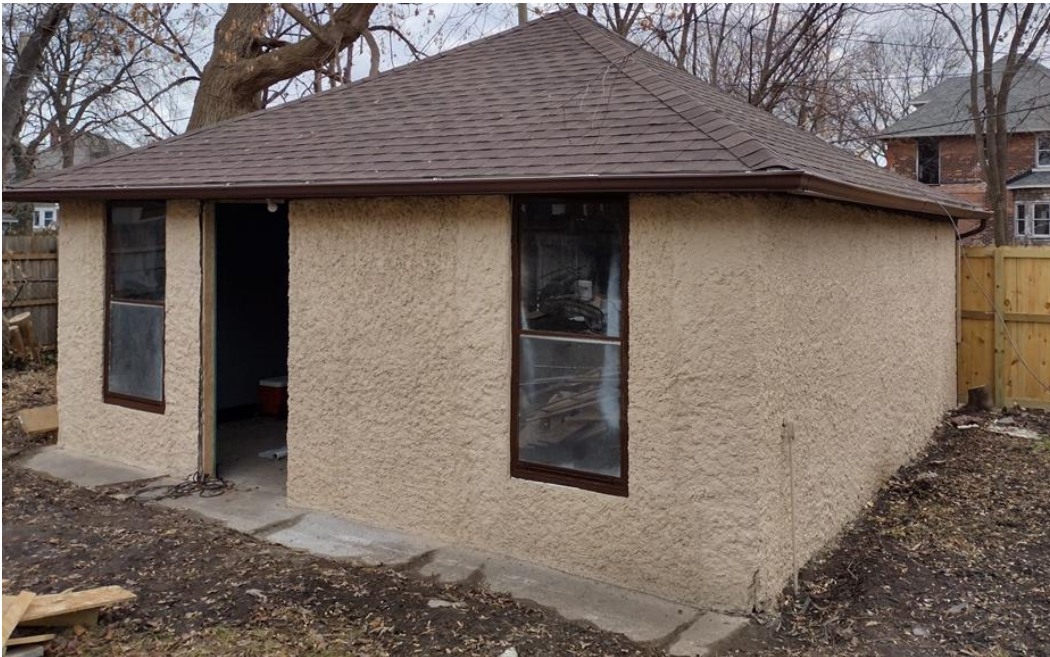
“After” photo of garage. Undated photo provided by applicant.

The application scope of work states that the door opening, visible in the photo above, would be filled with the hollow, steel panel door that is presently visible on the front of the house.

- The westernmost sash window on the garage was a historic (it appears to have been original to the house) and character-defining (it added to the texture and character of the façade, as mentioned above, and was a subdivided wood window, as mentioned in the Elements of Design) feature. Standard #2 requires that it be preserved. If beyond repair, it should be replaced in kind.

- Although the replacement of the easternmost window on the garage is appropriate, the new window lacks the depth and character of a historic wood window and is therefore not an appropriate new window. Examples of appropriate new windows include double-hung, wood, or aluminum-clad wood, sash windows with a recessed lower sash as seen on historic windows.

- The elimination of the westernmost, north-facing, garage door opening is not appropriate. Interventions that retain the character of the historic door opening, such as the installation of a compatible new door, or infill with stucco recessed several inches to retain the sense of depth provided by the original opening, would be appropriate.

- The westernmost, north-facing, garage door opening is a historic feature that should not have been eliminated.
- The light fixture is not compatible with the house, as described in the *Security Lighting Guidelines*.

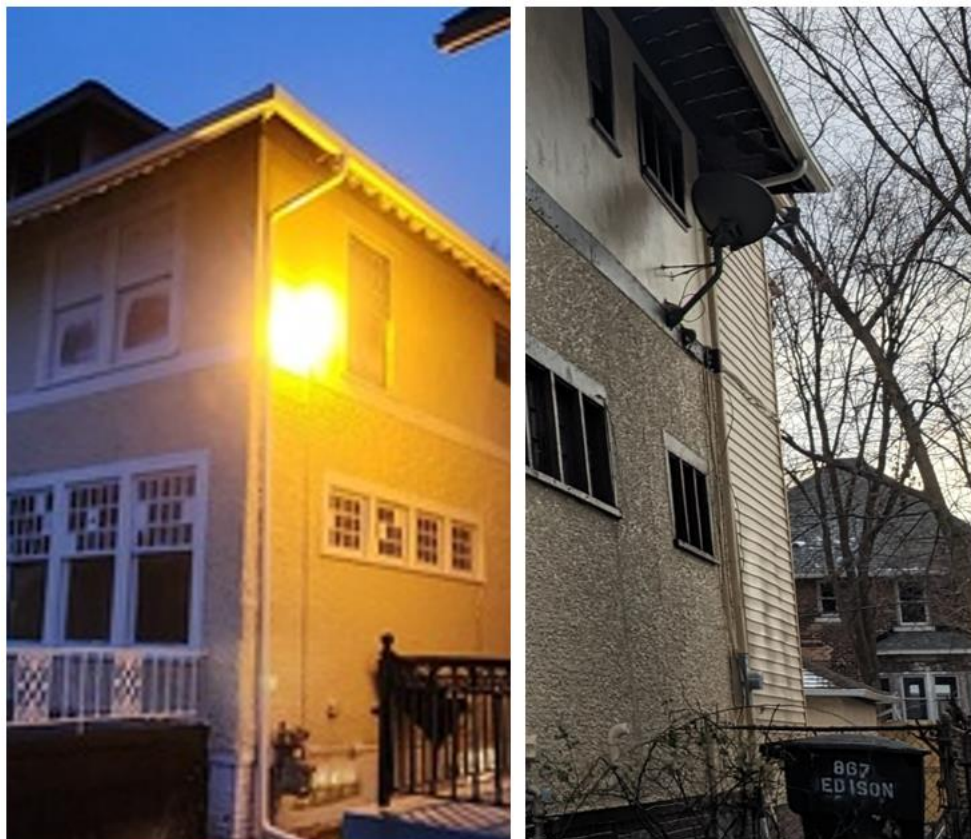
Also observed by staff are a security light at the northwest corner of the house and an expanse of unfenestrated vinyl siding on the rear of the house, potentially enclosing a two-story sun porch or similar mass. The former

work was completed between 2009 and 2011 and observed by staff in May 2022. Notice of Work Observed letters were issued to the prior owner and realtor on May 16, 2023, and August 18, 2023. The applicant and current property owner indicated in a December 7, 2023, email to staff that the light will be removed. The vinyl siding work appears to be an older violation, as it is visible in the earliest available Google Maps image, taken in August 2011.

Left: Observed security light. 2022 SeeClickFix submission. Right: Vinyl siding observed by staff during November 2023 site visit.

- The security light fixture does not meet the Commission’s *Security Lighting Guidelines* (2023).

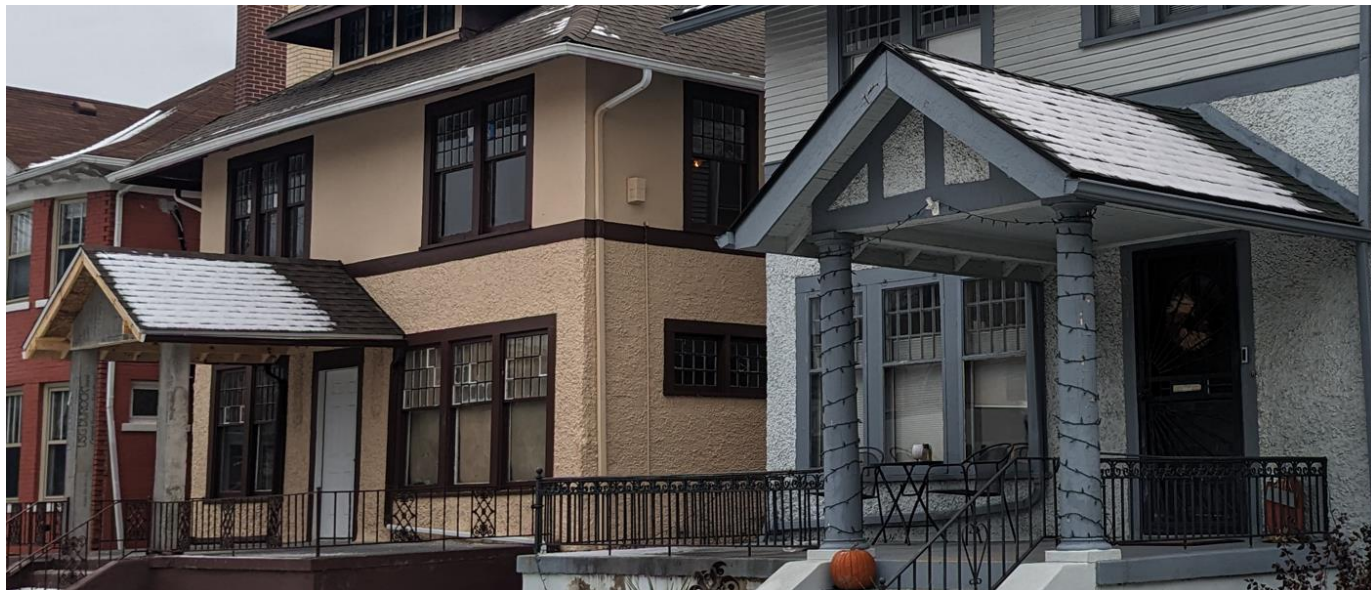
A side-by-side comparison of 859 Edison (left) and 867 Edison (right) highlights the architectural compatibility of the new porch. The work is nonetheless inappropriate (see “Issues,” below). November 2023 photo by staff.
