STAFF REPORT: 02/07/2024 REGULAR MEETING PREPARED BY: J. ROSS

ADDRESS: 2490 LONGFELLOW APPLICATION NO: HDC2024-00007

HISTORIC DISTRICT: BOSTON-EDISON

SCOPE: INSTALL SOLAR PANELS ON ROOF

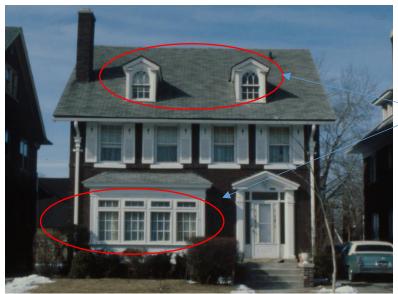
2490 Longfellow, 1980, HDAB designation slide

• The building's original wood windows were replaced with vinyl units sometime between 1980 and 2007, as depicted in the below images. Staff did review HDC and building department records and did not identify any record that the current vinyl windows were approved by the HDC and/or received a permit.

Arched window openings and eave returns at dormers and mullions at first story bay are no longer extant. Also, wood windows and associated trim are no longer extant

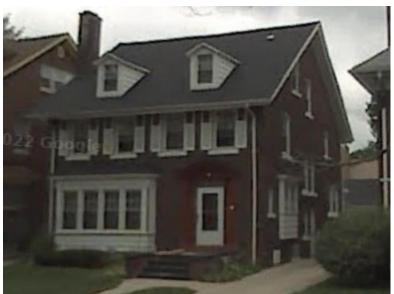
2490 Longfellow, 2007 Google Streetview image. Note that arched windows and eave returns at dormers, mullions at front elevation bay, and wood windows are no longer extant

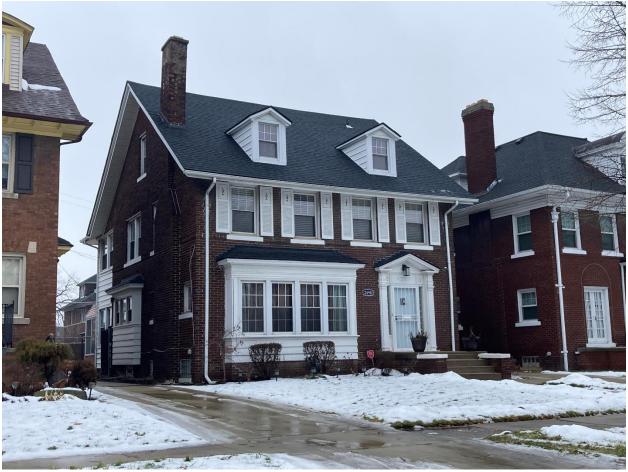
2490 Longfellow, note that the current windows are vinyl and aluminum coilstock is located at the window trim. 1/25/2024 staff photo
