**STAFF REPORT:** 03/13/2024 MEETING

**APPLICATION NUMBER:** HDC20204-00047

**ADDRESS:** 2900 ST. ANTOINE STREET (637 BREWSTER)

**SCOPE OF WORK:** INSTALL WINDOWS, REMOVE ENTRY CANOPY\*

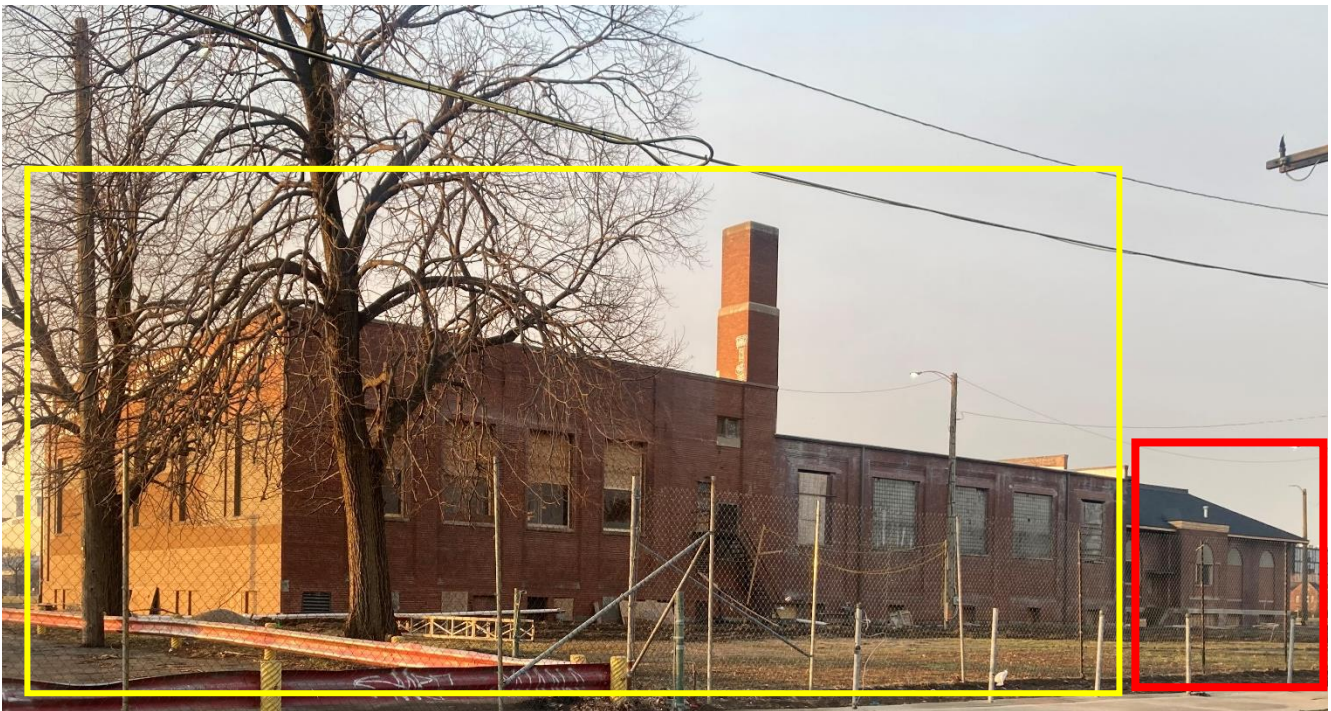
**2900 St. Antoine current condition, facing southwest. 1917 original library wing, outlined in red and 1929 community/recreation center addition outlined in yellow. Staff photo taken 2/27/2024**

The limestone cladding was removed from this canopy without HDC approval

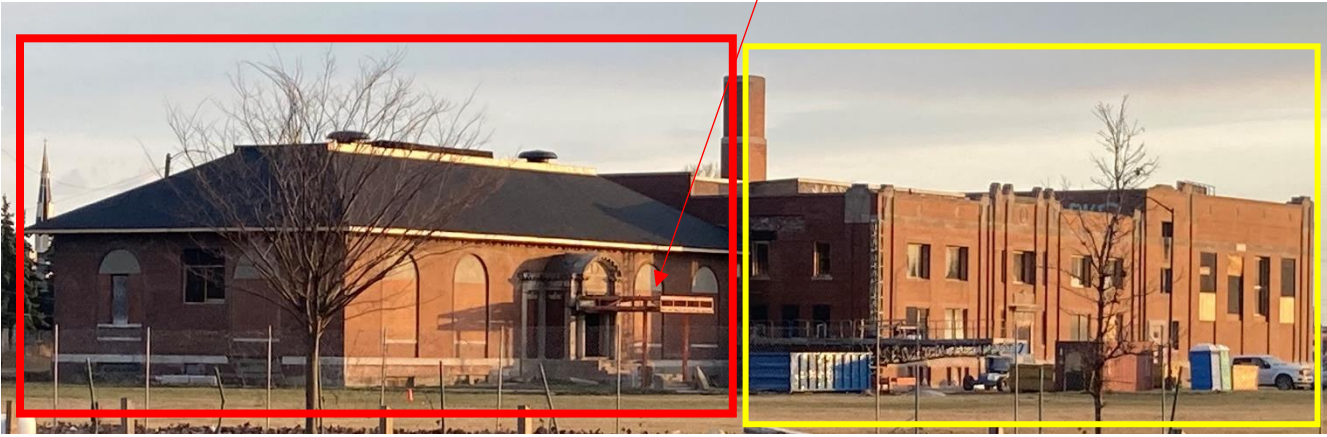
2900 St. Antoine, current condition, facing northeast. 1917 original library wing, outlined in red and 1929 community/recreation center addition outlined in yellow. Note the remaining steel framing at the 1917 wing's entry door. Staff photo taken 2/27/2024.

A limestone clad canopy was added over the original wing's primary entrance in 1967. The applicant is seeking to demolish this canopy. Note that they have recently removed the limestone cladding without HDC approval and/or permit, leaving only the steel framing. The stone steps at this entrance will be retained. Where damaged beyond repair, the stone steps will be replaced in kind. New steel handrails will also be added at this entrance.

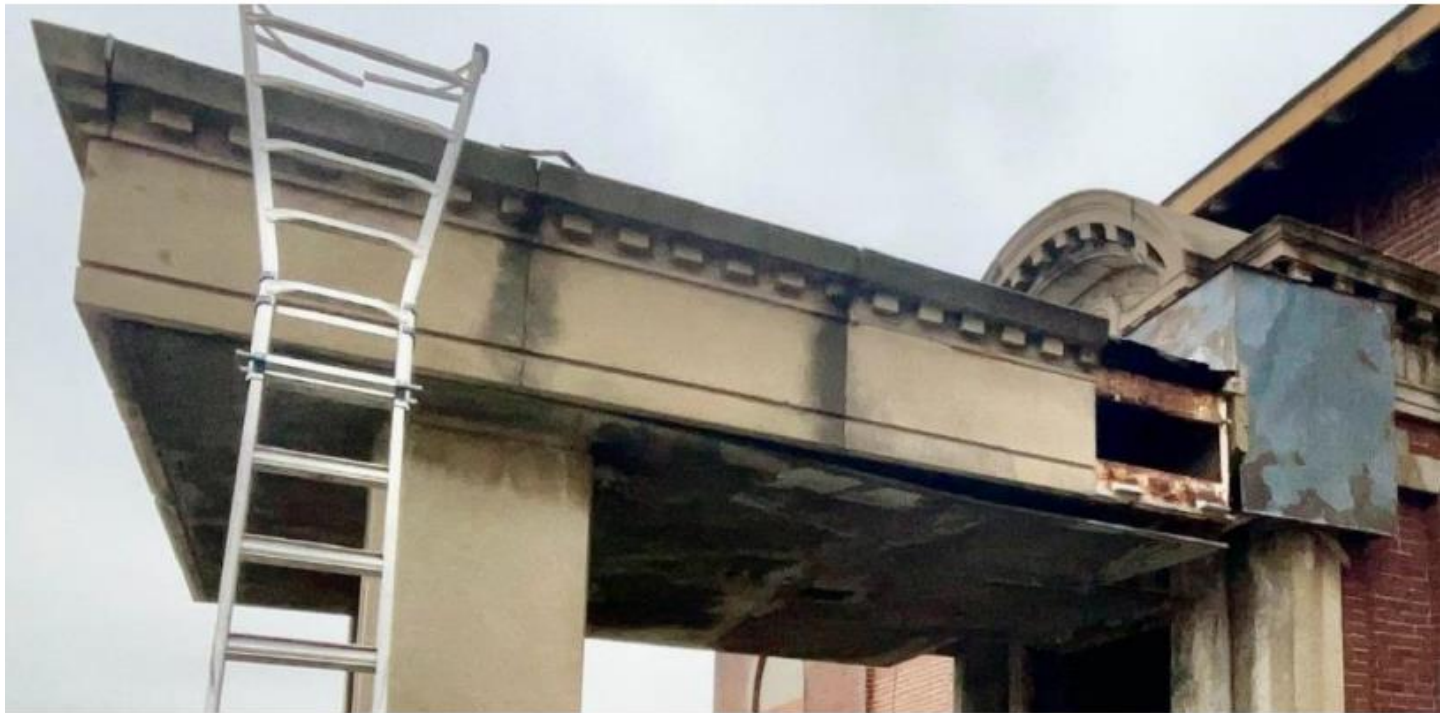
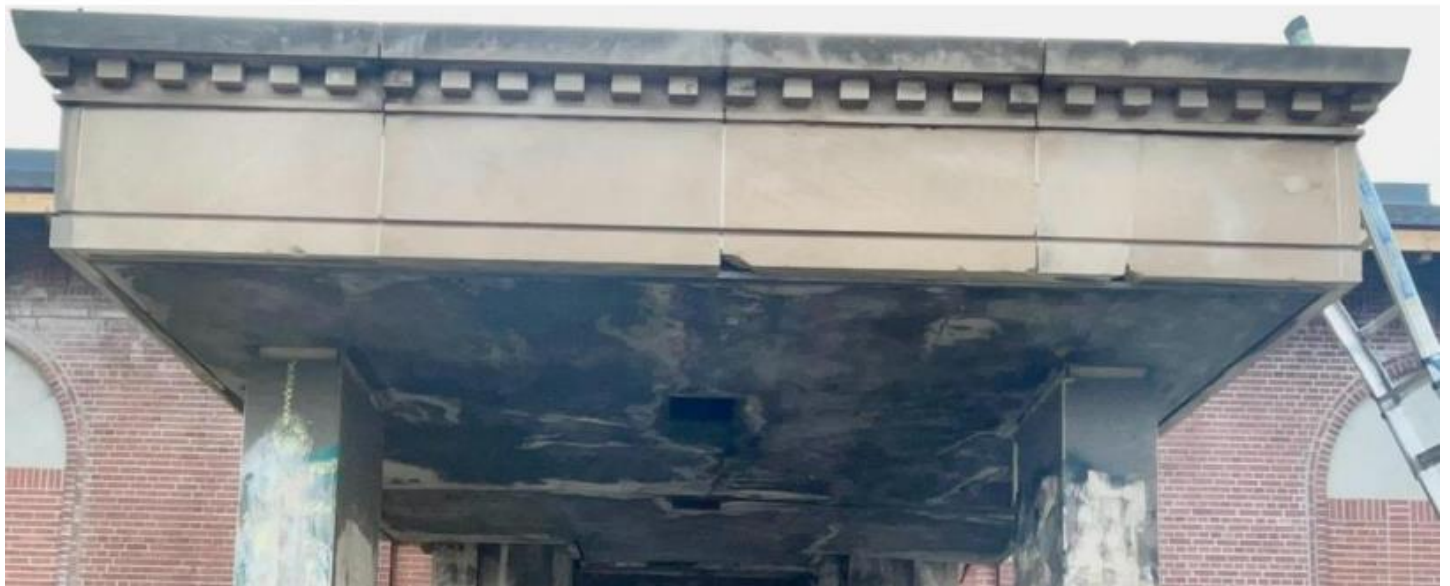
**2900 St. Antoine, flat roof canopy prior to the unapproved limestone cladding removal. Photos provided by applicants**

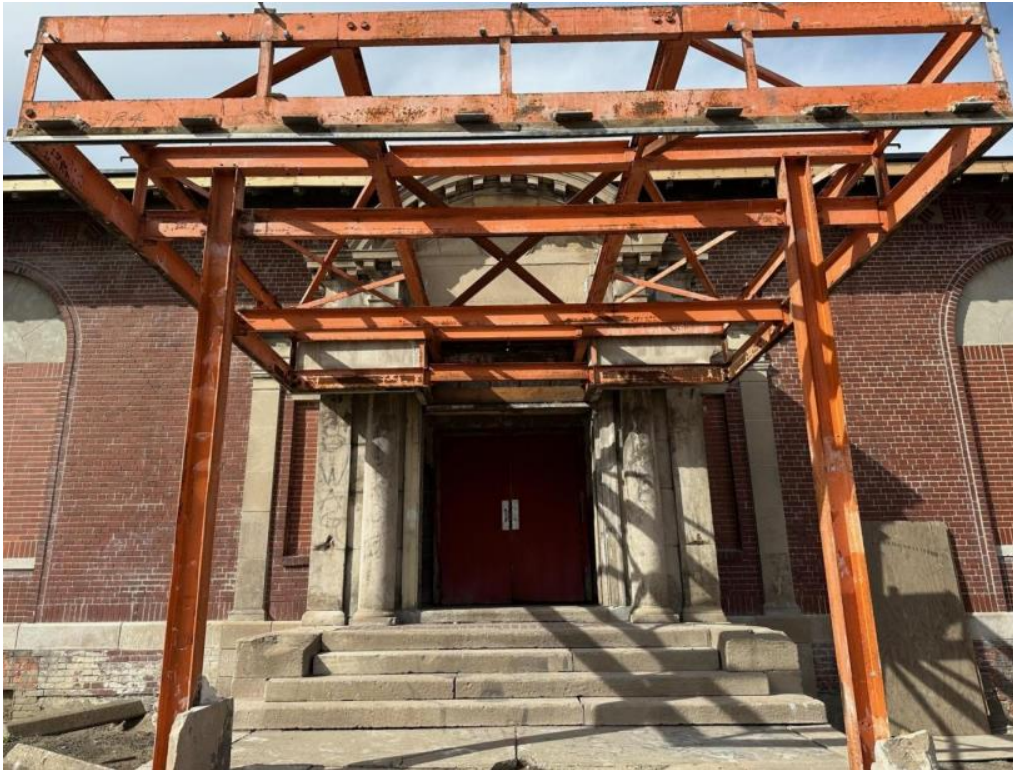
2900 St. Antoine, flat roof canopy after to the unapproved limestone cladding removal/current condition. Photo provided by applicant

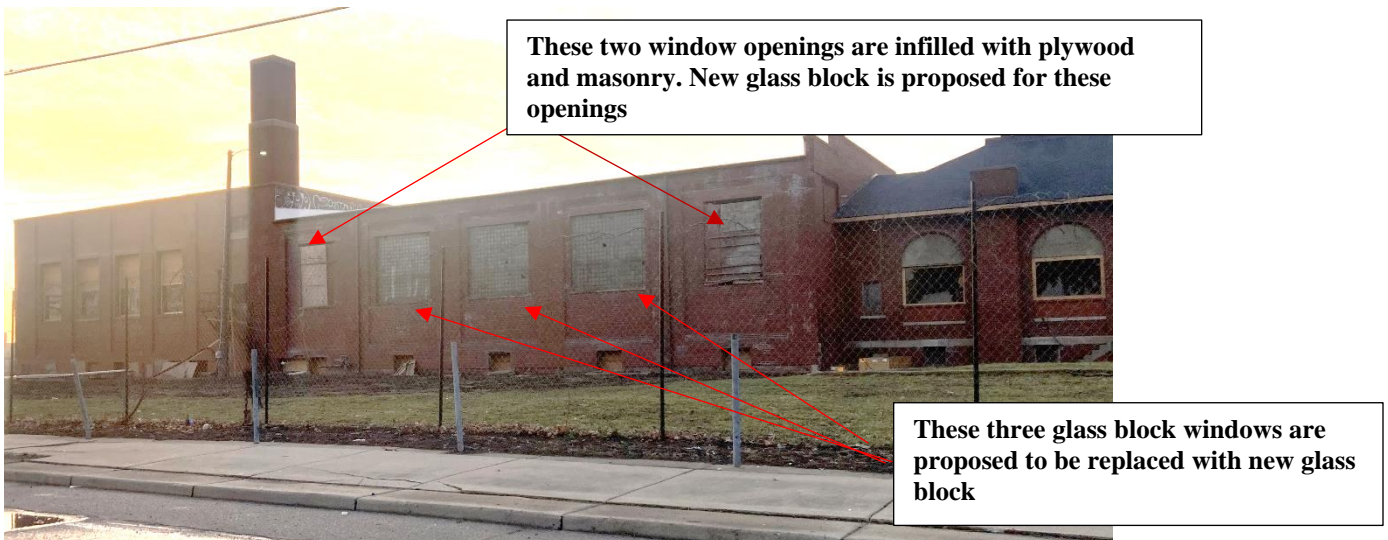
- The proposal is seeking to replace the three existing glass block windows at the building's north elevation with new glass block. Glass block is also proposed for the two flanking window openings, which are currently infilled with plywood and masonry (see below photo).

**2900 St. Antoine, facing southeast. Photos taken by staff on 2/27/2024**

- Glass block walls and windows are typical to Streamline Moderne and Art Deco buildings of the 1930s and 1940s. However, note that the material was typically employed intentionally as a decorative/design element to emphasize rounded edges and corners. While the 1929 addition is Art Deco in style, the glass block found at the north elevation window openings is likely not original to its date of construction as appears as a utilitarian element employed to affordably enclose a large opening. It is possible that the glass block window infill is of historic-age, however staff was unable to find any evidence that it was added during the building's period of significance. It is therefore staff's opinion that the current glass block is not compatible with the building's historic appearance.

- The glass block that is currently located at the building's north elevation is not compatible with the building's historic appearance. If these incompatible windows are proposed for removal or if plywood and masonry infill at this elevation is proposed for removal, the new windows must be compatible with the building's historic character per the National Park Service's (NPS) brief entitled *Replacement Windows that Meet the Standards*, which notes that "replacing existing incompatible, non-historic windows with similarly incompatible new windows *does not meet the Standards*. Therefore, new glass block shall not be installed within the building's north elevation window openings. The applicant shall provide a proposal for compatible/appropriate new

windows to HDC staff for review and approval prior to issuance of the project's permit. Should staff determine that the work does not meet the Standards, the project shall be forwarded to the Commission for review at a future regular meeting.

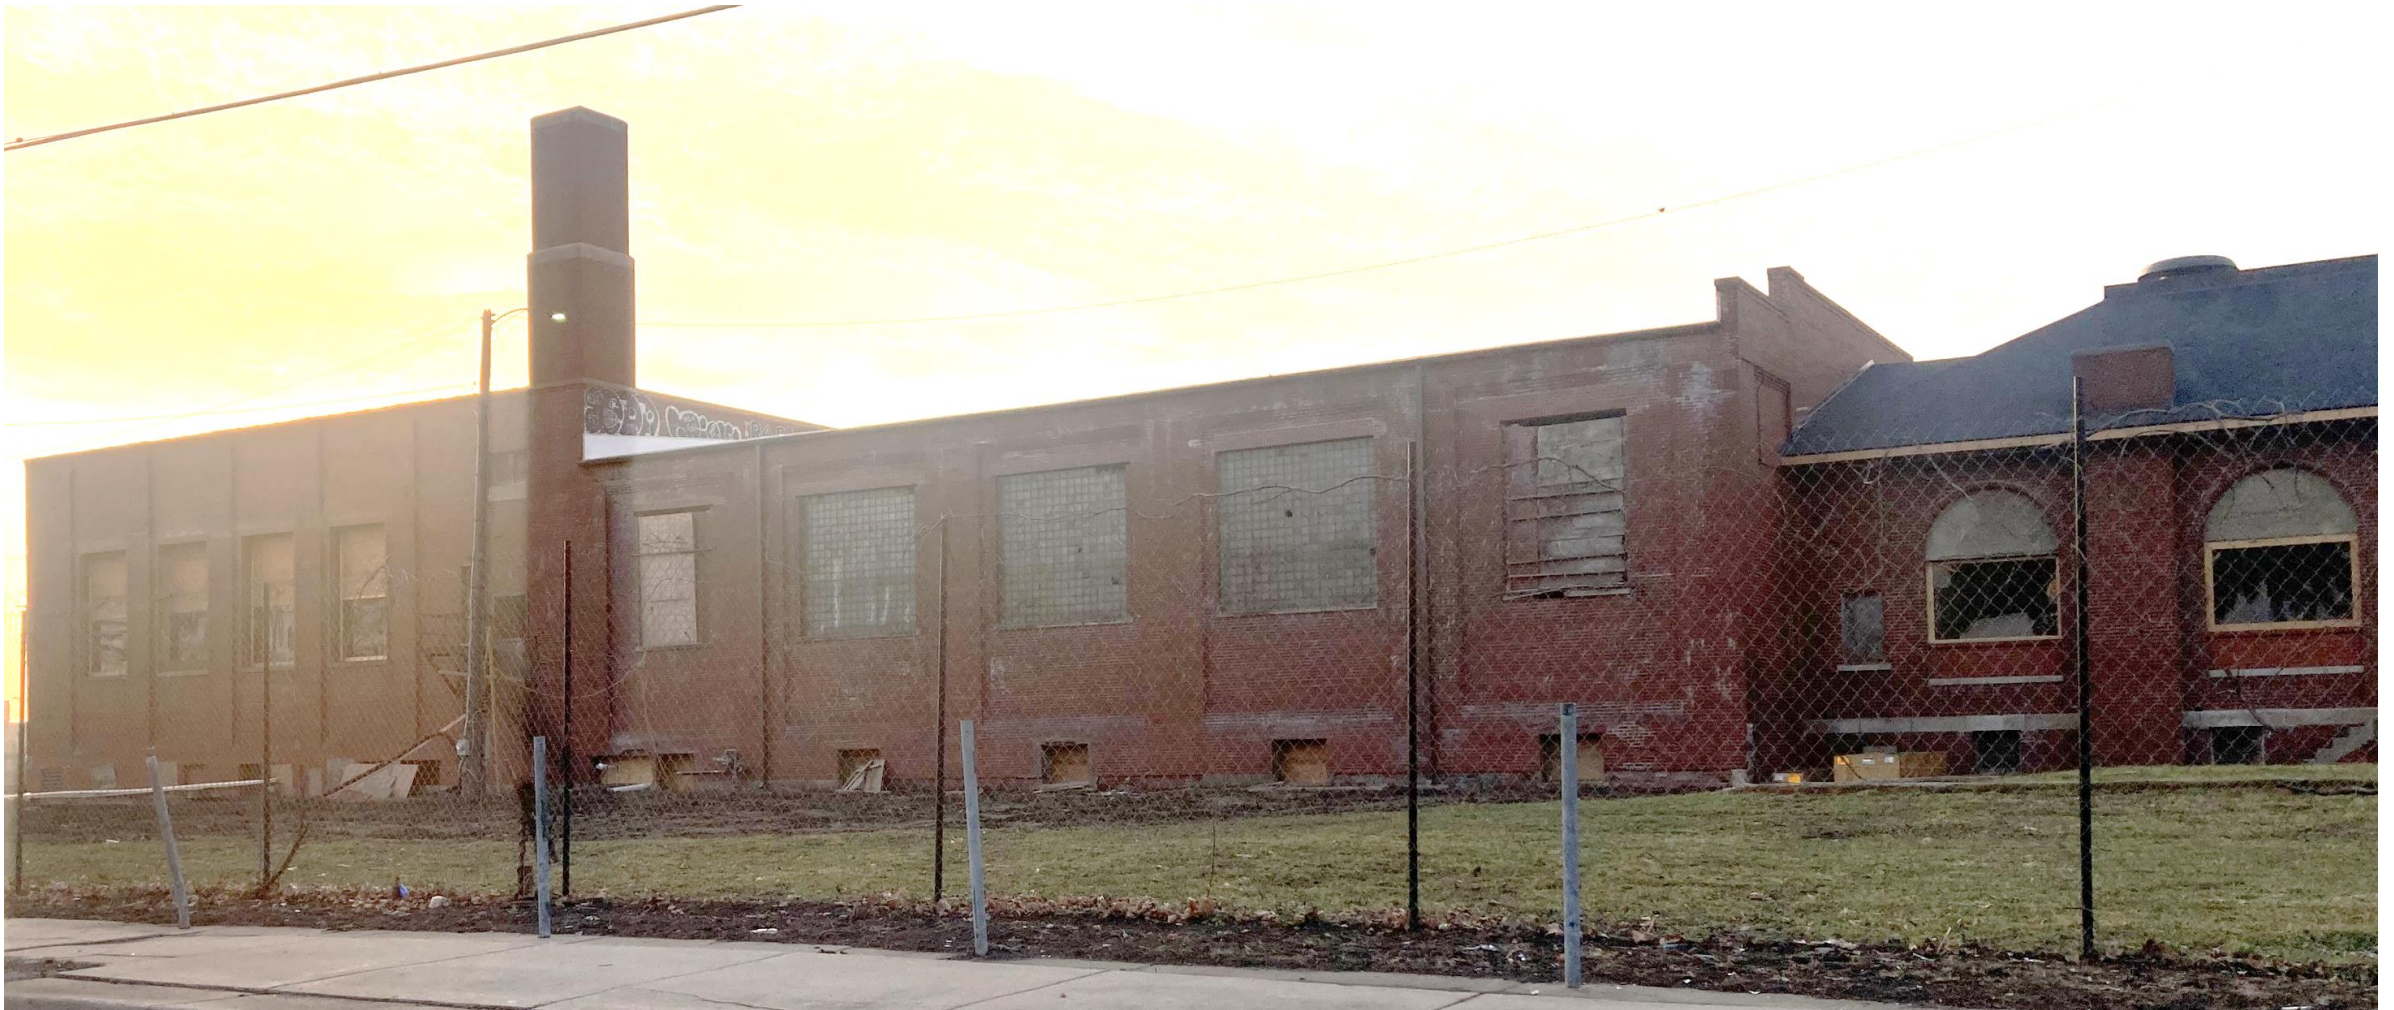
- Although not compatible with the building's historic appearance, the north elevation glass block was present at the time of the property's designation. Therefore, retaining the incompatible existing glass block and undertaking minor repairs/routine maintenance where necessary meets the Secretary of the Interior's Standards for Rehabilitation as it is a condition that existed at the time of designation. However, if these incompatible windows are proposed for removal, the new replacement windows must be compatible with the building's historic character per the National Park Service's (NPS) brief entitled *Replacement Windows that Meet the Standards*, which notes that "replacing existing incompatible, non-historic windows with similarly incompatible new windows *does not meet the Standards*" [Replacement Windows that Meet the Standards - Historic Preservation Tax Incentives \(U.S. National Park Service\) \(nps.gov\)](#) The NPS further states that "replacement of missing or non-historic windows must, however, always fill the original window openings and must be compatible with the overall historic character of the building. The general type of window – industrial steel, wood double-hung, etc. – that is appropriate can usually be determined from the proportions of the openings, and the period and historic function of the building. The appearance of the replacement windows must be consistent with the general characteristics of a historic window of the type and period, but need not replicate the missing historic window. In many cases, this may be accomplished using substitute materials." It is HDC staff's opinion that the proposed installation of glass block at the building's north elevation does not meet the Secretary of the Interior's standards for Rehabilitation.

FACING SOUTHEAST, TOWARDS GLASS BLOCK WINDOWS AT 1929 ADDITION'S NORTH ELEVATION
