STAFF REPORT: 02/08/2024 REGULAR MEETING

APPLICATION NUMBER: HDC2024-00184

ADDRESS: 2491 LONGFELLOW

SCOPE: ALTER DWELLING (WORK COMPLETED WITHOUT APPROVAL), REMOVE TREE, INSTALL PARKING PAD AND FENCE

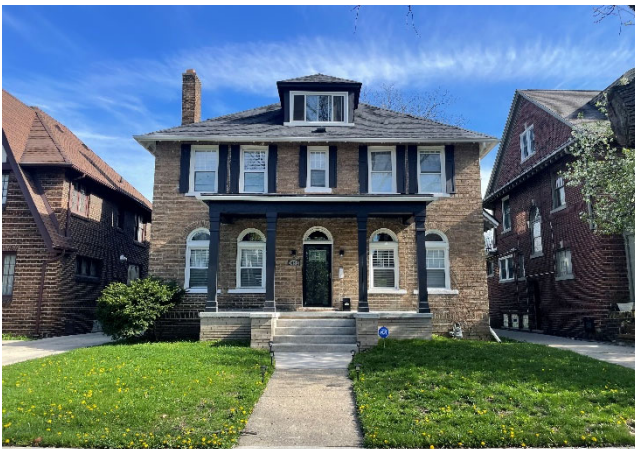
Site Photo 1, by Staff April 19, 2024: (North) front elevation showing replaced vinyl windows, altered porch and landscape.

- The shingles installed on the house and garage roof are dimensional asphalt shingles that replaced previous asphalt shingles, and, in staff's opinion, appropriate for the district. (See Site photos 1, 2, and 3.)

- While staff has no issue with the material of the front door and rear doors, it is staff's opinion that the vision panel for both the front and rear doors are not appropriate for the design of this house. In the case of the front door, a leaded-glass rectangular form is inconsistent with the simplicity of the colonial revival style architecture. At the rear of the house, the steel doors introduce a fan-shaped window opening at both rear doors that is not compatible and a simple rectangular panel window would suffice, in staff's opinion. *(See photos 1, 2 and 6)*

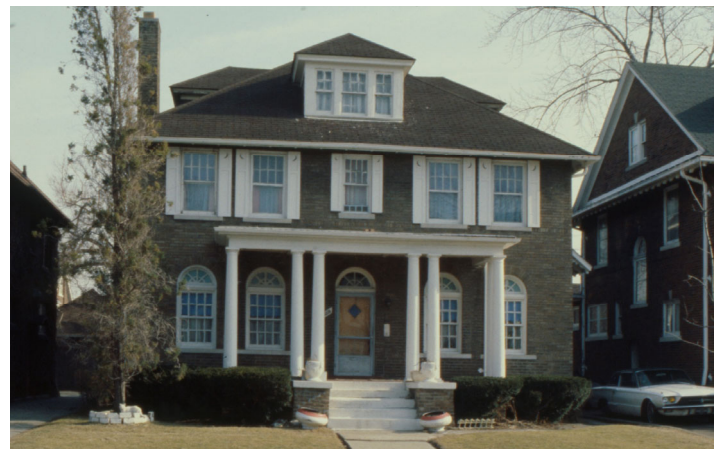
Image, 1980: (North) front elevation showing original windows and porch condition.

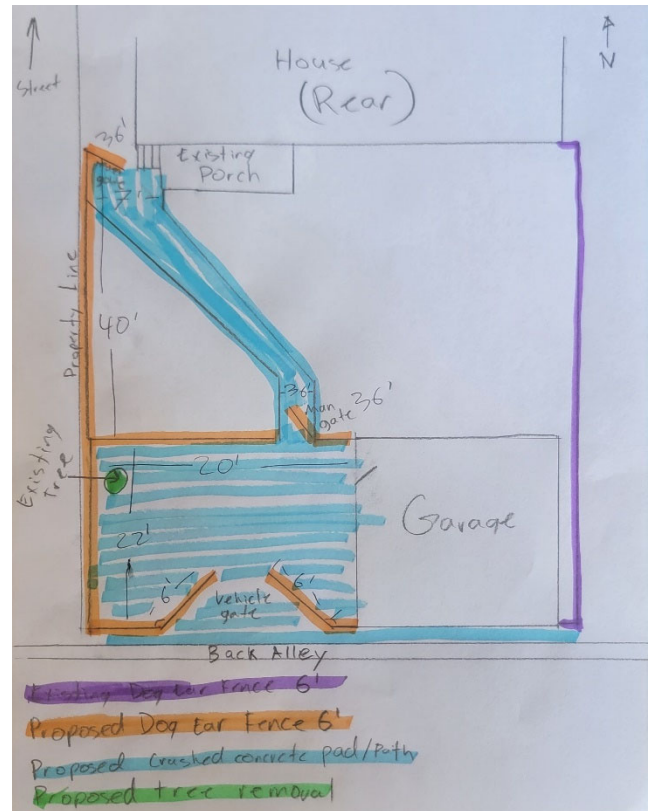
Fig 1, by Applicant: Proposed installation of the gravel pad and walkway, fence, and tree removal.

- Staff finds that the proposed gravel parking area and walking pathway are appropriate.
- Staff has the opinion that the proposed 6’ wood panel fence along the rear property line and inside the backyard are appropriate as they provide continuity to existing fence conditions and follow the HDC guidelines. Staff received clarification from the applicant’s contractor that the reason for waiting one year is allow the treated wood to age before being stained.

- The applicant provides HDC staff with a planting plan that offers at least one shade tree on the property to replace the removed tree.
- The applicant provides HDC staff with a paint or solid stain color for the fence.

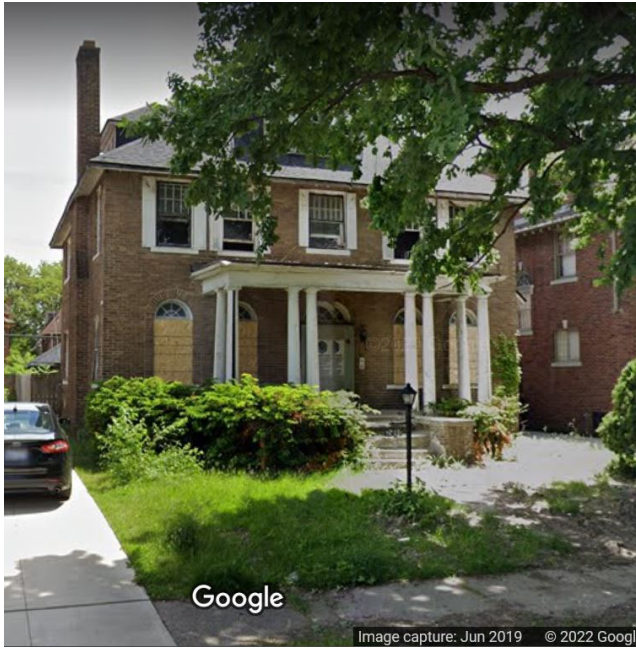
Fig 2, by Google Street View, June 2019: (North) front elevation showing conditions prior to previous owner.

- No documentation of the condition of the original windows was available but staff observed that the wood windows were present until at least 2019 from Google Street View images. (See figures 2 & 3)

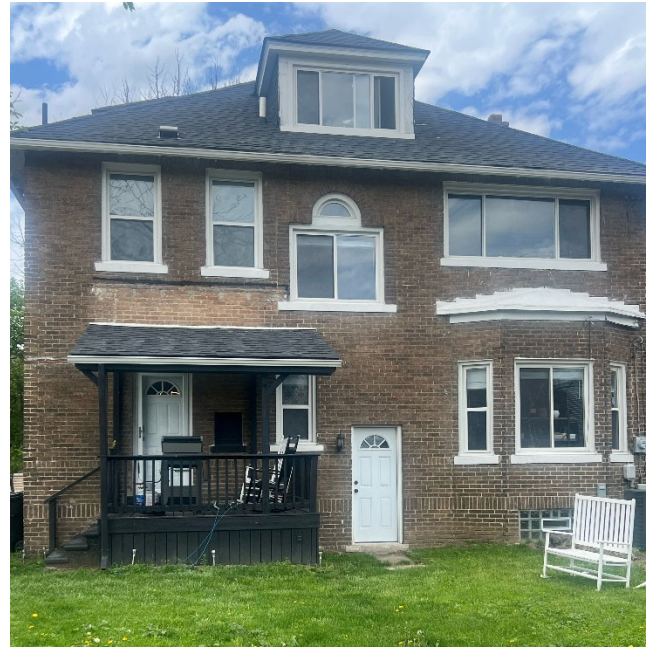
Site Photo 2, by Applicant: (South) rear side elevation showing replaced vinyl windows, altered rear porch and replaced rear door.

- Staff observed that the original rear porch has been removed and new porch constructed. Scars left on the brick face above the new porch roof show the original extent of the rear porch, which was likely a flat roof that extended to, but stopped short of the window at the first floor in alignment with the windows above it. While the best approach is to closely align the new construction with the historic location of the former roof, it is staff's opinion that the newly constructed rear porch is not demonstrably inappropriate at this rear elevation because it consists of wood materials, has a wood decking, skirting and wood railing that meets the Standards and conforms to the district's Elements of Design.

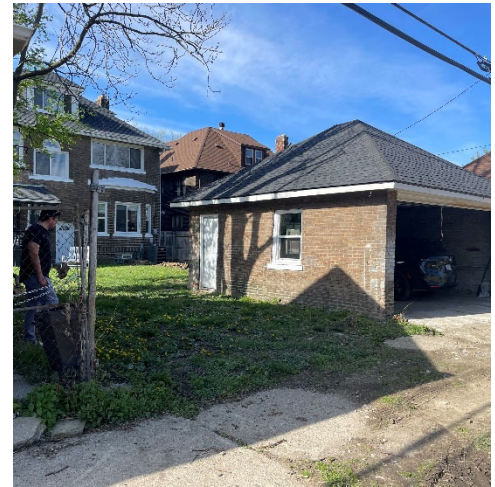
Site Photo 3, by Staff April 19, 2024: looking north from the alley, showing garage roof and proposed pad site.

- The new steel panel garage door and steel man door, in staff's opinion, are appropriate, in staff's opinion. *(See photos 3& 7)*

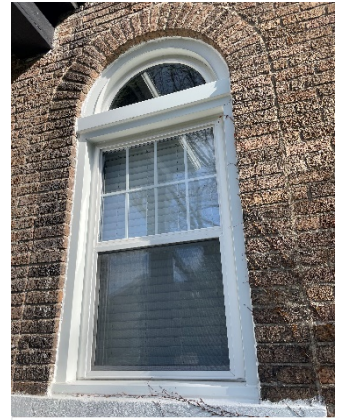
- In addition to a material change from wood to vinyl, the configuration and operation of the windows was also changed. For example, the dormer double-hung windows were replaced with slider windows. Coil stock is observed around most of the windows so it is not known if the original brick mould is still present. These newly installed windows have several features that are not appropriate:

- the surrounding coil covering the brickmould is large and gives the windows a chunky appearance and with the arched transoms, larger seems are found around the perimeter,

- the meeting rails in the double hung windows do not meet,

Site Photo 4, by Staff April 19, 2024: (North) front elevation showing detail of thick, vinyl coil stock around brick mold and seam, and color tinted transom, proposed

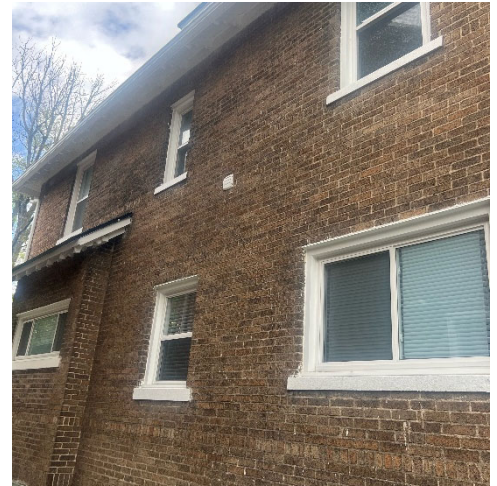
Site Photo 3, by Applicant: (west) side elevation showing replaced vinyl windows.

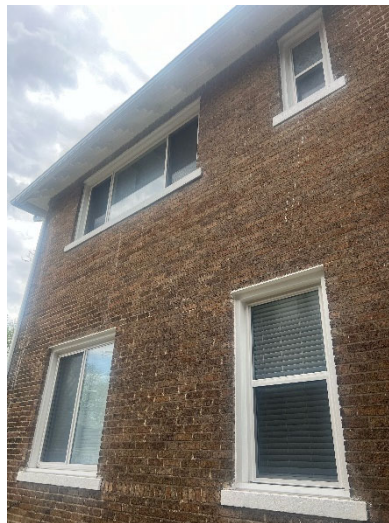
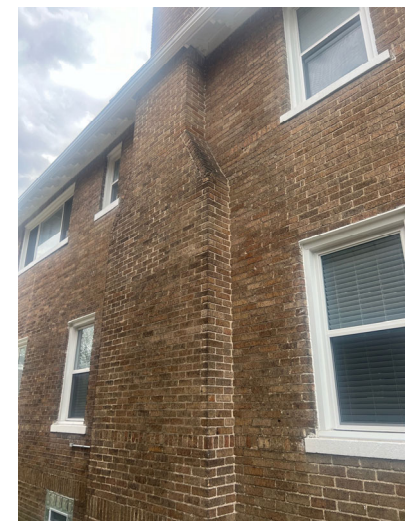
Site Photos 4&5, by applicant April 2024: east elevation, showing replaced vinyl windows.

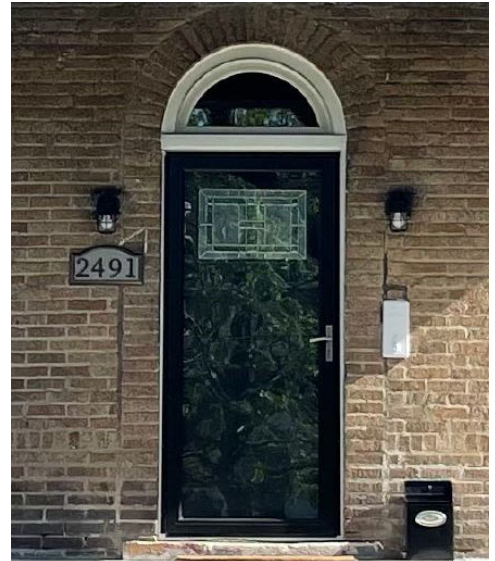
Site Photo 6, by Staff April 19, 2024: (north) front elevation showing replaced front door and light fixtures.

- It is staff's opinion that the new light fixtures are an appropriate use of design and maintain a similar scale, material and placement to the historic fixtures. *(See photo 6.)*

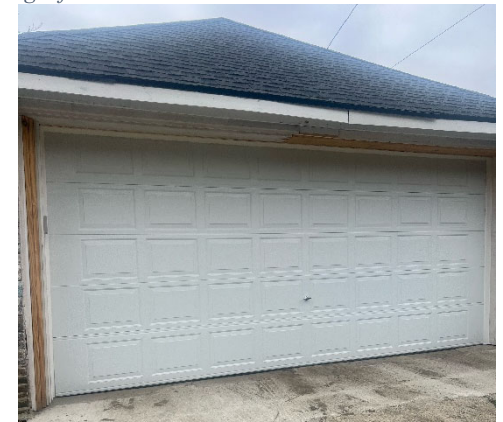
Site Photo 7, by Applicant April 2024: (south) showing replaced garage door.

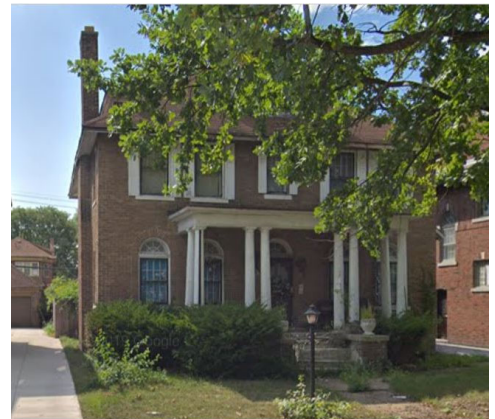
- Although in need of some pruning and care, the foundation evergreen shrubs were present until 2019 and were replaced with lawn or no plantings at all. Staff has the opinion that these foundation plantings contribute to the property’s historic character and complement the architecture of the property. Their removal without substantial cause and without a plan for replacement is not appropriate. (See figure 3.)

Figure 3, by Google Street View 2018: (north) front elevation showing conditions prior to previous owner.

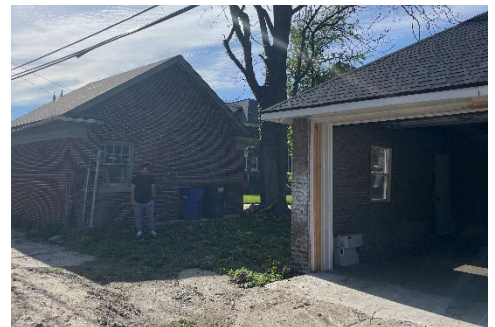
- The tree is of historic age and in need of pruning. However, the overall health of the tree appears to have reached a point where it is a threat to both the neighbor’s garage and the applicant’s garage due to its proximity and overall condition. The root system appears to be pushing close to the garage’s foundations. It is staff’s opinion that the removal of this tree is appropriate. Staff recommends the replanting of at least one shade tree on the property to maintain the historic canopy of the neighborhood. (See photo 8.)

Site Photo 8, by staff, April 19, 2024: (looking northwest from the alley) showing proposed location of parking pad and tree removal.
