REVISED STAFF REPORT: 06/12/2024 MEETING
APPLICATION NUMBER: HDC20204-00318
ADDRESS: 1475 LONGFELLOW
HISTORIC DISTRICT: BOSTON-EDISON
APPLICANT: TIM FLINTOFF (4545 ARCHITECTURE)
OWNER: SHARIF AFFAS
DATE OF PROVISIONALLY COMPLETE APPLICATION: 5/20/2024
DATE OF STAFF VISIT: 5/29/2024

SCOPE OF WORK: ERECT REAR ADDITION

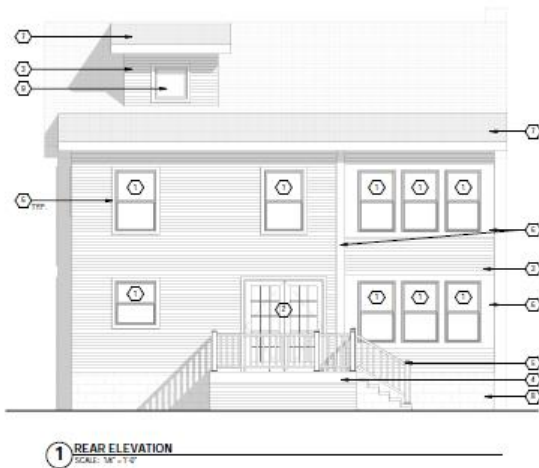
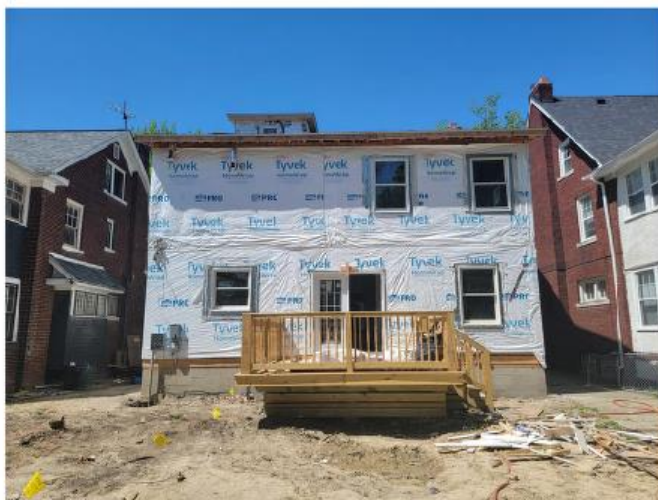
Photo (below) of current rear wall/addition erected without HDC approval and off permit. Drawing (above) depicts proposed rear elevation. The applicant is seeking approval to retain the rear addition with some revisions to/addition of window openings

- Finally, staff recommends that the Commission deny the newly erected rear addition because it does not meet the Standards for the following reasons:
 - Its construction resulted in the removal of the significant historic-age one-story, sunroom bay which was formerly located at the building's southeast corner.

- The addition has been appended directly to the rear elevation, with no relief/daylight between the new construction and original building as it is two-stories in height and extends the full width of rear elevation. As a result of its scale, the addition has completed altered the historic character of the building's rear elevation.

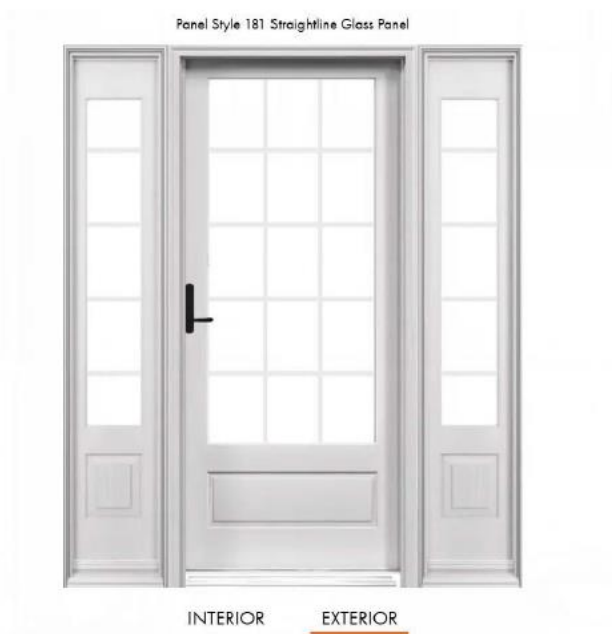
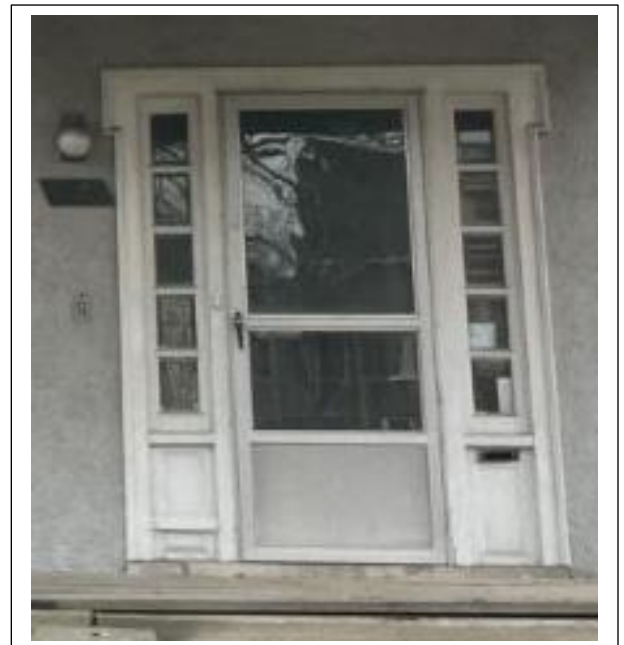
Proposed new front door (left). Original/historic/character-defining front door which was recently replaced without HDC approval. Note distinctive trim detail which will not be replicated with the current proposed door and sidelites.

- New front door and sidelites. Note that the new elements will not replicate the distinctive front door trim which was extant as recently as December 2023. Also, the final material choice for the new door and sidelites have not been outlined. Staff therefore recommends the Commission deny this scope item

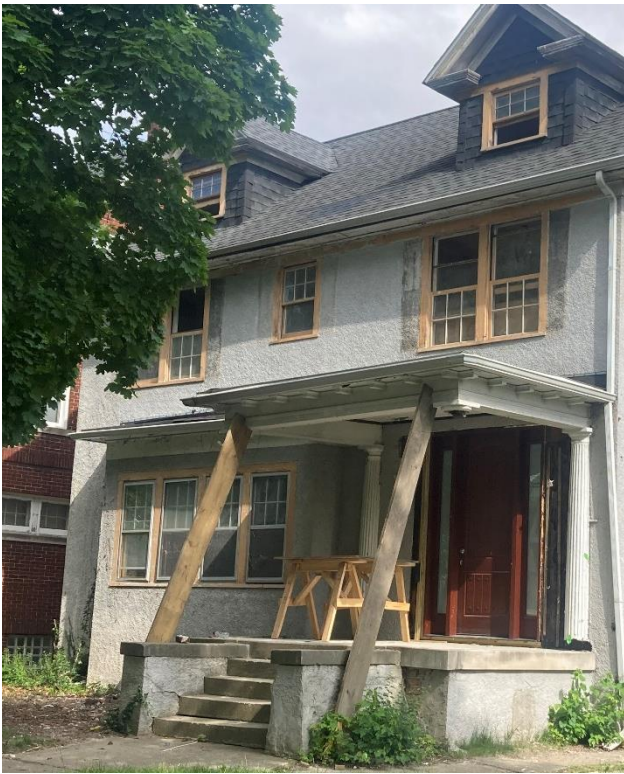
1475 Longfellow, current appearance of front elevation. Staff photo taken on 5/29/2024. Note that shutters, porch columns, and front door have been removed without HDC approval sometime between December 2023 and May 2024., *after* the property owner had received an approval from HDC staff for the replacement of the roof and repair of original windows.

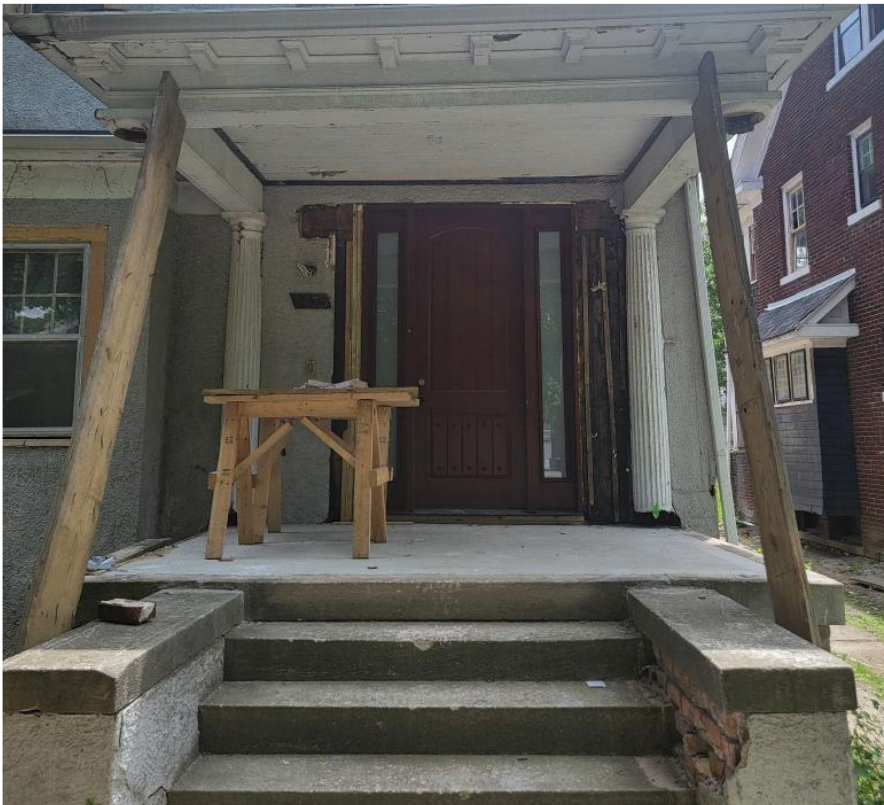
1475 Longfellow, current appearance of front elevation primary entrance. Photo provided by applicant. Detail of new front door and sidelites. Note that the historic fluted pilasters which flank the front door still remain.

- New fiberglass columns and pilasters at front elevation porch. The original wood pilasters which flank the front door remain and do not appear to be deteriorated beyond repair. In re: to the two original wood columns which were replaced without approval, the application has not included information which indicates that they were deteriorated beyond repair. Also, it is possible to obtain new columns which match the old in material, detailing, and dimension. Staff therefore recommends that the Commission deny this scope item

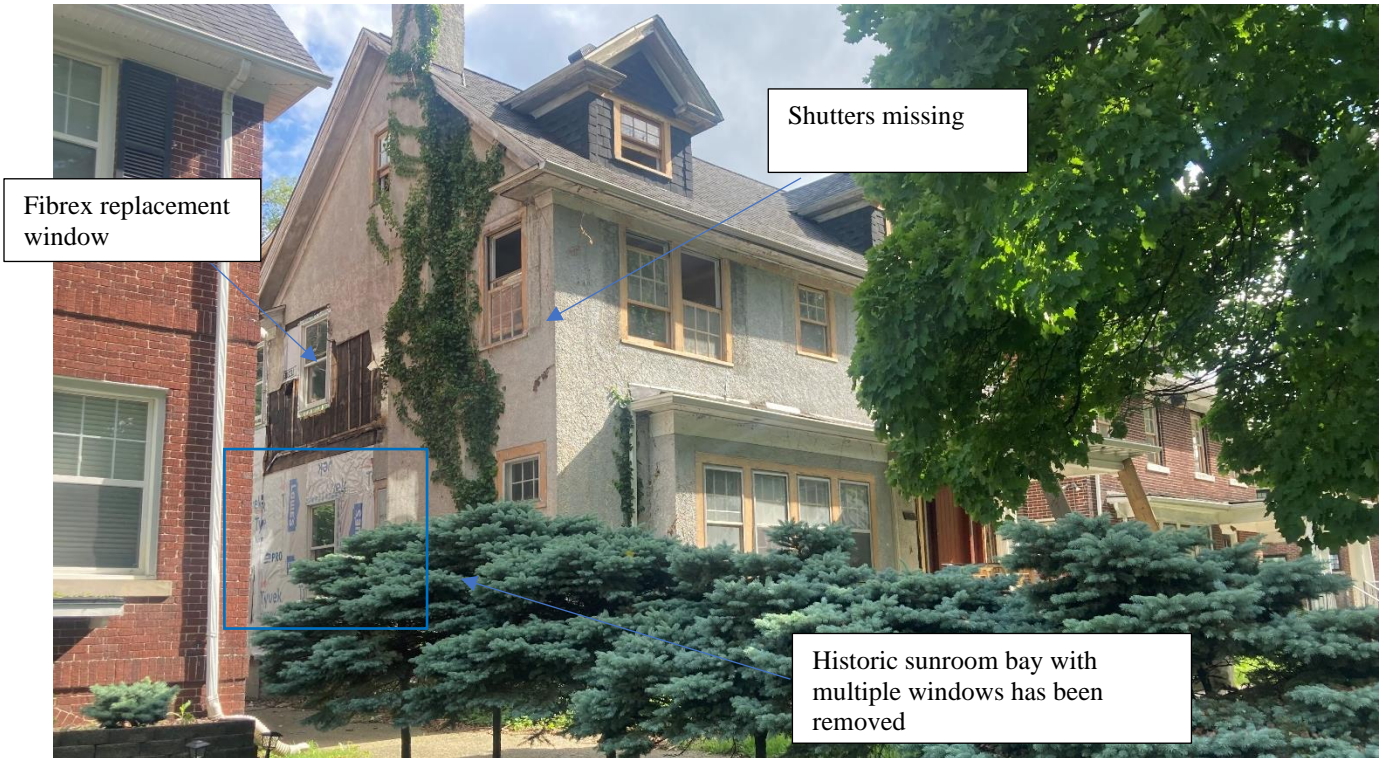
East elevation, staff photo taken on 5/29/2024. Note replacement window at second story. Also, the second story shutters and first story sunroom bay are no longer extant (see area outlined in blue). This work was completed without HDC approval

- As noted above, it is staff's opinion that the historic-age sunroom bay wing which was located at the building's southeast corner was a distinctive character-defining feature of the building. Its unapproved removal therefore does not meet the Secretary of the Interior's Standards for Rehabilitation. Staff therefore recommends that the Commission deny the removal of the wing.

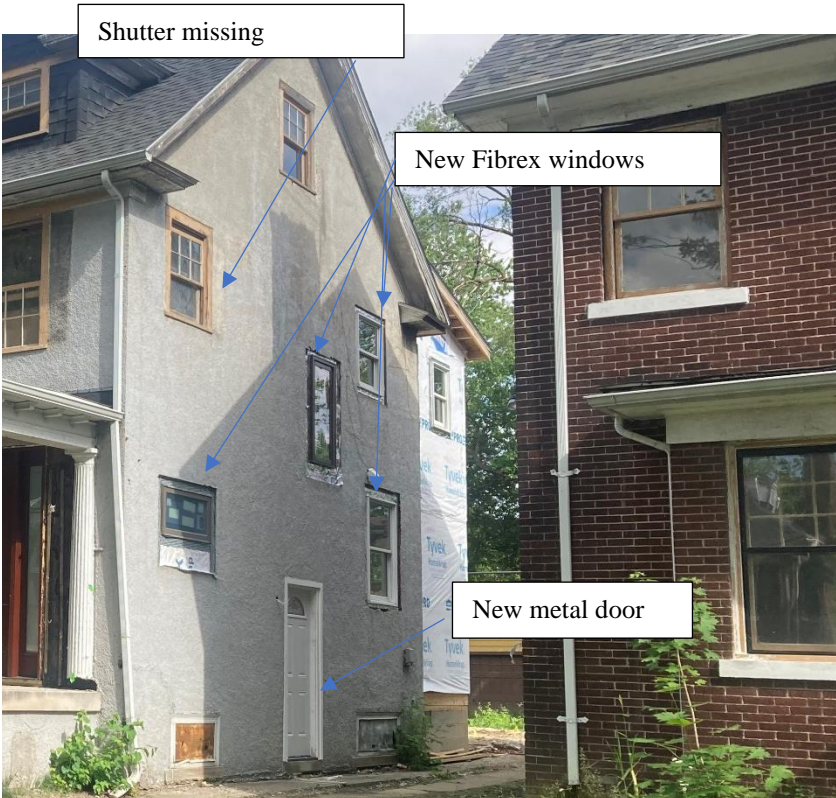
West elevation, staff photo taken on 5/29/2024. Note that shutters and the original wood door at the first story has been replaced with a metal door with a fanlight vision panel. Also, note four new windows have been added

- New west elevation door. Staff recommends that the Commission deny this scope item because the style and material of the proposed new door does not match the historic-age door that was replaced without HDC approval

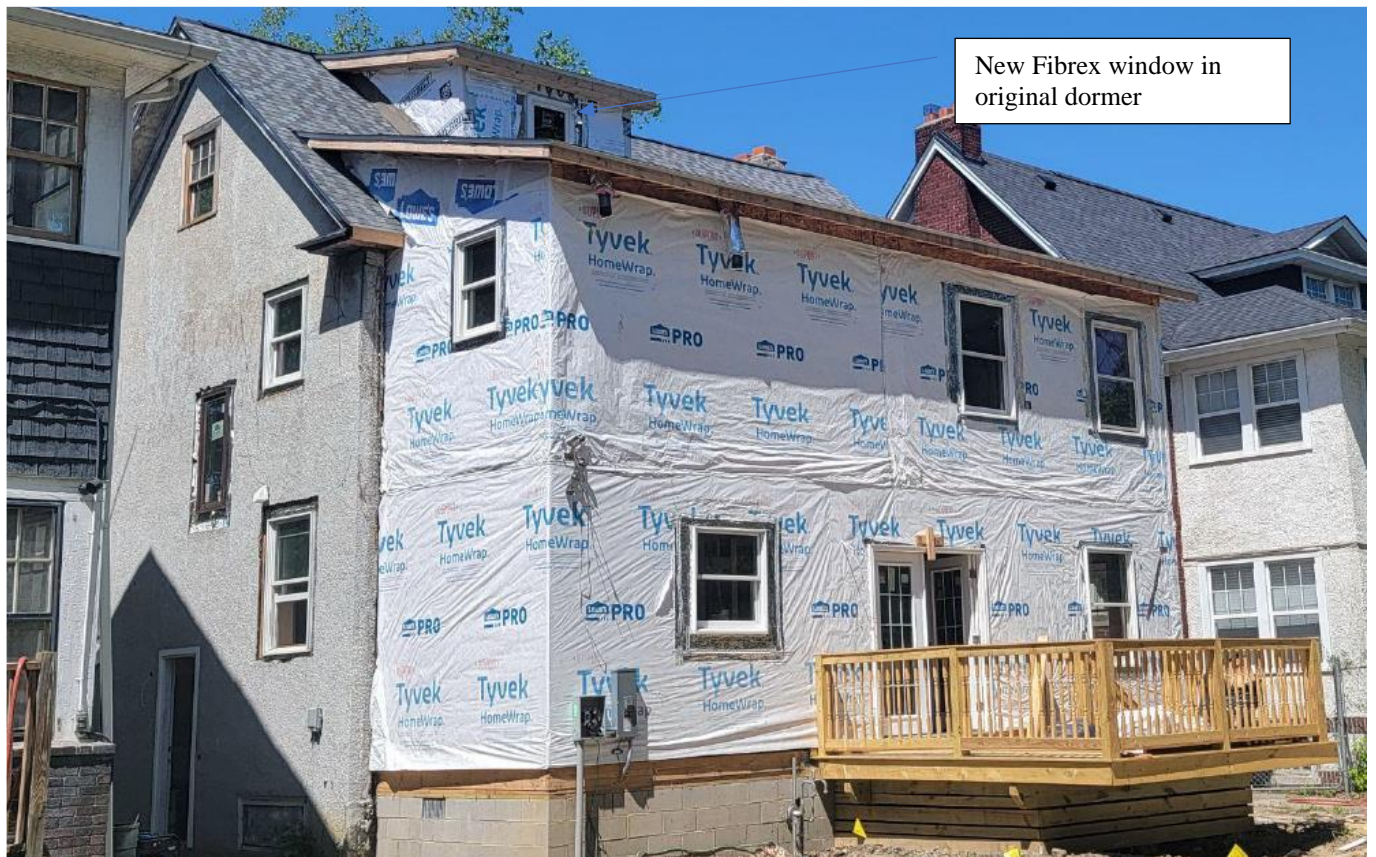
Rear elevation, showing unapproved addition, deck, and new window in original dormer. Facing northeast. Photo taken by the applicant.

- It is staff's opinion that the newly erected rear addition does not meet the Standards for the following reasons:
 - Its construction has resulted in the removal of the significant historic-age one-story, sunroom bay which was formerly located at the building's southeast corner.
 - The addition has been appended directly to the rear elevation, with no relief/daylight between the new construction and original building as it is two-stories in height and extends the full width of rear elevation. As a result of its scale, the addition has completed altered the historic character of the building's rear elevation.
