STAFF REPORT: 06/12/2024 MEETING

APPLICATION NUMBER: HDC20204-00182

ADDRESS: 1485 LONGFELLOW

SCOPE OF WORK: ERECT REAR ADDITION

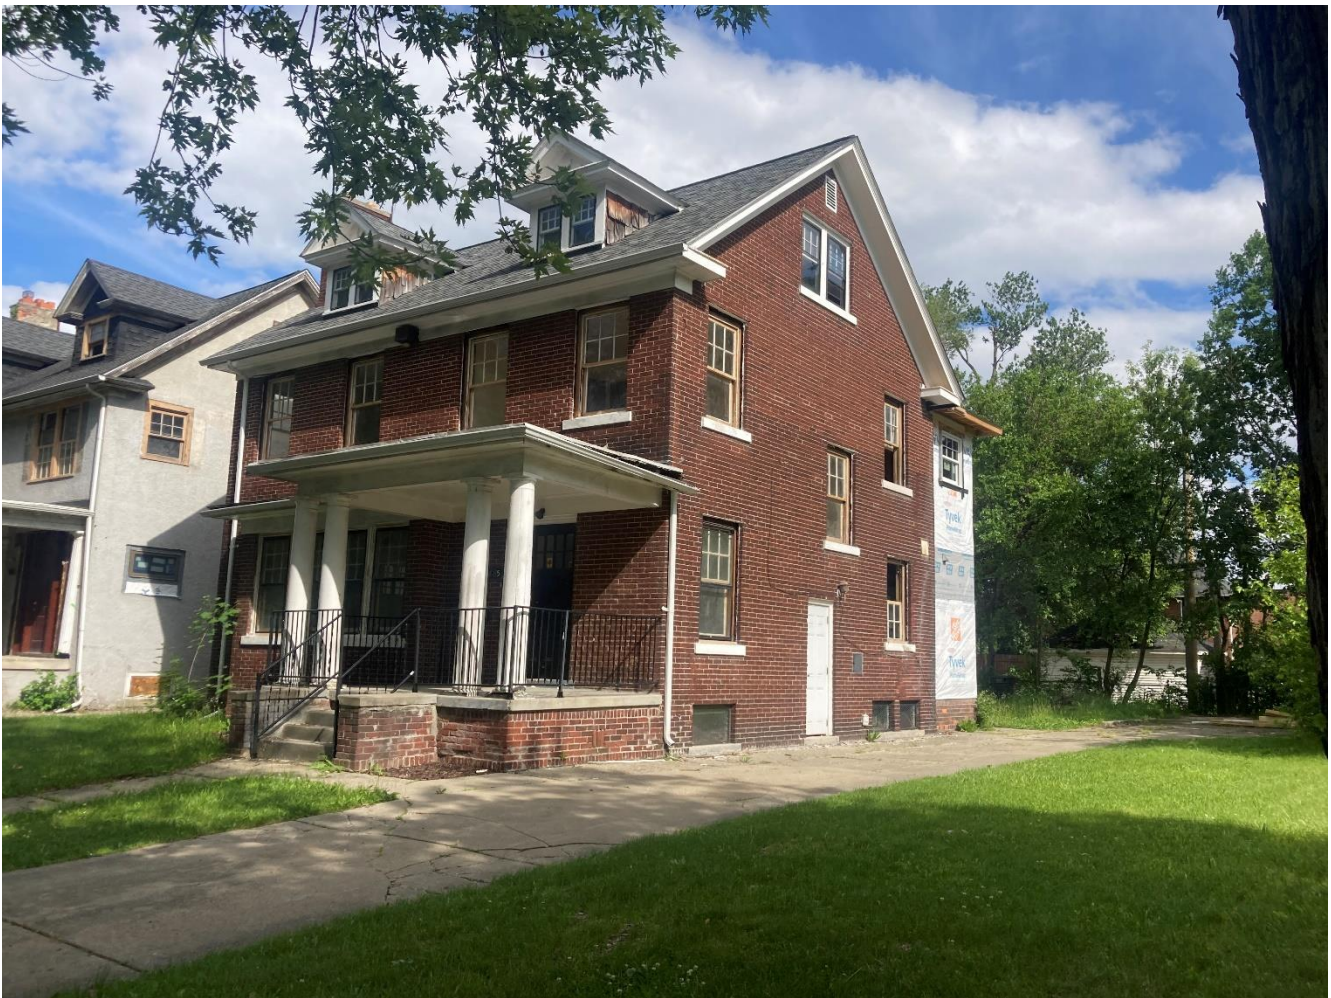
1485 Longfellow, current conditions. Facing southwest. Staff photo taken on 5/29/2024

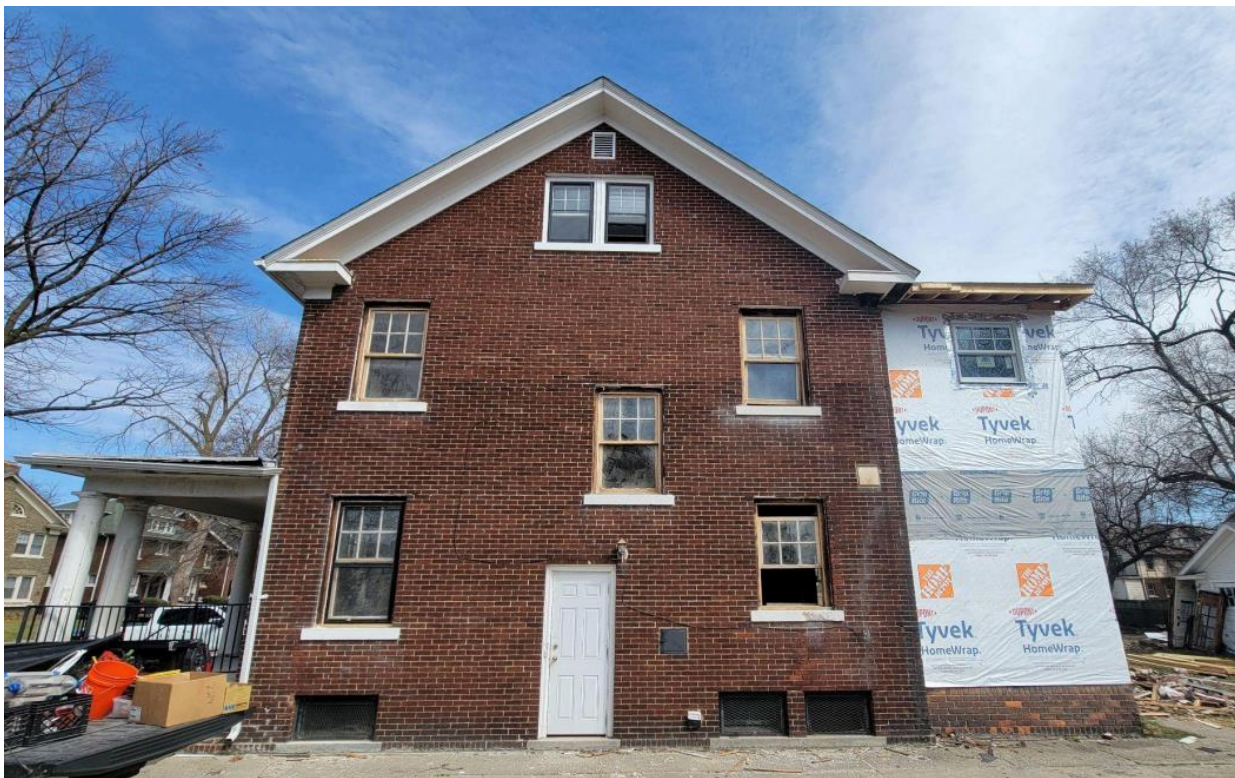
1485 Longfellow, current conditions. Facing south. Note new two-story addition which was erected without HDC approval. Photo provided by applicant

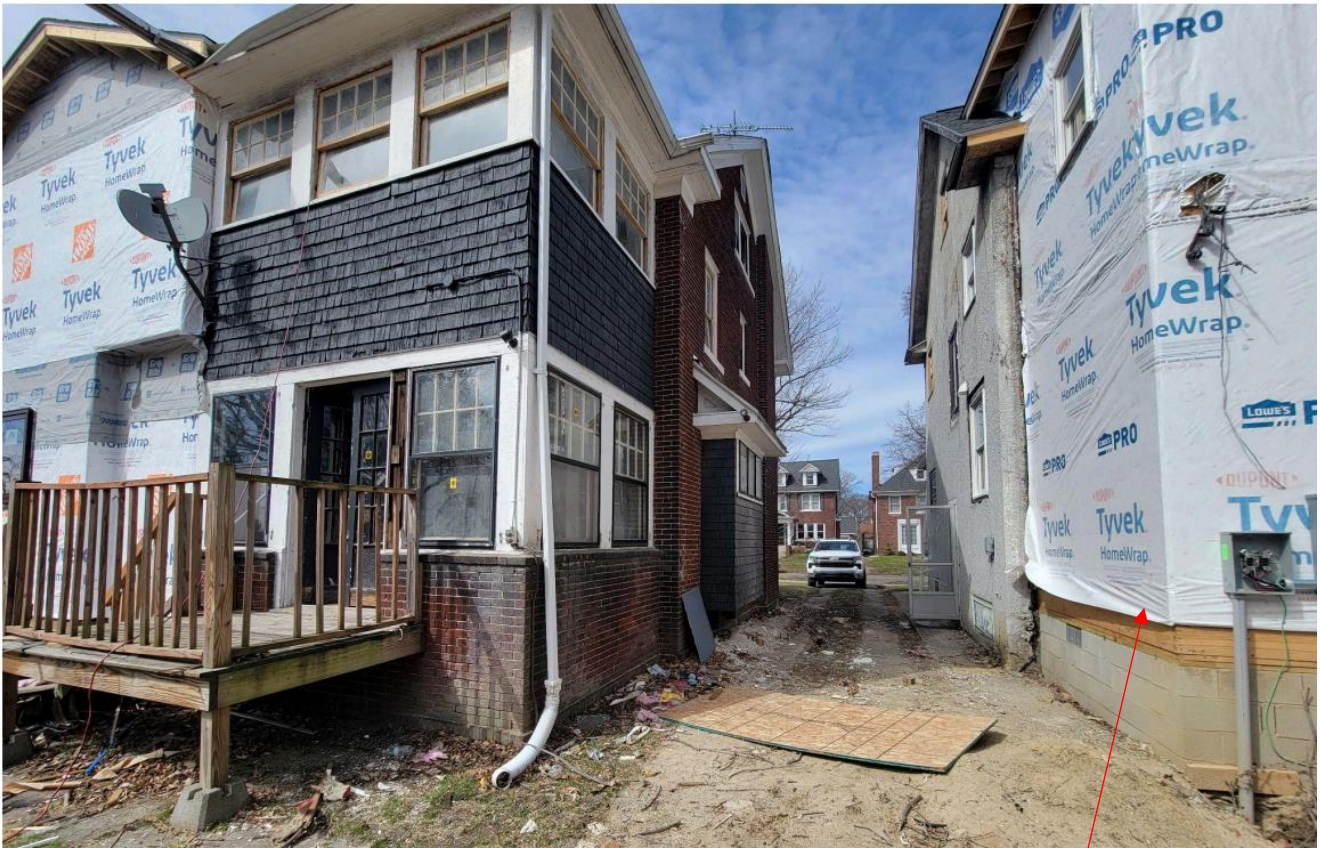
1485 Longfellow, current conditions. Facing northwest. Note that new two-story addition which was erected without HDC approval is directly adjacent to the original, character-defining flat-roof, 2-story wing. Photo provided by applicant. Also note historic wood French doors proposed for replacement. Also, note that a new addition has been added to the rear of the home next door/1475 Longfellow without HDC review/approval. 1475 and 1485 Longfellow are owned by the same person. An application for the new addition at 1475 Longfellow has been submitted to the Commission for review at the 6/12/2024 regular meeting

- It is staff’s opinion that the newly erected rear wing does not meet the Standards because it has been directly appended to the character-defining, two-story, rear wing resulting in the removal of its entire west wall and completely changing its overall form. Also, the large scale of the addition overpowers/is not subordinate to the significant rear wing.
- Staff notes that the revised design proposes to install windows which are generally compatible in design, light configuration, and operation with the house’s historic windows. Staff also does note that the proposed replacement of the addition’s gabled roof will somewhat mitigate its overpowering effect on the main, side-gabled portion of the house. However, it is staff’s opinion that its scale is not subordinate to the character-defining historic rear wing and will still result in the removal of the wing’s west wall.

Recommendation # 1 - Section 21-2-73, DENIAL – Erect a rear wing

- The newly erected rear wing has been directly appended the character-defining, two-story, rear wing resulting in the removal of its entire west wall and completely changing its overall form. The west facing wall of this wing, which is important to the building's historic character, has been destroyed. Also, the large scale of the addition overpowers/is not subordinate to the significant rear wing.

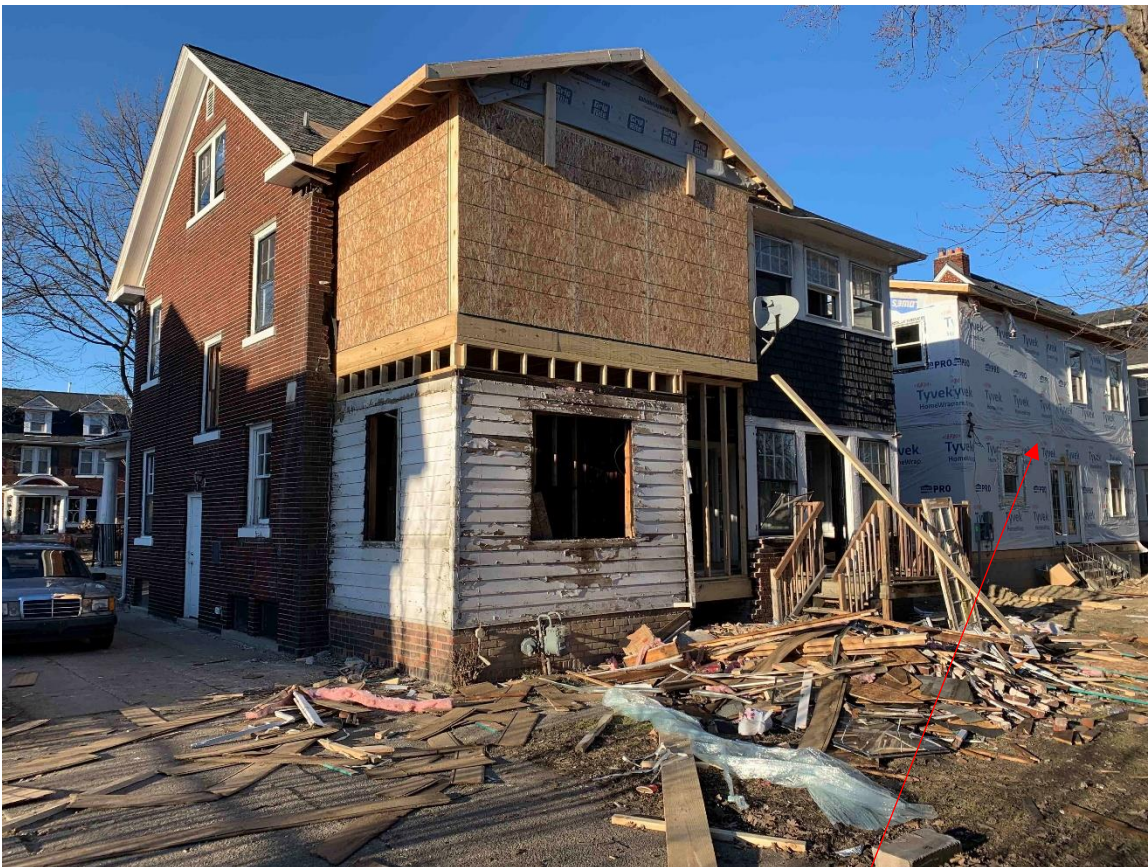
- On 2/15/24, a neighbor alerted staff that an addition was being erected at the building’s rear wall. Staff reviewed HDC records and determined that the work had not been reviewed and/or approved by the Commission. Please see the below photo of the conditions at the house’s new rear addition on 2/15/2024. Note that staff reported this violation to the Detroit Building department and they issued a stop work order on 2/29/2024 at the property.

Photo showing home on 2/14/2024. Submitted by resident. Facing northwest, showing unapproved work at rear (outlined in yellow). Also, note that a new addition had been added to the rear of the home next door/1475 Longfellow without HDC review/approval. 1475 Longfellow is also owned by owner of 1485 Longfellow

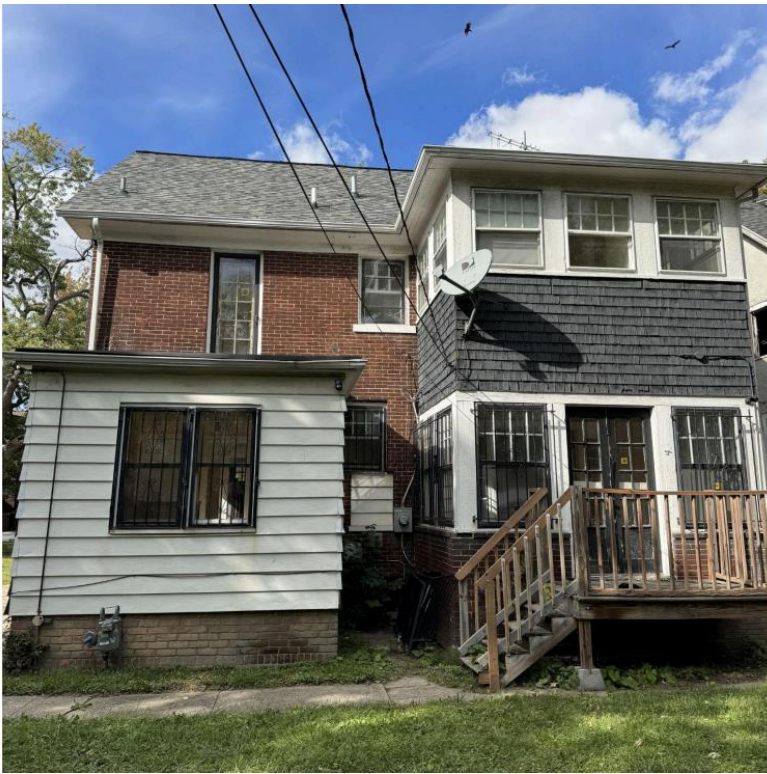
Rear of home, prior to unapproved work, facing north. Photo provided by applicant.
