STAFF REPORT: 07/10/2024 MEETING

APPLICATION NUMBER: HDC20204-00227

ADDRESS: 2285 LONGFELLOW

SCOPE OF WORK: REPLACE SIDING AND SOFFIT WITH SYNTHETIC PRODUCTS

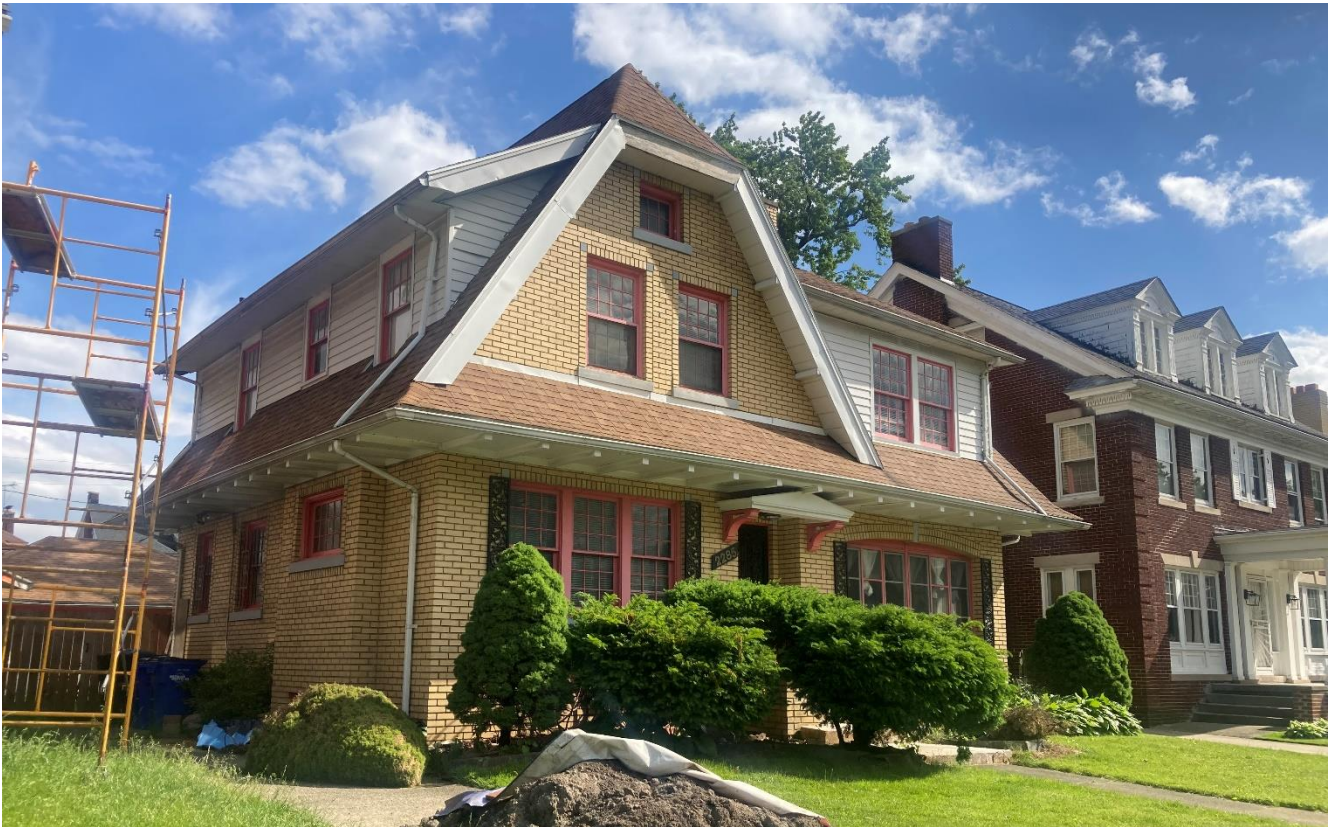
2285 Longfellow. Staff photo taken 5/29/3034. Remarkably, there are two other extant identical houses in the nearby LaSalle Gardens neighborhood. Photos located near the end of the report.

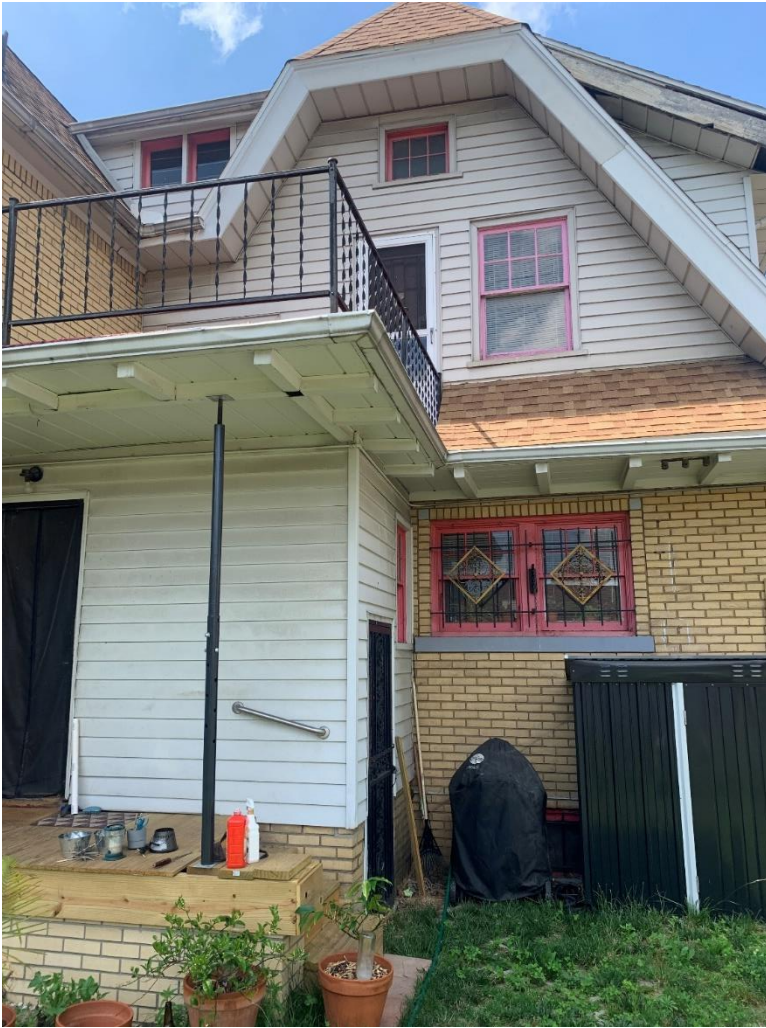
2285 Longfellow, rear. Photo provided by applicant

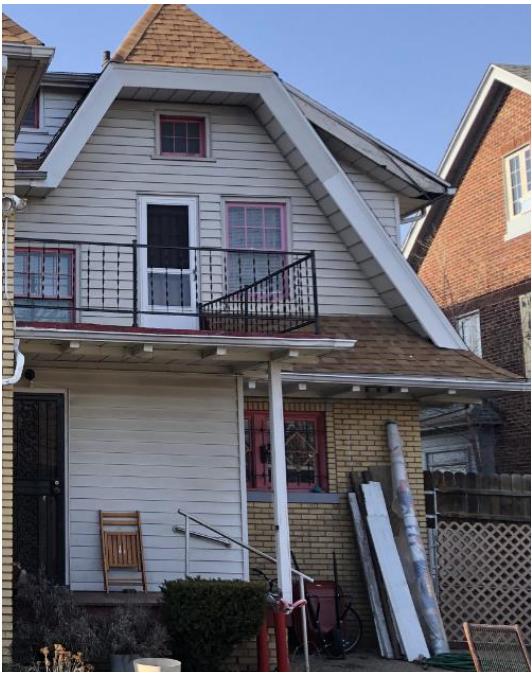
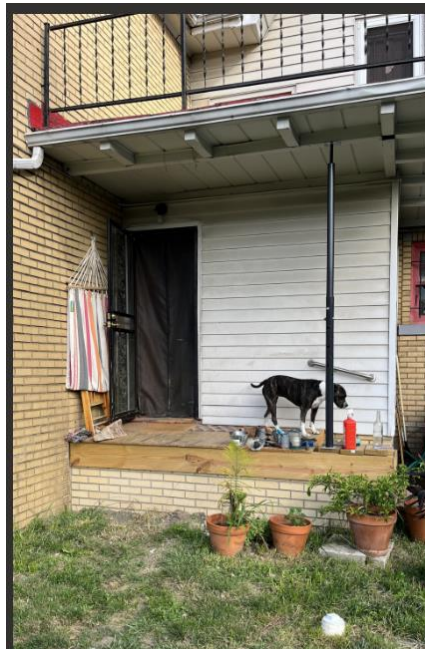
- The applicant received a Certificate of Appropriateness to repaint the house in 2017, replace nine windows in 2018, and to install a new fence and driveway in 2021
- Staff reviewed a recent photo of the rear elevation and noted that repairs to the porch have been recently undertaken, to include brick repair and the installation of new wood decking and steps. A porch support has also been removed (see the below photos). A review of HDC files indicated that this work has not been approved by the Commission. The applicant has therefore elected to add this scope item to the current application. It is staff's opinion that the repair of the porch as completed is compatible with the house's historic character and did not result in the removal of distinctive, character defining elements.

Rear porch. Condition prior to unapproved repair (left) and current condition showing new brick, wood decking, and temporary support (right). Photos provided by applicant

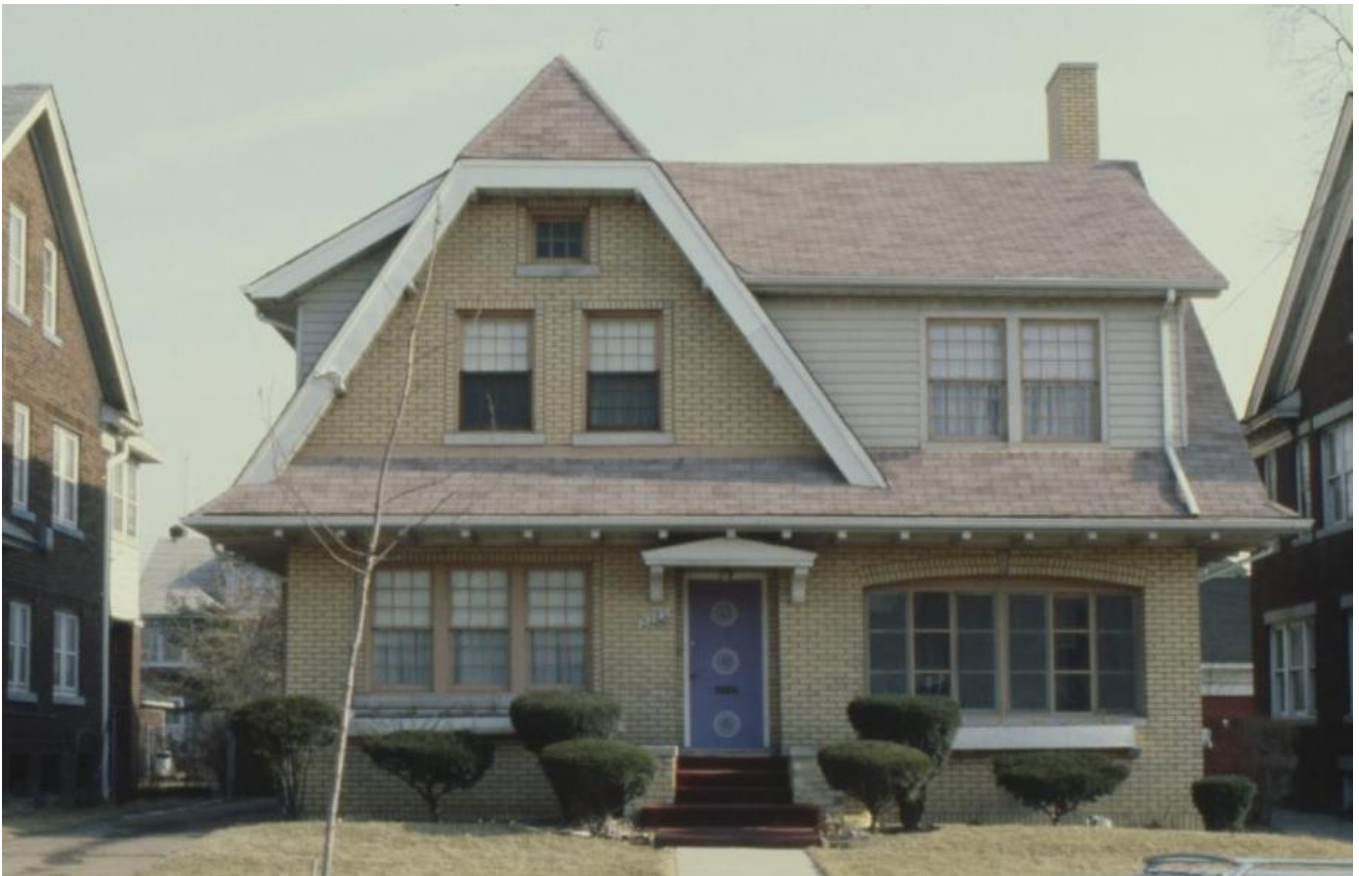
- Per the below photo, the aluminum at the dormers, eaves and fascia, was present at the time of the district's designation

2285 Longfellow. Designation photo, taken in 1980

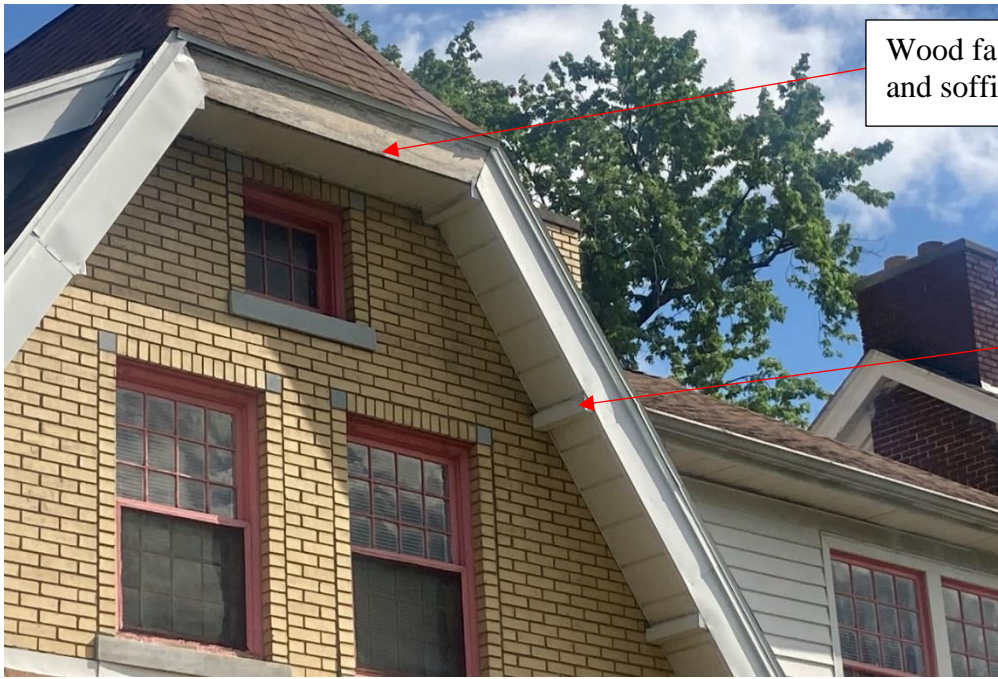
- The below photos, as well as the presence of decorative brackets at the eaves, suggest that the original wood eaves and fascia are largely intact beneath the current aluminum wrapping. If the current aluminum wrapping is to be removed, staff recommends that the any remaining wood eaves, fascia, and brackets be retained and repaired in kind where deteriorated. If these original elements do not remain beneath the existing aluminum wrapping, new wood eaves and fascia which are compatible to the building's historic appearance should be installed. The addition of new vinyl or aluminum to these areas as these materials would be incompatible with the building's historic character and thus would not meet the Secretary of the Interior's Standards for Rehabilitation.

Wood fascia and soffit

Aluminum clad bracket

Staff photo, taken on 5/29/2024. Facing front elevation gable end. Note that an area of the original wood fascia is visible after a portion of the aluminum wrapping has fallen off. Also note brackets in the eaves, currently wrapped in aluminum.

- The original wood eaves and fascia likely remain beneath the current aluminum wrapping. If the current aluminum wrapping is to be removed, any remaining historic wood soffits, fascia, brackets, and window/door trim should be retained and repaired with new wood to match the existing where deteriorated. If these original elements do not remain beneath the existing aluminum wrapping or are deteriorated beyond repair, new wood soffits, fascia, and window/door trim which are compatible to the building's historic appearance should be installed. The addition of new vinyl or aluminum to these areas as these materials would be incompatible with the building's historic character

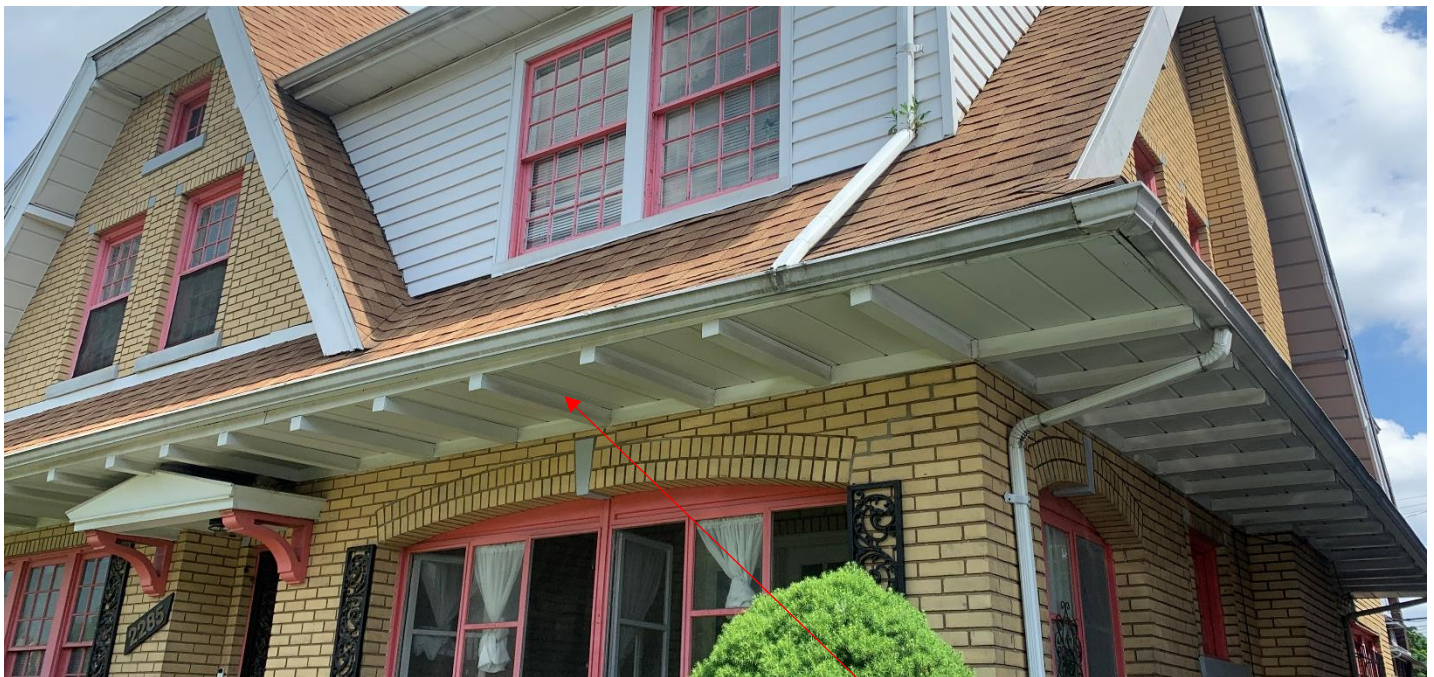
Photo by applicant. Showing brackets in the eaves, currently wrapped in aluminum

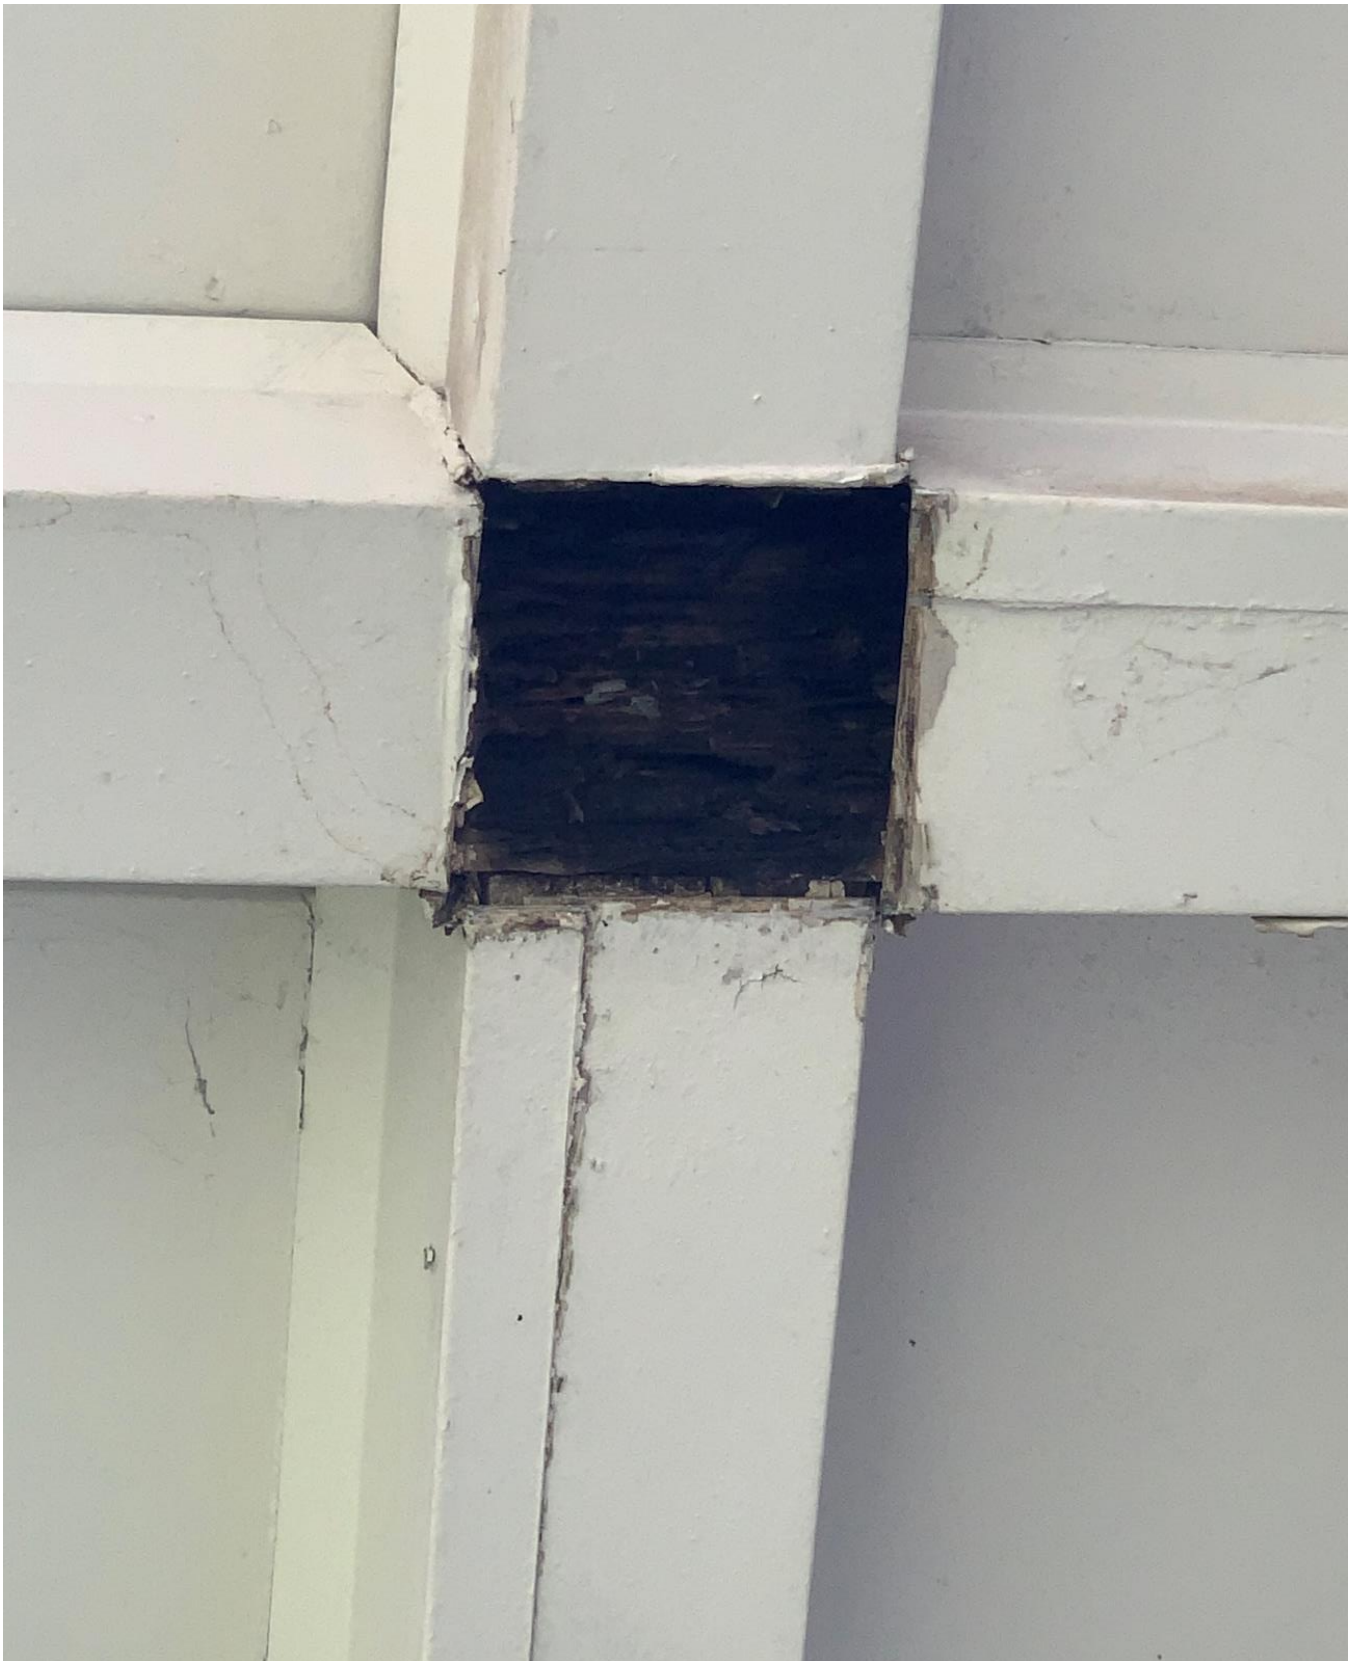
Photo by applicant. Detail of wood bracket in the eaves at the rear elevation. Showing area of wood rot.
