**STAFF REPORT: JULY 10, 2024 MEETING**  
**APPLICATION NUMBER: HDC2024-00322**  
**ADDRESS: 4340 GLENDALE**

**HISTORIC DISTRICT: RUSSELL WOODS-SULLIVAN**  
**APPLICANT: PETER BERNARD**  
**PROPERTY OWNER: AFIWI LLC (PETER BERNARD, AGENT)**  
**DATE OF PROVISIONALLY COMPLETE APPLICATION: JUNE 17, 2024**  
**DATE OF STAFF SITE VISIT: JUNE 20, 2024**

**SCOPE: REAPLACE WINDOWS (WORK STARTED WITHOUT APPROVAL), INSTALL FENCE (WORK COMPLETED WITHOUT APPROVAL), PAINT DWELLING**

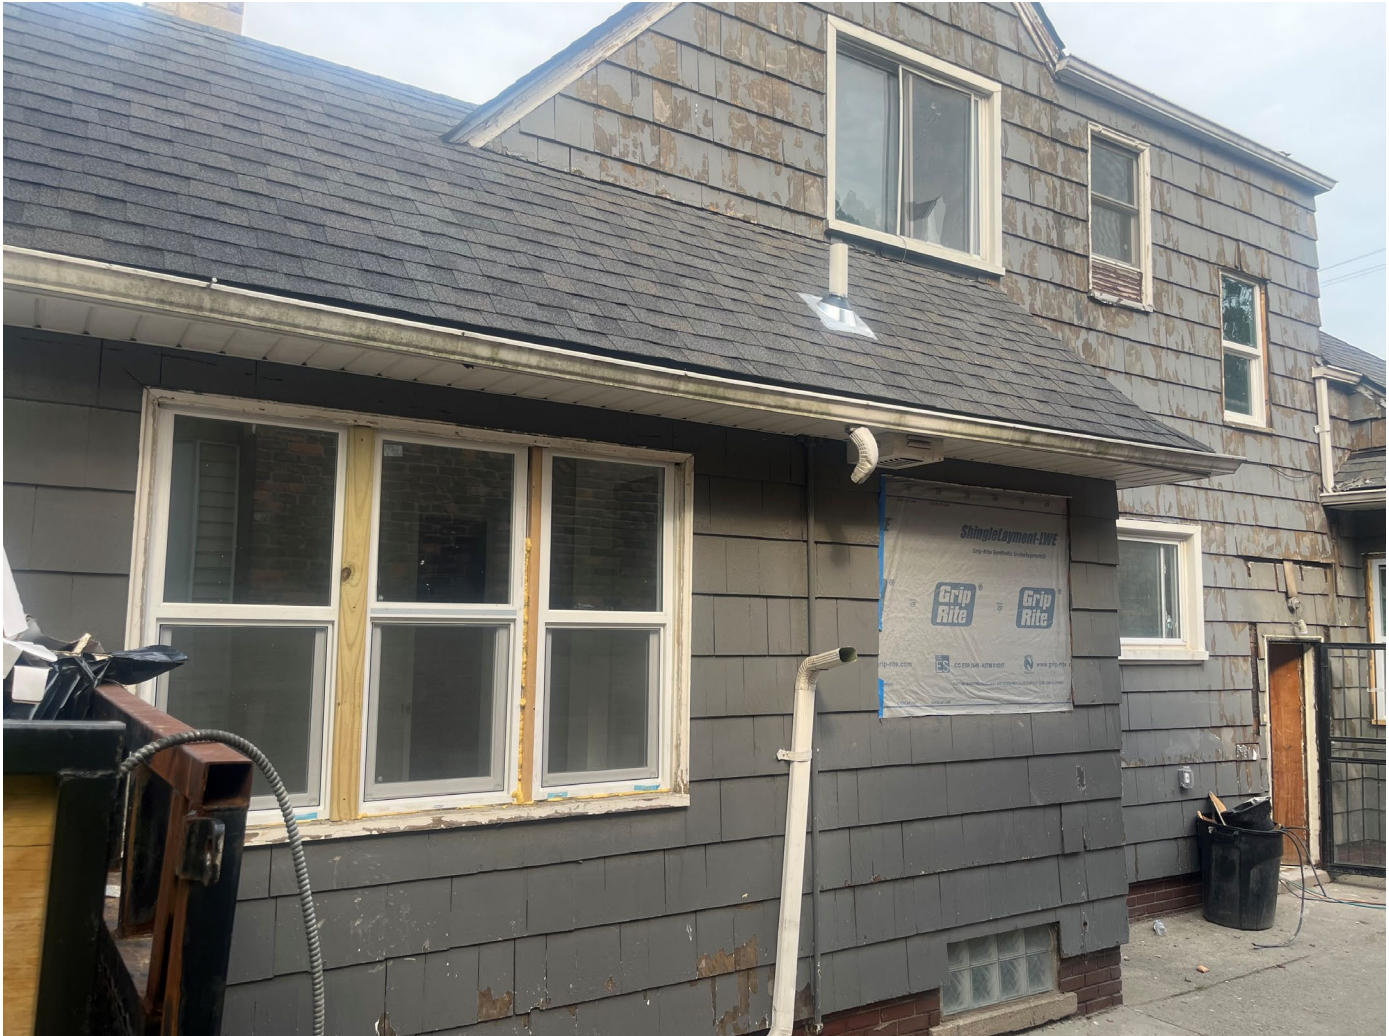
**Figure 3: Image showing east side of dwelling with new windows and an infilled window opening.**

- The replacement windows on the dwelling, (both those installed ca. 2008 and the 2024 windows), are not appropriate replacements for the original windows. They do not adequately resemble the original units in terms of dimensions, materials, lite divisions, and often operation. Vinyl windows are not appropriate replacements for wood sash windows, due to their synthetic appearance and poor durability. Staff

recommends the Commission issue a denial for all of the vinyl replacement windows.

It is staff’s opinion that the proposed (and partially completed) vinyl window installation and window infill is not appropriate. Vinyl windows are not an appropriate replacement for the wood sash windows. Staff recommends that the Commission issue a denial for the proposed new window installation because the work does not meet the Secretary of the Interior’s Standards for Rehabilitation, in particular Standards 2 and 6:

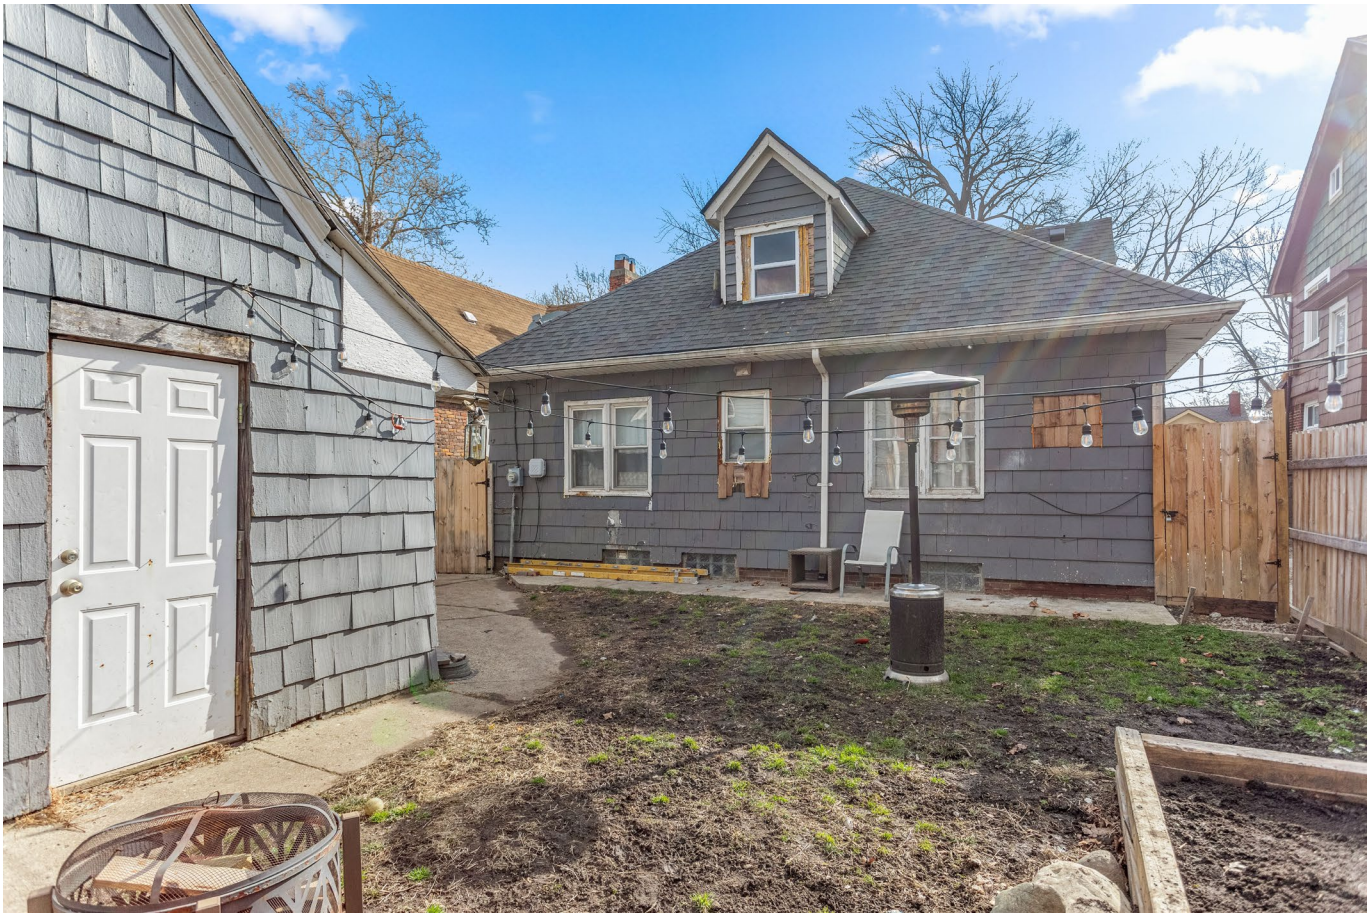
**Figure 4: Image showing rear of dwelling with new windows and an infilled window opening. A replacement pedestrian door at the garage is not included with this application.**

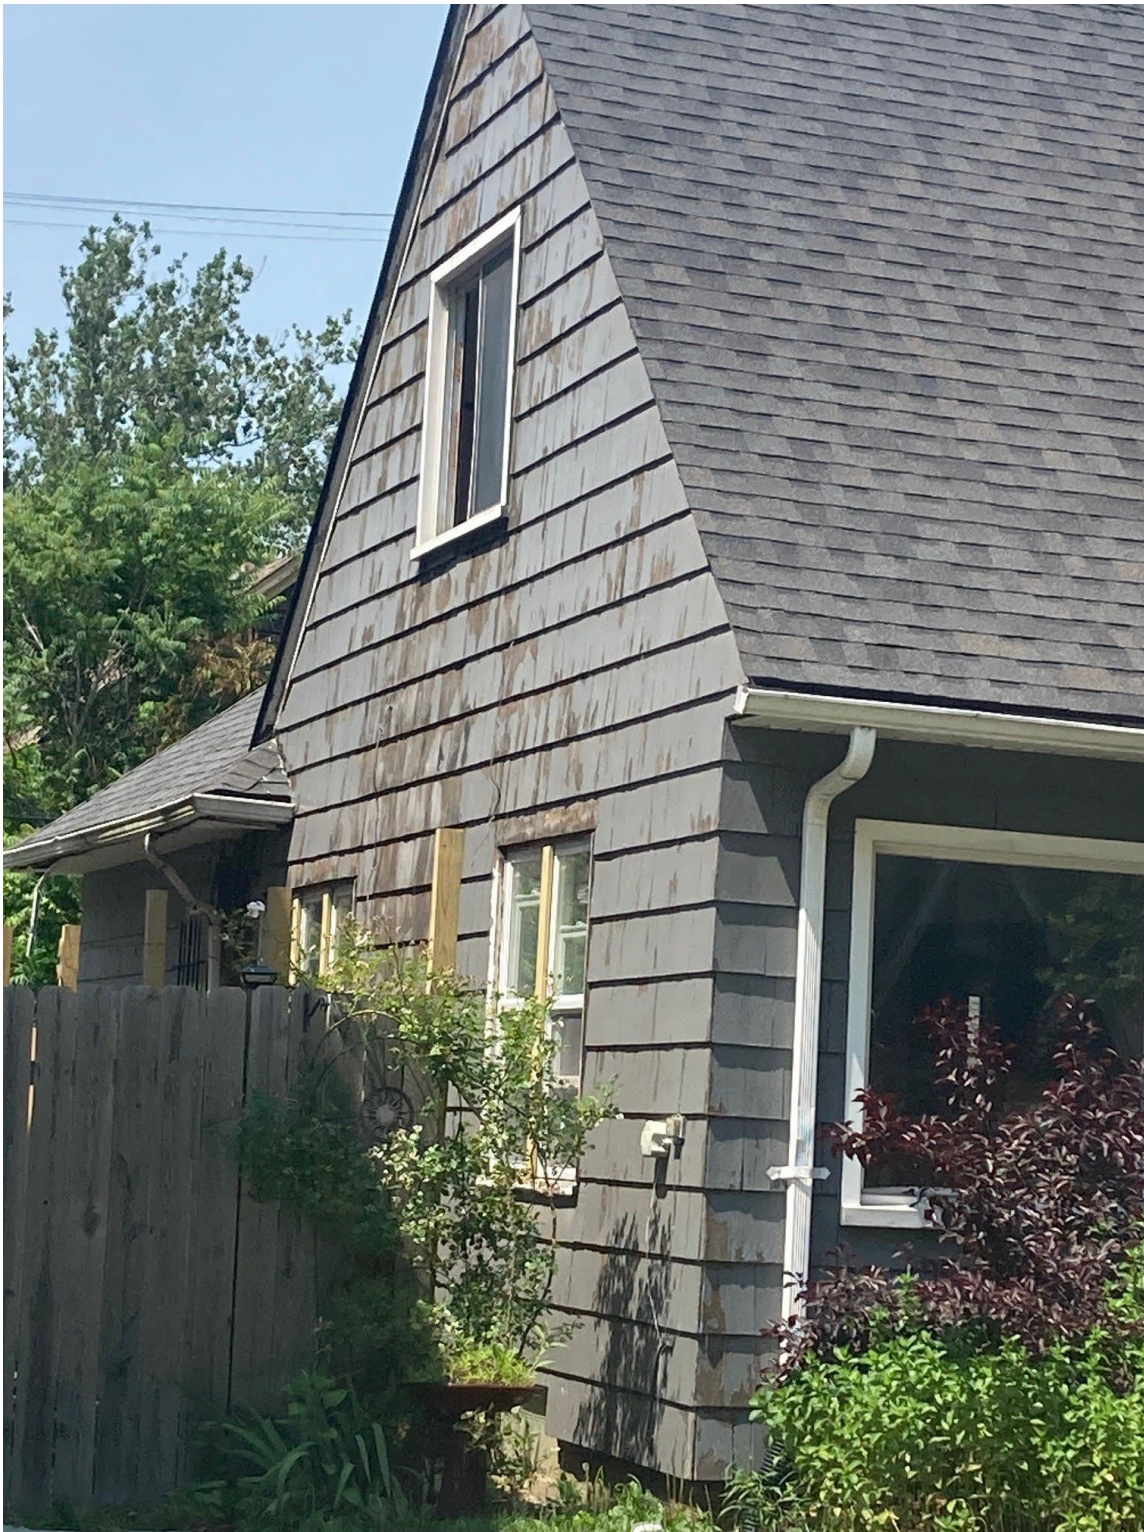
**Figure 5: View of replacement windows on west side of property.**

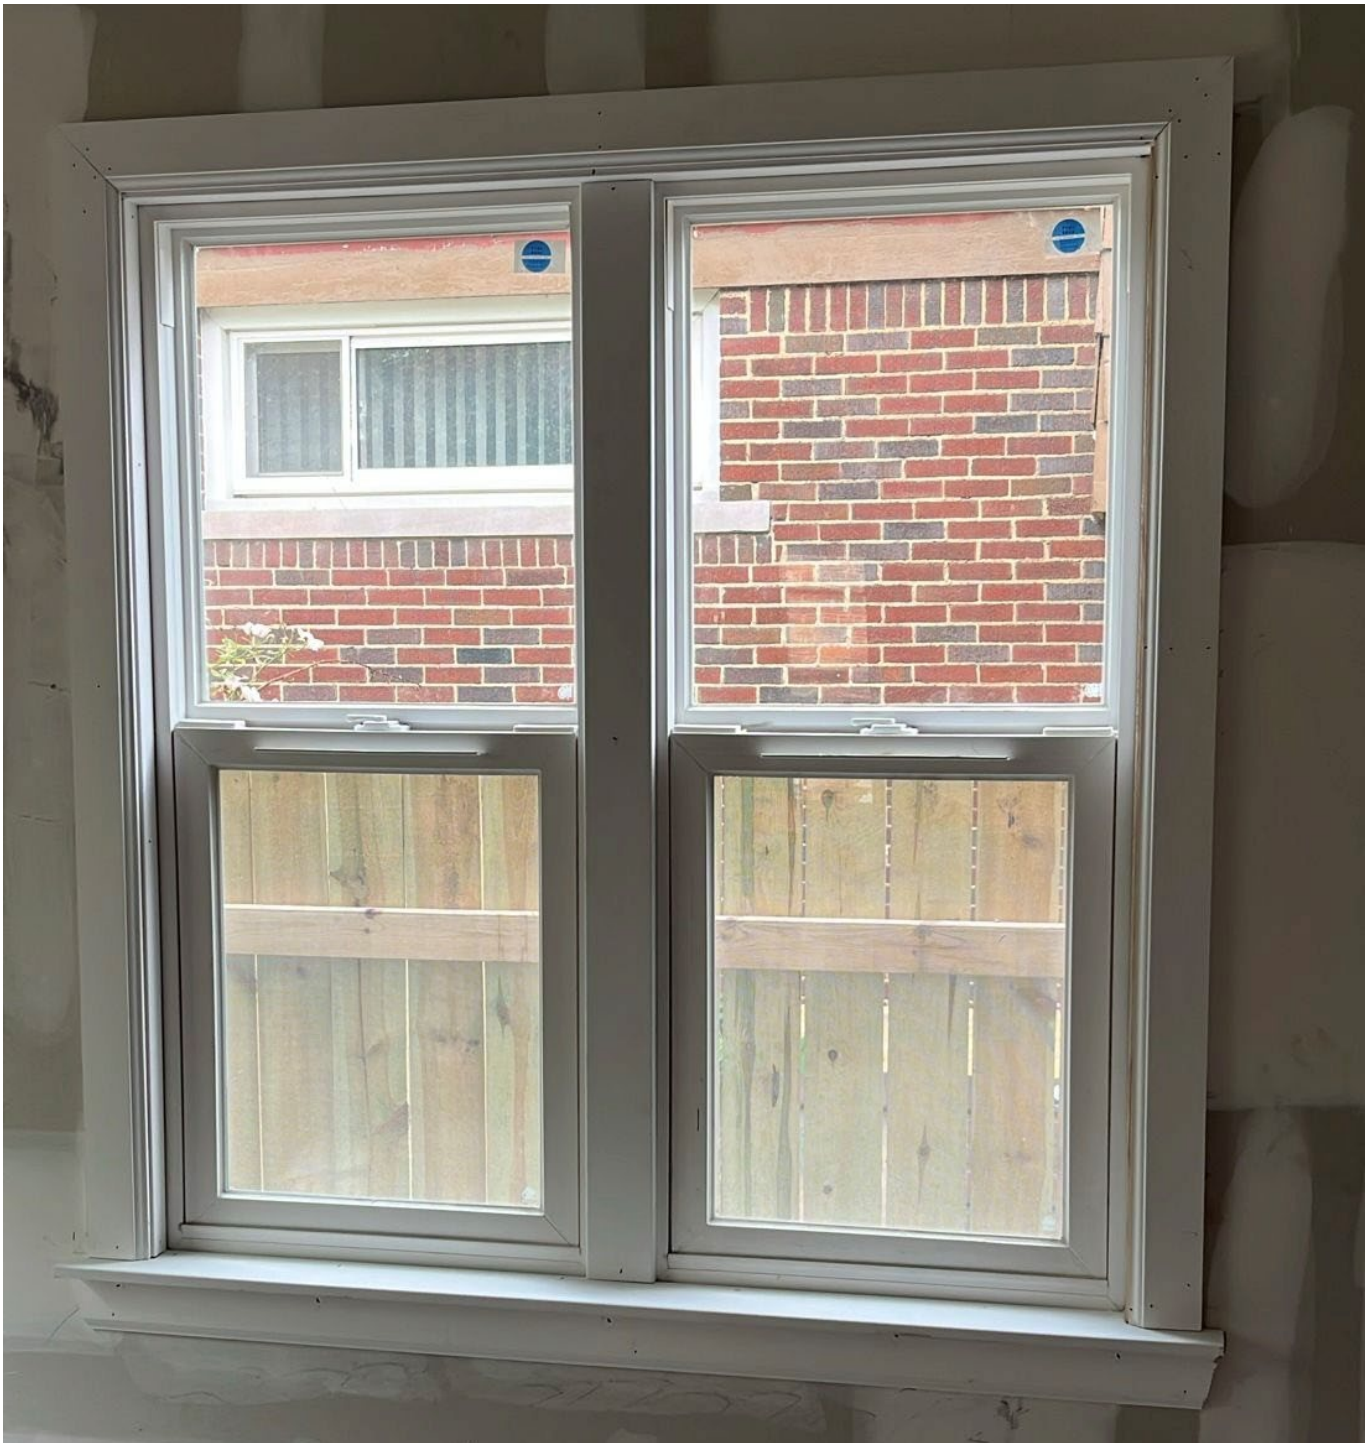
**Figure 6: View of new windows from interior of the dwelling.**

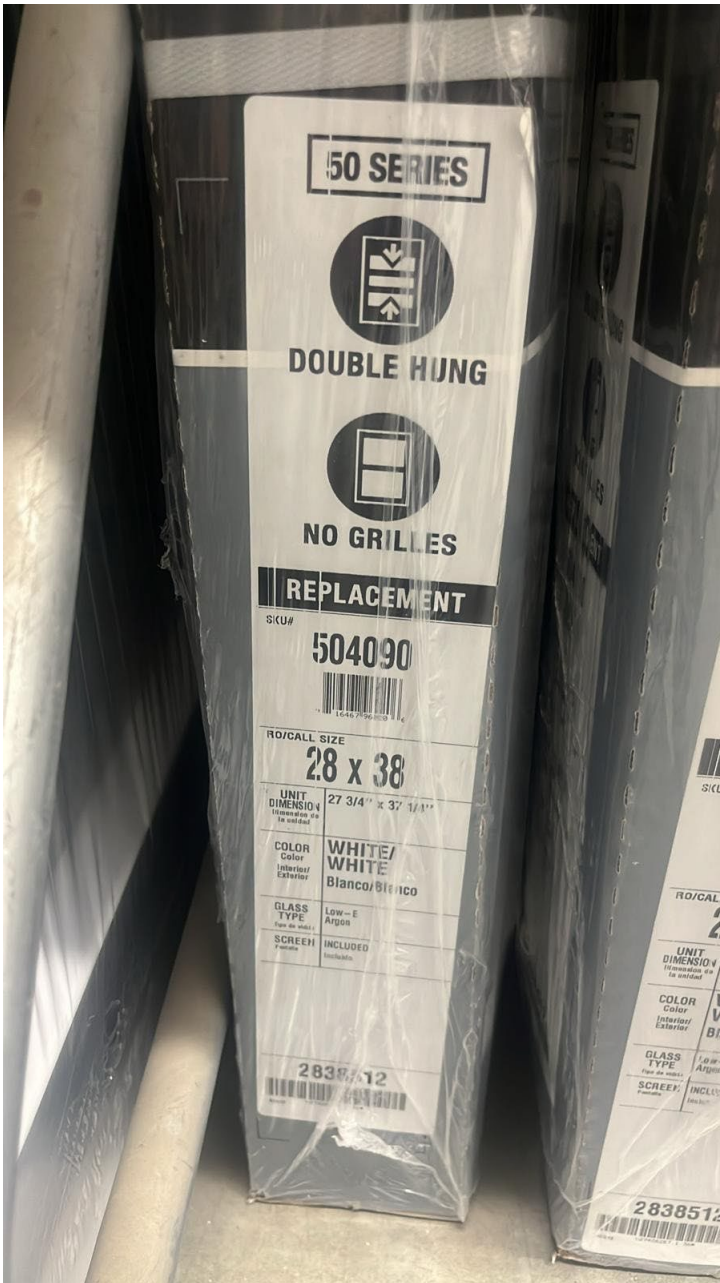
Figure 7: Image showing the label on the vinyl windows installed (from the applicant submission).

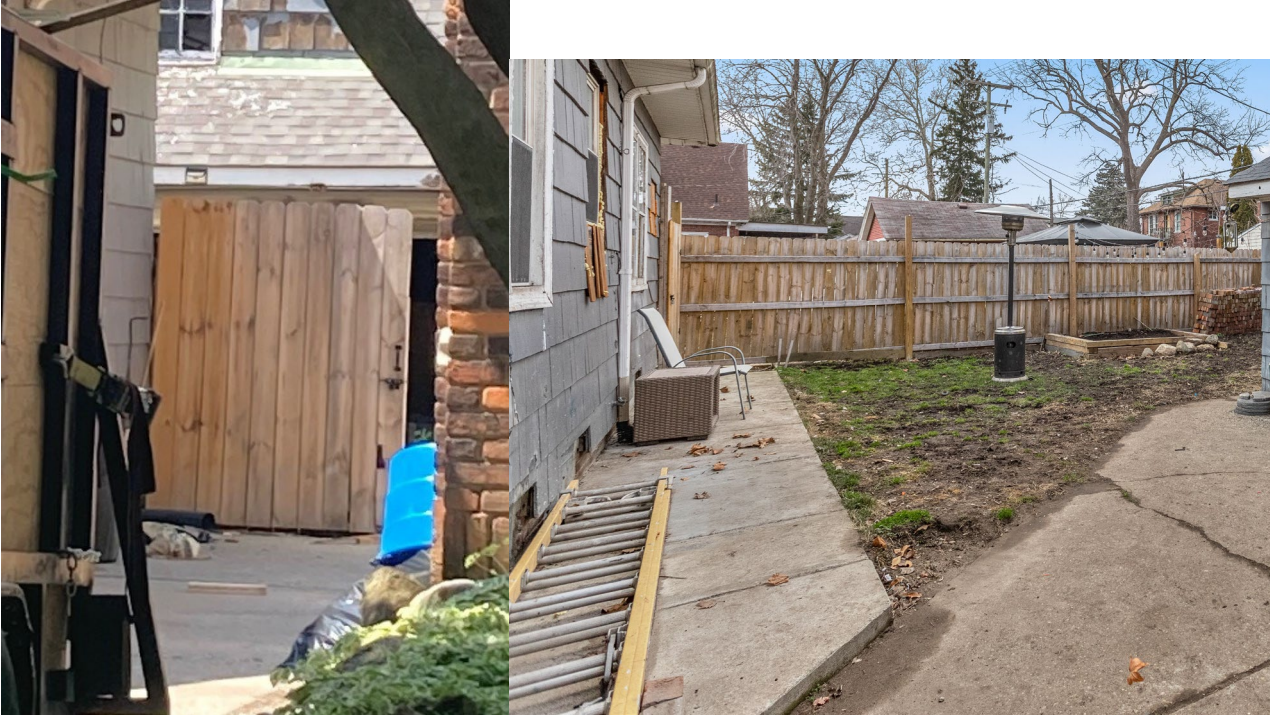
The applicant is also seeking approval for a dog eared-wood fence that was already installed without review by a previous owner. The approximately 6' tall fence runs around the perimeter of the rear yard and features two gates at the rear wall of property. The fence is currently unpainted.

**Figure 9: Images showing the fence and gates as installed.**

1. The installed fence and gates be painted a complimentary color to the dwelling or stained with an opaque wood stain.

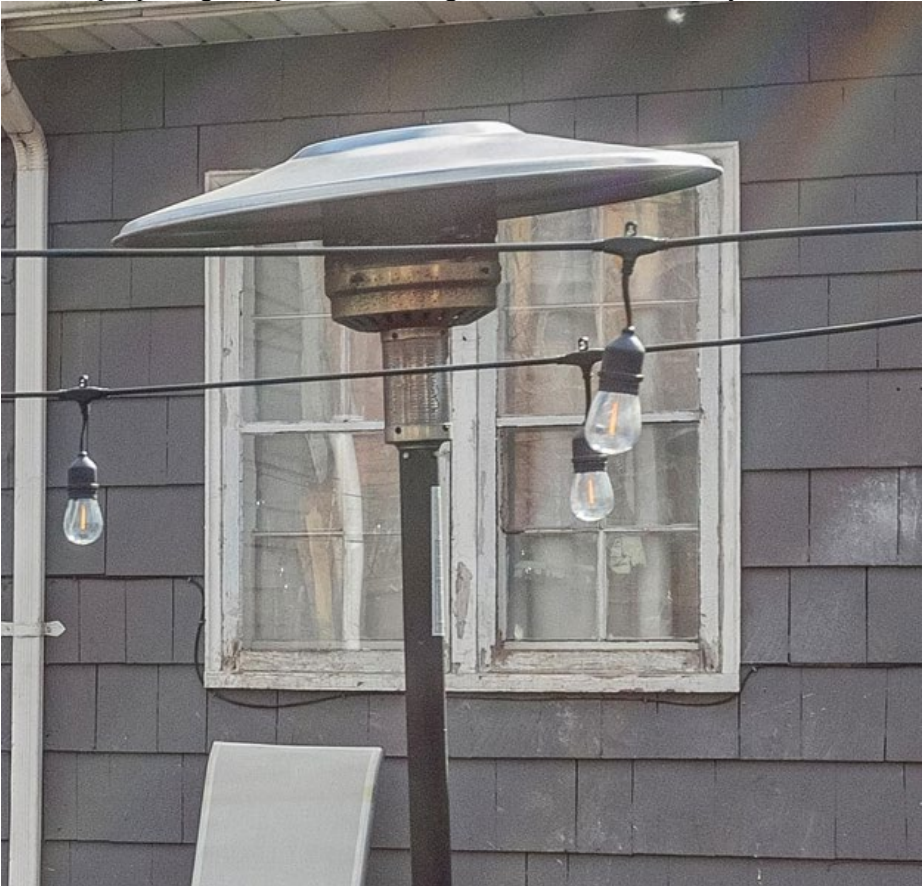
- The Russell Woods-Sullivan Historic District was established in 1999.
- According to the designation photograph for the property, the majority of the original windows appeared to be double-hung, wood sash units with a four-over-four lite configuration. One original set of two windows remains on the rear of the dwelling. An original six lite window is present on the garage. The applicant is proposing to replace these original units with new vinyl windows.

**Figure 10: Original, paired, four-over-four windows with wood storms present at the rear of the property.**
