STAFF REPORT: 08/14/2024 REGULAR MEETING

APPLICATION NUMBER: HDC2024-00354

ADDRESS: 14846 ASHTON

SCOPE: DEMOLISH GARAGE AND ERECT GARAGE

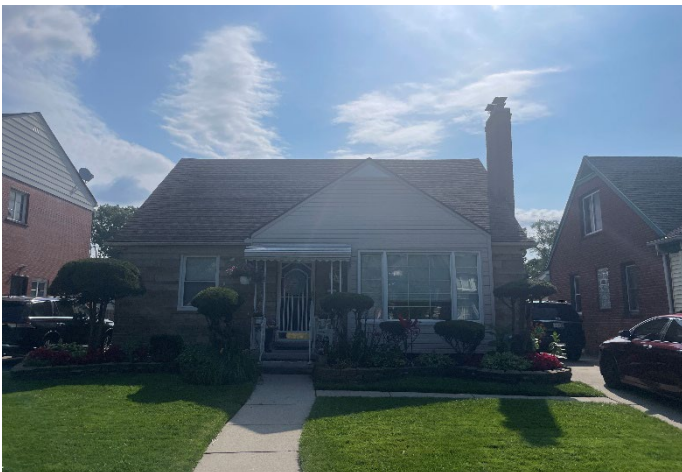
Site Photo 1, by Staff July 25, 2024: (West) front elevation of house.

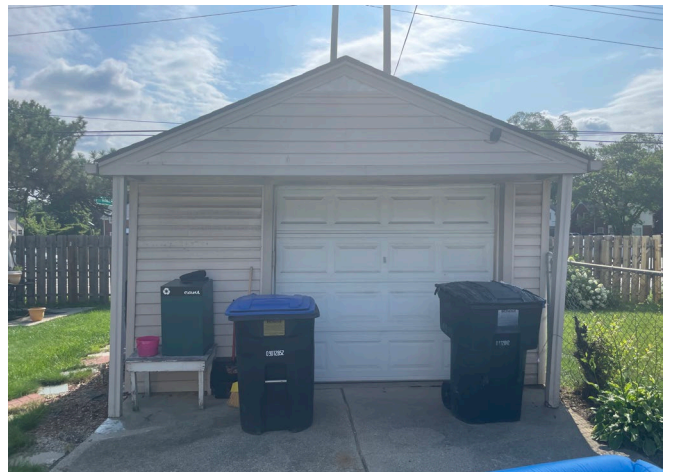
Site Photo 2, by Staff July 25, 2024: (West) front elevation of the existing garage.

- Staff offers the opinion that the publicly visible original garage, even though of modest scale and utilitarian use, conveys an era of mid-century design that illustrates a strong relationship with the house with a complementary front facing gable, low pitched roof, and modest scale as described by the Elements of Design and as reflected by its presence at the time of historic designation. Staff believes that this structure is a contributing historic resource to the property despite its humble appearance.

- The owner permitted staff to observe the garage up-close and inside the structure on July 25, 2024. The owner stated that the garage has been hit 3 times by vehicles coming off the service drive while they have had residence there. The garage has a slight lean from the impact hitting the northeast corner according to the owner. However, staff observed that the garage was stabilized and not in a state of deterioration. The concrete floor is cracked in

several areas, but not irreparable, in staff's opinion. Staff also noticed from the interior, that a window and man door have been boarded in and the vinyl exterior siding hides these previous openings. The structure retains its historic integrity, contributes to the historic district, and is not beyond repair, in staff's opinion.

Staff therefore recommends that the Commission issue a Denial for the above work items, as they do not meet the Secretary of the Interior's Standards for Rehabilitation, specifically Standards:

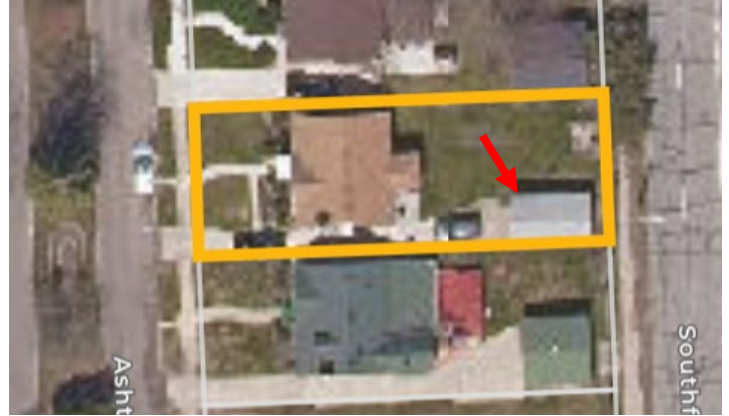
Aerial#1 of Parcel # 22075026, showing original garage (red arrow) and driveway behind the house.

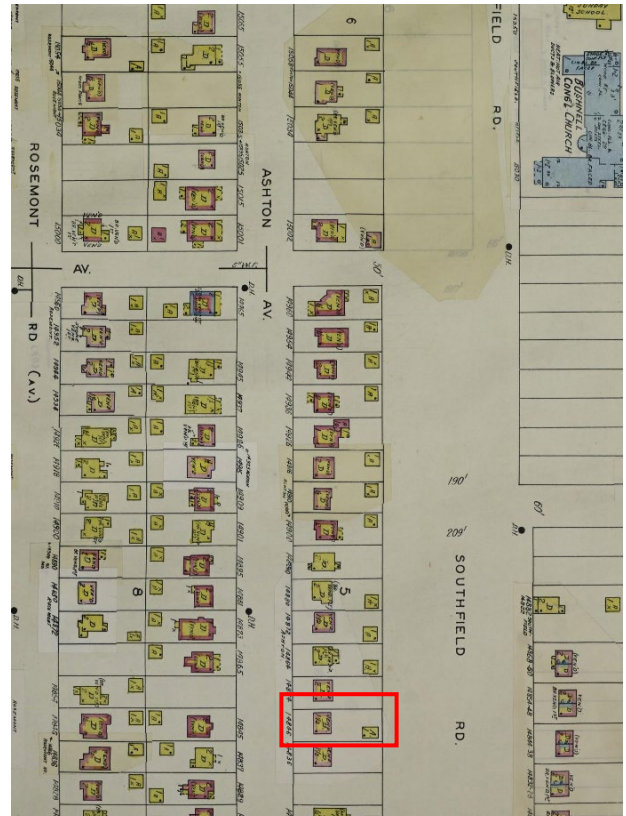
- Despite the lean and easement conflict, staff has the opinion that the presence of the garage likely predates the easement, which is not grounds for dismantling the structure. (The Southfield Freeway was constructed in 1959, 10 years after the construction of the house. Staff was not able to identify the precise construction date of the garage but assesses that its construction is likely close to the construction of the house in 1949. *See figures 1-2*)

Figure 1, Sanborn vol 26, 1938-1950: showing garage presence of garage and house (red outline) at time of widening of Southfield Rd.

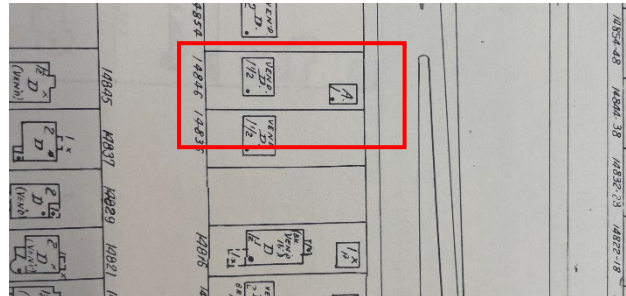
Figure 2, Sanborn 1983: showing garage presence of garage and house (red outline) with Southfield Freeway present.

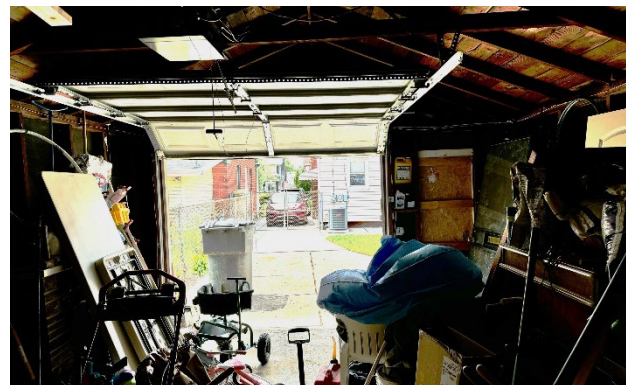
Site Photo 3, by Applicant, 2024 showing interior garage entrance and boarded up man door.

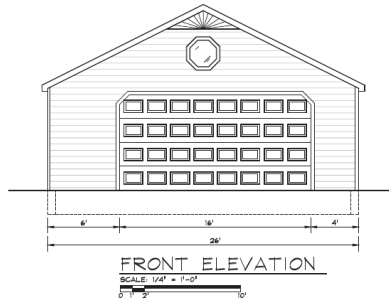
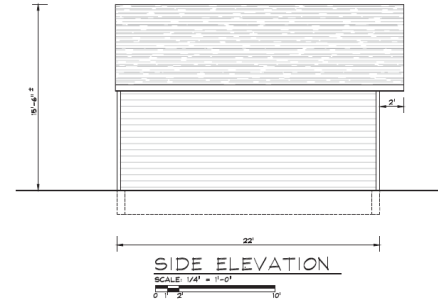
Figures 1&2, by Applicant: showing proposed front and side elevations of the garage.

- Staff has the opinion that the proposed height and scale of the new garage goes beyond an appropriate size that is deferential to the primary structure, i.e., the house. Also, the proposed octagonal window at the front gable introduces a new element that is not appropriate nor relates to the primary structure. It is staff's opinion that the proposed height, scale and window design for this garage are inappropriate as they do not meet the Elements of Design nor "relate to the main dwelling". Staff opines that a lower pitch roof and a smaller footprint with a simple front gable design would be an appropriate alternative should the Commission decide that the construction of a new garage is appropriate.

- Staff offers the opinion that the scale of the garage, particularly it’s width, height, and material use of vinyl siding and introduction of an octagonal window is demonstrably inappropriate because it does not relate with the house nor follows the Elements of Design, where “Garages, when original, often correspond in materials to the main body of the dwelling, but are of modest, one-story, simple box design with single- or double-doors.”

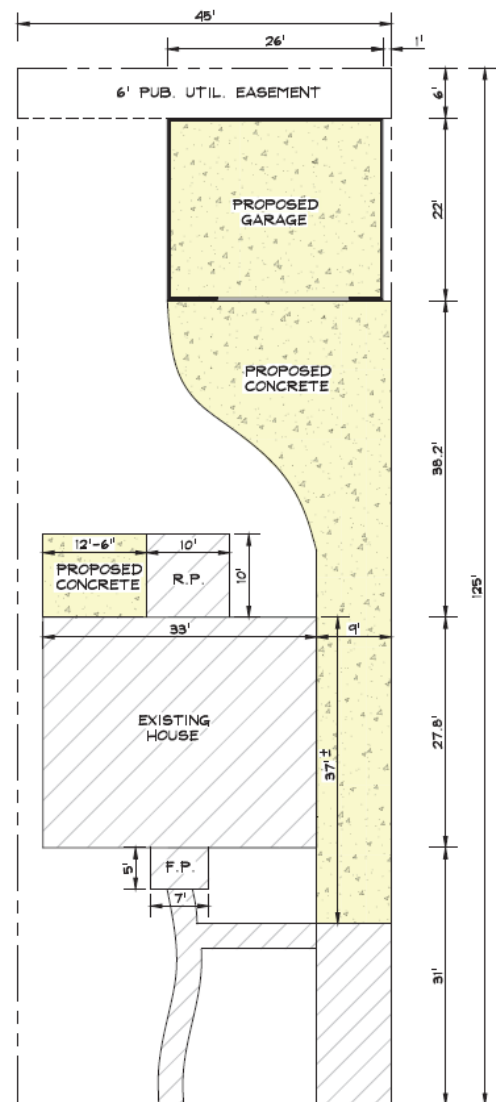
- Staff has no issue with the proposed concrete patio. (See Fig 3 and Site Photo 4.)
- It is staff's opinion that the proposed driveway either match the dimensions of the existing drive, or at a width that matches a reduced scaled garage should the Commission approve a new garage.

Figure 3, by Applicant: proposed site plan showing garage, driveway and rear patio locations.

It is staff's opinion that the construction of the rear concrete patio and driveway is appropriate. Staff therefore recommends the Commission issue a Certificate of Appropriateness for the work as proposed because it meets the Secretary of the Interior Standards for Rehabilitation and the Rosedale Park Historic District's Elements of Design.

- The driveway is replaced within its current footprint.

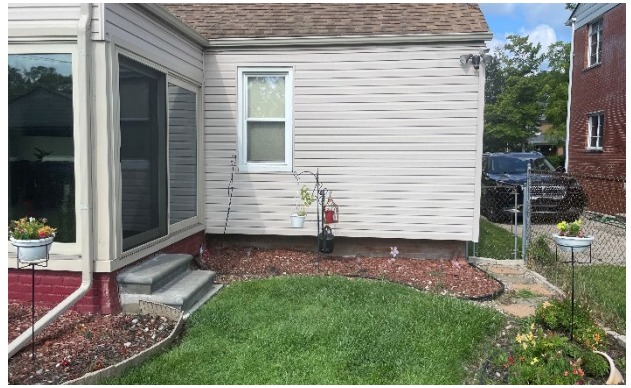
Site Photo 4, by Staff, July 25, 2024, showing location of proposed concrete patio.

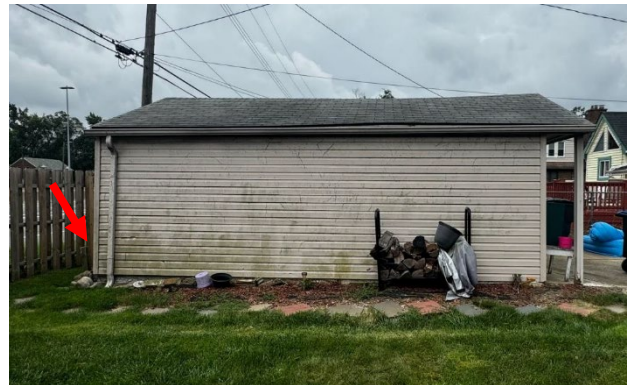
Site Photo 5, by Applicant, showing north side of the existing garage. The arrow indicates the location of past vehicle impact.
