STAFF REPORT 08-14-2024 REGULAR MEETING

APPLICATION NUMBER: HDC2024-00357

ADDRESS: MULTIPLE LOCATIONS IN THE PUBLIC RIGHT-OF-WAY

SCOPE: REPLACE STREETLIGHTS

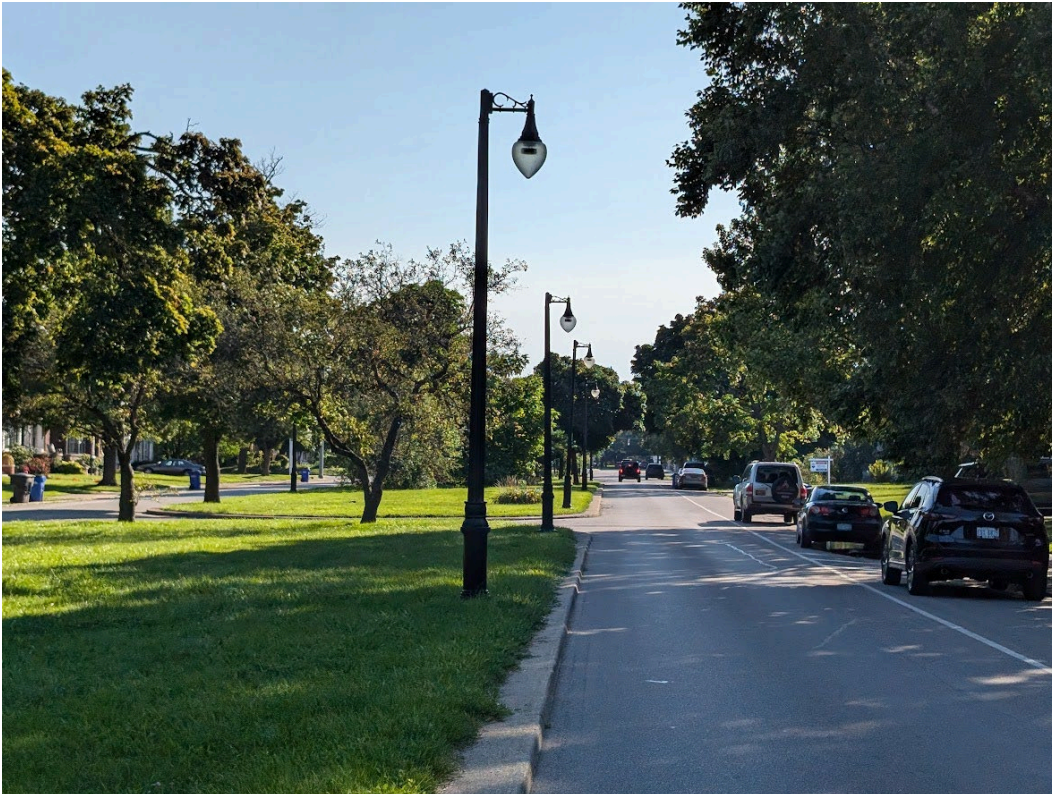
Typical view of existing fiberglass (non-historic) streetlights in the Boston-Edison Historic District. Staff photo, August 7, 2024.

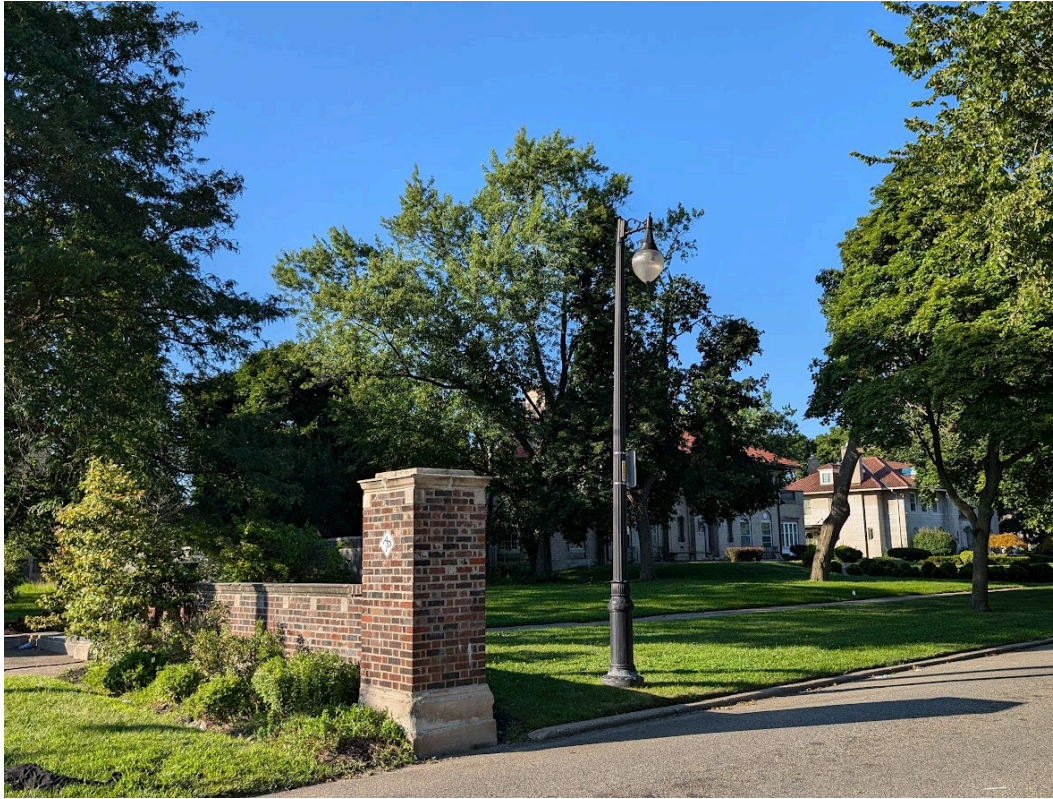
Existing fiberglass pole at the historic entrance to the Arden Park-East Boston Historic District. Staff photo, August 7, 2024.

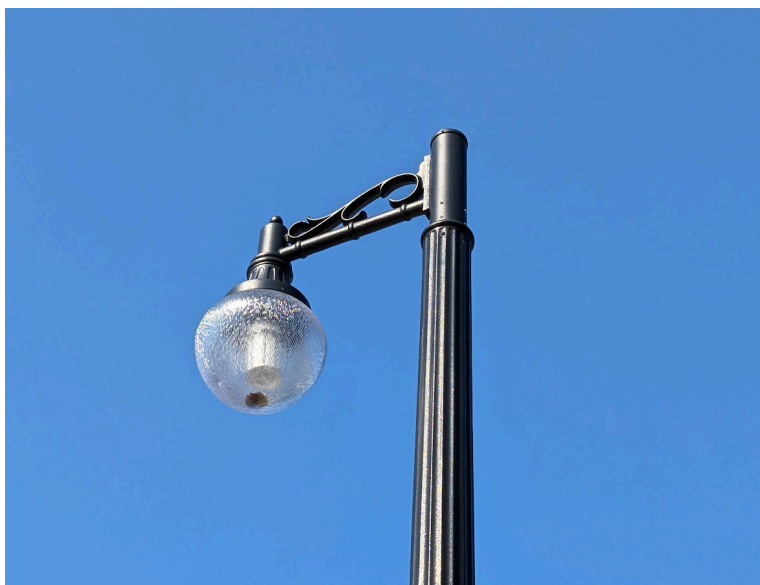
Detail view of arm and luminaire on pole along Oakman Boulevard. Note cheap “plastic” appearance. Staff photo, August 7, 2024.

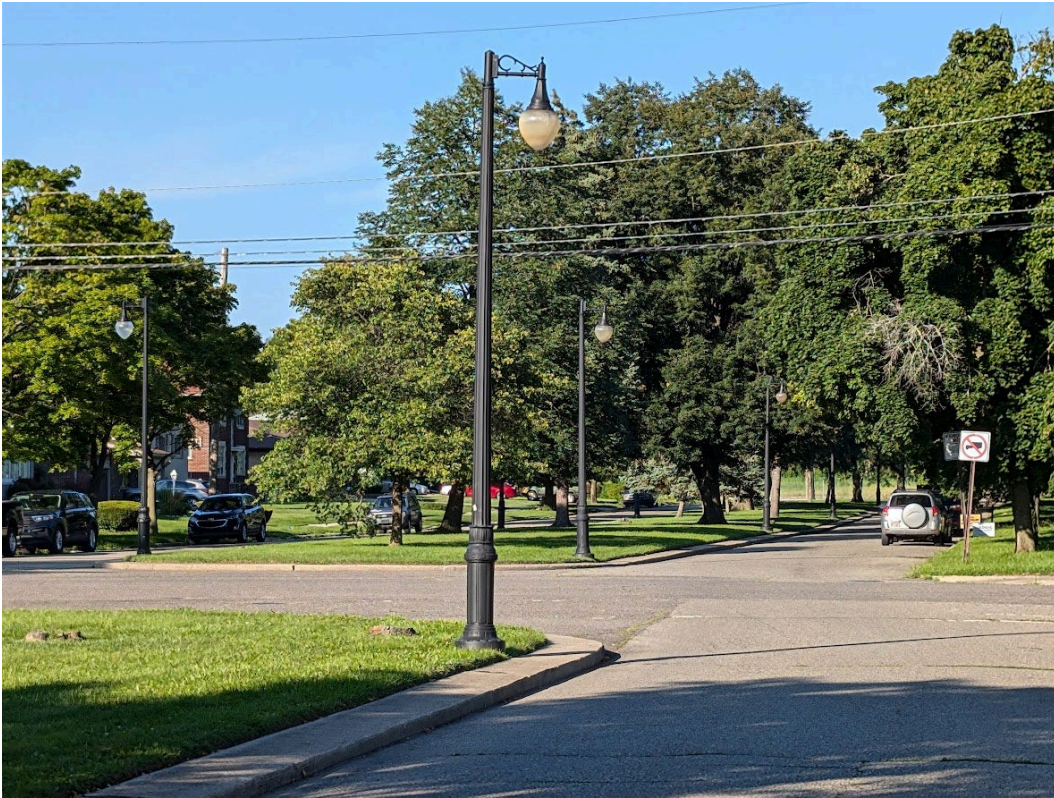
Another view of the current fiberglass poles along Arden Park Boulevard. Staff photo, August 7, 2024.

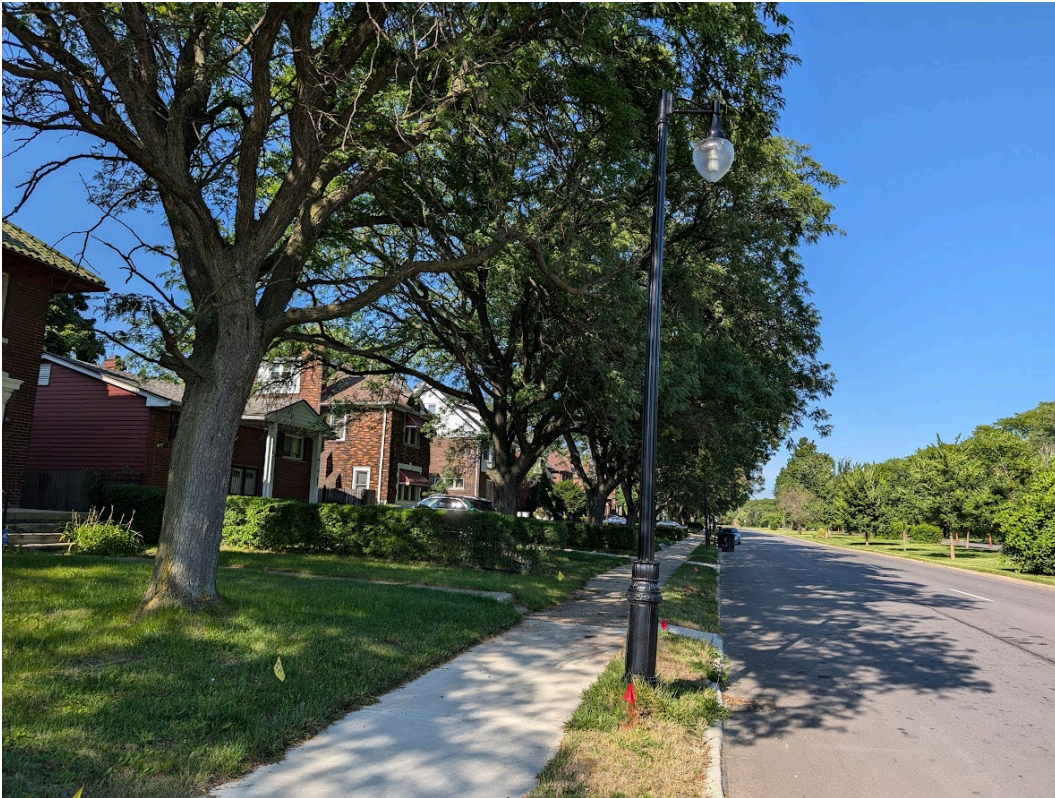
View of an existing fiberglass pole in the Oakman Boulevard Historic District. Staff photo, August 7, 2024.

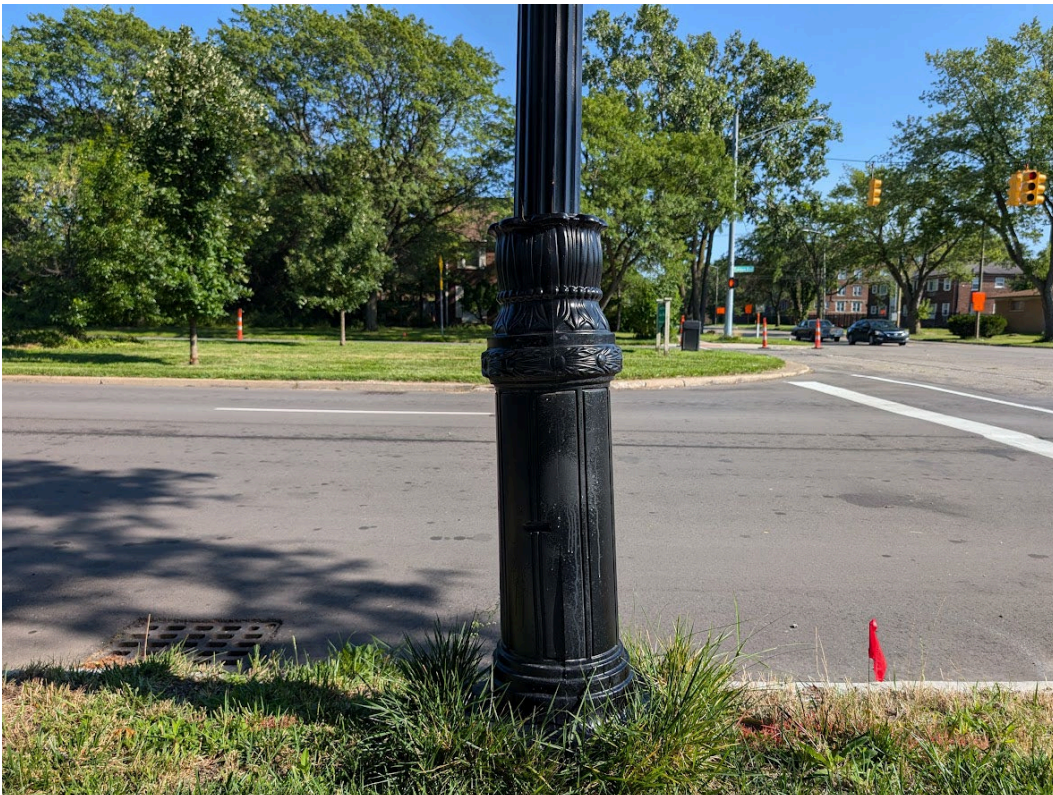
Detail view of a fiberglass pole along Oakman. Note dislocated base leaning to the left, as well as the machined “historic” details attempting to portray a traditional appearance with no historic connection to the Oakman Boulevard Historic District. The dominant expression of these poles are gaudy and cheap. Staff photo, August 7, 2024.

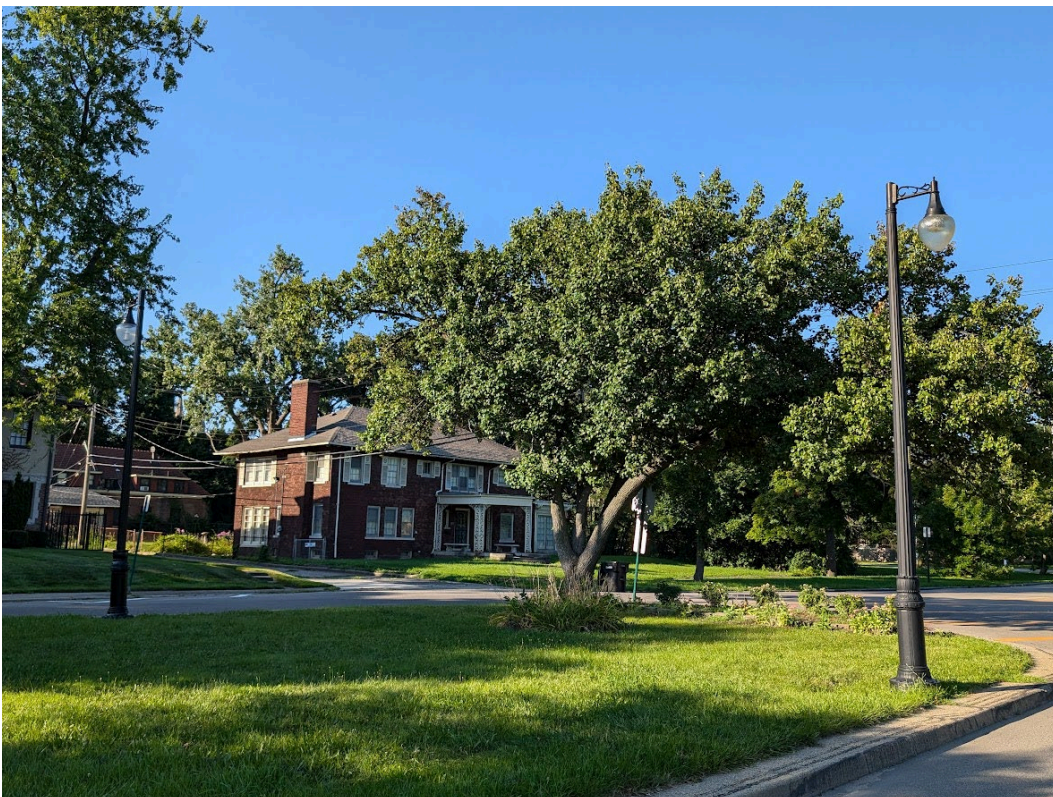
Existing fiberglass poles flanking Chicago Boulevard in Boston-Edison Historic District. Some of the plastic luminaires on these poles have been replaced with smaller globes, contributing to a chaotic appearance, Staff photo, April 7, 2024.

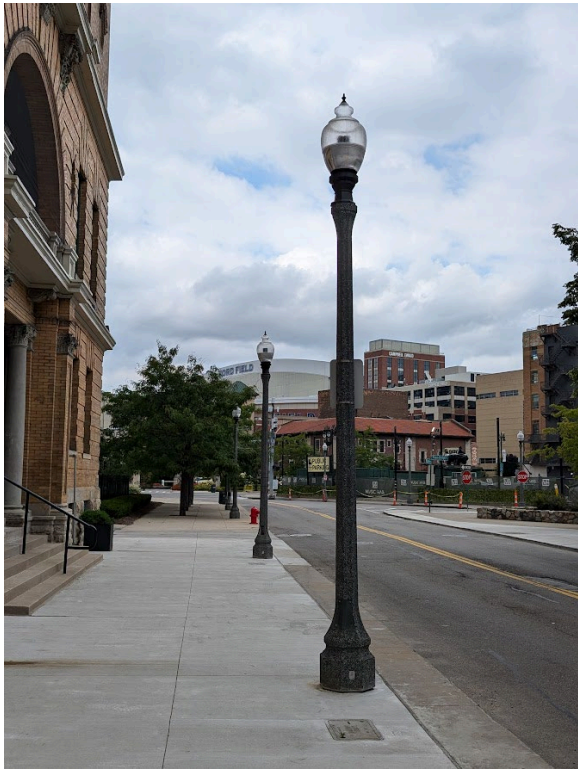
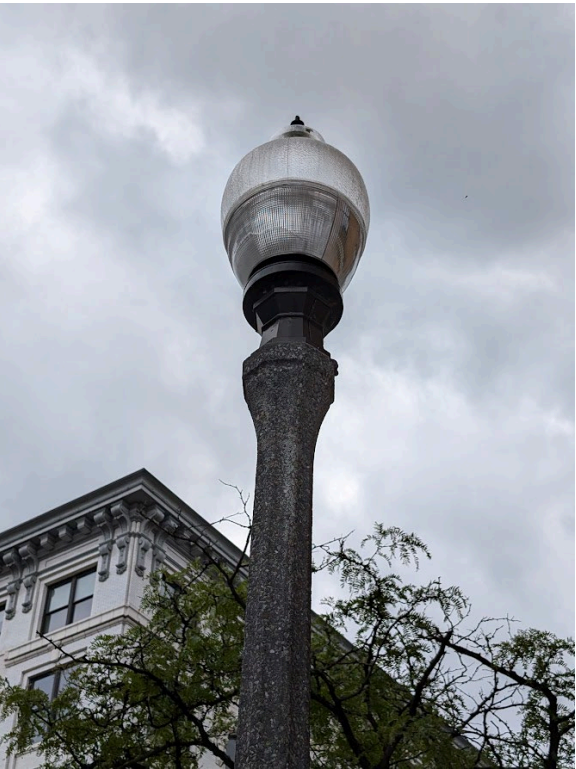
These poles, found at Harmonie Park, appear to be older versions of the stresscrete "Belmont" poles proposed in this application. In staff's opinion, the simpler design and elegant stature of these units is superior to the aggressively false historicism and gaudy appearance of the fiberglass poles. Staff photo, August 8, 2024.

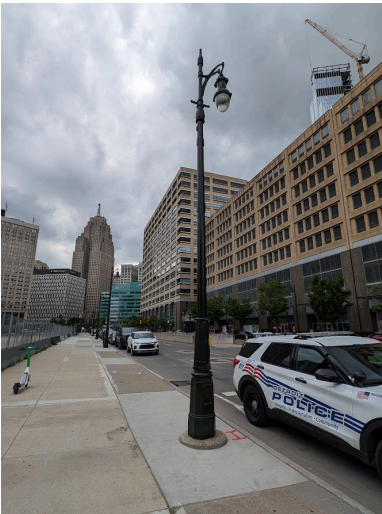
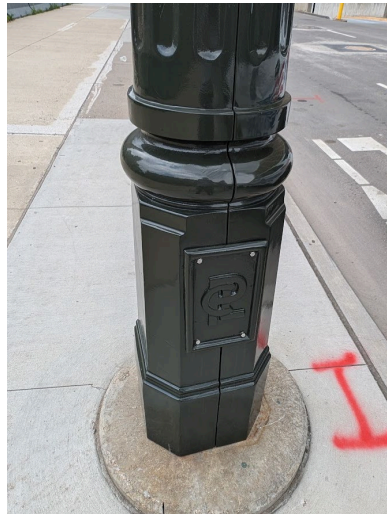
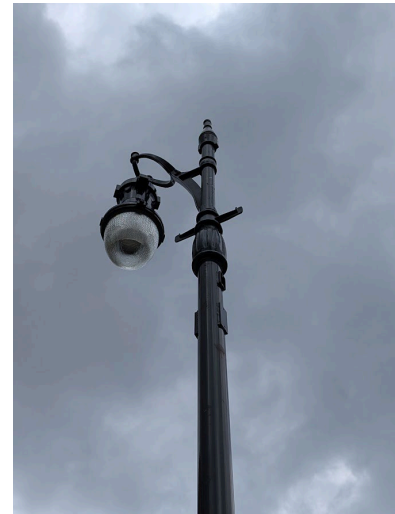
Here is an example of a reproduction steel PLC pole, one of many installed in recent years downtown. Note modern construction (two-halved base, steel pole with no footpegs) in comparison with the cast iron base and wood shaft on an original pole pictured below.

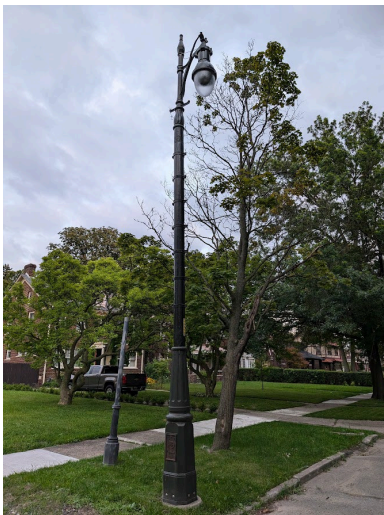
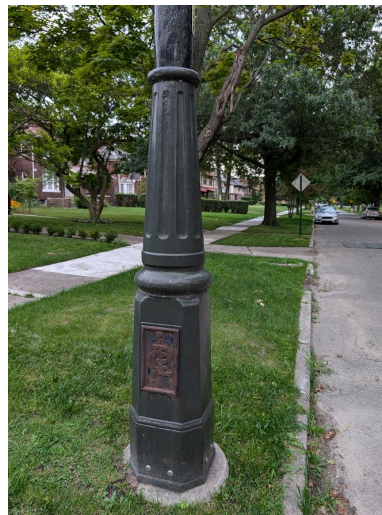
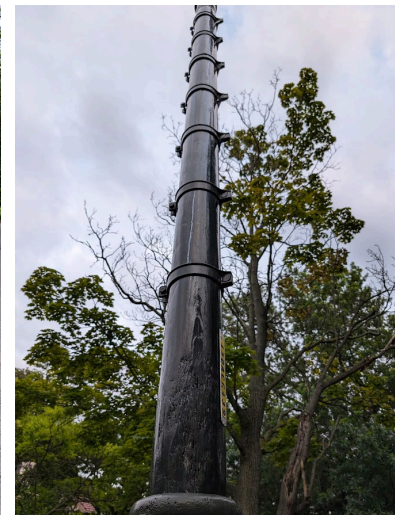
Original 110-year old PLC pole, restored and reinstalled in Indian Village HD. Note cast iron base, wood shaft, foot pegs.

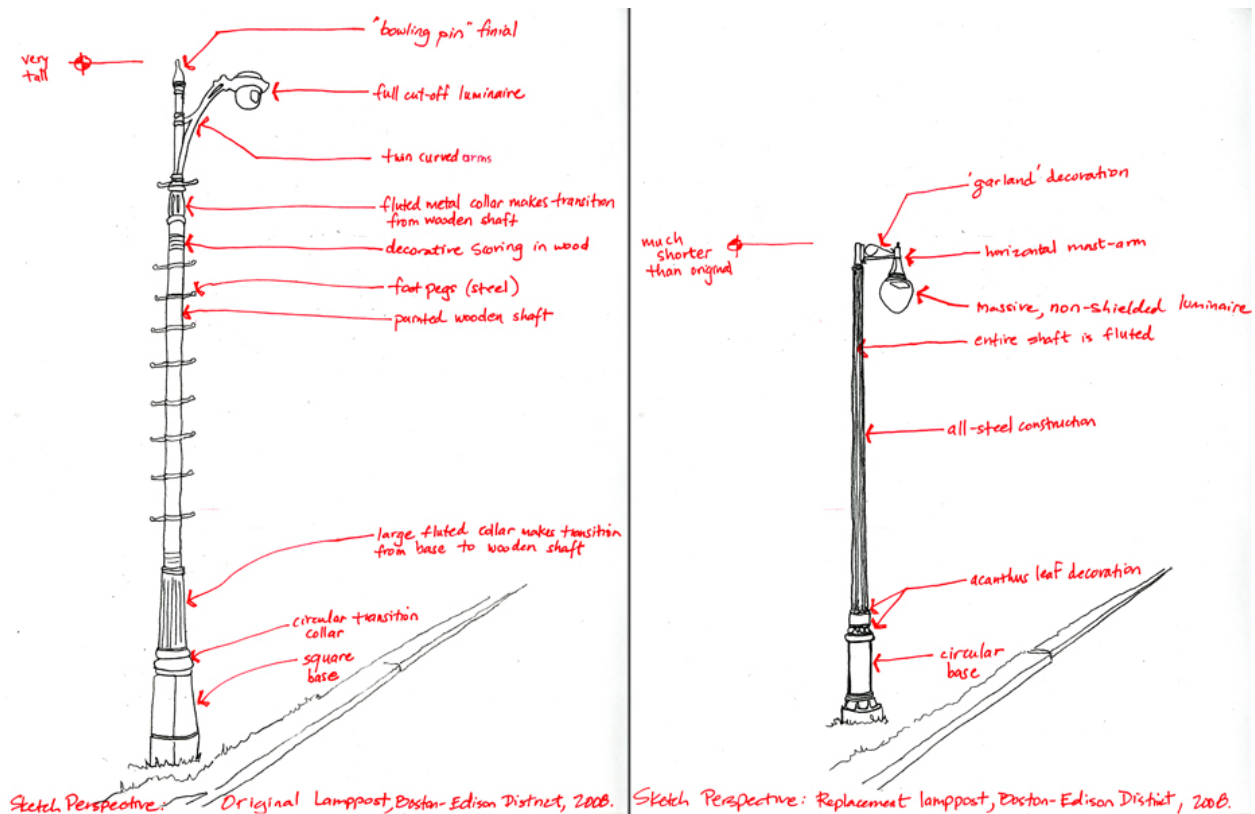
Sketch images prepared by the author, circa 2008, during the replacement campaign in Boston-Edison. While some details may be incorrect, the general comparison presented is between the original poles (left) and the existing (right) fiberglass units.

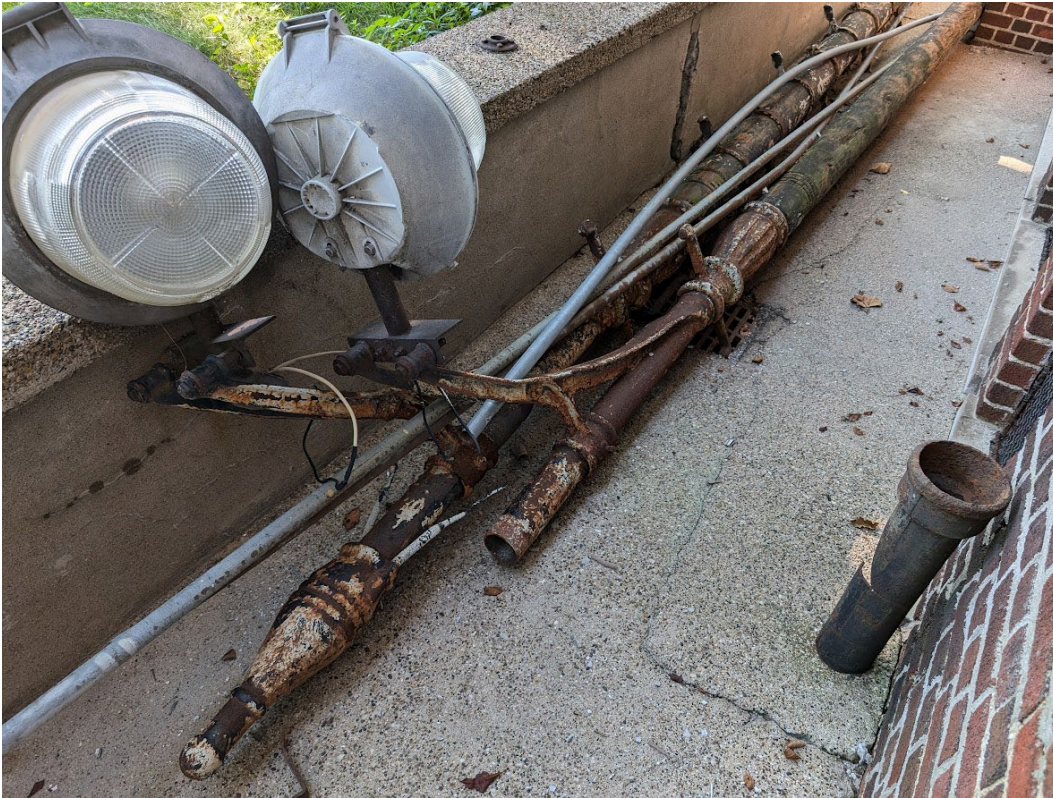
An image in HDC files of the original Boston-Edison PLC poles, salvaged after removal circa 2008. Exact date/location unknown.
