STAFF REPORT: AUGUST 14, 2024 REGULAR MEETING

APPLICATION NUMBER: HDC2024-00400

ADDRESS: 1971 CHICAGO

SCOPE: REPLACE WOOD WINDOWS WITH VINYL WINDOWS

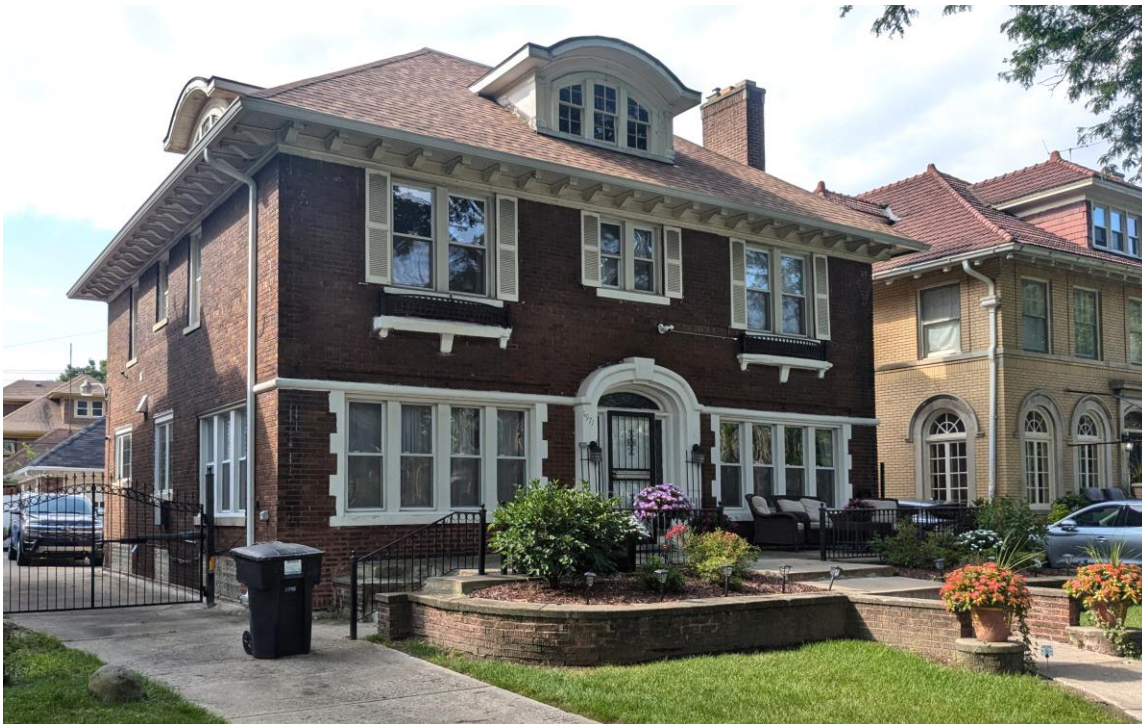
July 2024 photo by staff.

Vinyl windows on the first and second floors, installed without approval, received a Notice of Denial and Order dated August 10, 2000 (original shutters had already been removed prior to this time, also without approval). According to that document, “the Commission hereby orders a remedy to duplicate the original muntin pattern on the vinyl windows or the windows returned to wood to match the original.” The required work has not yet been performed.

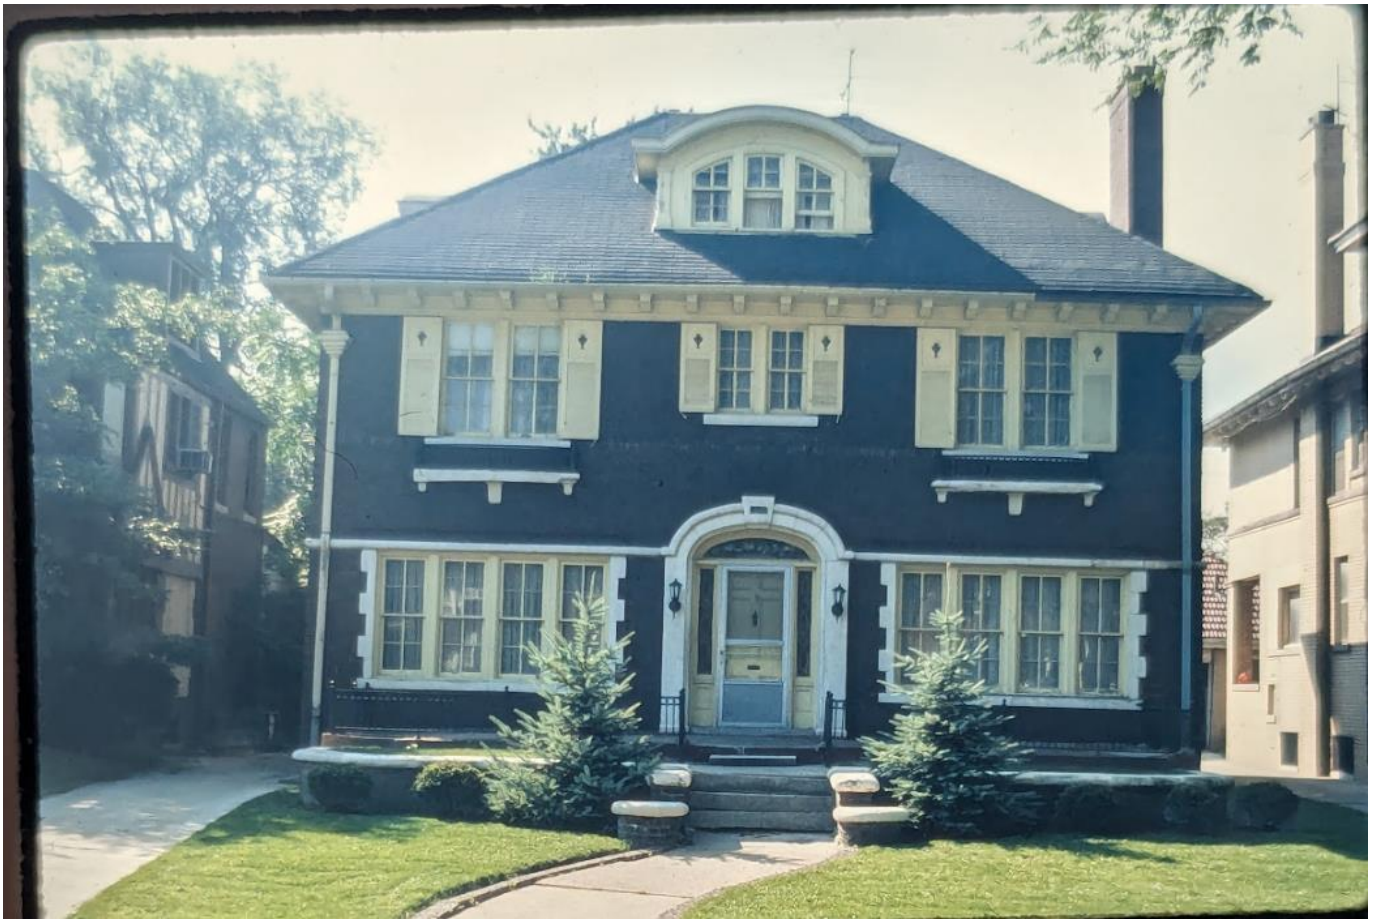
1974 photo by the Historic Designation Advisory Board. Note character-defining four-over-four windows since replaced without approval.

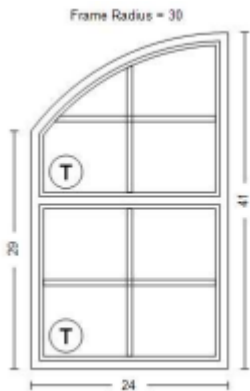
Example replacement window, per submitted window schedule.

The proposed new windows would be single-hung, sash windows in white vinyl, with simulated divided lites.

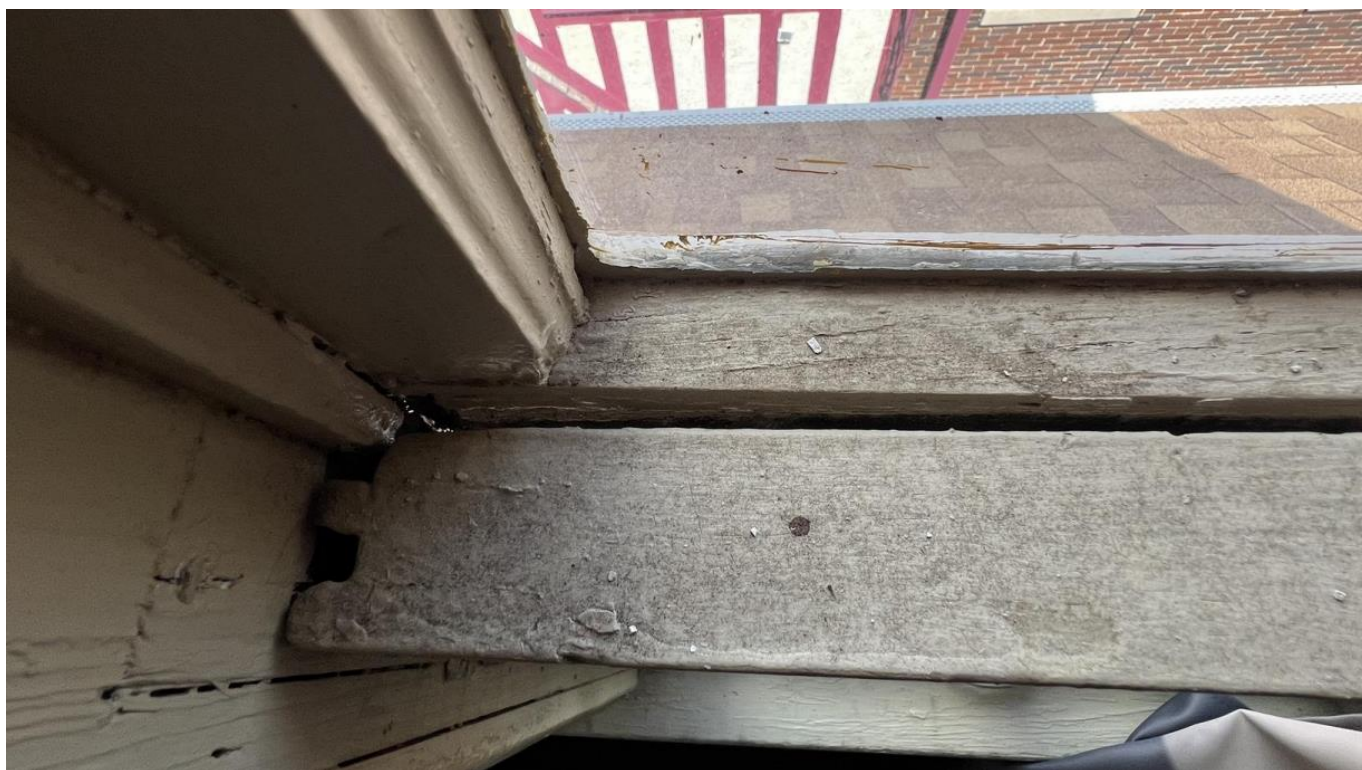
- The applicant states that there is deterioration to the windows, noting “rotten wood” and that they “no longer open and close all the way.”
- Photos provided with the application show additional, relatively minor, deterioration, such as peeling paint and missing sash cords. Photos also show that the windows seem to have been painted over several times, a condition that will impair their operation.

Photo from application showing peeling paint and missing sash cord.

- The deterioration noted above constitutes typical maintenance needs of old windows and is repairable (John H. Myers, “The Repair of Historic Wooden Windows,” Preservation Brief 9, (National Park Service Technical Preservation Services), <https://www.nps.gov/tps/how-to-preserve/briefs/9-wooden-windows.htm>). Any areas of damaged wood appear, to staff, to be minor and localized, and also repairable. Thus, the windows do not seem to meet the standard of being “deteriorated beyond repair,” the standard required for their replacement under the Secretary of the Interior’s Standards for Rehabilitation (quoted in full below).

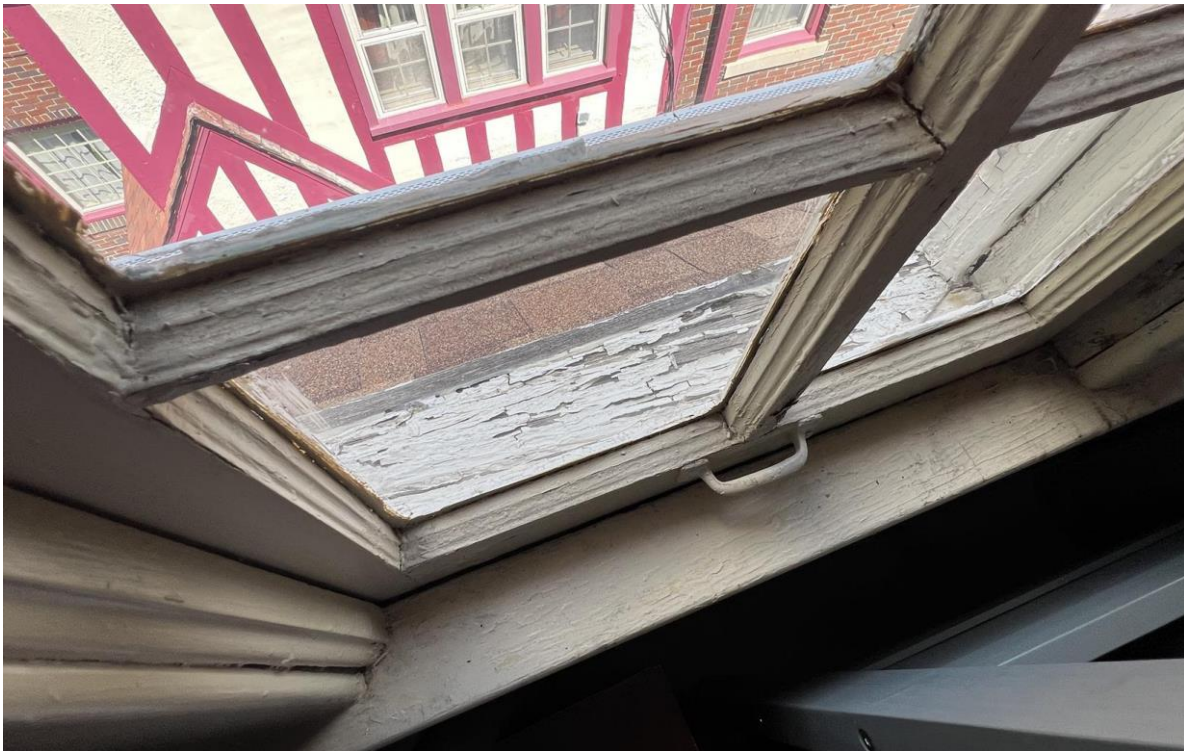
Photo from application showing peeling paint.

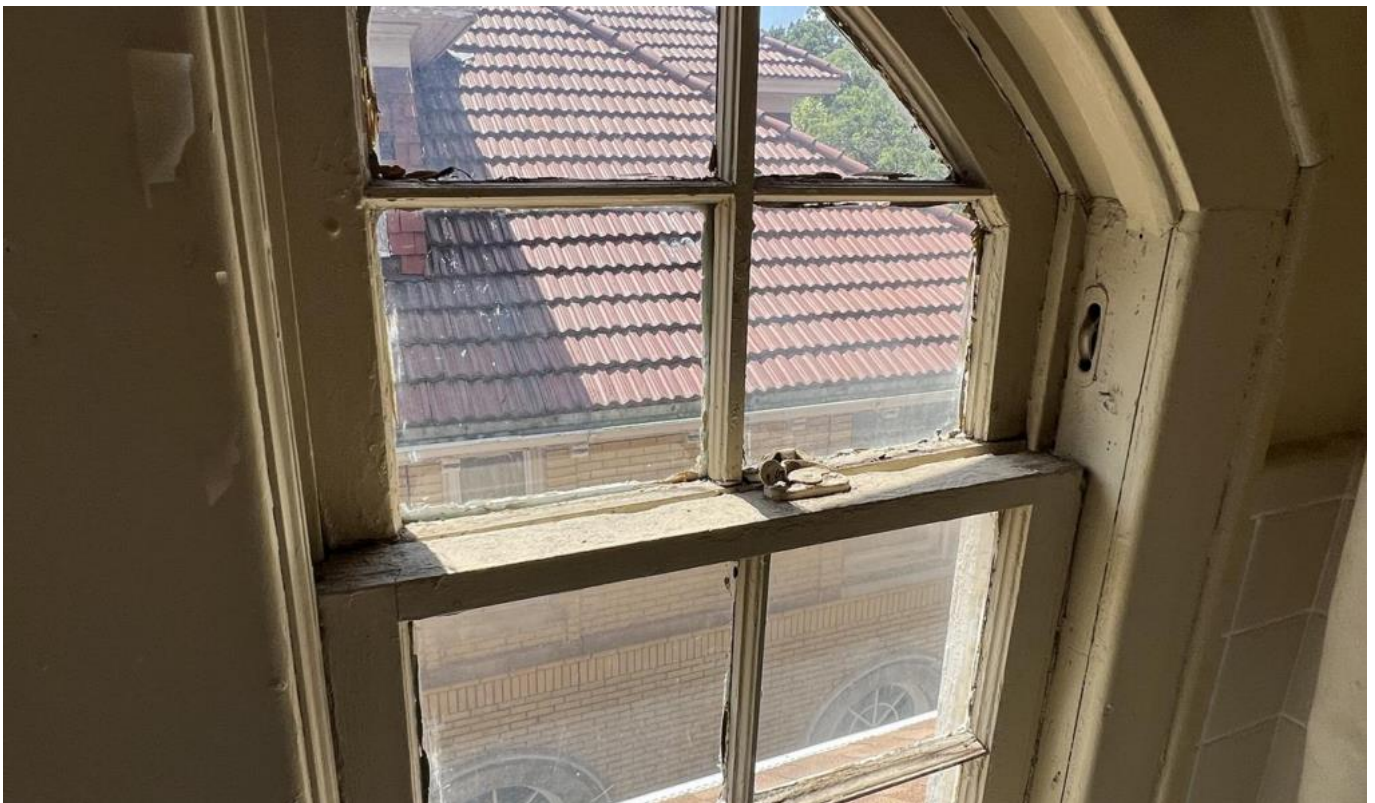
Photo from application showing peeling paint and missing sash cord.

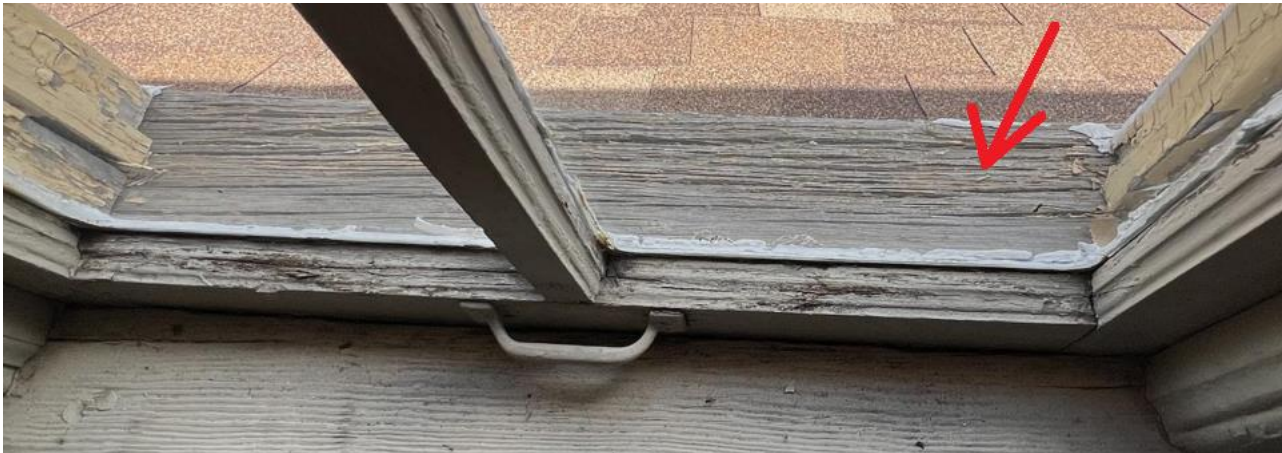
- As an additional note, more extensive deterioration to exterior sills is visible in application photos. However, repair or replacement of these elements is not part of the proposed scope; replacement would require a separate application to the Historic District Commission.

Application photo showing deterioration of sill; cropped by staff with arrow added.
