STAFF REPORT: 8/14/2024 REGULAR MEETING
APPLICATION NUMBER: HDC2024-00404
VIOLATION NUMBER: 912
ADDRESS: 677 W. CANFIELD
HISTORIC DISTRICT: WEST CANFIELD
APPLICANTS/ PROPERTY OWNER: MATTHEW ALLEN FLESZAR
DATE OF PROVISIONALLY COMPLETE APPLICATION: 07/22/2024
DATES OF STAFF SITE VISITS: 06/26/2024, 7/25/24

SCOPE: ALTER REAR DOOR AND WINDOW OPENINGS AND REAR PORCHES (WORK COMPLETED WITHOUT APPROVAL)

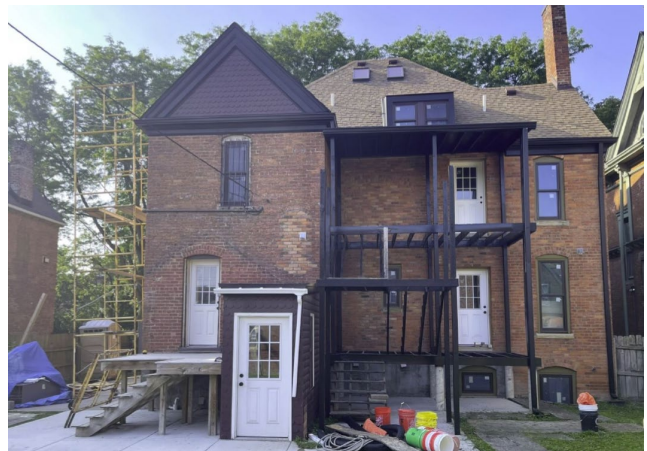
Site Photo 2, by Applicant July 2024: (South) rear elevation showing current conditions.

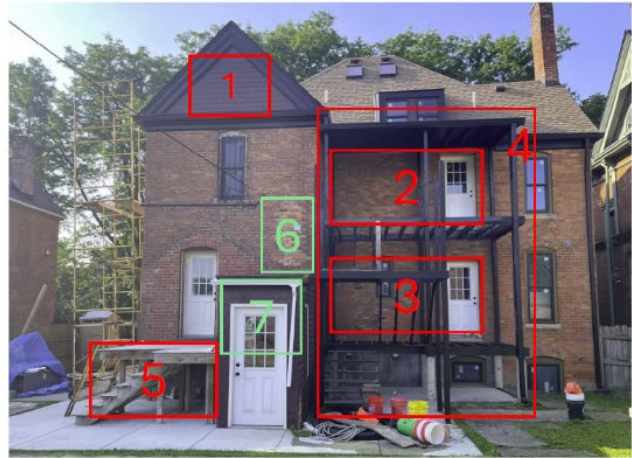
- 1) Replace filled-in gable window
- 2) Modify 2nd floor apartment window & door layout
- 3) Modify 1st floor apartment window & door layout
- 4) Extend deck/balcony footprint
- 5) Modify porch steps

- 6) (June 2020 COA) 1 ½ floor window filled-in w/ brick
- 7) (August 2020 COA) basement stairwell structure

Figure 1, by Applicant, July 2024: (South) rear elevation location showing locations of work: red and gold boxed areas are included in this proposal, the green boxes indicate previously approved work and are excluded from this application.

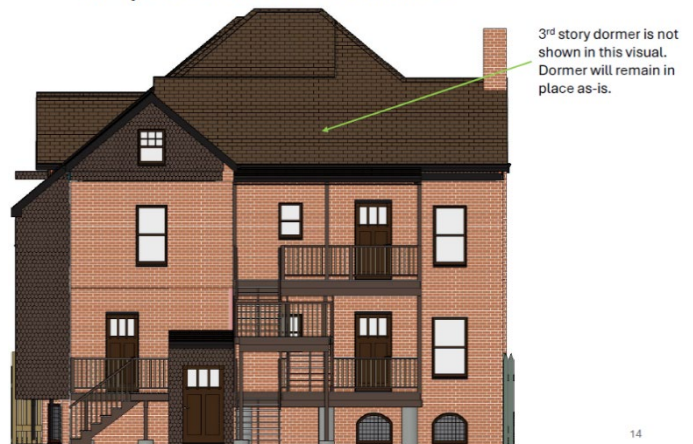
Figure 2, by Applicant, July 2024: (South) rear elevation, showing proposed outcome. Note that the missing 3rd story dormer is a drawing error confirmed by the applicant.

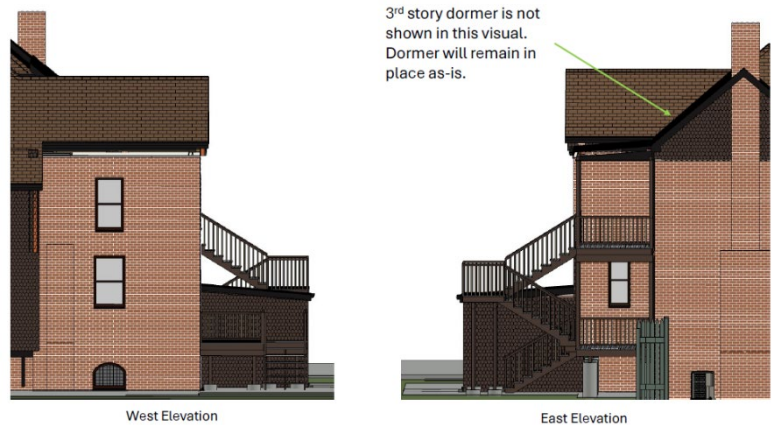
Figure 3, by Applicant, July 2024: (South) rear elevation side views, showing proposed balcony and stair footprints. Note that the missing 3rd story dormer is drawing error confirmed by the applicant.

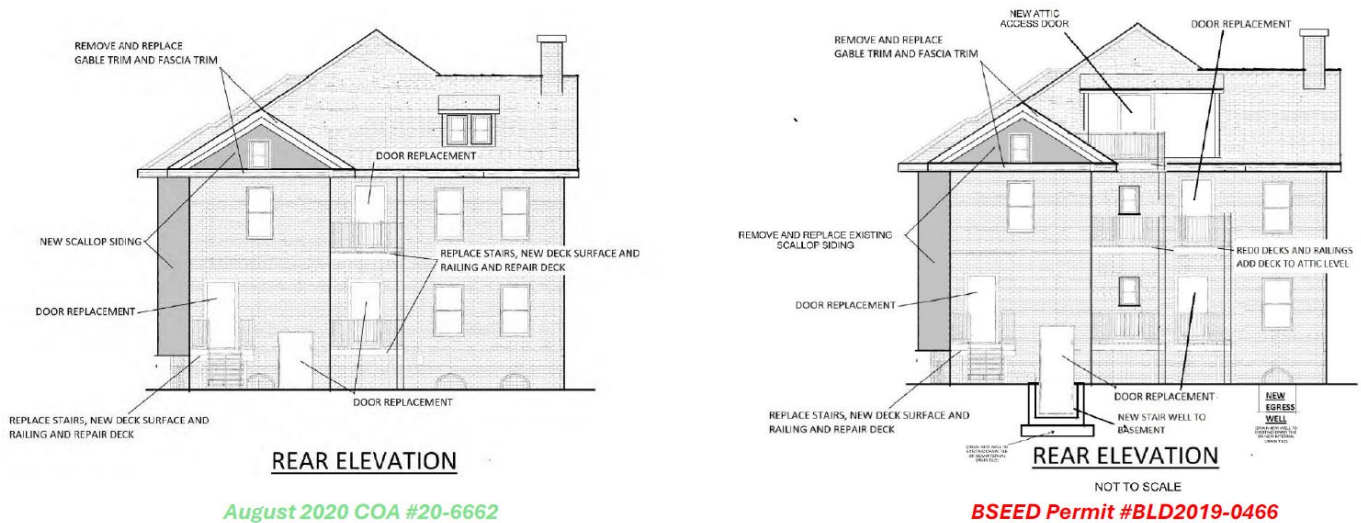
Figure 4, by Applicant: (South) rear elevation drawings comparing previously approved 2020 COA and BSEED permit, which was not approved by the Commission. Please note that the 3rd story alterations to the dormer and balcony were not constructed but the alterations to the door and windows, basement access, and extension of the rear balcony footprint is underway. This is NOT the final proposed drawing but indicates the progression of changes in the drawing concept over time.

- In October 2020, a permit was issued in error by BSEED (see BLDG19-04662, figure 4) without HDC review. Staff requested information from BSEED and received the response that this permit was also certified under BLDG2021-02018. Under both permit numbers these drawings reference the 2020 HDC COA (#20-662), but the drawings of both rear elevations do not match. BSEED’s Supervisor of Plan Review offered the explanation that at the time of this application BSEED would process permits if there was a COA on file, but currently they require sign-off by HDC staff regardless of having a COA or not.

- The BSEED approved drawing shows a 3rd story alteration: the dormer is changed into an attic door with the balcony extending to this higher level. This drawing also shows the unapproved extension of the rear balconies and the alterations of door and window openings at the 1st and 2nd floors and a new egress basement stairwell. This work has started but not completed except for the 3rd story elements (never constructed). This 3rd story change is NOT in this proposal. Instead, the roof line over the second story is proposed to be extended to cover the rear balcony extension, leaving the rear dormer in place. Staff received confirmation from the applicant that this dormer will remain, even though the proposed drawing shows that it is missing as noted in the applicant’s final proposal. (See figures 1, 2, 4 and site photo 2.)

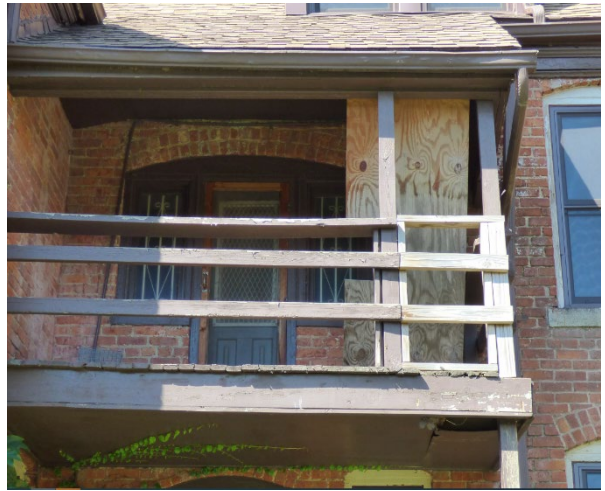
- As stated in the Elements of Design cited above, brick detailing is characteristic of this historic district. It is staff's opinion that the brick detailing above the arched windows and door openings are historic, distinctive character-defining features. Arches have been replaced with a rectilinear form with the replacement of windows to door openings in areas 2 & 3 (See figure 1, photos 2, 3-5.) In these areas smaller windows are placed where they appear to have impact where some of the arches remain, thereby impacting this distinctive character defining feature.

Site Photo 3, by Applicant, date unknown: (South) rear elevation, showing original arched brick detailing over door and window openings.

- The original openings and historic brick detailing of the door and window archways be preserved or restored when filled in with brick or replaced with a new window or door.

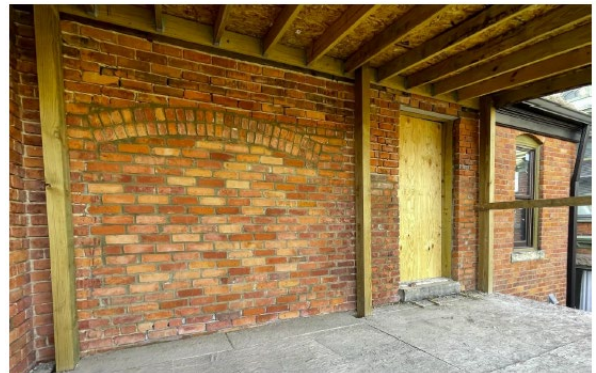
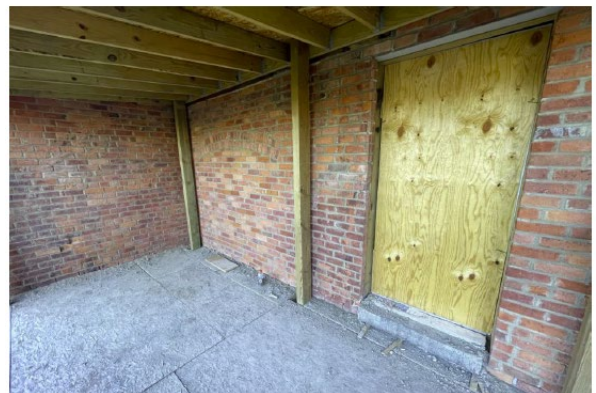
Site Photos 4&5, by Applicant, 2024: (South) rear elevation, showing remains of arched brick detailing over door and window at second floor (area #2, shown in figure 1).

- It is staff's opinion that the brick detailing above the arched windows and door openings are historic, distinctive character-defining features. The original openings and arches over the windows at the rear 1st and 2nd floors have been replaced with door openings that have removed historic features that characterize this property. Additional smaller proposed windows appear to be located at areas where some of these brick arches remain. It is staff's opinion that this proposal in its current state is not in compliance with National Park Service Standards 2, 3, 4 and 5. However, it is staff's opinion that these features could potentially be retained or restored. (See figure 1, photos 2, 3-5.)
