STAFF REPORT: 09/11/2024 REGULAR MEETING

APPLICATION NUMBER: HDC2024-00425

ADDRESS: 1474 W. BOSTON

SCOPE: REPLACE WOOD WINDOWS WITH ALUMINUM-CLAD WOOD WINDOWS

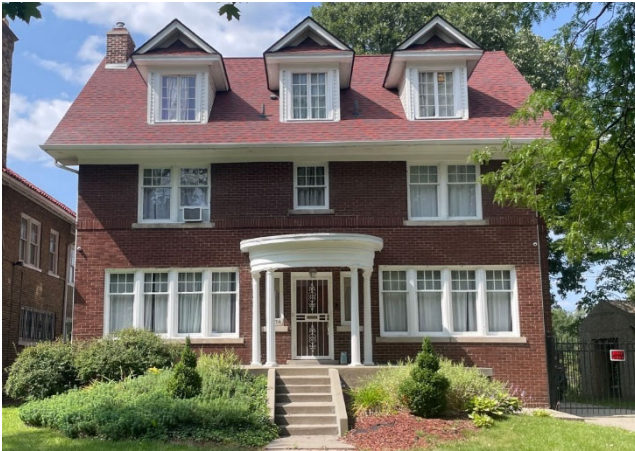
Site Photo 1, by Staff Aug. 22, 2024: (South) front side showing original wood windows still in place.

- The front upper story and the east side windows are particularly visible from the public and are proposed for replacement with aluminum clad-wood windows. Except for the front dormer windows, which are 2/4 wood casements, the other front windows are 6/1 cottage windows. The side wall has 6/1 double-hung wood windows. All windows have true divided-light mullions. It is staff’s opinion that all of these true divided-light windows are distinctive, character-defining features. Their loss would substantially detract from and destroy the historic appearance of the building. (See photos 1-4)

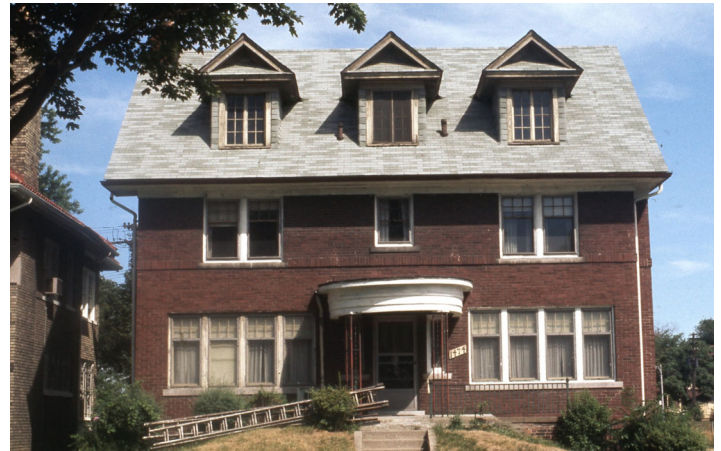
Site Photo 2, designation photo 1974: (South) front side showing original wood, double-hung windows with true divided light.

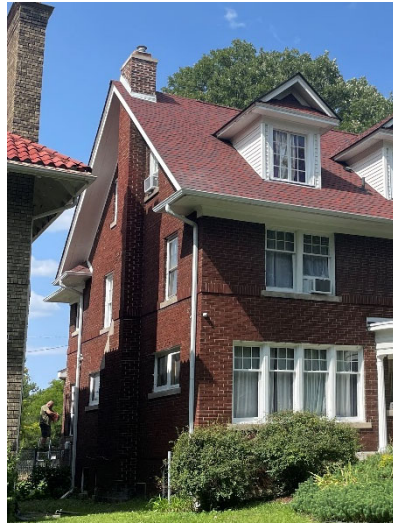
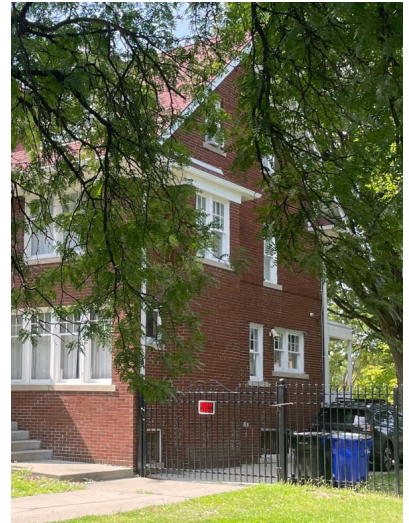
Site Photos 3&4, by Staff Aug 22, 2024: West and East sides, showing original wood windows.

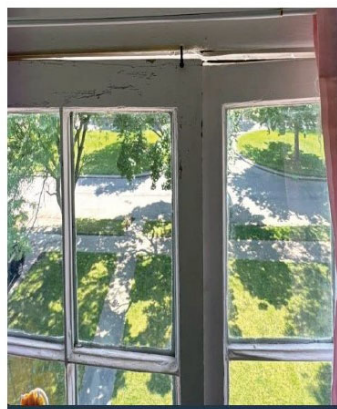
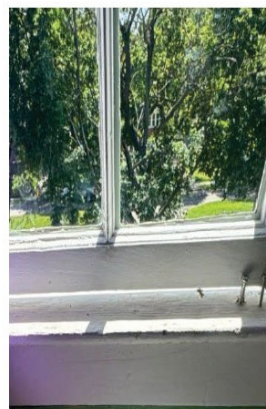
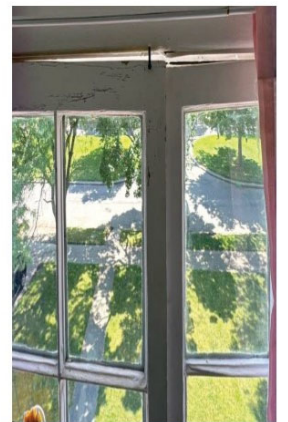
Figure 1, by Applicant: (South Interior 3rd Floor casements) front interior casement windows proposed to be replaced with double-hung, aluminum-clad wood windows.

windows are shown in previous photos, such as the designation photo (See site photo 2). Furthermore, the photos shown by the applicant, reveal that the windows are repairable.

- Photo documentation establishes that the condition of the original wood windows is repairable and not beyond repair.
- No repair estimate was provided.
- It is staff's opinion that the removal of the original wood windows with true divided light and in 3 windows a change from casements to double-hung windows greatly alters the original *scale, design, and materiality* of the building's fenestration and the new windows are incompatible and inappropriate for this historic property. Therefore, this work item does not meet the Secretary of the Interior's Standards for Rehabilitation and does not conform to the district's Elements of Design.

Staff therefore recommends that the Commission issue a Denial for the above work items, as it do not meet the Secretary of the Interior's Standards for Rehabilitation, specifically Standards:

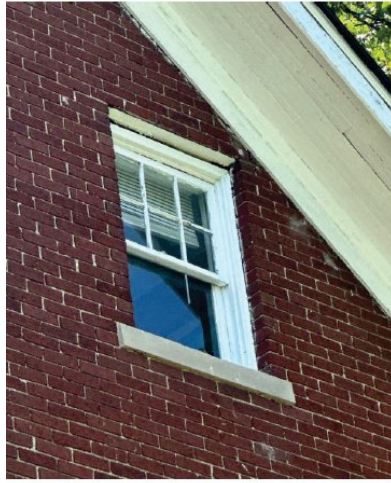
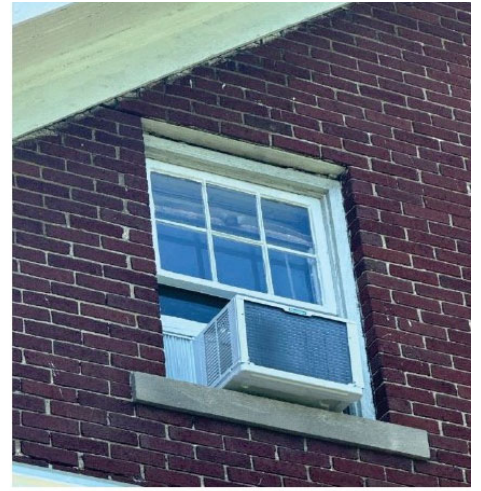
Figure 2, by Applicant: (east) side elevation showing proposed 2nd floor windows for replacement with aluminum clad wood windows.
