STAFF REPORT: 09/11/2024 REGULAR MEETING

APPLICATION NUMBER: HDC2024-00435

ADDRESS: 4031 FULLERTON

SCOPE: REPLACE STEEL SASH WINDOWS WITH COMPOSITE WINDOWS

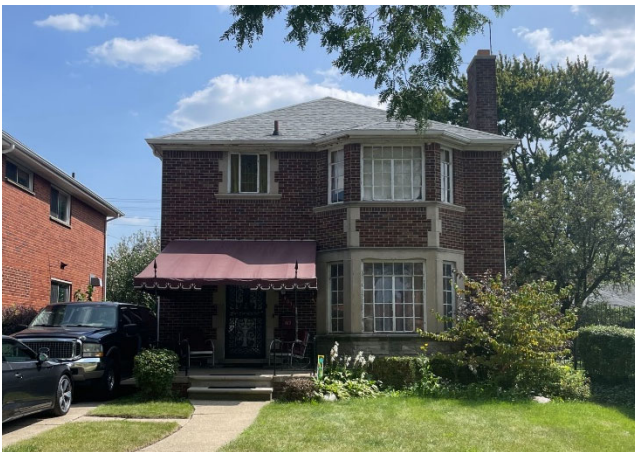
Site Photo 1, by Staff Aug 22, 2024: (North) front showing original windows still in place.

- The front and the west side windows are particularly visible from the public and are proposed for replacement with fibrex windows. It is staff's opinion that these true divided-light, steel casements are distinctive character-defining features. Their loss would substantially detract from and destroy the historic appearance of the building. (See photos 1-2, Figs 1-4)

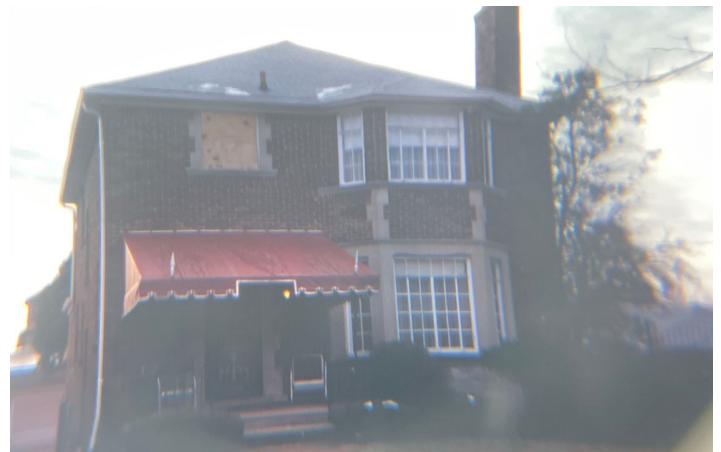
Site Photo 2, designation slide 1999: (North) front showing original steel sash casements with true divided light.

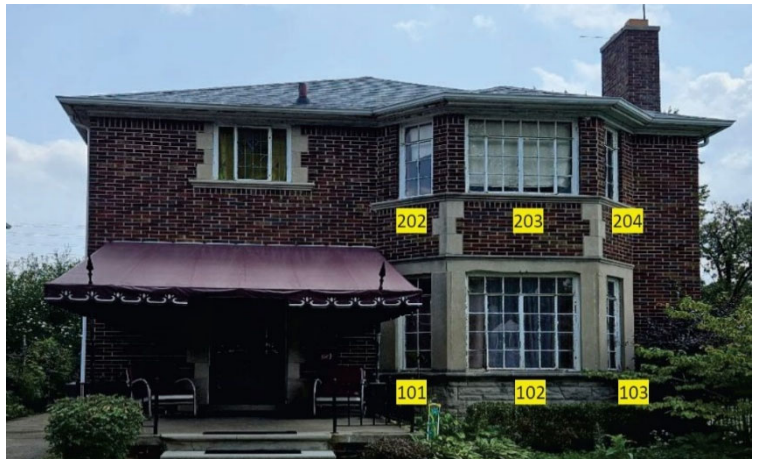
- Front (north), (Windows numbered 101-103, 202-204, *See fig. 1*): Replace six (6) steel casements with Anderson Renewal composite fixed and casement windows. The transoms and sidelights of the existing windows will be replaced with full operational casements at the side bays (101, 103, 202, and 204), whereas the casements, transoms and sidelights of the front facing windows will be replaced with fixed windows.
- Rear (south) (Window numbered 108, *See fig. 2*): Replace one (1) steel casement with Anderson Renewal composite casement window. The transoms and sidelights of the existing window will be replaced with full operational casement, with 4x4 configuration.

Fig 1, by Applicant, 2024: Front (North) showing proposed window replacement locations.

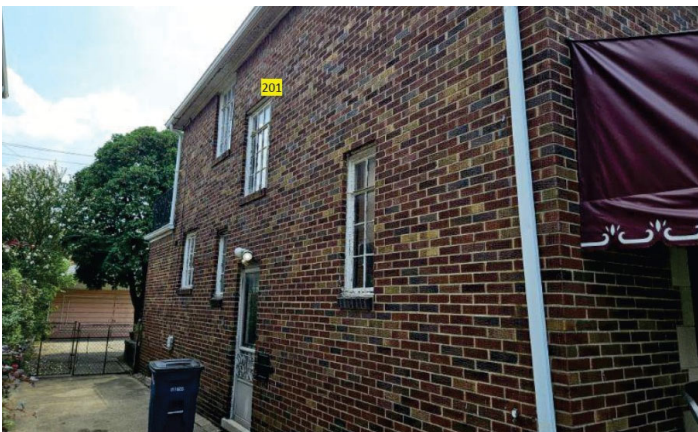
- Side (east) (Window numbered 201, *See fig. 3*): Replace one (1) steel casement with Anderson Renewal composite casement window. The transoms and sidelights of the existing window will be replaced with full operational casement, with 4x4 configuration.

Fig 3, by Applicant, 2024: Side (East) showing proposed window replacement location.

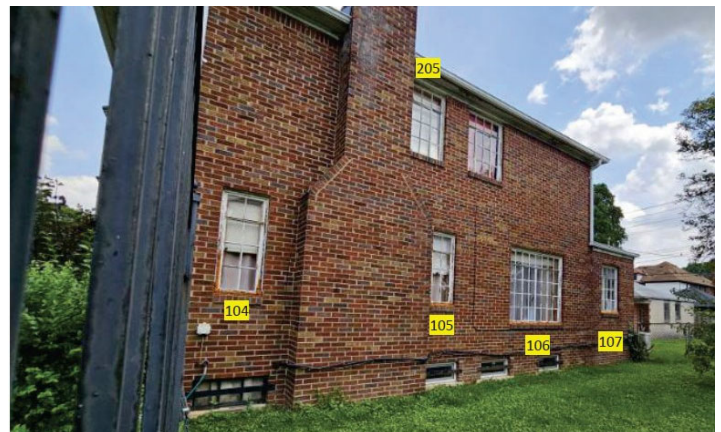
- Side (west) (Windows numbered 104-107, 205, *See fig. 4*): Replace five (5) steel casements with Anderson Renewal composite fixed and casement windows. The transoms and sidelights of the existing windows will be replaced with full operational casements with no transoms or sidelights.

Fig 4, by Applicant, 2024: Side (West) showing proposed window replacement locations.

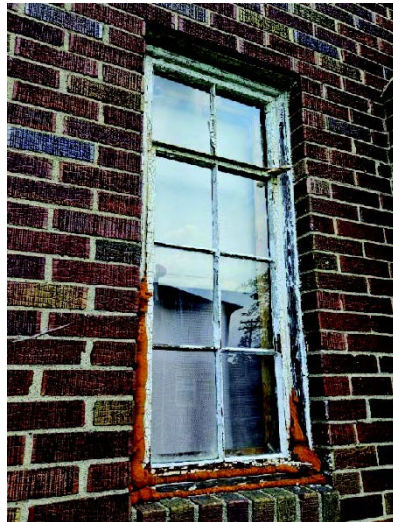
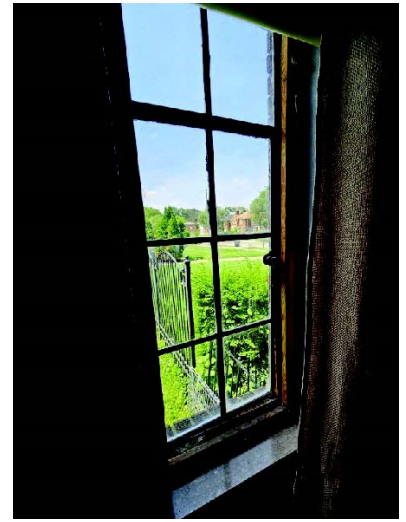
Figures 4&5, by applicant 2024: Window #104, west side, showing casement window condition with foam applied to exterior.

- Staff reviewed the exterior and interior photos of the casements provided by the applicant. Although there does appear to be some corrosion along the west elevation windows where spray foam was applied to the exterior, staff does not see evidence that these or any of the other casements are beyond repair. Wire brush cleaning of the area, along with replacement of glass panes where needed, the replacement of operation cranks, and similar work appear to be within a reasonable range of repair.

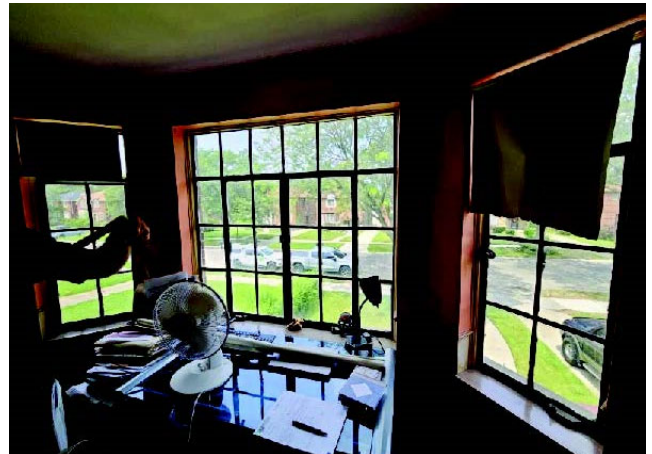
Figure 6, by Applicant: Windows 202-204, (North Interior, 2nd floor) Interior casements proposed to be replaced with fibrex windows.

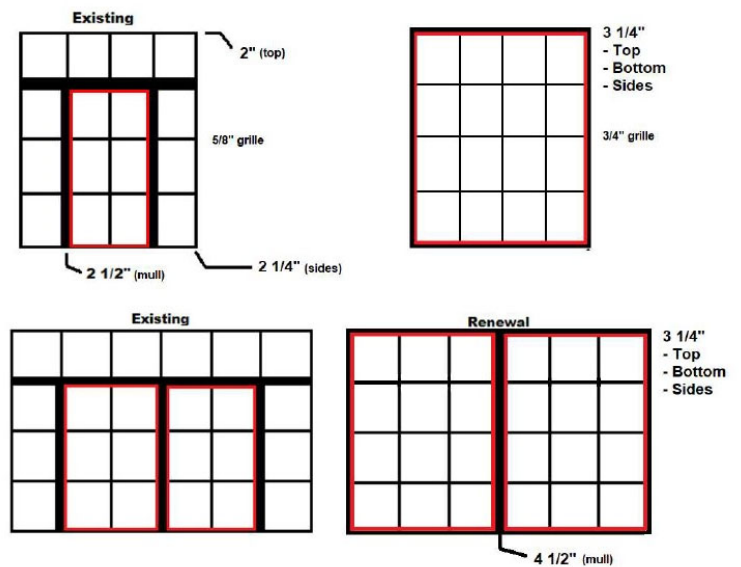
- Staff requested dimensions for the proposed casements and received the comparison of the existing and proposed mullion dimensions (see fig. 7) and the section dimensions of the proposed casements (See fig 8). Staff observed how these dimensions increase in width, ignore the existing transoms and sidelights, and provide a bulkier appearance in the head and jamb.

- Alter the operator frame location, width and depth dimensions.
 - Slight differences in the dimensions of the muntins and frame has a noticeable effect on the overall character of the window. These proposed changes are noticeably larger, increasing the top frame dimension, for example, from 2" to 3 1/4". (See figures 7&8.)

Figure 7, by Applicant: This illustrates existing (left column) and proposed (right column) dimensions of the mullion pattern for the casements

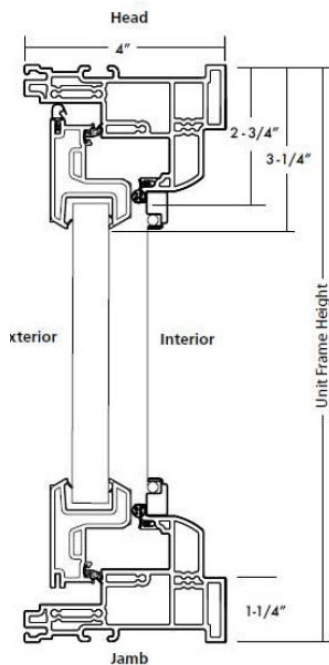
Figure 8, by Applicant: Sectional dimensions of the proposed casement's head and jamb.

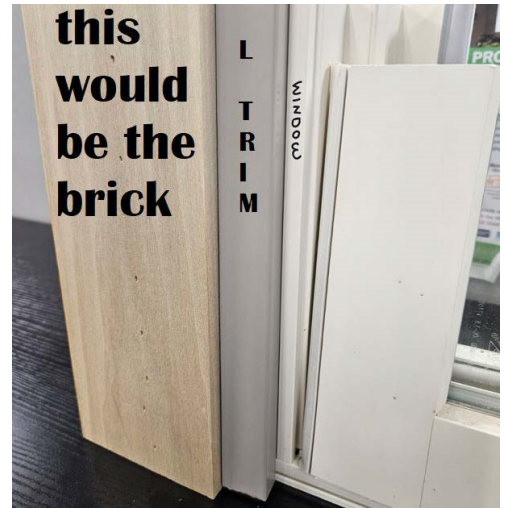
- Staff received confirmation that the brick mould would be removed and an aluminum or fibrex "L trim" (see fig.9) be installed between the window opening and the new casements. This L trim does not meet NPS guidelines, which necessitates that any replacement of steel sash windows with a new frame should be of minimal dimension.

Figure 9, by Applicant: This is a mock-up to illustrate the use of the "L-Trim" aluminum coil stock that would be set between the window and brick opening.
