**STAFF REPORT:** 09/11/2024 REGULAR MEETING

**APPLICATION NUMBER:** HDC2024-00437

**ADDRESS:** 1501 ATKINSON

**SCOPE:** REPLACE WINDOWS WITH VINYL WINDOWS, REPLACE DOORS, ALTER FRONT PORCH AND REAR DECK (WORK COMPLETED WITHOUT APPROVAL)

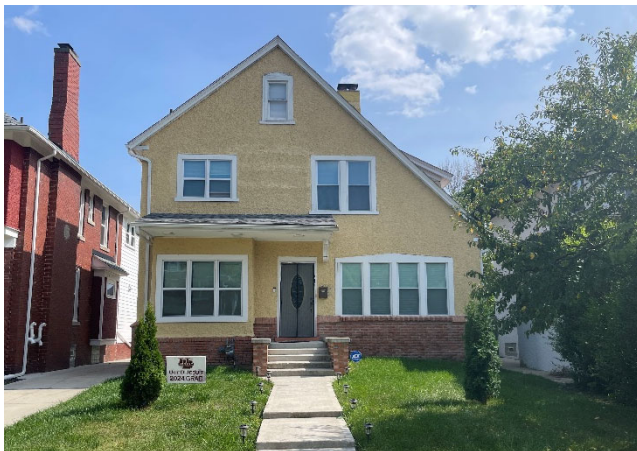
*Site Photo 1, by Staff Aug. 22, 2024: (North) front showing replaced vinyl windows, altered porch and landscape.*

- Staff observed that the lengths of the wood sills and trim at the front face of the house have been slightly lengthened or thickened at the 2<sup>nd</sup> and 3<sup>rd</sup> stories. Also the brick ledge/sill along the first story ribbon of windows has been rotated from a diagonal to more perpendicular angle. It is staff’s opinion that these changes alter the historic narrow features of the window’s trim set against the stucco surface, creating a more square, blocky appearance that greatly alters the distinctive character-defining features of the façade’s fenestration.

- Staff observed from Sanborn maps that neither a front or rear porch were shown as features to the house. (See Sanborn image.)
- It is staff’s opinion that a front roof overhang once occupied the location where the current front roof is located, supported by a bracket (see site photo 1, fig 1&2). While the current construction is located approximately to the original, staff has the opinion that the introduction of a sloped roof at this location, rather than the original, near-flat structure, creates a heaviness and covers more than an appropriate amount of the front face of the façade, thus changing the architecture of the house.

Staff therefore recommends that the Commission issue a Denial for the above work items, as it do not meet the Secretary of the Interior's Standards for Rehabilitation, specifically Standards:

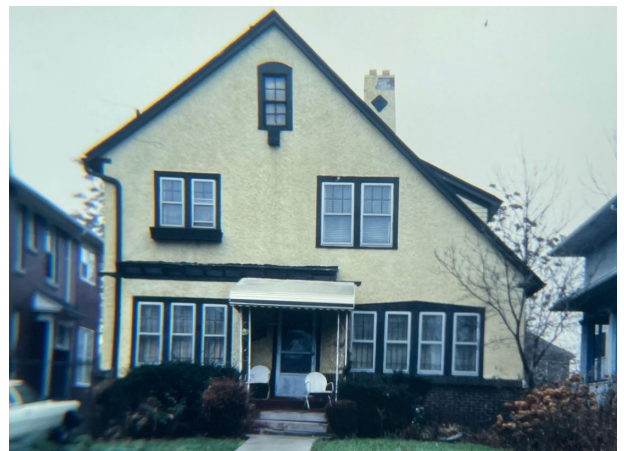
*Fig. 1, Designation image 1980: (North) front showing original windows and porch condition.*

- No documentation of the condition of the original windows was available but staff observed that the wood windows were present until at least 2019 from Google Street View images. (See figures 1&2)

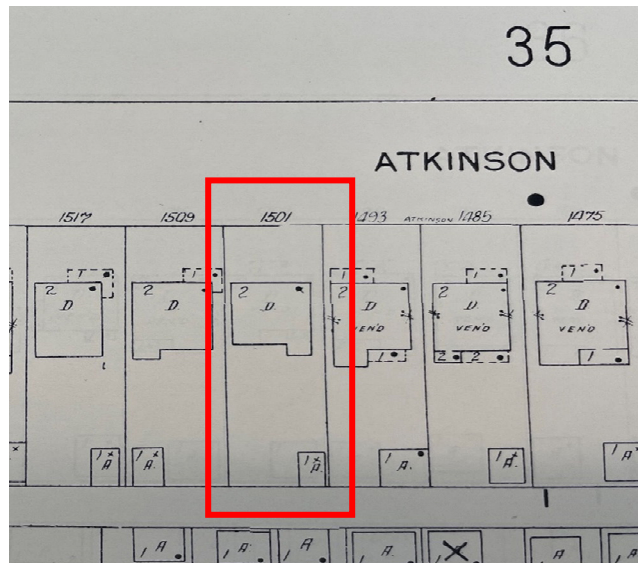
*Sanborn, 1996 Vol 9: showing no prior rear or front porch.*

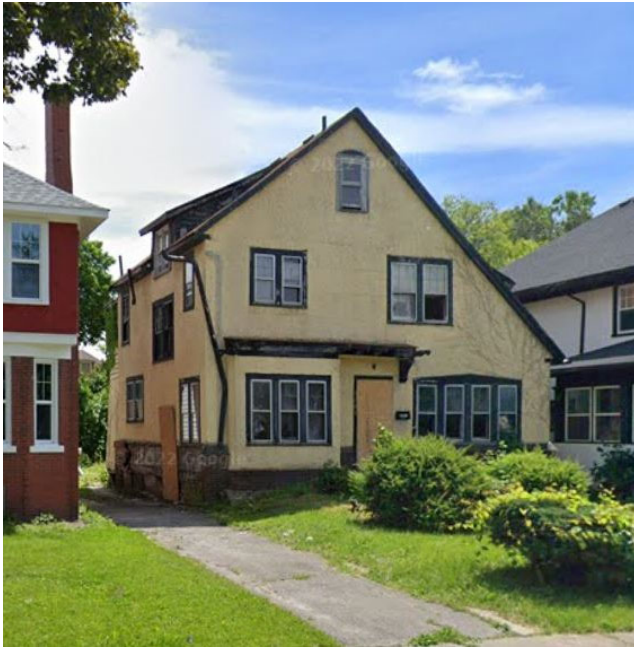
*Fig 2, by Google Street View, June 2019: (North) front elevation showing conditions prior to previous owner.*

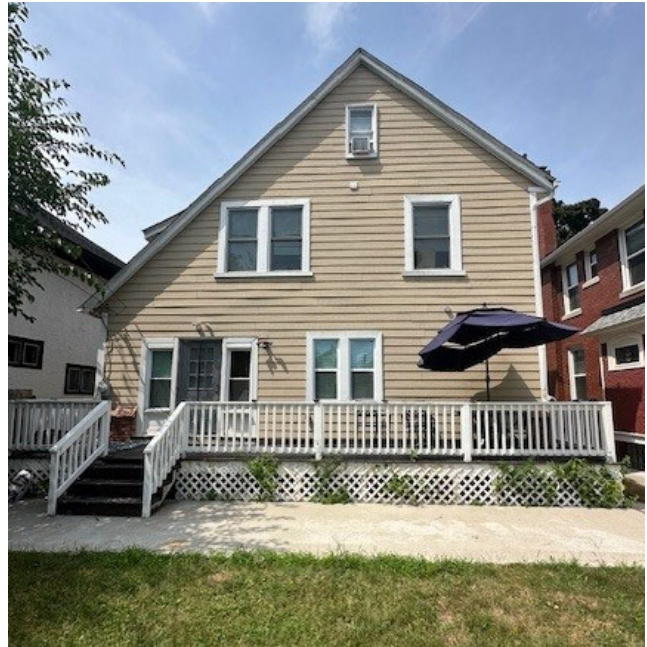
*Site Photo 2, by Applicant: (South) rear side elevation showing replaced vinyl windows, rear deck and concrete pad/walkway.*

- It is staff’s opinion that the newly constructed rear deck, railing and concrete pad/walkway are compatible elements.

It is staff's opinion that the installation of glass block basement windows, rebuilding of the front porch deck, stairs, and walkway, installation of the rear deck and walkway, paint stucco, and replacement of the side door is appropriate. Staff therefore recommends the Commission issue a Certificate of Appropriateness for the work as proposed because it meets the Secretary of the Interior Standards for Rehabilitation and the Boston-Edison District Elements of Design.

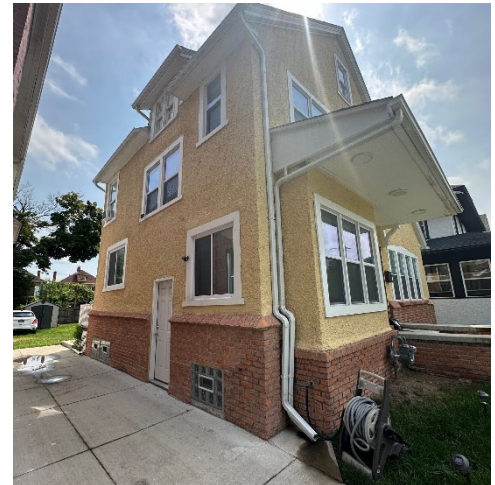
*Site Photo 3, by Applicant 2024: front (north) and side (east) sides, showing front porch roof and replaced windows and side door.*

- Staff received confrimation that the front and side doors are steel. While staff has no issue with the side door, it is staff’s opinion that the vision panel for the front is not appropriate for the design of this house. In the case of the front door, a leaded-glass oval form is inconsistent with the simplicity of the rectilinear fenestration of this house. A rectangular panel wood door with a rectangular vision panel would suffice, in staff’s opinion. (See photo 1 and fig. 1.) Finally, the introduction of black mesh fabric with a center divider further obscures the front door with a material and design that is not appropriate, in staff’s opinion.

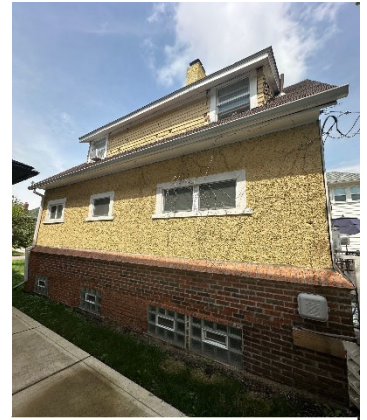
- Although the glass block basement windows did not strictly follow the HDC guidelines by recessing the glass block into the window opening that was once occupied by the historic location of the wood windows, staff has the opinion that the installation at these side basement locations is reasonably appropriate.

*Site Photo 4, by Applicant, 2024: (West) side elevation showing vinyl and glass block windows. (Image is slightly skewed by applicant to fit this tight location in one photo.)*
