STAFF REPORT: 9/11/2024 MEETING

ADDRESS: 1667 EDISON

APPLICATION NO: #HDC-2024-00493

SCOPE: REPLACE WINDOWS & REHABILITATE GARAGE

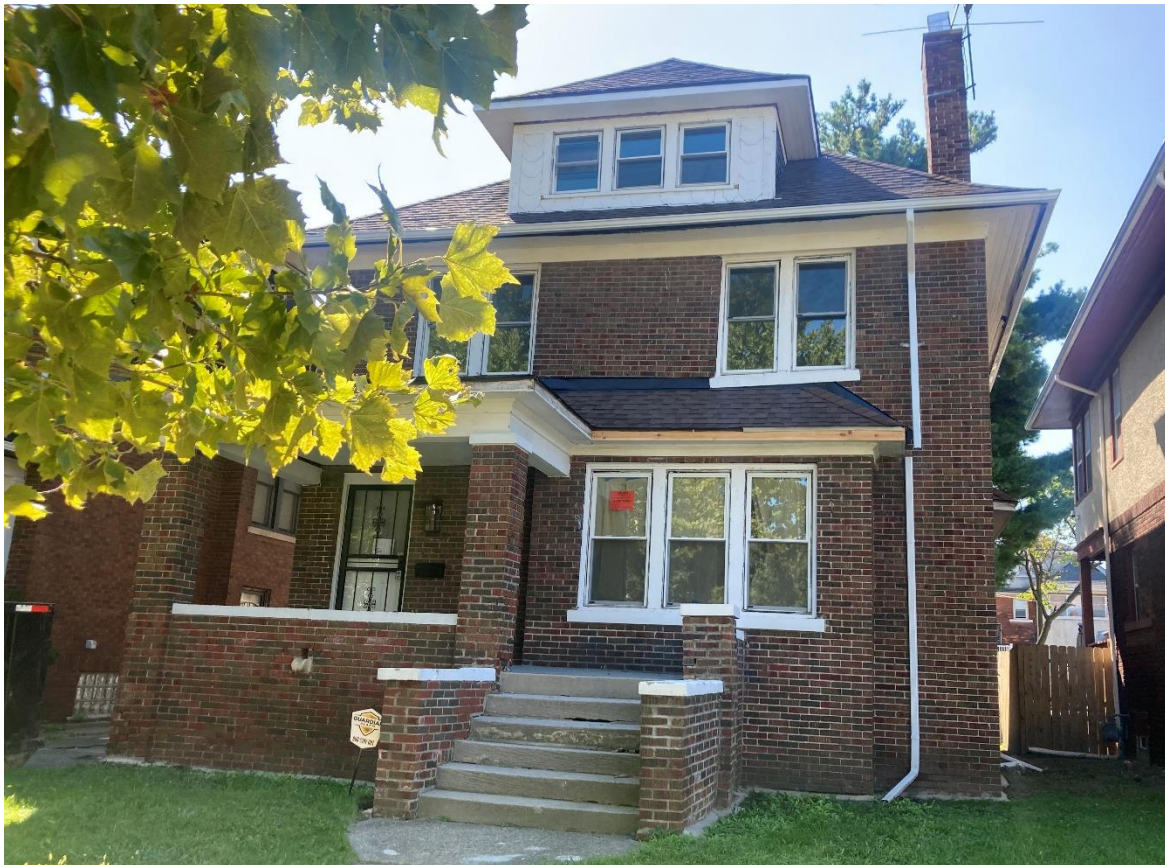
1667 Edison, current appearance. Photo taken by staff on 9/1/2024

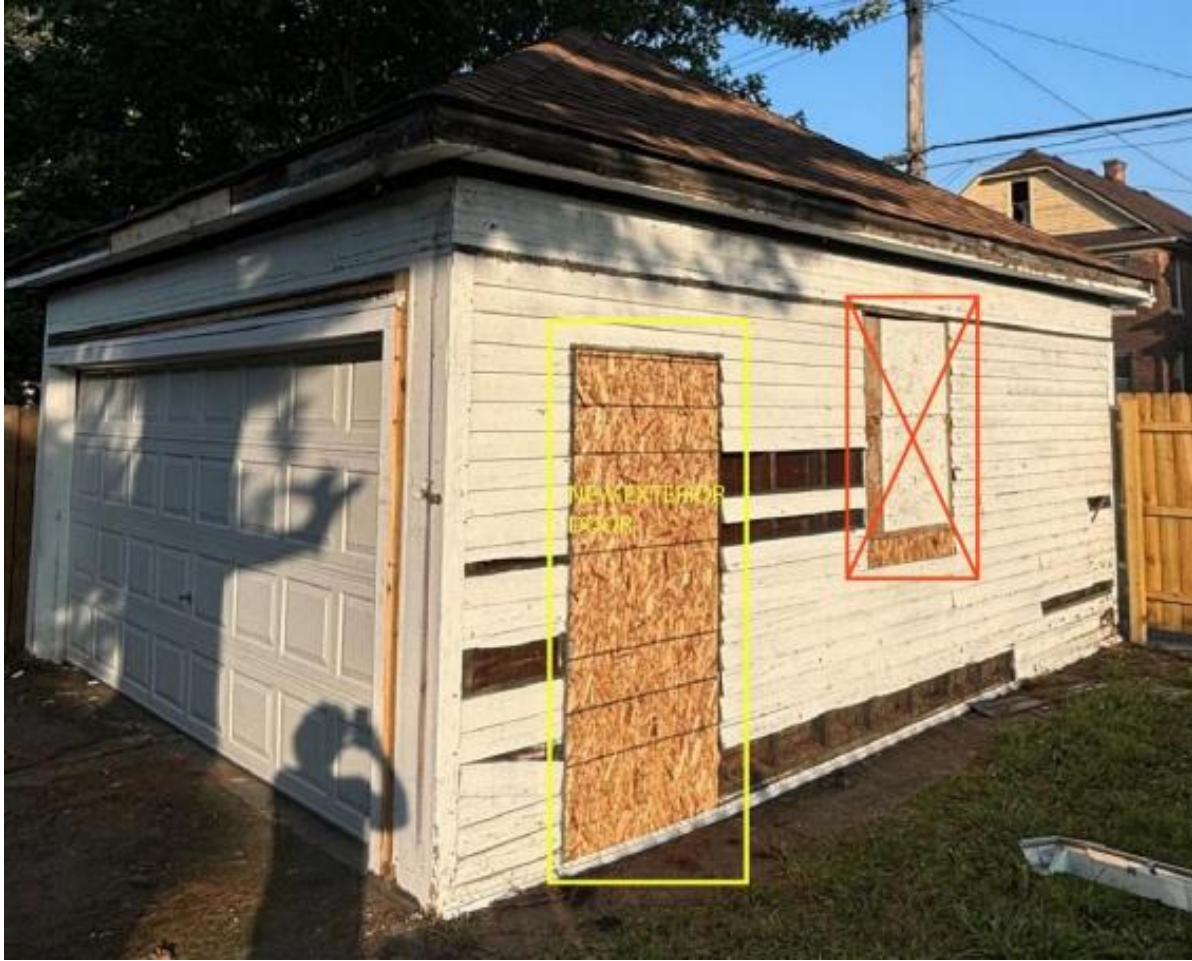
The property's original/historic-age garage currently sits to the rear of the house. The building is rectangular in plan and is topped with a pyramidal, asphalt shingle roof with wood soffits. Exterior walls are clad with wood siding. The west/side wall doors and windows have been covered with plywood. The garage's primary façade displays a non-historic metal overhead door.

1667 Edison, garage, current appearance. Photo provided by applicant

- Repair existing wood siding. Where wood siding is missing, install new wood siding to match existing
- Install new person door at side/west wall in current opening. Door style/material not provided
- Cover existing side/west wall window opening with lapped wood siding to match existing cladding

- HDC staff shall be afforded the opportunity to review and approve the person/pedestrian door which shall be installed at the garage's side wall prior to the issuance of the project's permit.

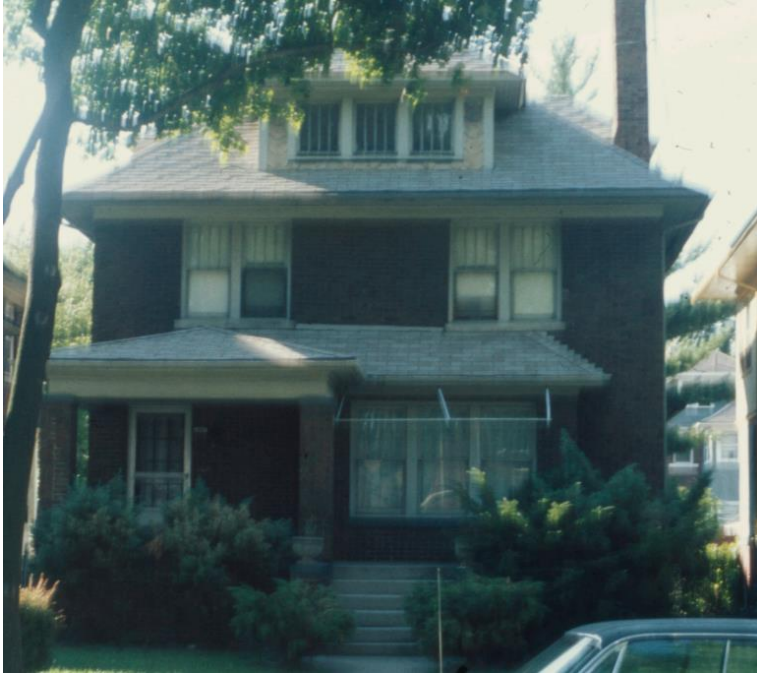
1667 Edison, designation slide, taken by the HDAB in 1974

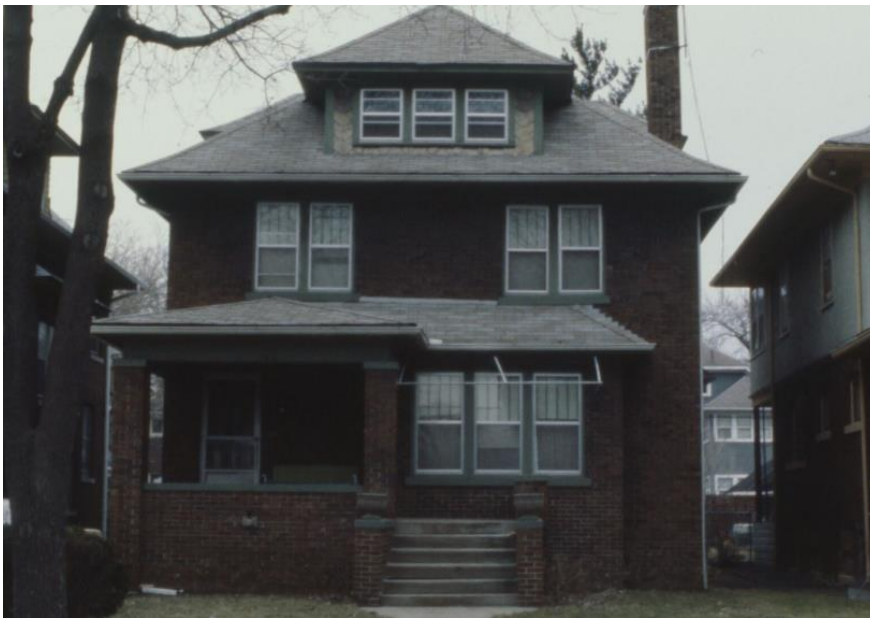
1667 Edison, designation slide taken by the HDAB in 1980. Note that the property has aluminum storm windows. However, all of the original/historic wood windows remained intact behind the storms

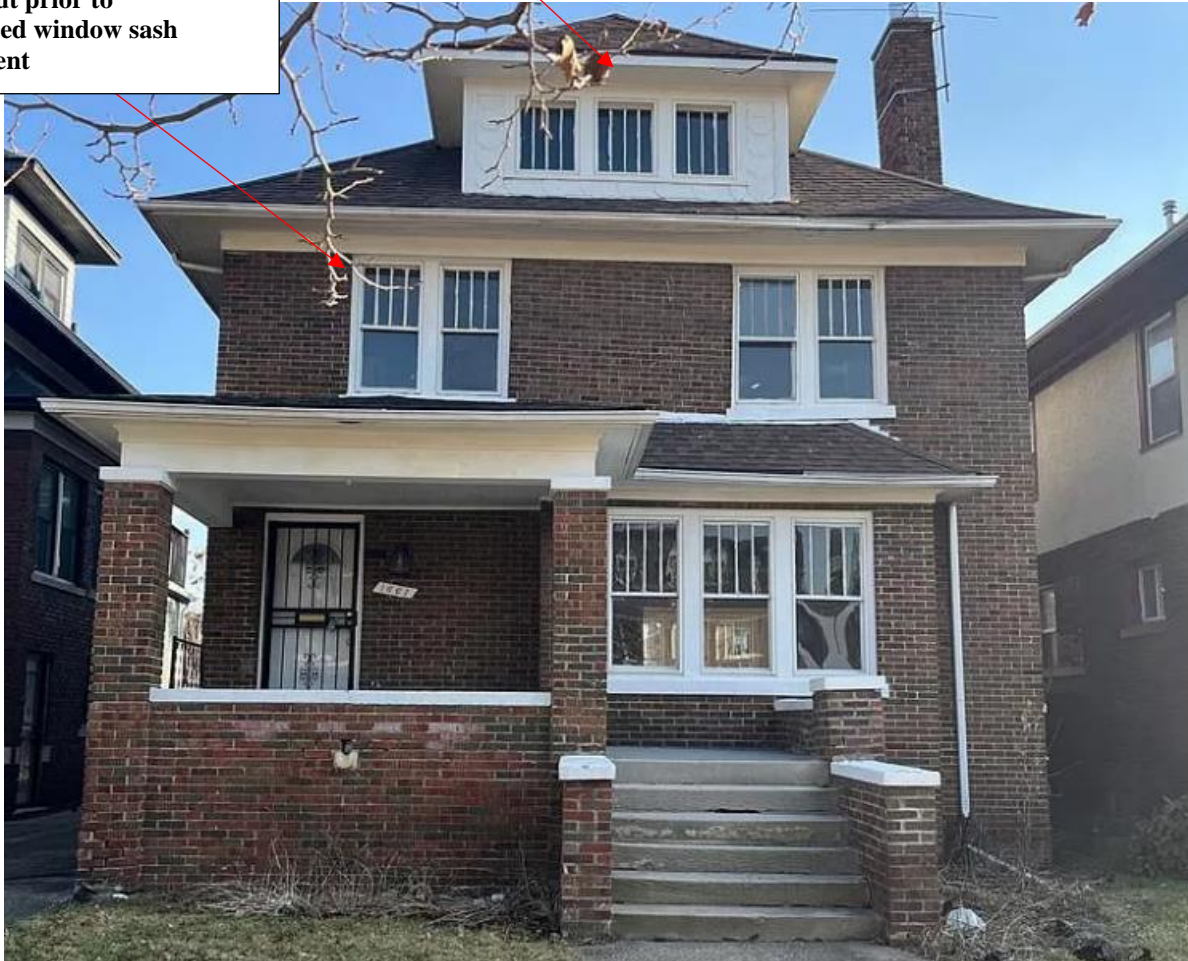
Front façade, photo taken in early 2024 by Realcomp (included in real estate listing) showing condition/appearance before the unapproved work

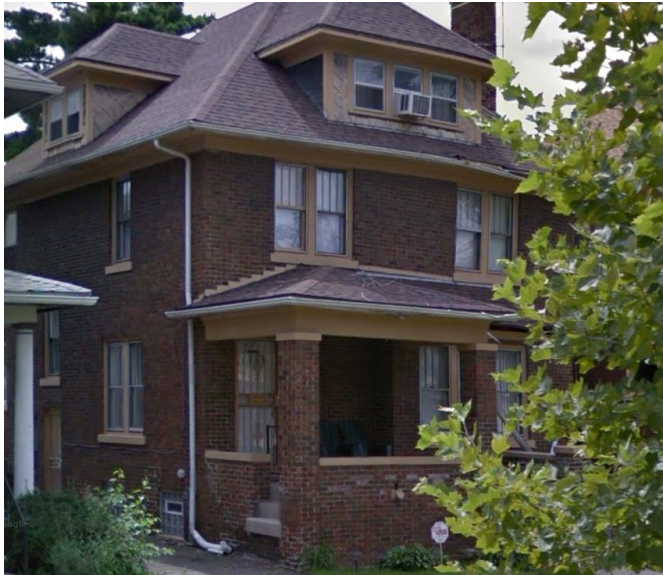
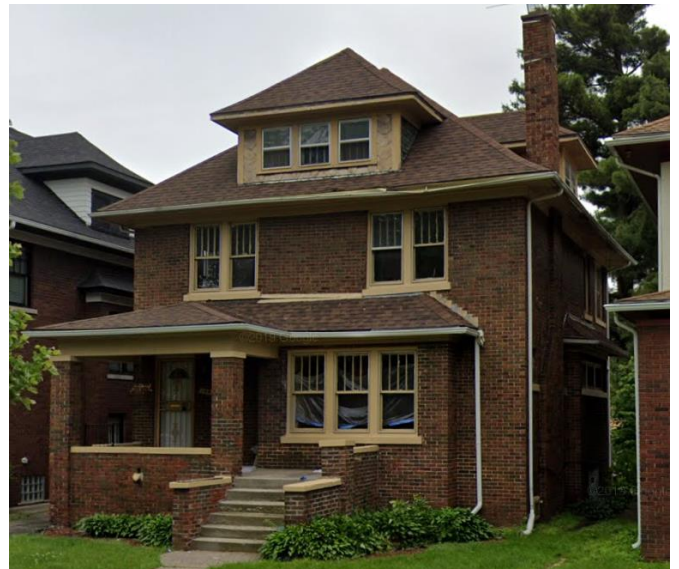
Google Streetview images, taken in 2016. Note that the attic/dormer 4-light wood windows are present but covered on the exterior by storm windows. Also, note that windows at the side elevation appear to be the same 4/1 type which were present at the front façade.

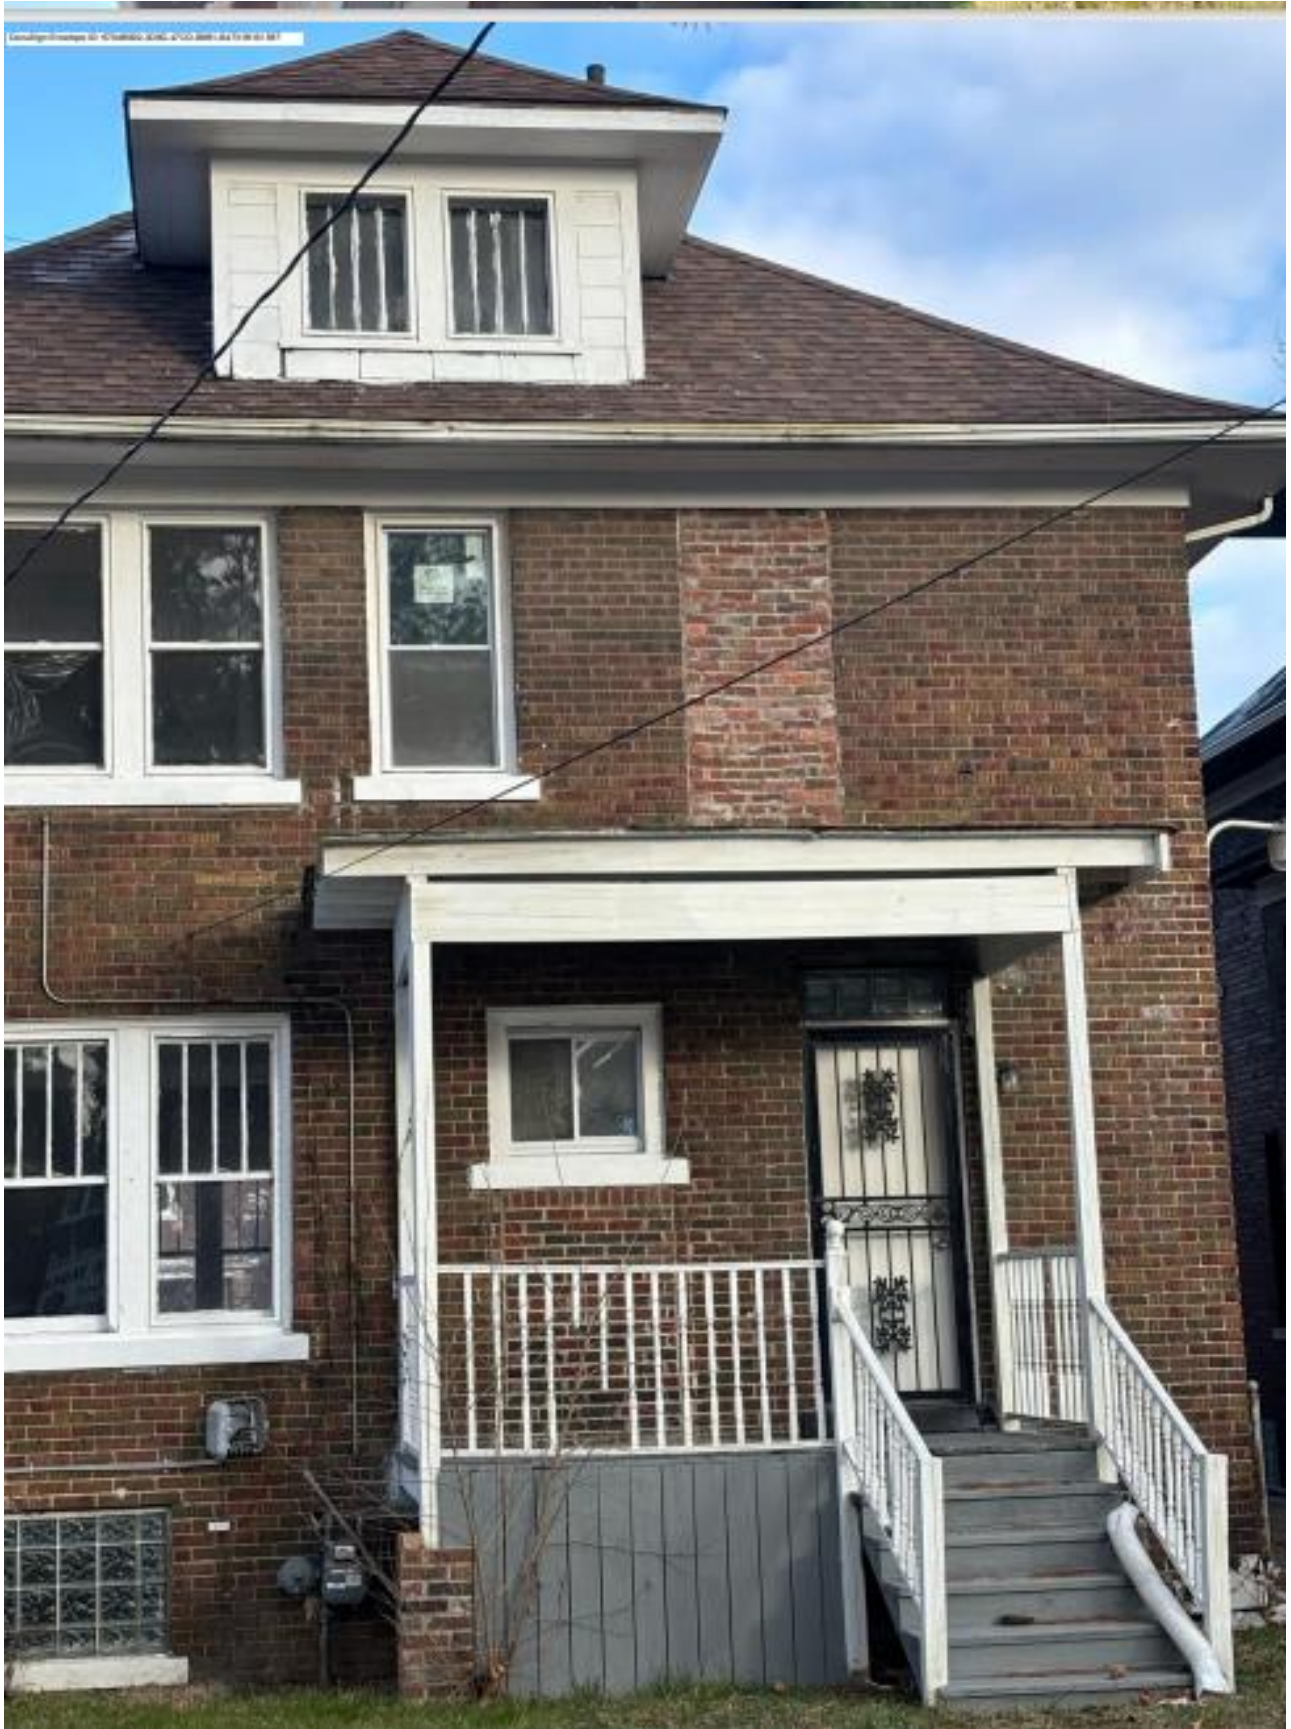
Rear wall, showing 4/1 double hung wood windows and 4-lite wood casement windows prior to current unapproved work. Note that the 1/1 vinyl windows at the second story and the small slider window at the first story are also recent unapproved alterations likely added prior to the current applicant's ownership. Photo provided by applicant.

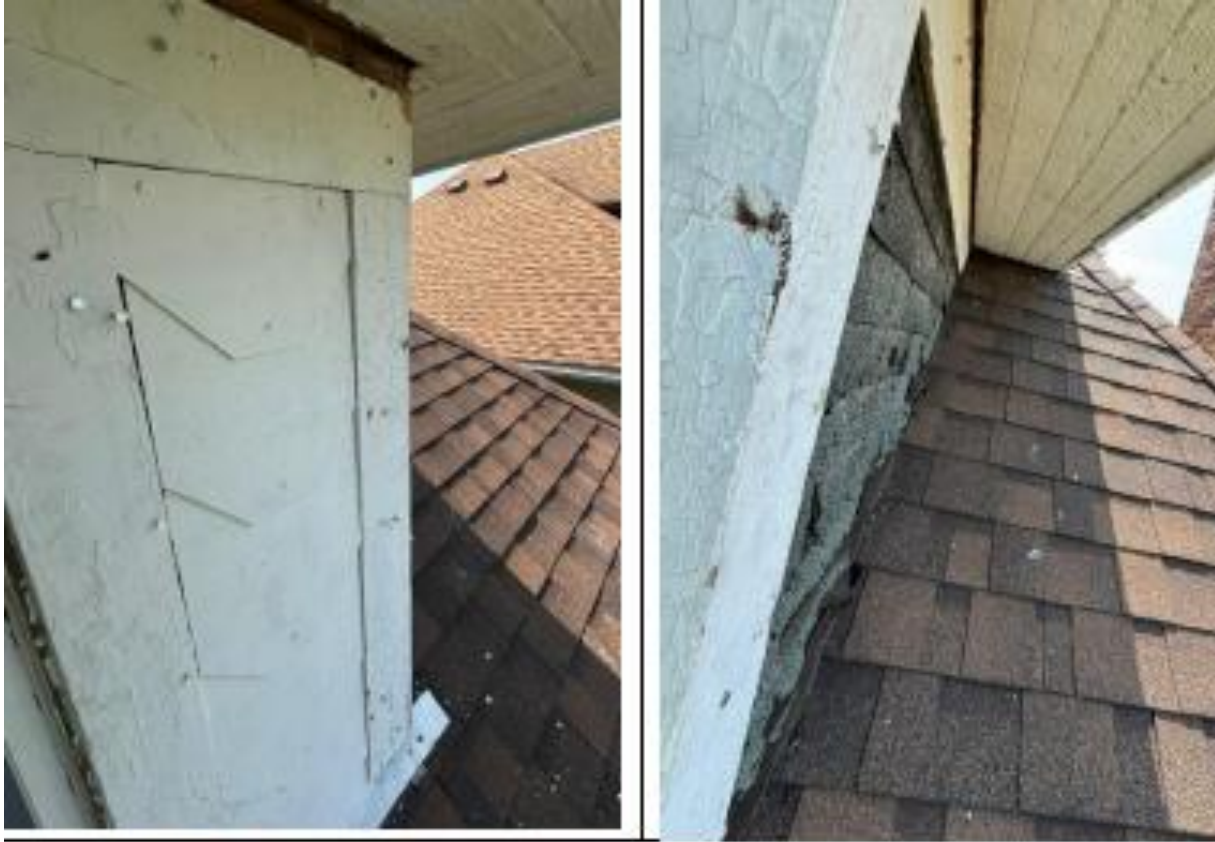
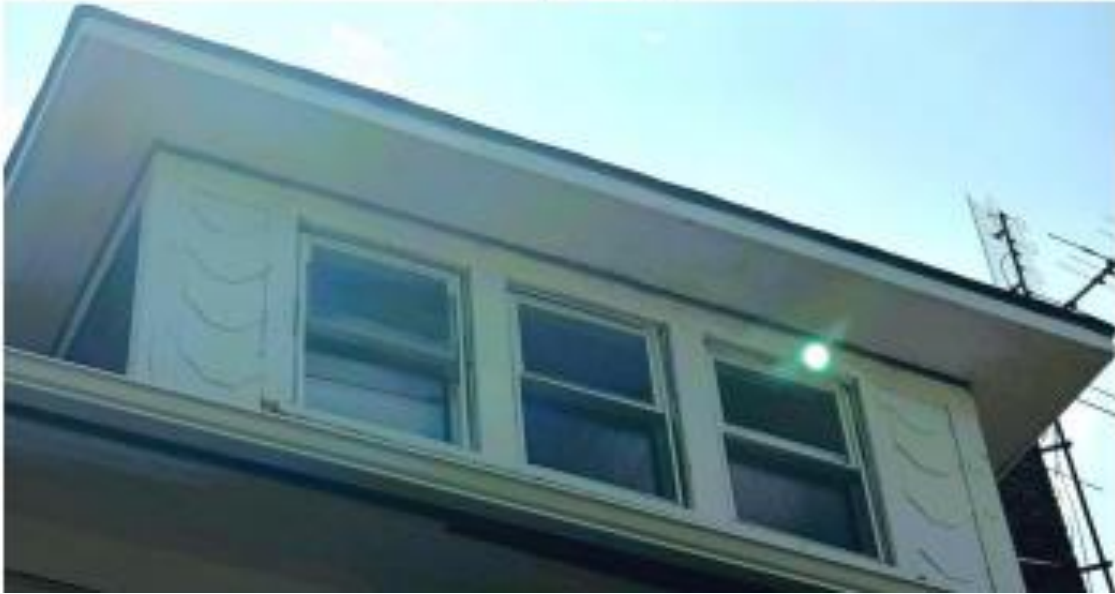
Front dormer. Note that front wall is clad with a scalloped wood siding while sidewalls are covered with asphalt shingles. Photos provided by applicant.

- The wood siding found at front wall of the primary façade's dormer appears to be of historic age and was present at the time the district was designated. It is staff's opinion that this siding is a distinctive, character-defining feature as the dormer is highly visible and the wood siding is of historic age. Therefore, the replacement of this siding does not meet the Standards in staff's opinion.

- The existing siding at the front wall of the primary façade's dormer shall be retained. If any areas of the siding at this location is deteriorated, it shall be replaced in kind to match existing

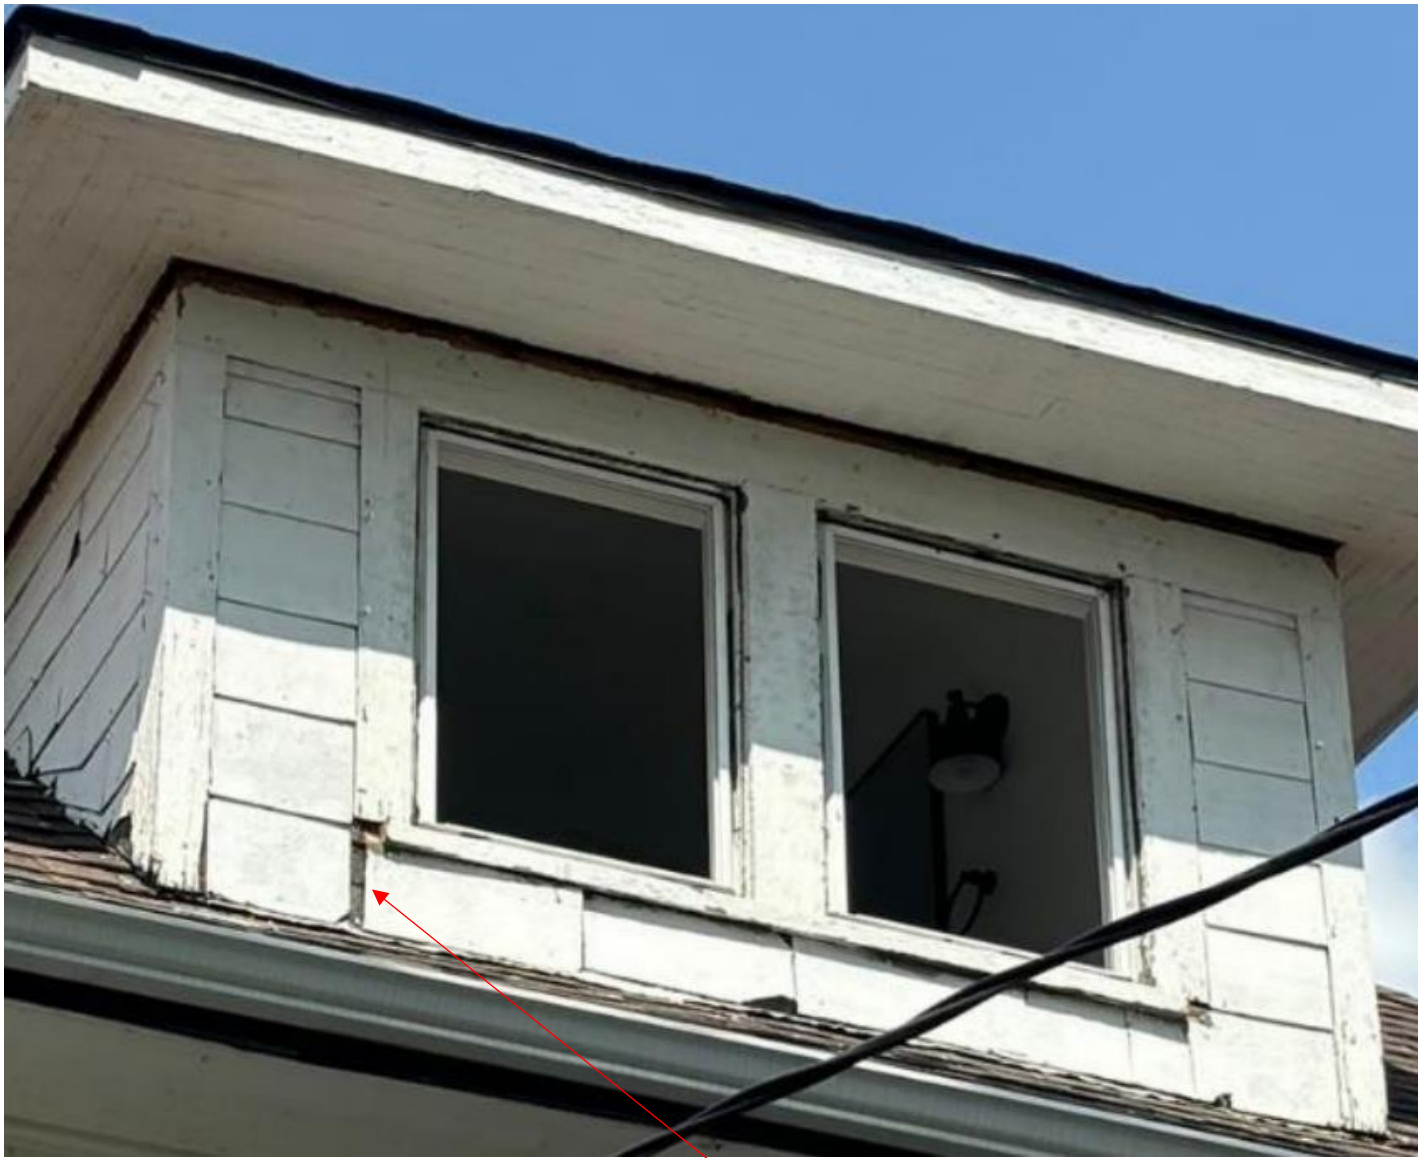
- The wood siding found at front wall of the primary façade's dormer appears to be of historic age and was present at the time the district was designated. However, it is staff's opinion that the wood at the rear dormer's front wall appears to be of a more recent vintage as it appears to have been applied over asphalt shingles (see below photos). While staff does not recommend the application of new siding at the front walls of the primary elevation's dormer because it appears to be historic age, staff does support the replacement of the cladding the rear dormer because it is not historic and detracts from the house's character.

Rear dormer. Note that front wall is clad with wood siding while sidewalls are covered with painted asphalt shingles. Asphalt shingle is visible below wood siding at this location. Photos provided by applicant.

- If new lapped composite siding is installed at the dormers, it shall display a smooth finish and must be painted a color which is compatible with that found at the house's trim. The applicant shall provide the final siding material choice and color to HDC staff for review and approval prior to the issuance of the project's permit

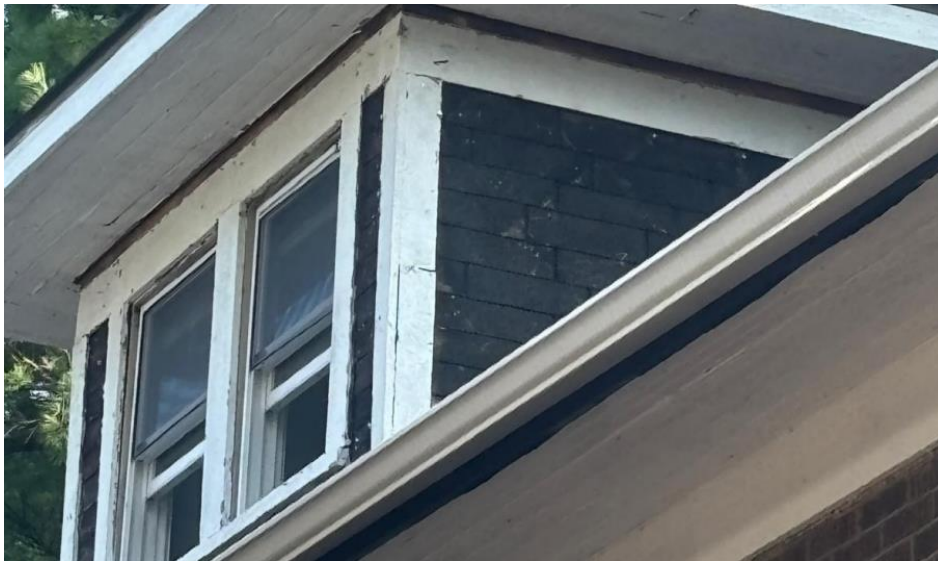
The two dormers at the side walls are clad with asphalt shingles. Photo provided by applicant.
