**STAFF REPORT: SEPTEMBER 11, 2024 MEETING**

**APPLICATION NUMBER: HDC2024-00454**

**ADDRESS: 1710 BAGLEY**

**SCOPE: REPLACE EXISTING SIDING WITH ENGINEERED SIDING**

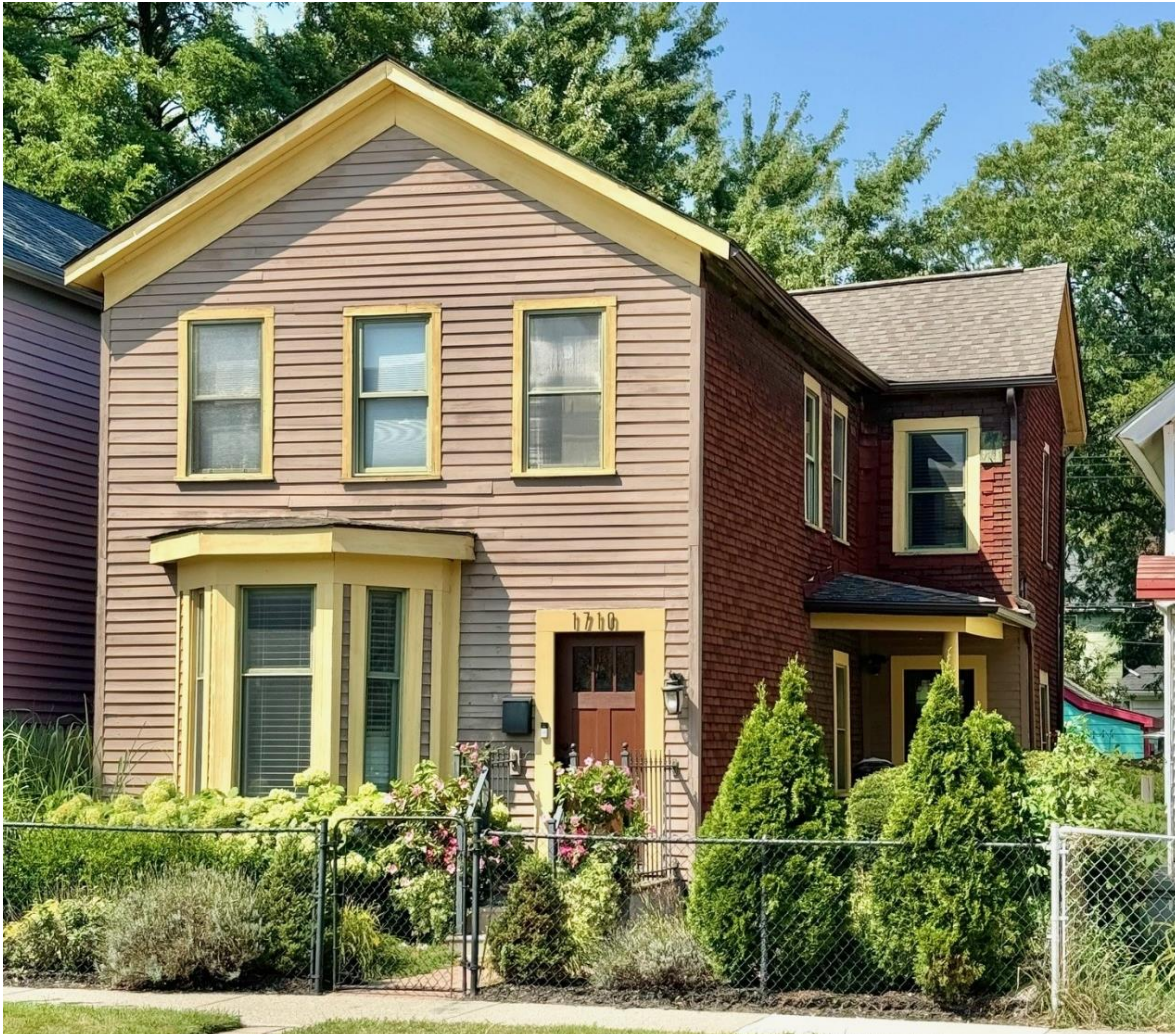
A cross-gable roof near the rear of the house covers an extension to the east that has a second entrance and a small, covered porch. The siding on the facade is not historic age and Insulbrick siding remains on the side walls.

*Façade, east-facing wall. Staff photo, August 27, 2024.*

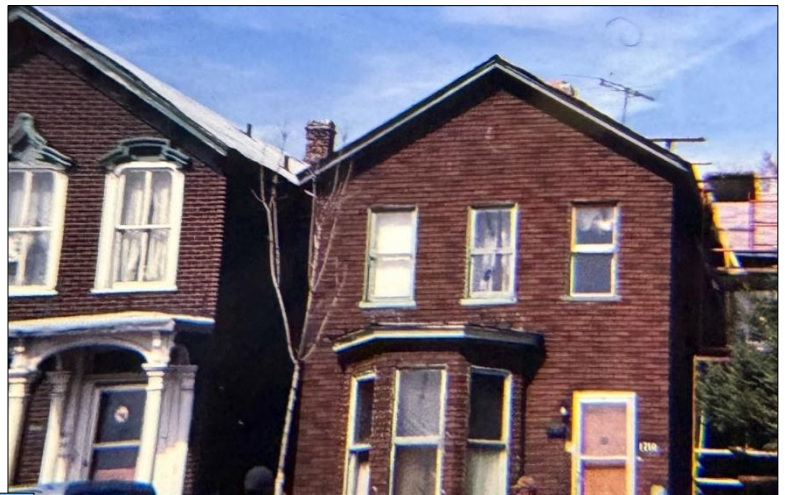
- The 1984 designation photo shows the front wall had also been covered in asphalt siding that remains in place on the side walls. The neighboring property was also covered in asphalt siding (aka Insulbrick).

Above: 1984 designation photo, HDAB.

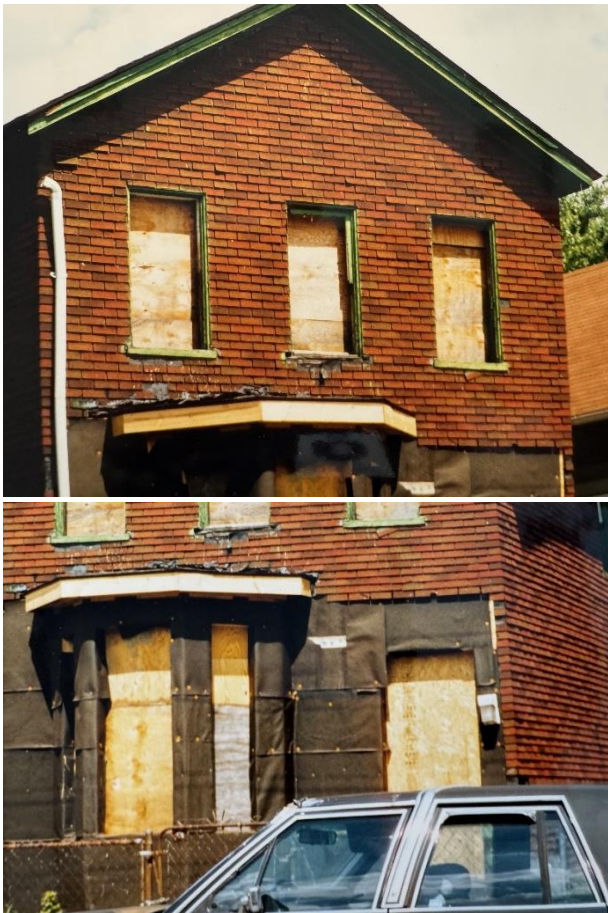
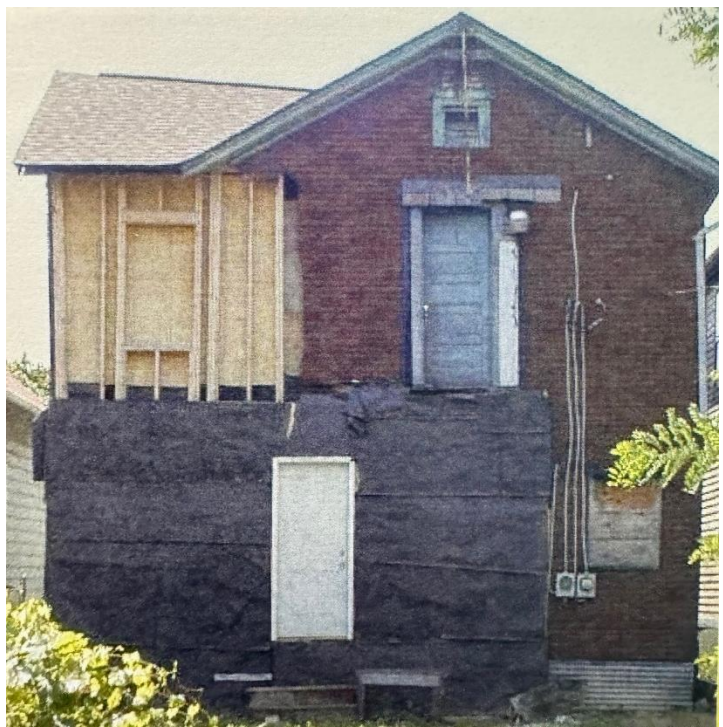
*Photos from HDC files that show the condition of the property in August 2002, when HDC staff reviewed applications for new windows and the removal of the asphalt siding.*

- In 2002, HDC staff approved the installation of aluminum-clad wood windows, as well as the removal of the asphalt siding. Based on existing conditions, the removal of the siding from the sides of the house was not completed.

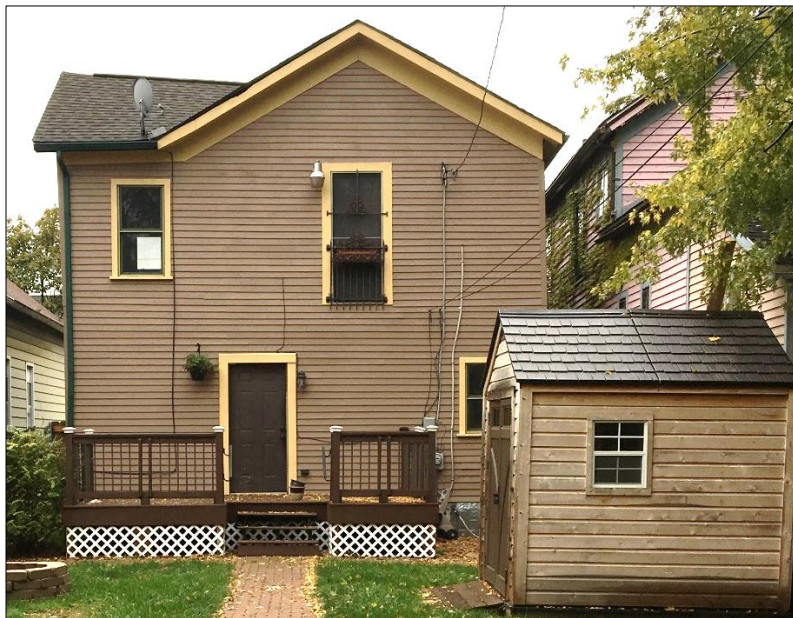
*Rear condition of house, as of 2017.*

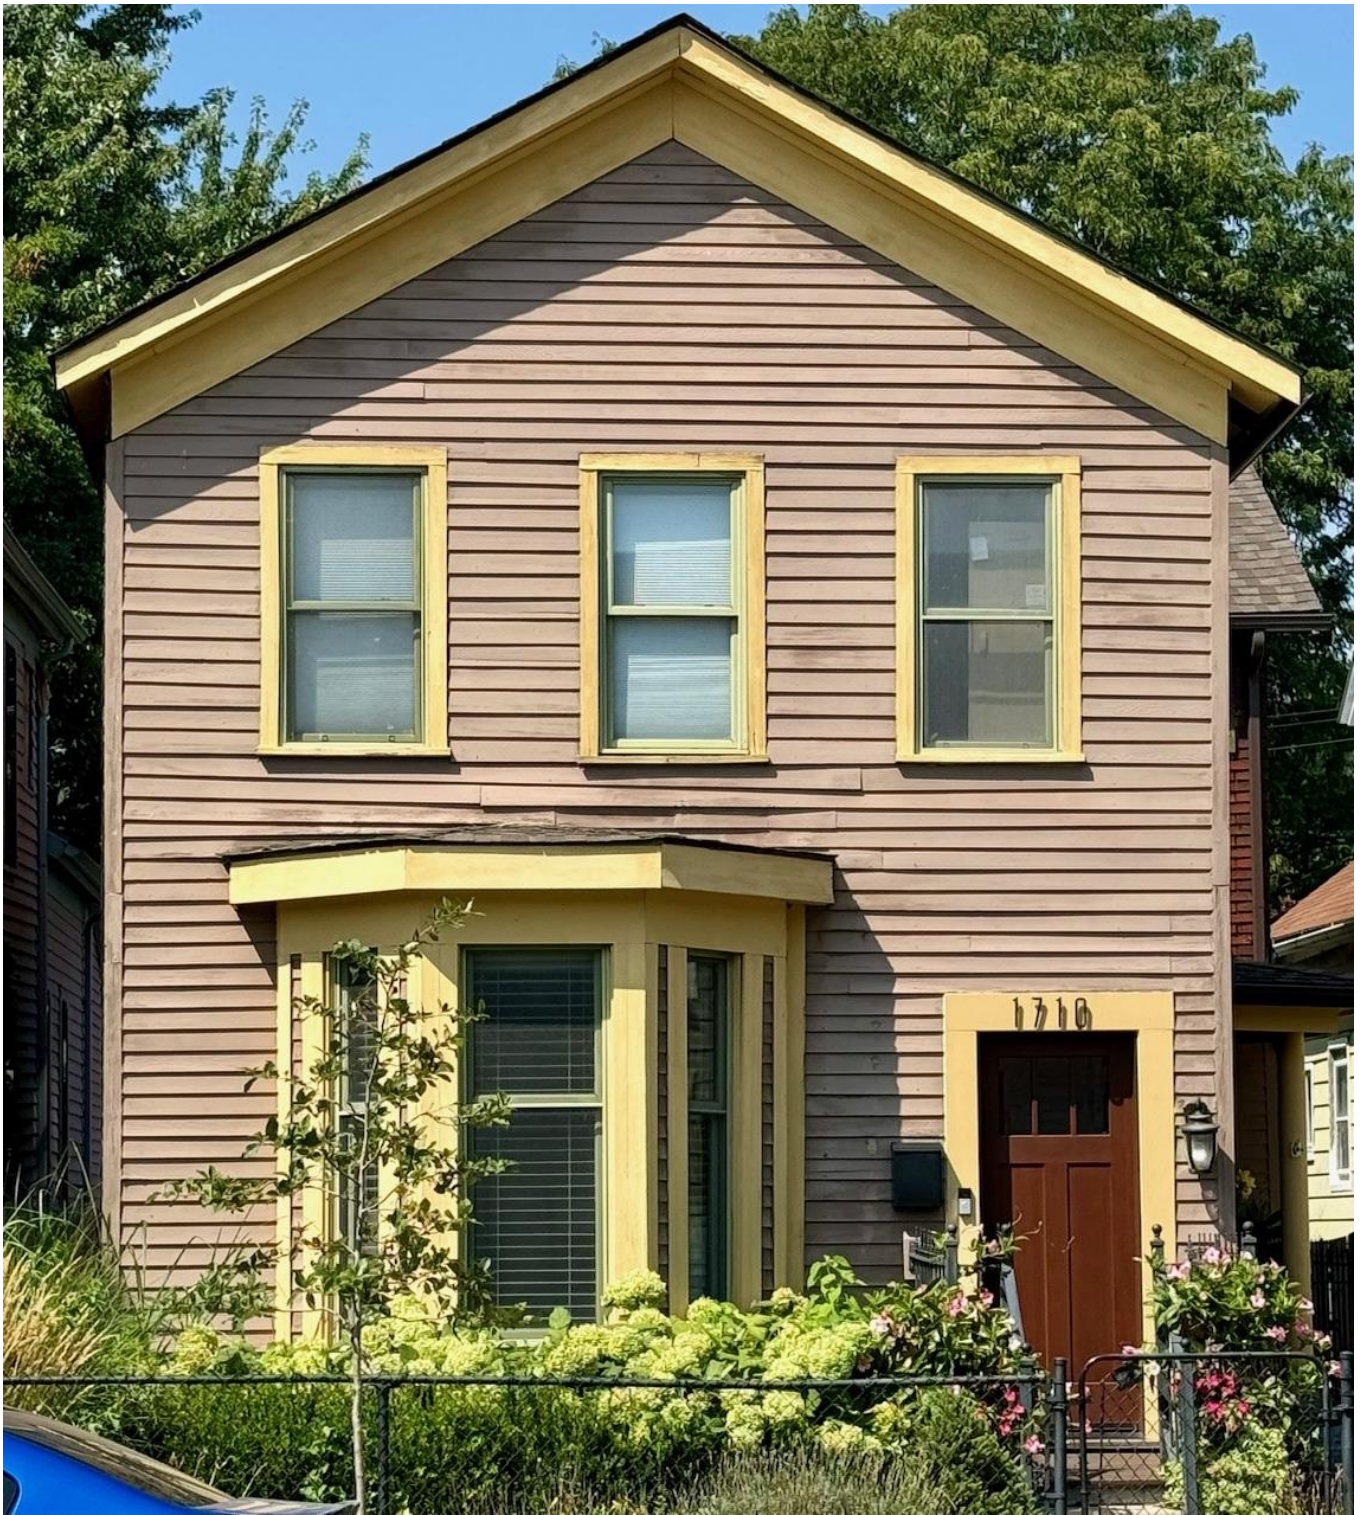
*Existing conditions on facade of house, August 2024. Staff photo.*

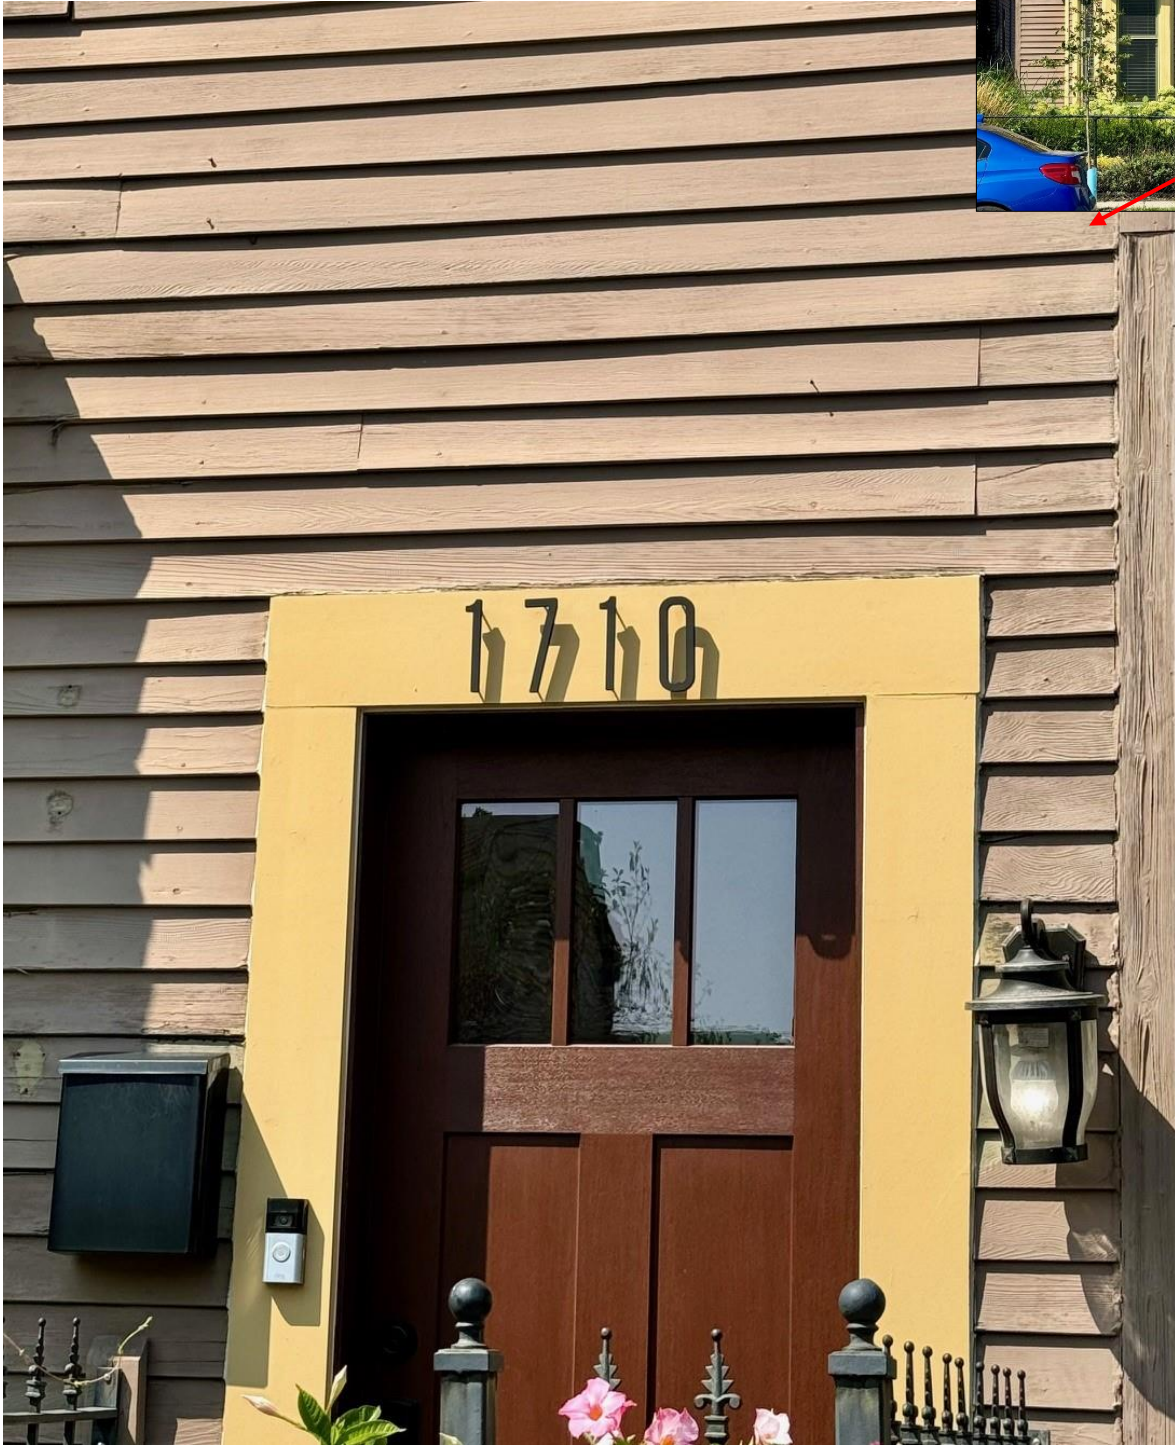
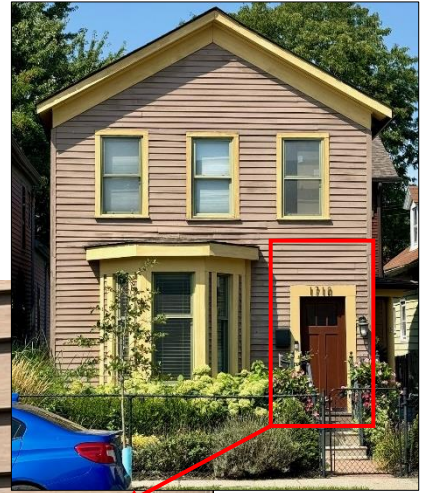
*Existing conditions of siding at front entrance, August 2024. Staff photo.  
The lap siding was installed with different length pieces, creating visible seams.*

Furthermore, the various board lengths, visible above the bay window and front door (shown on the previous page), many of which have warping vertical edges, draws additional attention to the non-historic material at the primary elevation.

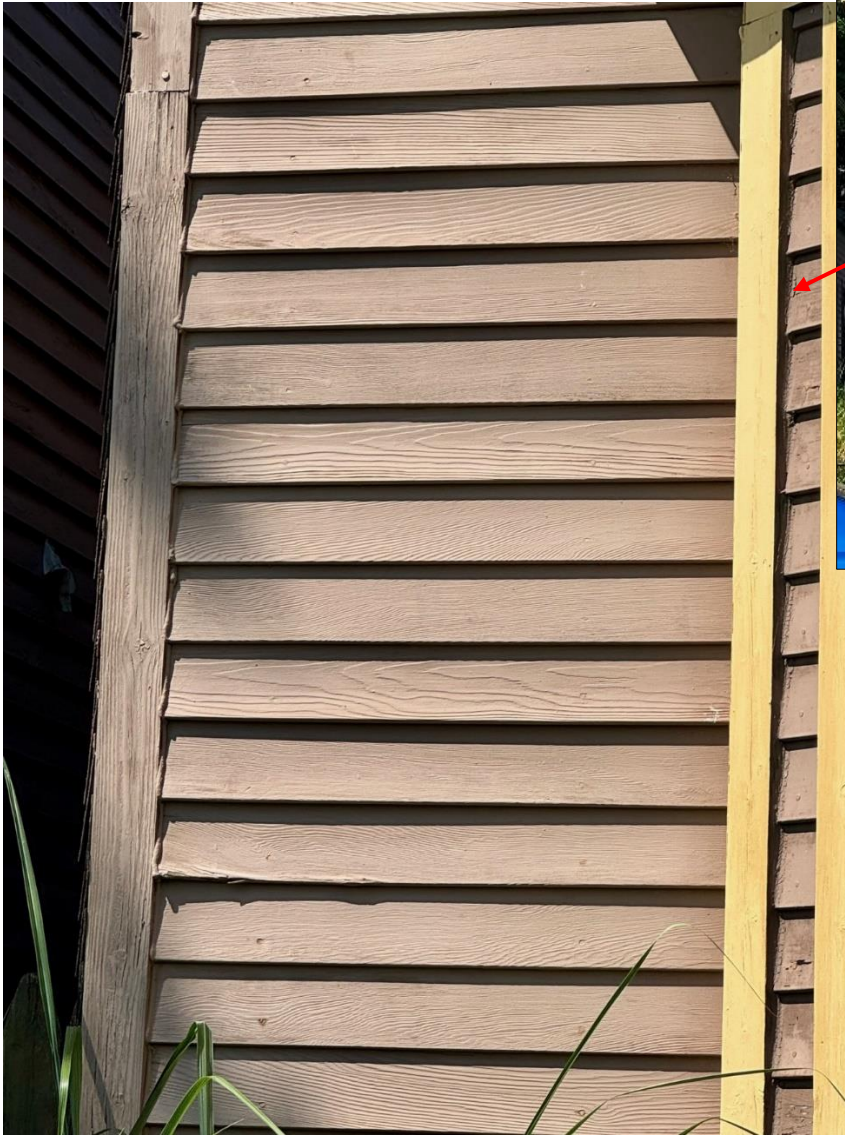
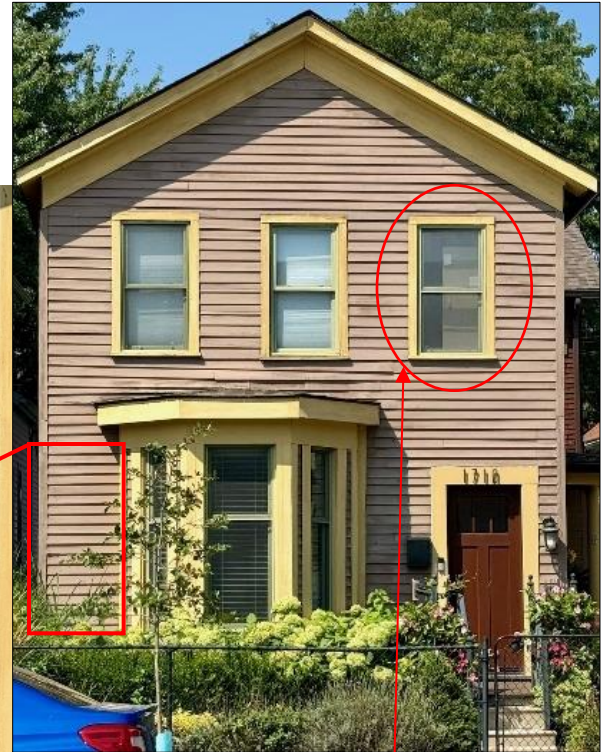
Staff photos, August 2024.

It is staff's opinion the wood trim surrounds of the window openings are newer material but was milled and installed to match the distinctive window casing design of 19<sup>th</sup> century wood-sided houses.

The circa 2002 lap siding offers a compatible dimension, exposure and edge profile to wood siding. However, when looked at closely from the sidewalk (and at left), the siding has an irregular embossed/raised grain pattern that extends the length of each board. The vertical trim at the edge of the house has a similar raised grain finish. This might be reclaimed wood as it appears to be nailed to the house, but the finish is not typical to most wood siding and is not a compatible finish to the era of the house and surrounding historic properties.

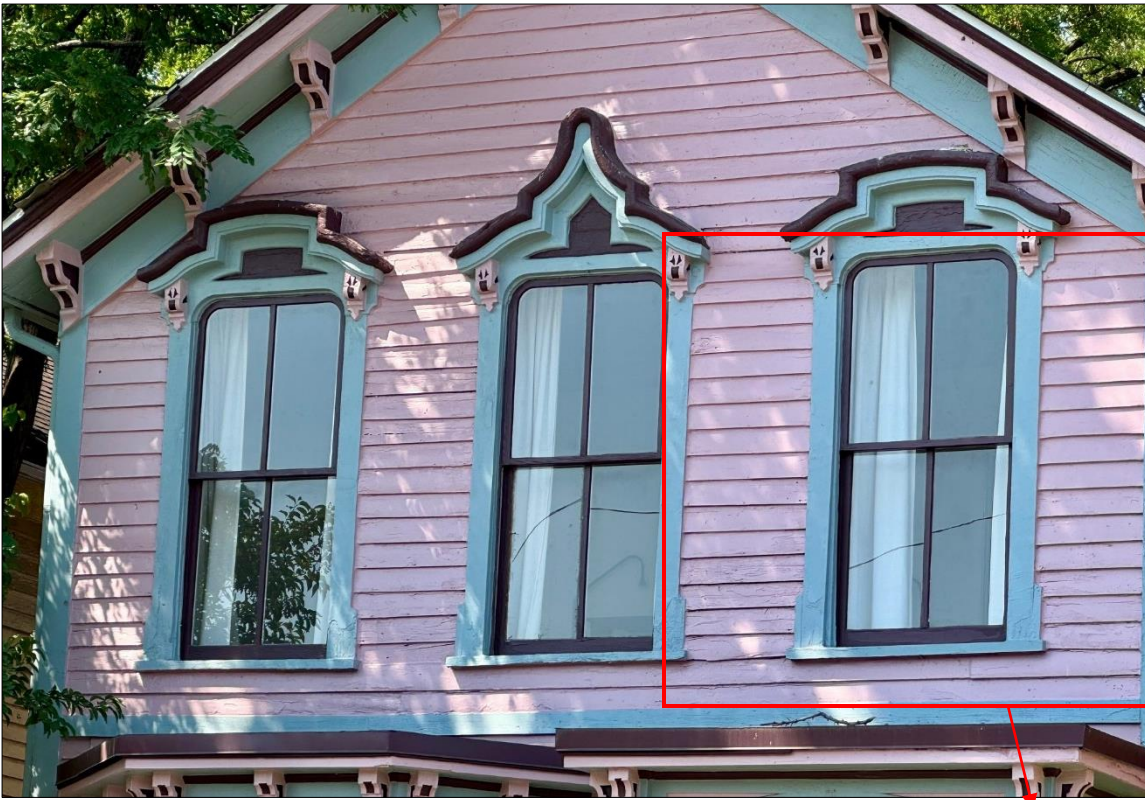
1714 Bagley, neighboring house to immediate west of 1710 Bagley.

As shown in the 1710 Bagley designation photo, this house also had asphalt siding, which was removed to re-expose the original wood siding.

The wood siding originally had, and generally retains, a smooth finish. The “embossed grain” surface on some areas of the lap siding is due to the uneven finish of not fully removed multiple coats of paint that was applied over the course of 100 + years, and is an expected and authentic expression for century-old siding.

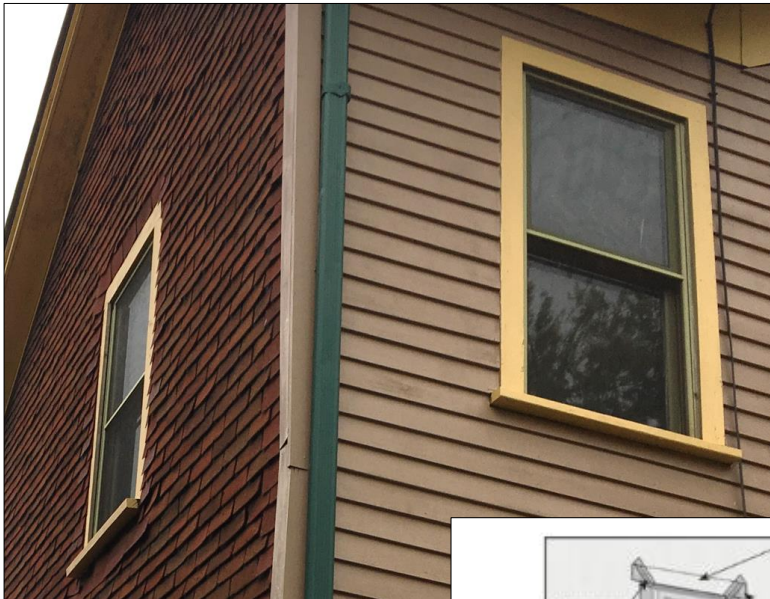
- The design and dimensionality of the window casings is a distinctive character-defining feature of the dwelling; this detail identifies the era of construction/age of the house and must be retained, or replaced in kind with new wood and painted finish.
  - The installation drawings provided by LP Smartside shows a design of uniformly dimensioned, flat window trim at the top, bottom and sides.

Above: Applicant photo of the east side window and rear window. The angled photo clearly shows the dimension and profile of the replicated 19<sup>th</sup> century window casing and sill.

- The design and dimensionality of the window casings is a distinctive character-defining feature of the dwelling; this detail identifies the era of construction/age of the house and must be retained, or replaced in kind with new wood and painted finish.

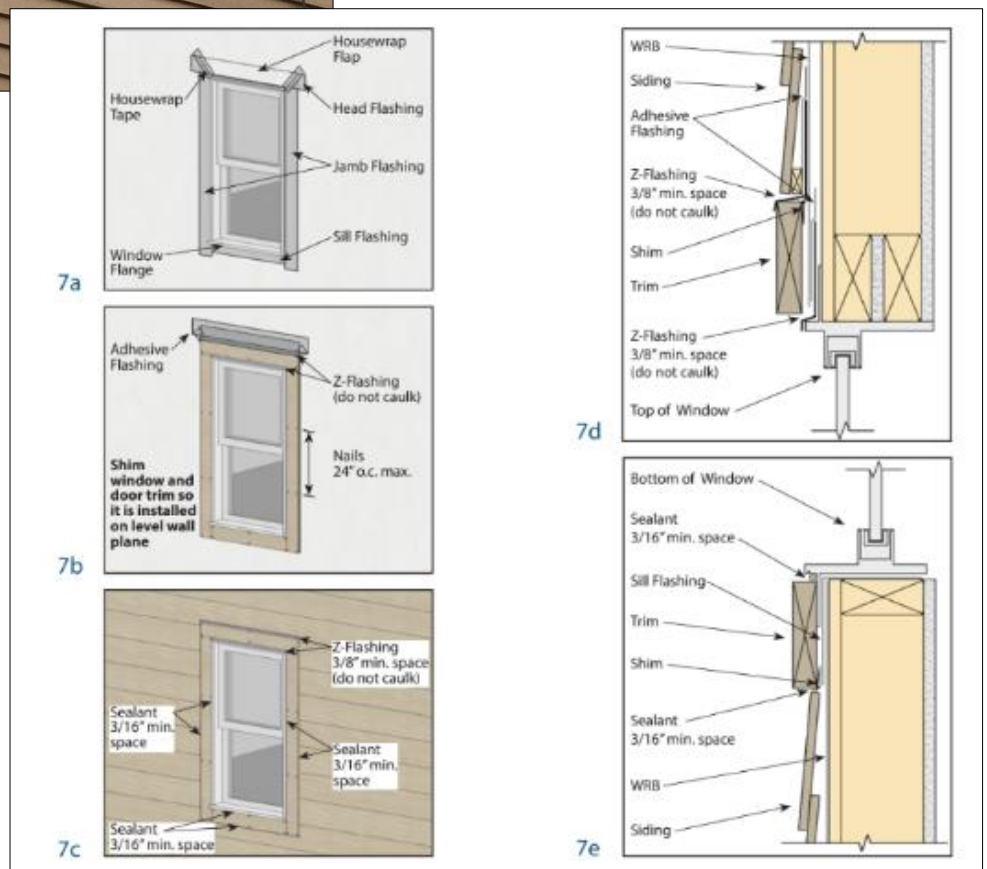
Right: Installation drawing from LP Smartside website. Note the rendering and sections of the top and bottom of the window trim specify uniform height and flat profile trim.

- The installation drawings provided by LP Smartside shows a design of uniformly dimensioned, flat window trim at the top, bottom and sides.
