STAFF REPORT: SEPTEMBER 11, 2024 MEETING

APPLICATION NUMBER: HDC2024-00495

ADDRESS: 3747 TYLER

SCOPE: INSTALL WOOD WINDOWS, DOORS AND ERECT REAR PORCH

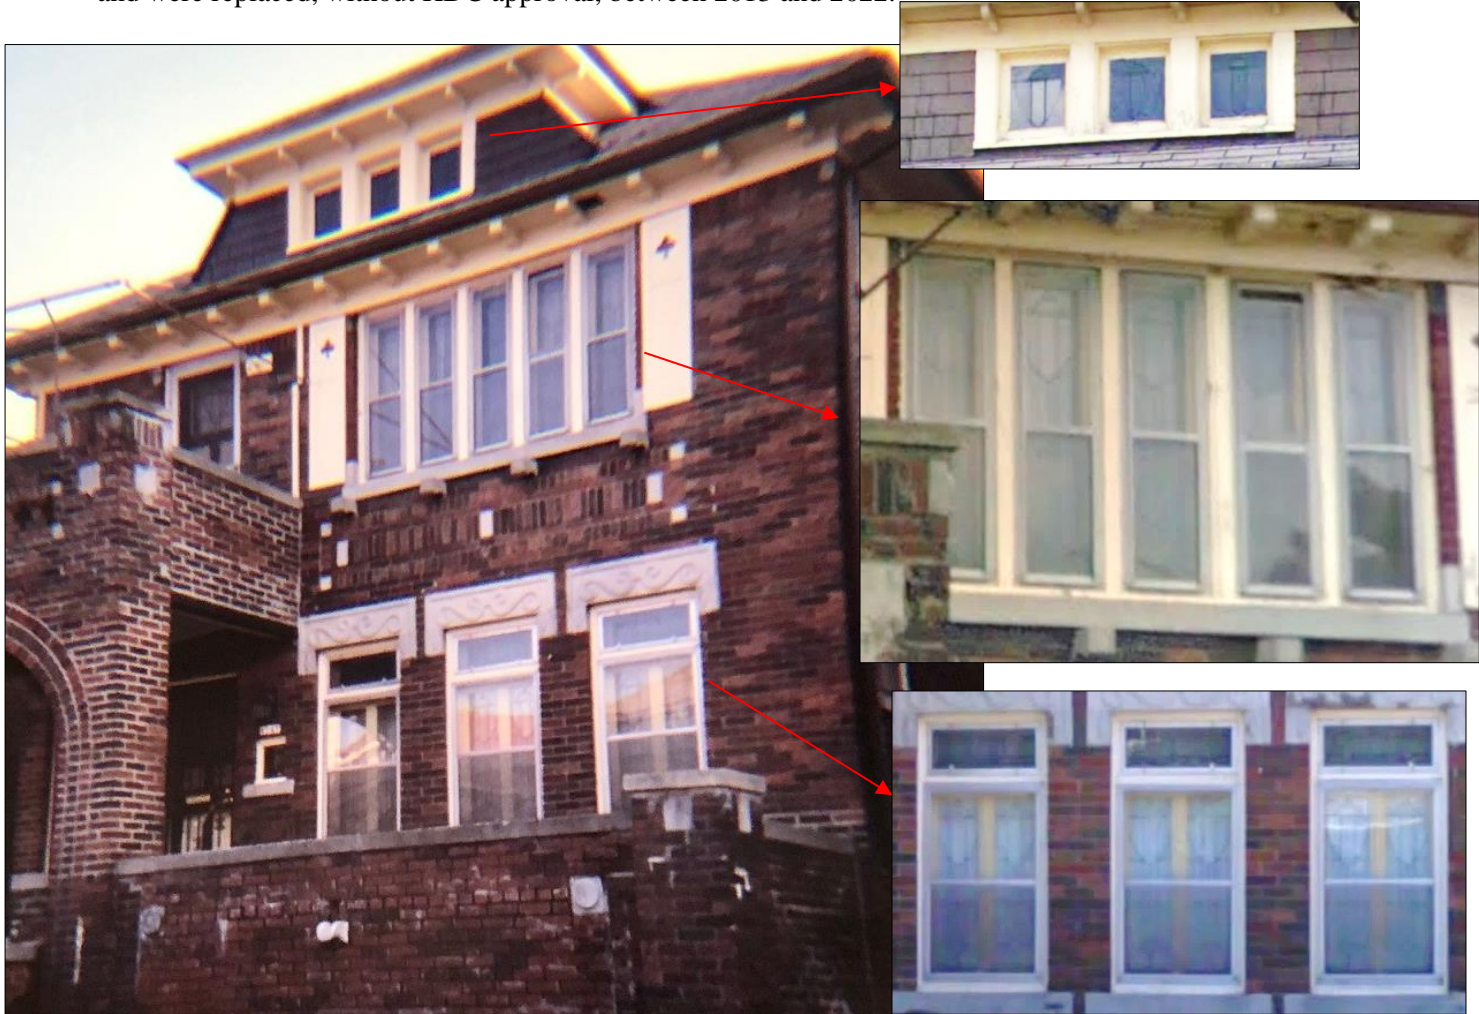
- The Russell Woods-Sullivan historic district was established in 1999.
- The designation photo shows leaded glass windows within each window opening on the front wall, as well as the three doors (two entrance and one upper porch). The first and second floor windows were vertically oriented casement units (casement design visually obscured by storm windows). The third floor had small square windows. The windows and doors were distinctive character-defining features and were replaced, without HDC approval, between 2013 and 2022.

1999 Designation photo, HDAB. Bottom right: 3755 Tyler, Google street view, June 2022.

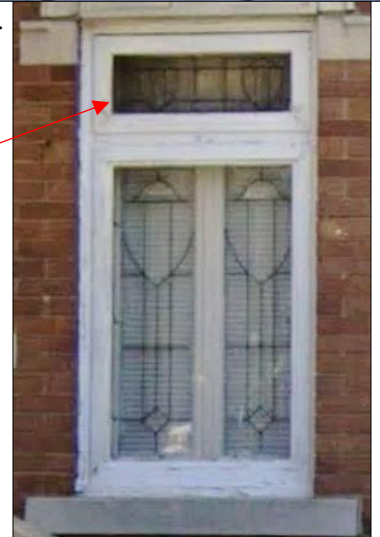
- The window shown at right is in the neighboring house (3755 Tyler) which has an identical leaded glass pattern to what had been in place at 3747 Tyler. This photo clearly shows the repeating leaded glass pattern in the transom window.
- The installation of storm windows in a double-hung operation obscured the casement windows, and once the windows were gone, gave erroneous and misleading information as to the original window operation and decoration.

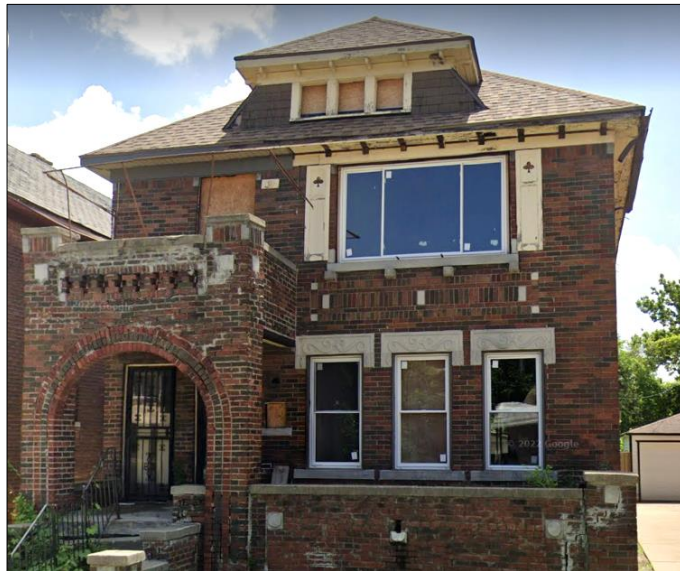
- Reviewing additional Google street view images, the remaining windows and doors were removed between June 2019 and June 2022 and the existing vinyl windows were installed.

Google street view, June 2022.

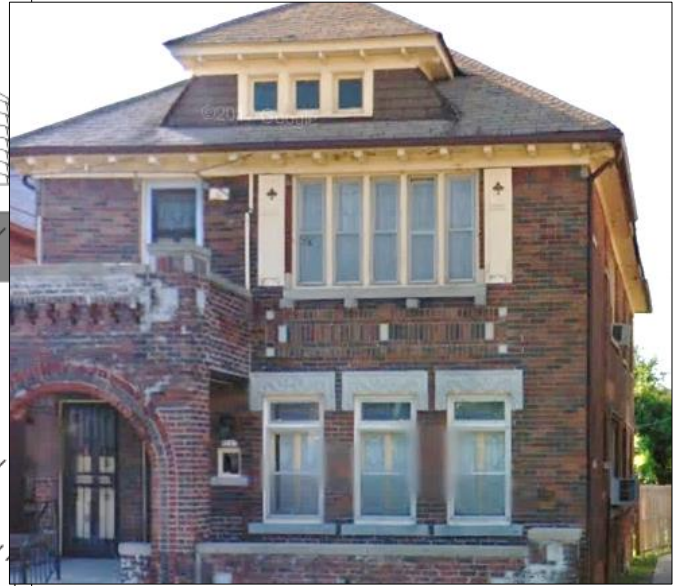
August 2011 Google street view photo. The leaded glass casement windows at the first and second floor are disguised due to the installation of double-hung storm windows.

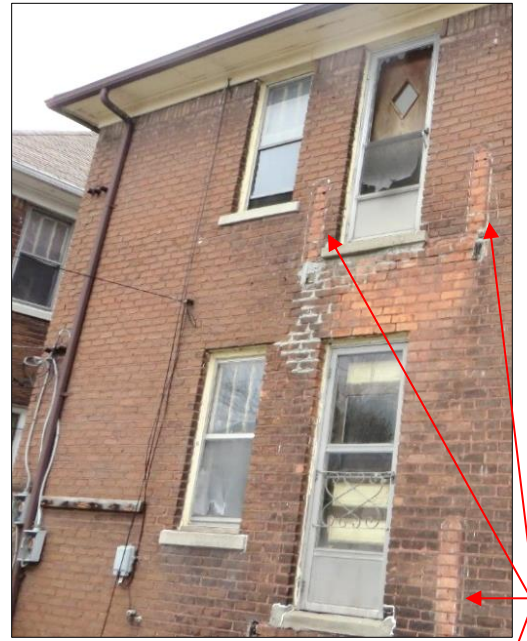
2018 photo of rear elevation. "Ghost" images of the original porch are evident on the brick.

- The application proposes to remove the vinyl windows and install wood windows with a 3-over-1 pattern to match the documented historic condition. A two-story porch is proposed in a dimension and design that is similar to the ghost images shown in the 2018 photo that documents the placement of the former porch.
