STAFF REPORT: 10/9/2024 MEETING

ADDRESS: 2061 LONGFELLOW

APPLICATION NO: #HDC-2024-00532

SCOPE: ERECT GARAGE AND REHABILITATE DWELLING

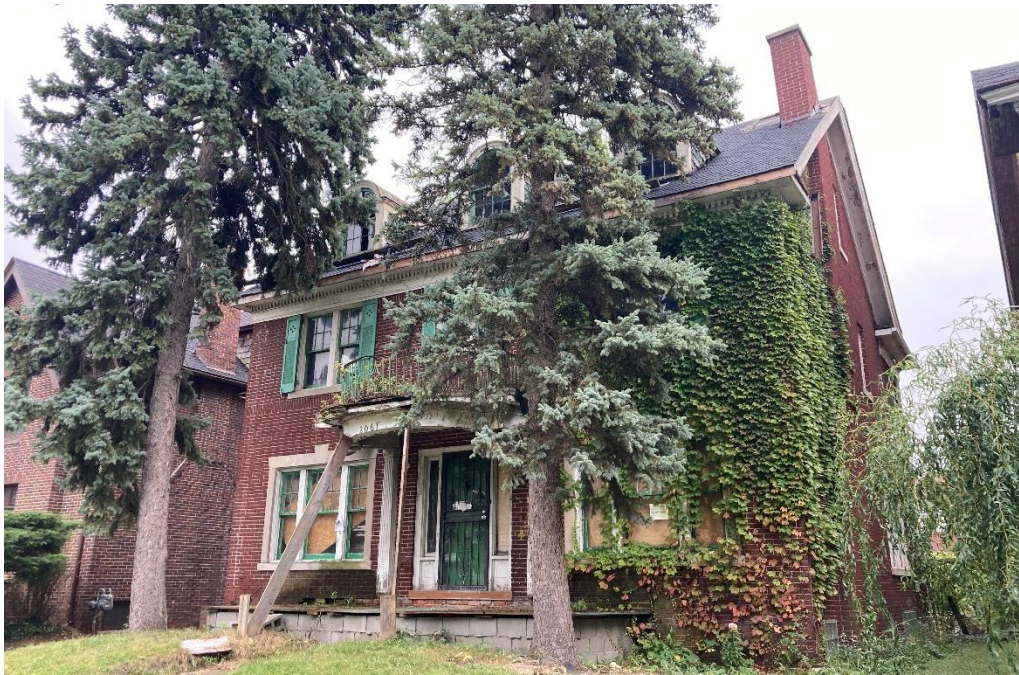
2061 Longfellow, current appearance. Staff photo taken on 9/30/2024

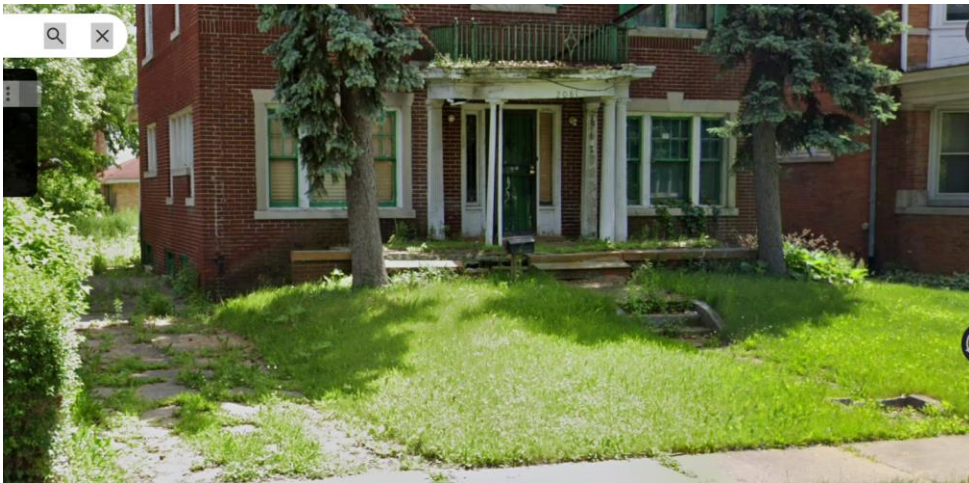
Google Streetview, appearance in 2019. Note that the original front porch deck and columns, driveway and concrete walkway with steps remain, albeit in deteriorated condition

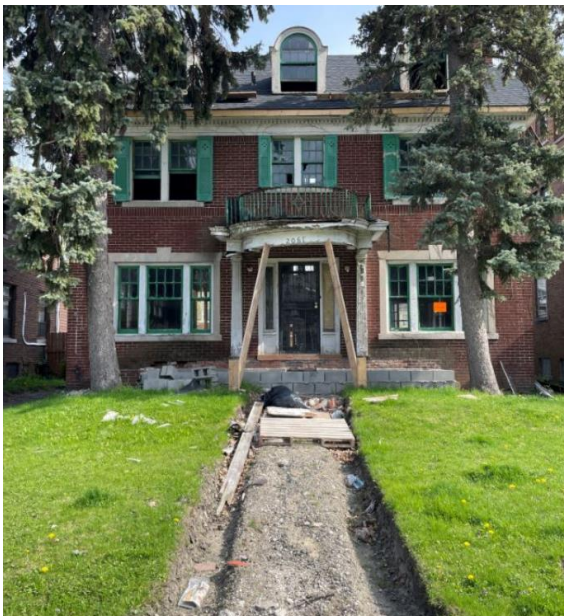
Staff photo taken in 2021 to document work undertaken without approval. Note that walkway has been removed, the brick front porch deck/floor has been removed and replaced with concrete block, and the porch columns have been removed

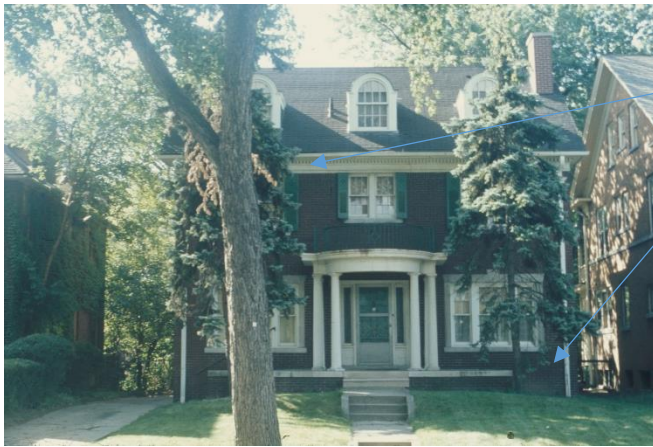
- The applicant is seeking the Commission’s approval to remove two large, historic-age trees which are directly to the north of the dwelling’s façade/porch because their roots are contributing to damage of the dwelling’s foundation and front porch (see the below photos). The HDC staff landscape architect supports the applicant’s proposal to remove the trees and concurs with their conclusion that the trees are damaging the dwelling. Also, evergreen coniferous are not typical at such a location and thus is incompatible with the historic district. The applicant has proposed to replace these trees with two new trees in the front yard, well north of the dwelling. Staff supports this approach.

Two spruce trees proposed for removal

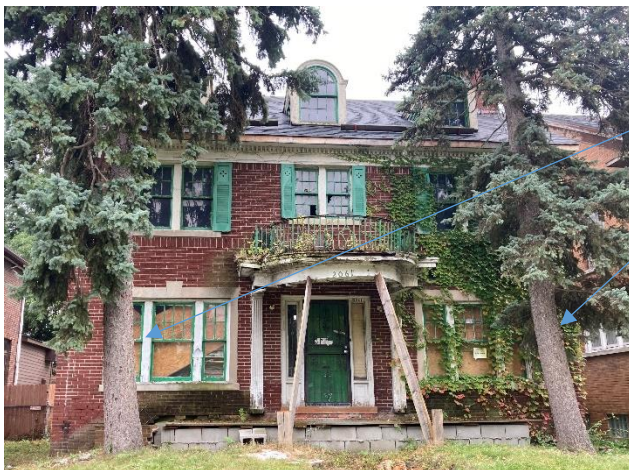
Two spruce trees proposed for removal

2061 Longfellow. Photo taken by HDC staff on 9/30/2024 showing current conditions

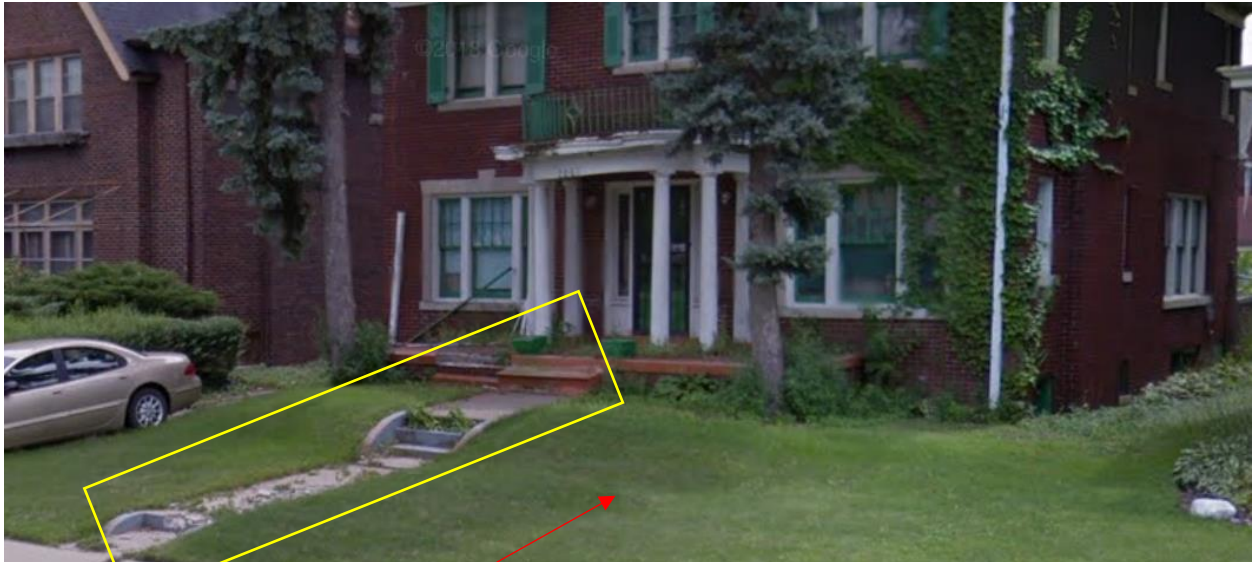
Note that a terrace does currently exist at the property's front yard, directly north of the front façade/front porch (see below photos). The concrete walkway which was removed from the front yard without HDC approval included a single step directly to the south of its junction with the public sidewalk and a three-step rise with a landing to the direct north of a single porch step. The current application appears to indicate that the existing terrace will be removed as it proposes a straight walkway which leads from the sidewalk to the porch steps (four steps total versus the single step which marked the original porch that was removed without HDC approval). It is staff's opinion that the existing terrace is a distinctive, character-defining landscape feature that should be retained. Staff also recommends that the original porch and front yard walkway step configuration/number be replicated in order to accommodate the terrace's maintenance.

Google Streetview, 2009 showing terraced landform at the front yard in addition to the concrete walkway and single porch step that was removed without HDC approval in 2021 (outlined in yellow)

- The terraced landform at the front yard shall be retained/shall not be lowered or flattened. The new front yard walkway and porch steps shall be redesigned to replicate those which were removed without HDC approval. HDC staff shall be afforded the opportunity to review and approve the final design prior to the issuance of the permit.

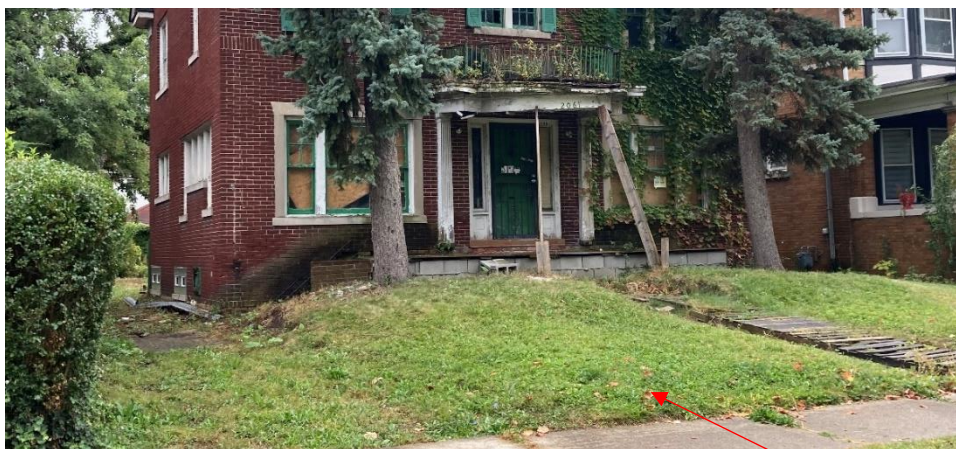
Current conditions, showing distinctive, character-defining terraced landform at front yard

- The front yard terrace is a distinctive character-defining feature of the property and therefore the Standards require that it be retained. The original porch and front yard walkway which were removed without HDC approval were also distinctive character-defining features of the property and should be replicated to maintain the property's historic appearance/character and to support the retention of the terrace.
- Per the above, the existing character defining leaded glass window at the rear wall proposed for removal does appear to be deteriorated beyond repair and the new casement window proposed to replace the character defining leaded glass window at the rear wall

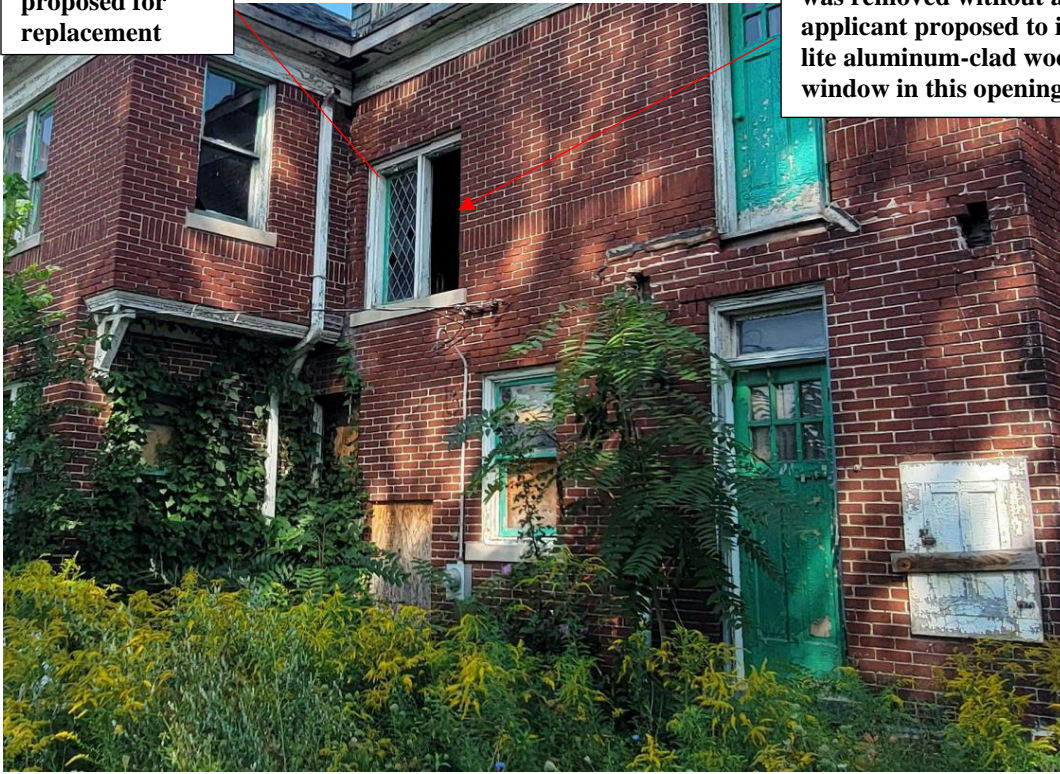
Rear wall, current appearance. Photo by applicant

- The application proposes to replace one existing distinctive character-defining leaded glass wood casement window at the rear wall, second story with a new single lite aluminum-clad wood casement window. Also, the application proposes to install a new aluminum-clad wood casement window to replace a second leaded glass wood casement window that was removed without HDC approval (see below). Note that the application does not provide evidence that the leaded glass window which is proposed for replacement is deteriorated beyond repair. Additionally, the replacement window does not represent an adequate replication of the leaded glass window that was removed without HDC approval. It is staff's opinion that these work items conflict with Secretary of the Interior Standards for Rehabilitation #6, which states the following:

This window is proposed for replacement

A leaded glass window at this location was removed without approval. The applicant proposed to install a single lite aluminum-clad wood casement window in this opening

- The one existing distinctive character-defining wood casement window (with diamond patterned lead coming)at the rear wall, second story proposed for replacement shall be retained and repaired.

- The new window which shall be installed at the rear wall, second story to replace a casement window with diamond patterned lead coming that was removed without HDC approval shall display a lite configuration and material which adequately replicates the window that was originally present within the opening. HDC staff shall be afforded the opportunity to review and approve the final window selection.

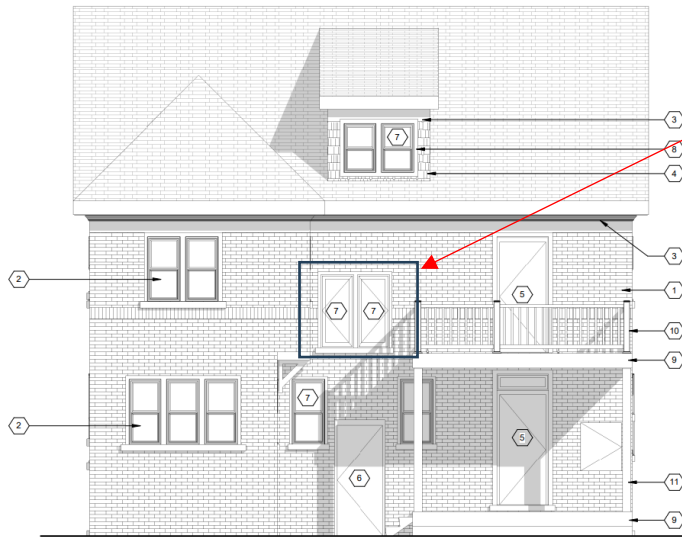
Proposed rear elevation

New windows proposed to replace historic leaded glass casement units
