STAFF REPORT: 10/9/2024 MEETING

ADDRESS: 4081 PORTER

APPLICATION NO: HDC2024-00501

SCOPE: PAINT DWELLING AND INSTALL STONE VENEER AT FAÇADE

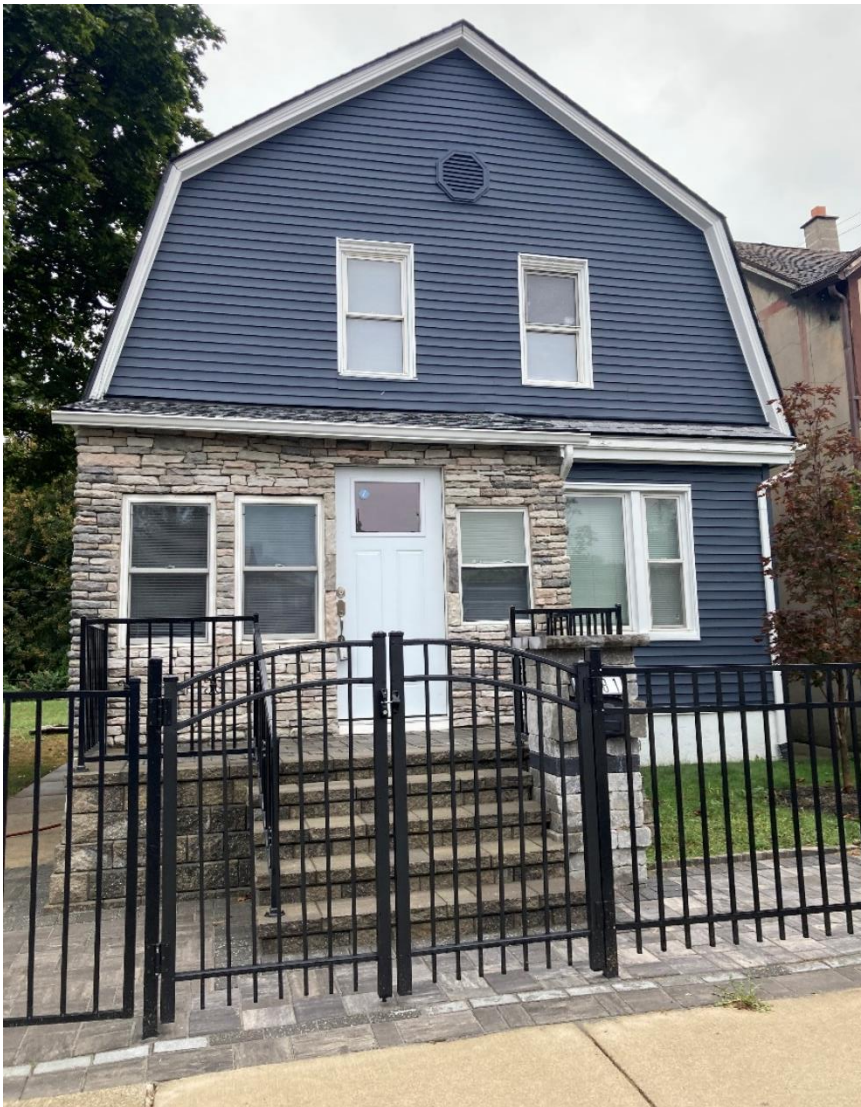
4081 Porter. Current appearance. Photo by staff 9/30/2024

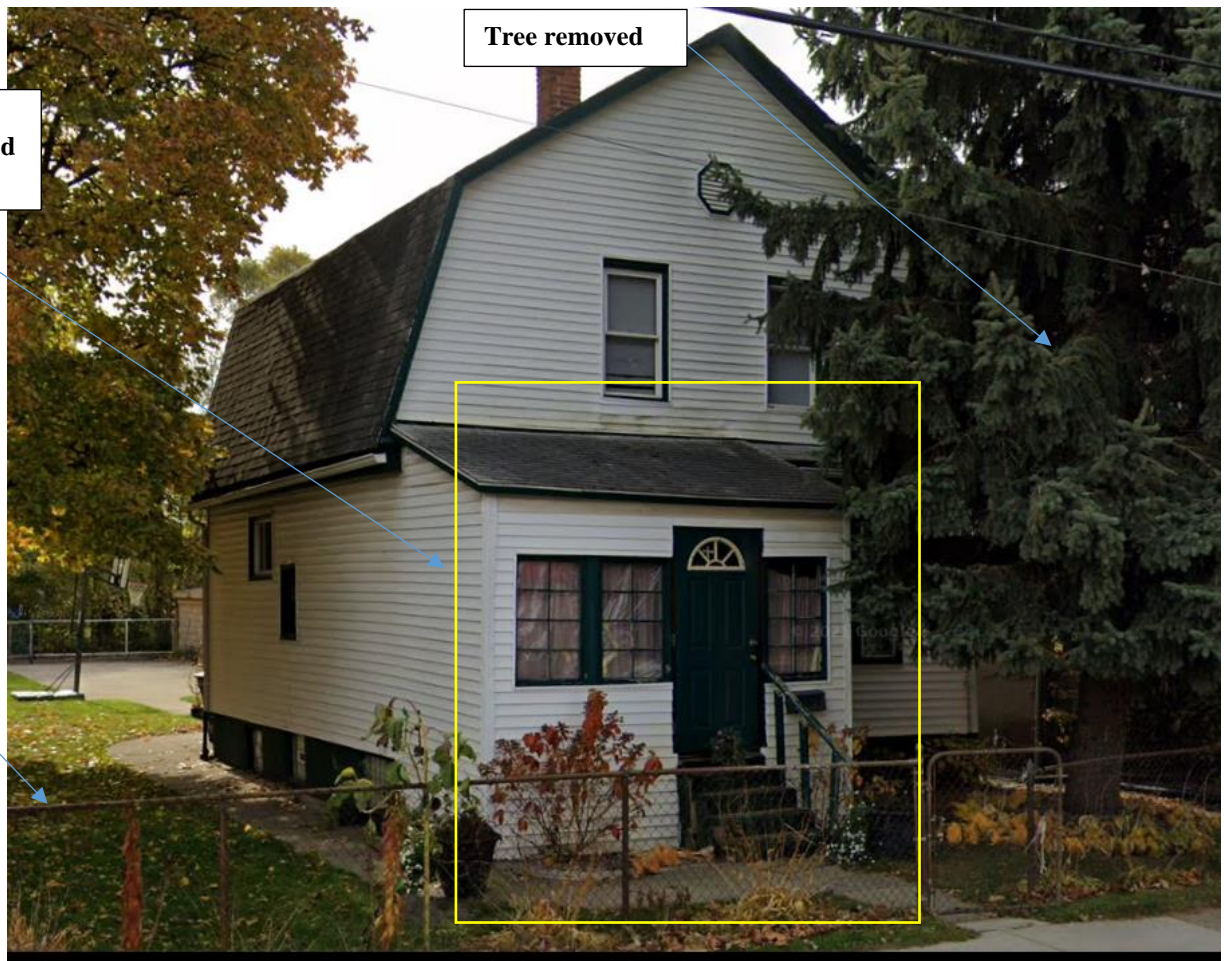
4081 Porter 2019, showing appearance before recent unapproved work. Google Streetview

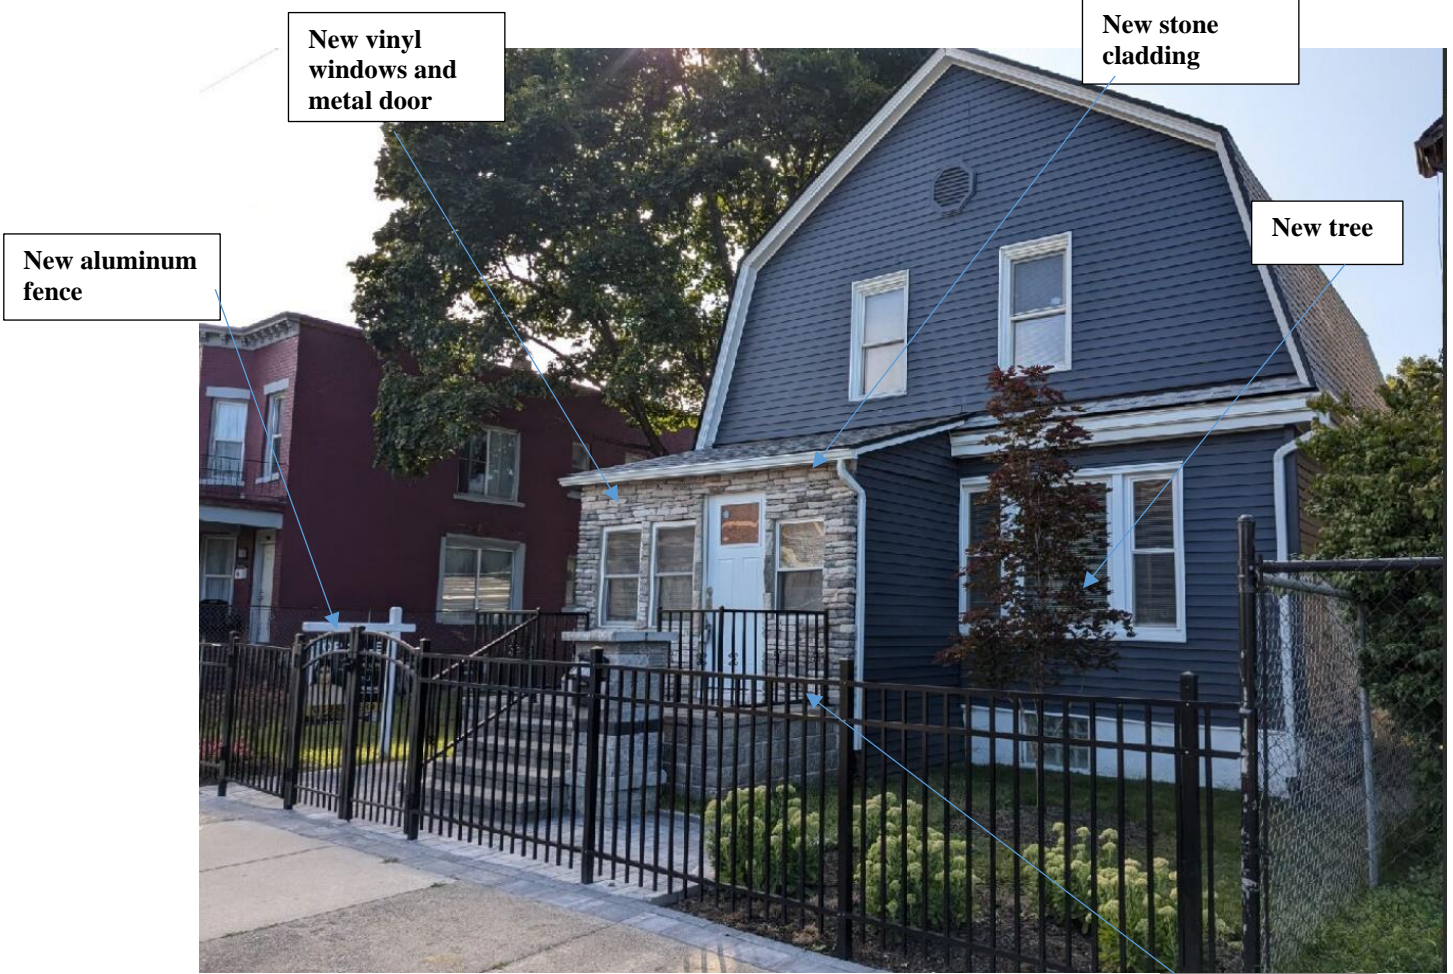
4081 Porter. Photo by staff taken in August 2024 after unapproved work.

New masonry porch/deck and paver patio/walkway

- Similarly, it is staff's opinion that the new masonry front porch deck and paver patio do not conform to the Standards and district's Elements of Design as they present a modern expression of masonry that is incompatible with the property's historic character. Also, regarding the new porch/deck, note that it replaced a small set of wood steps which extended well south of the sidewalk and north property line, which was in keeping with the established setback along the block. Although the other porches within the same block are all open, they each do include a similarly dimensioned set of steps which lead from the porch to the front yard beyond, leaving a comfortable amount of space between the edge of the steps and the sidewalk. However, due to the large size of the current porch/deck, the steps push well north of the datum established by the historic front porch steps in the near vicinity, with the bottom step landing only inches south of fence and sidewalk beyond. This is inconsistent with the existing porches within the district and the property's near vicinity.

Recommendation #1 - Section 21-2-78 -Denial – Install three vinyl windows and masonry cladding at enclosed front porch; install a masonry front porch/deck at primary entrance; install masonry paver patio and walkway at the front yard

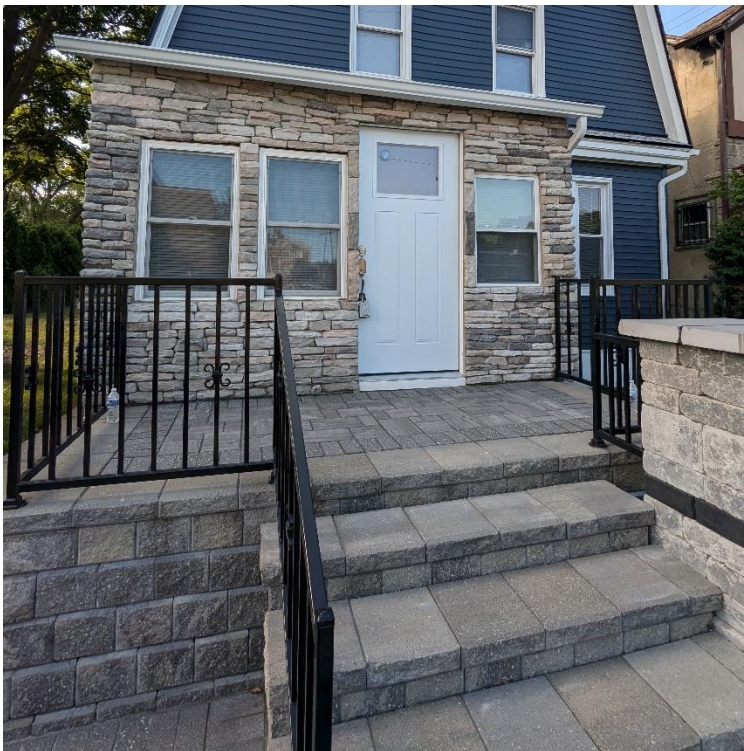
4081 Porter, detail of new masonry porch/deck. Photo by staff taken in August 2024 after unapproved work.

- Also, the due to the large size of the porch/deck, the steps extend well north of the datum established by the historic front porch steps in the near vicinity, as the bottom step lands only inches south of fence and sidewalk beyond. This is inconsistent with the existing porches within the district and the property's near vicinity.

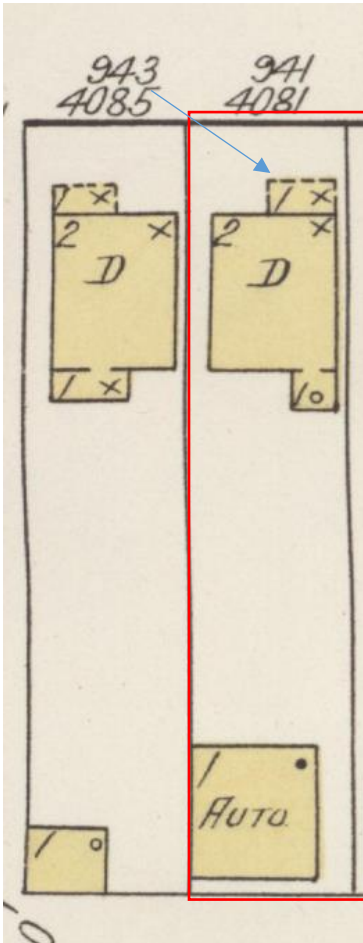
1921 Sanborn map

- Please see the below Sanborn Fire Insurance maps which indicate that the front porch was open in 1921, 1951, and 1971 (4081 Porter is outlined in red, blue arrows show porch)
