STAFF REPORT: OCTOBER 9, 2024, REGULAR MEETING

APPLICATION NUMBER: HDC2024-00490

ADDRESS: 15035 GRANDVILLE

SCOPE: REPLACE WOOD WINDOWS WITH VINYL WINDOWS

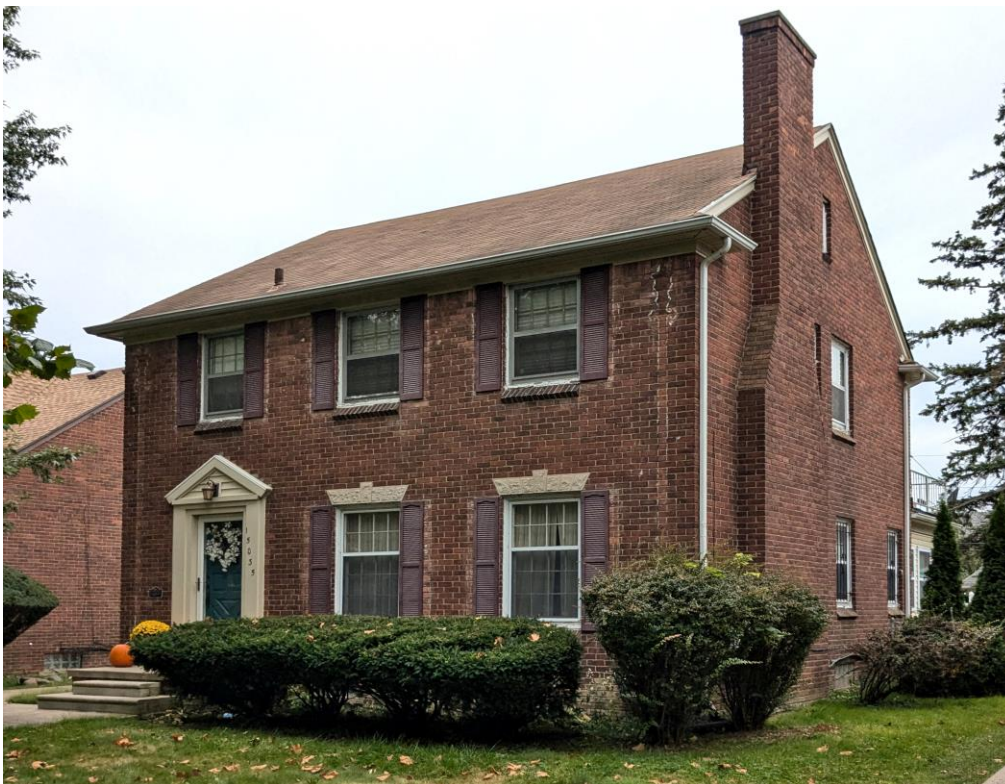
The subject building is a two-story house built in 1937 and facing east onto Grandville Avenue. It is a Colonial Revival, three-bay, side-gable house with a prominent wall chimney on the north elevation. Other character-defining features include a Classical pediment and pilasters around the front entrance, Classical cornice with returns at the roofline, and, subject of this application, distinctive wood sash windows. On the front façade, windows are eight-over-twelve on the first floor and eight-over-eight on the second floor and feature character-defining, angled rowlock sills and distinctive rusticated, flat-arched lintels with keystones. One small rear (west elevation) window is presently vinyl. A small, enclosed rear porch is clad in vinyl siding and has vinyl windows. The wood windows on the building feature aluminum storms.

September 2024 photo by staff.

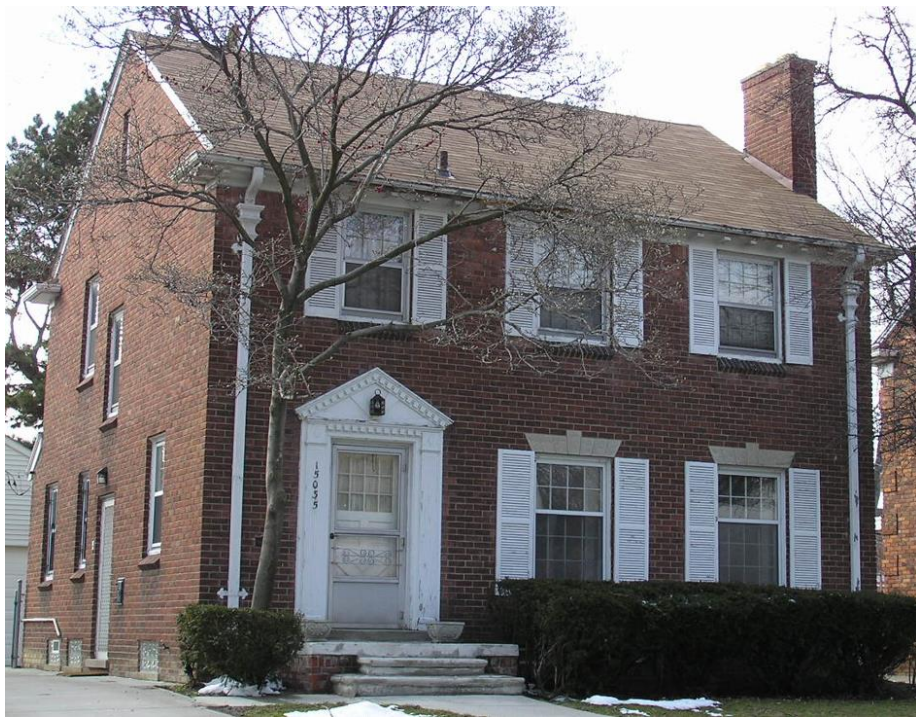
smaller vinyl shutters. This work was done between 2013 and 2018, according to Google Maps image. Sometime between 2007 and 2013, large dentils beneath the roofline and downspouts with prominent collector boxes once existed, both details commonly associated with Colonial Revival architecture and important to the character of the building, were removed. Finally, the entrance pilasters, with capitals, and pediment with distinctive dentil work, were covered in what appears to be vinyl or aluminum.

Circa 2007 photo by the Historic Designation Advisory Board.

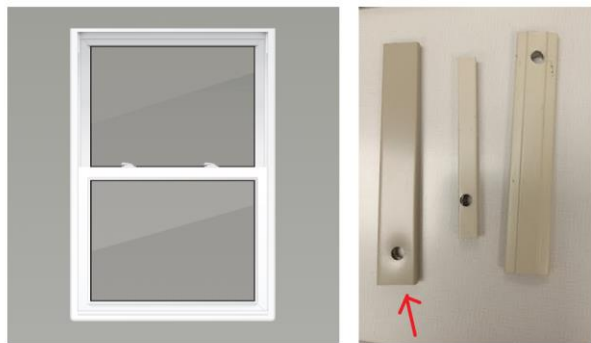
Left: WeatherGard double-hung sash window in white. Image from product website. Right: WeatherGard “flat” between-the-glass grid unit indicated by arrow. Image from applicant.

- The use of between-the-glass grids, rather than true muntins or simulated divided lites, provides a thin and textureless appearance that is noticeably different than that of a historic window.

- The between-the-glass grid pattern is different from the historic configuration. (For example, the eight-over-twelve pattern on the first floor, front façade windows would be replaced with a three-over-six pattern.)

- The proposed windows are vinyl, which is a non-historic material with a noticeably different finish and sheen than historic wood, and therefore contrary to Standard #6.

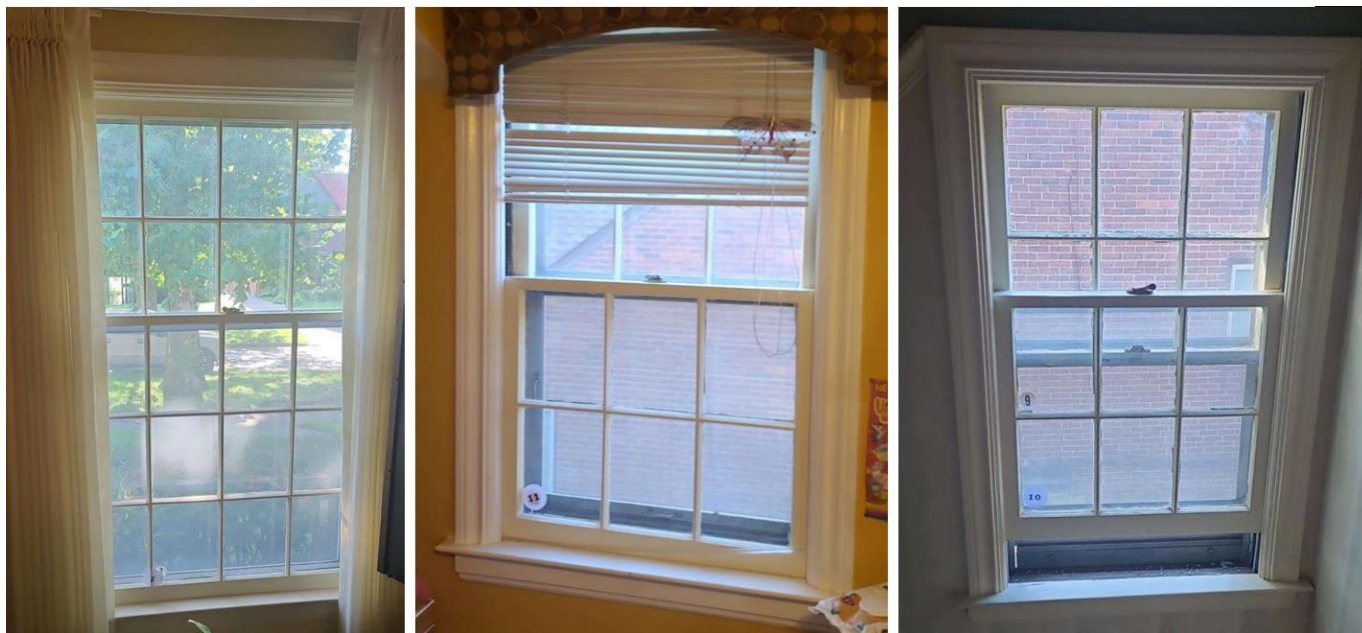
- The windows proposed for replacement are almost certainly original to the building, based on materials and style. Unambiguously character-defining: they are subdivided, as described in the Elements of Design, adding textural interest to the façade; further, sash windows are an important component of the building’s Colonial Revival style.

- Photos provided by the applicant do not show visible deterioration of the windows other than relatively small areas of peeling paint.

Example photos from application materials, arranged and cropped by staff.

Therefore, staff recommends that the Commission issue a Denial as the proposed work fails to meet the Secretary of the Interior’s Standards for Rehabilitation, in particular:
