STAFF REPORT: NOVEMBER 13, 2024 REGULAR MEETING

APPLICATION NUMBER: HDC2024-00458

ADDRESS: 4815 FULLERTON

SCOPE: REPLACE WOOD WINDOWS AND VINYL WINDOWS WITH VINYL WINDOWS

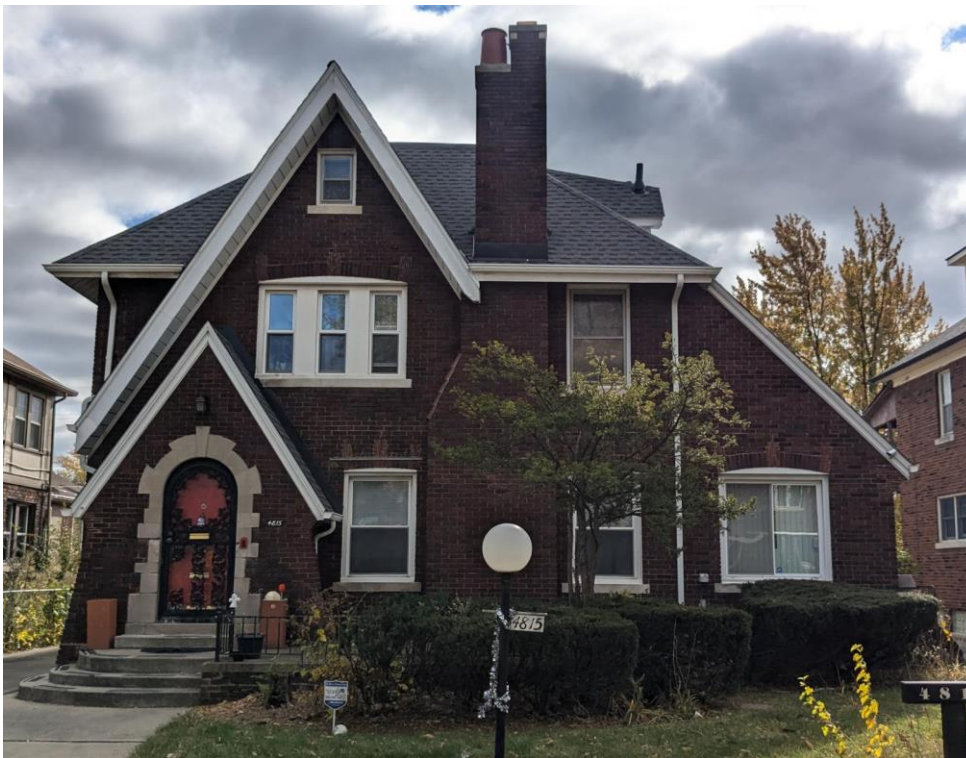
4815 Fullerton is a two-story, Tudor Revival house clad in dark brown brick. It was built in 1926. Character-defining features include its overall massing with nested, front-facing gables, a broad wall chimney on the front façade, and entry pavilion with tabbed stone surrounding a Tudor arch. Prior to the 1999 designation of the Russell Woods-Sullivan Historic District, a few non-historic alterations diminished the building's historic character. Many windows have been replaced with vinyl, especially on the front (north); windows on the sides and rear are mostly wood. A wide opening on the second floor, front façade, that likely once contained wider steel casement windows or mullioned wood windows, was reduced by the installation of narrower, vinyl windows. Vinyl soffit panels were also added.

November 2024 photo by staff.

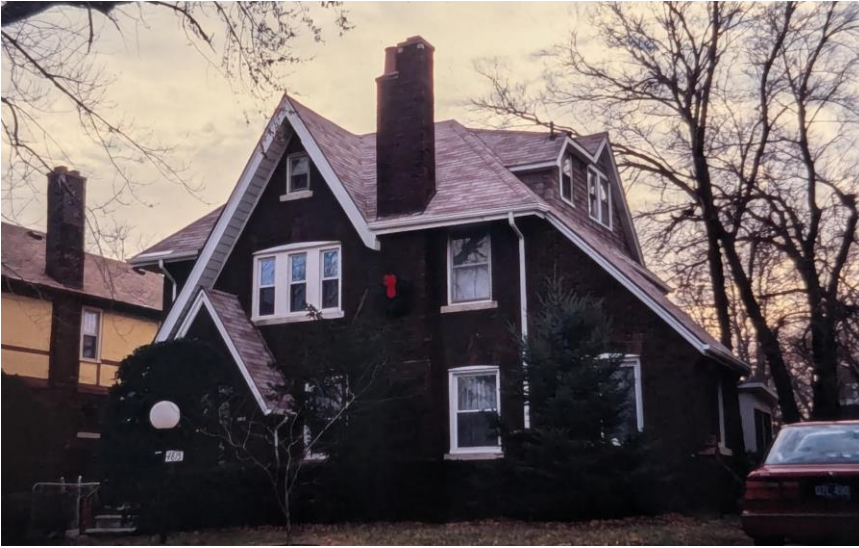
1999 photo by the Historic Designation Advisory Board.
