ADDRESS: 14528 ASHTON DRIVE

APPLICATION NO: HDC2025-00024

HISTORIC DISTRICT: ROSEDALE PARK

SCOPE: REPLACE FRONT PORCH, ALTER DRIVEWAY AND WALKWAY

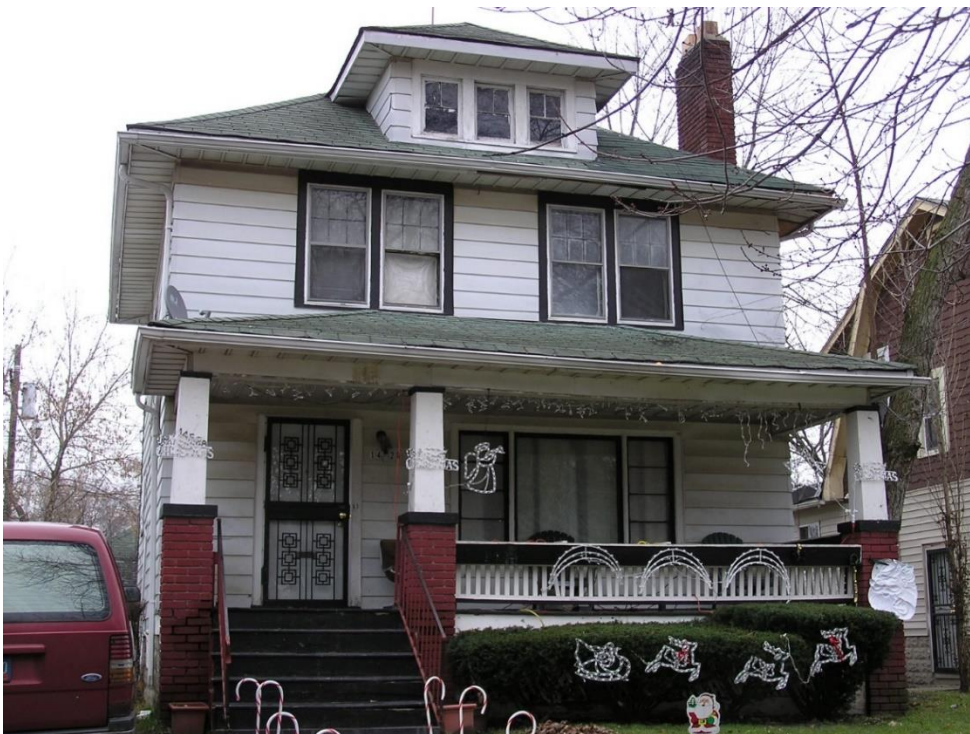
14528 Ashton, designation photo facing east. HDAB staff, 2008. Note wood railing decking, and steps. Handrails are metal.

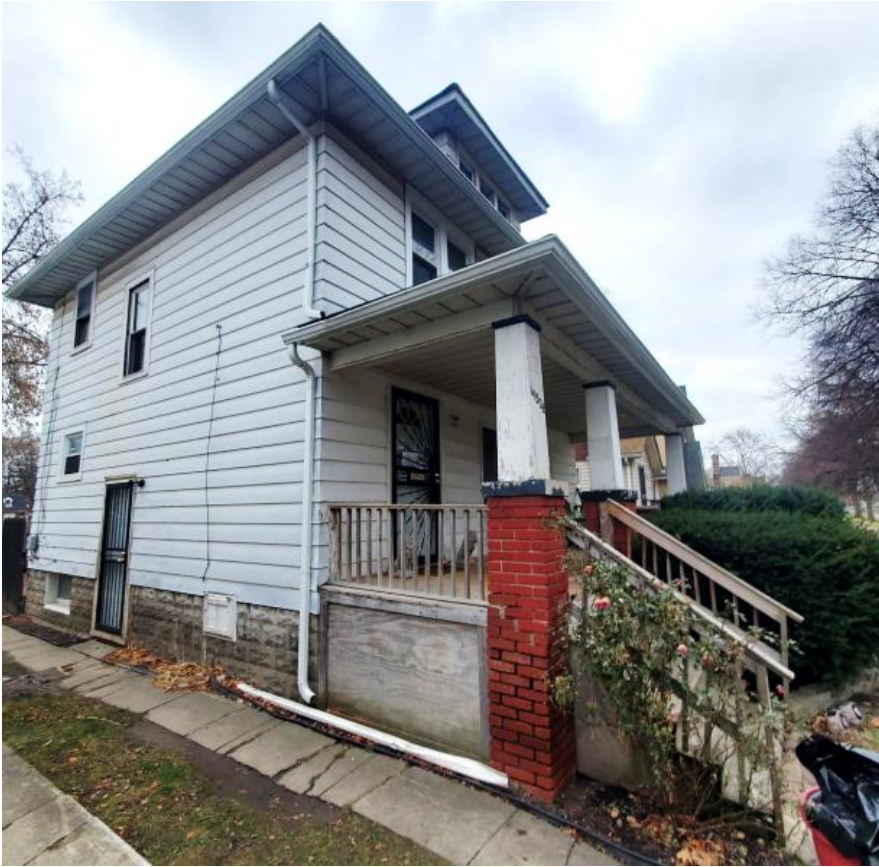
14528 Ashton, facing southeast. Photo by applicant showing current conditions. Note the wood railing, steps, skirting, and decking which were added without HDC approval in 2016.

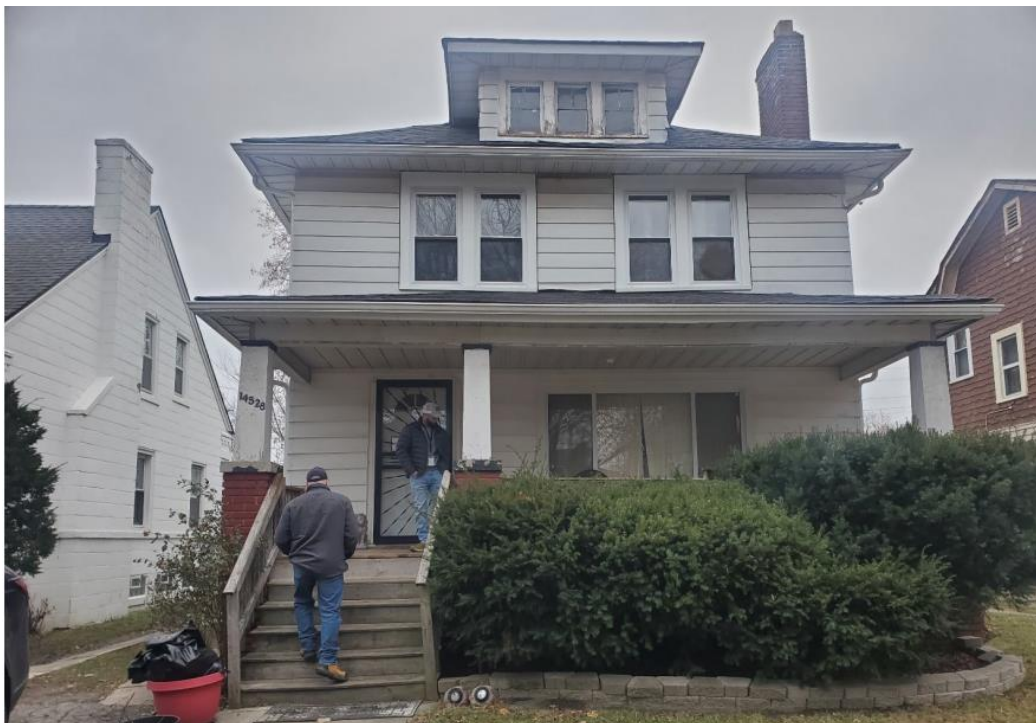
14528 Ashton, facing east. Photo by applicant showing current conditions. Note the wood railing, steps, skirting, and decking which were added without HDC approval in 2016. Also, note the non-historic masonry paver edging at foundation planting

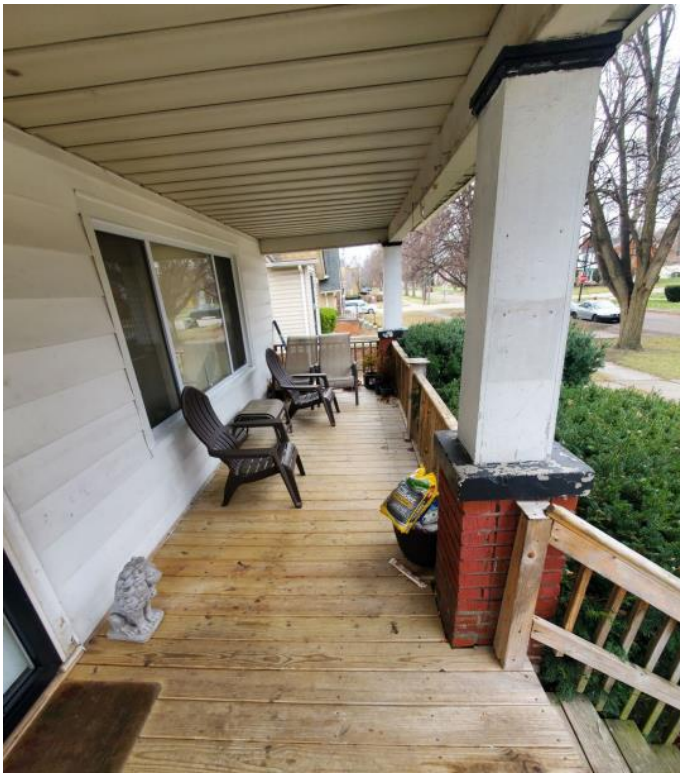
14528 Ashton, facing south. Photo by applicant showing current conditions. Note the wood railing, steps, skirting, and decking which were added without HDC approval in 2016. Also, note the non-historic masonry paver edging at foundation planting

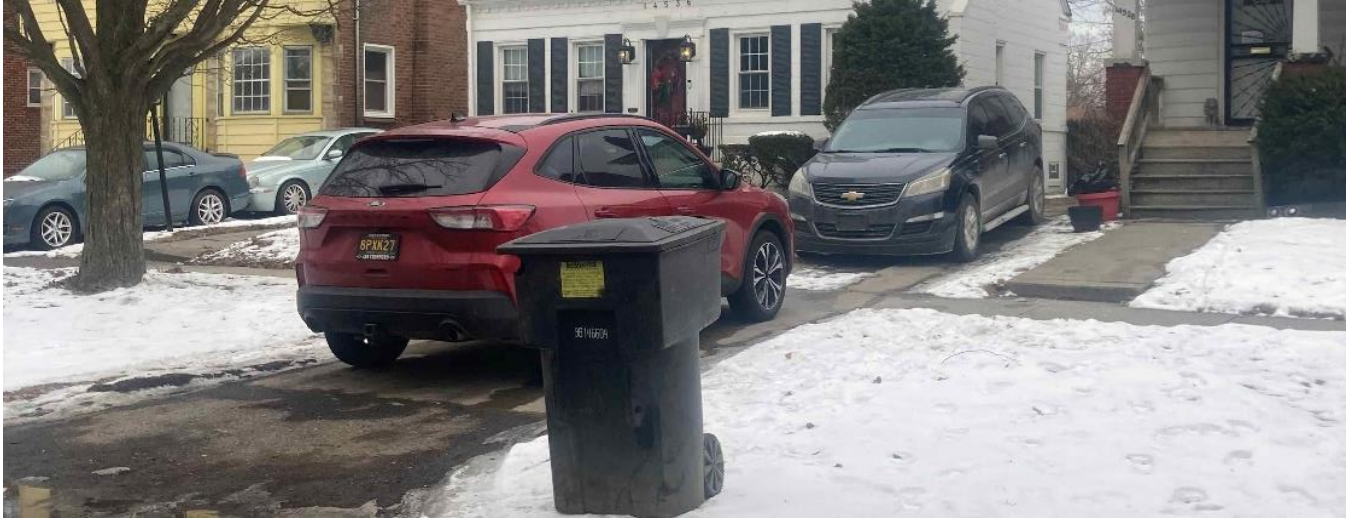
- Staff does note that the majority of properties within the near vicinity of the subject property have full/single slab driveways, with a smaller number of two-track/ribbon driveways. The width (single width), material (concrete), and location (side) of the nearby driveways is generally consistent with 14258 Ashton's.
- As two cars were parked in the driveway, staff was unable to fully document its condition during the 1/2025 field visit. However, see the below Google Streetview images of the driveway from 2009 (one year after the district's designation) and 2015 and note that it is in poor condition as a large portion was patched with asphalt and the concrete ribbons are cracked/broken throughout.

14528 Ashton, facing northeast, showing driveway. HDC staff photo taken on 1/28/202

- Staff recommends the replacement of the driveway as proposed for the above-listed reasons
- As previously stated, the current application proposes installing cement fiber panel skirting to replace the existing T1-11/plywood skirting which was added without HDC approval. The applicant has stated that fiber cement was selected because the material would provide better resilience to weather than wood. Regarding the new skirting:

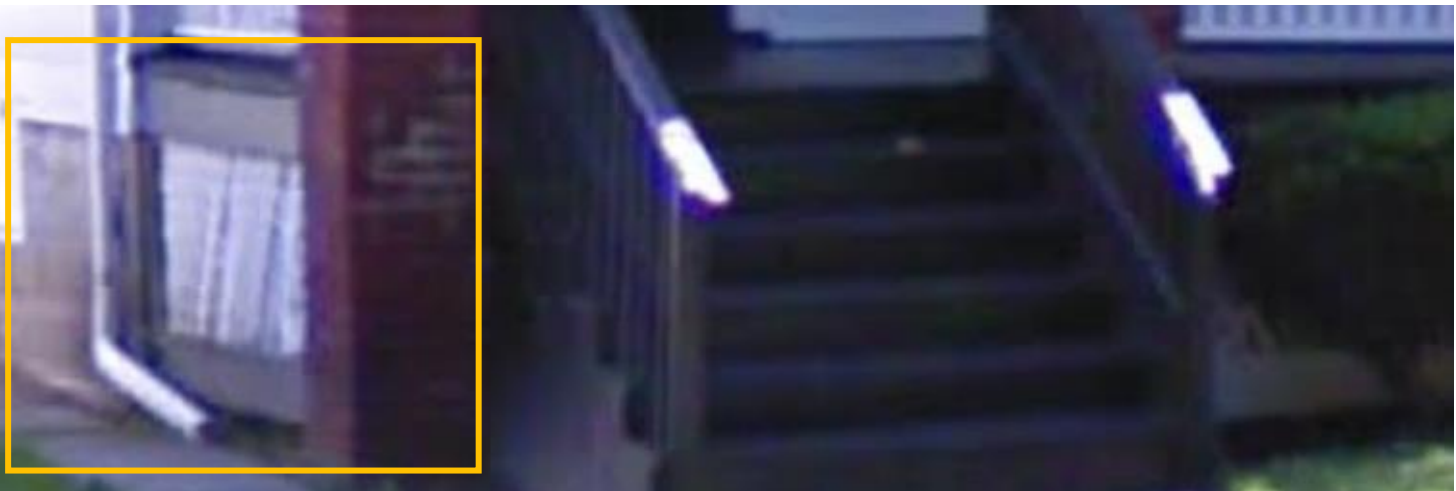
- See the below photo, which indicates that a wood, lattice type skirting, which appeared to be in poor condition, was present in 2009. As previously noted, this skirting was removed without HDC approval in 2016 and replaced with the current T1-11/plywood skirting. It is staff’s opinion that the lattice skirting present in the 2009 image likely did not date to the house’s original construction as it would be uncommon for porch skirting of this type and material to withstand long-term exposure to weather/the elements. Staff therefore supports the current proposal to install a new skirting of a compatible appearance which is made from a material that provides better resilience to weather than wood

14258 Ashton, Google Streetview image, 2009. This wood lattice skirting (outlined in orange) was replaced without HDC approval in 2016.

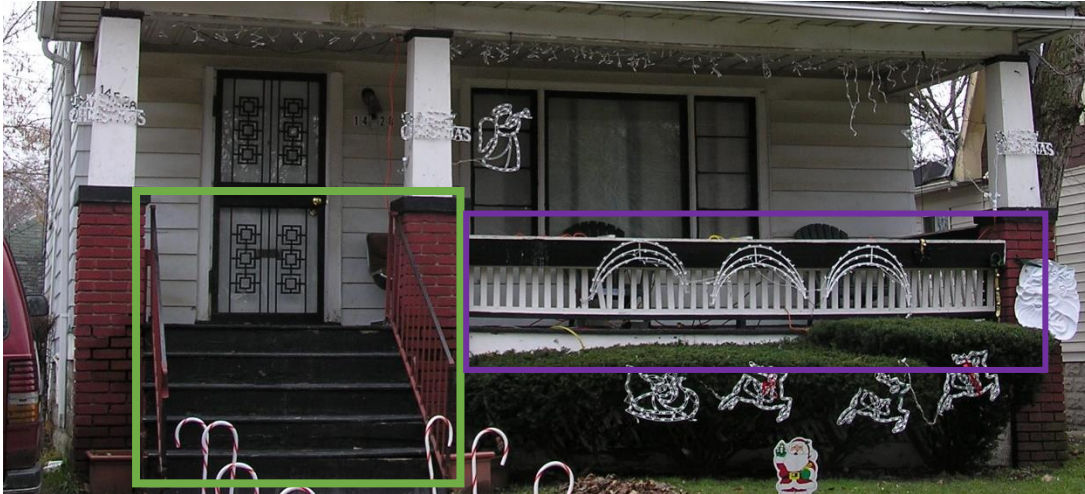
- As noted above and demonstrated in the below designation photos, the porch had wood guardrails and metal handrails at the time of the district's designation. The below Google Streetview image, taken in 2009, illustrates the dimensions, type, style, and material of the guardrails that were present at the time of designation and removed without HDC approval. Note that the metal handrails which appear in the designation photo appear to have been replaced without HDC approval with wood handrails by 2009. The wood guardrails were replaced in 2016 without HDC approval.

14528 Ashton porch, 2008 designation slide. Source, HDAB. Note the wood guardrails, steps, and flooring. The handrails (outlined in green) are metal while the guardrails (outlined in purple) are wood.

- The porch's new guardrails (railing which lines the perimeter of the porch deck) shall be wood and match the style of the historic railing that was present at the time of the district's designation. The railing height shall be no higher than the minimum required by building code (36") because the railing height is a historically significant feature of the house. HDC staff shall be afforded the opportunity to review and approve the new railing design prior to the permit's issuance.
- ~~New landscaping shall be planted to replace the shrubs at the front of the porch which shall be removed as a result of the proposed porch rehabilitation. HDC staff shall be afforded the opportunity to review and approve the new foundation plantings prior to the permit's issuance.~~

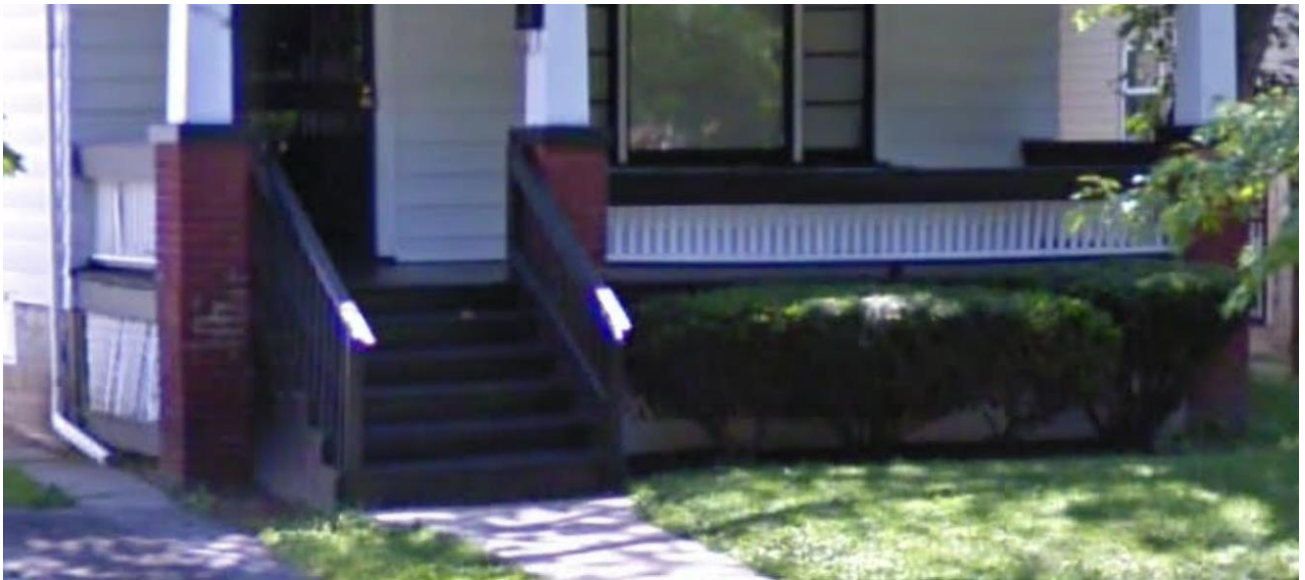
14528 Ashton porch, 2009 appearance. Source, Google Streetview. Note the wood guardrails, steps, and flooring. Also, wood lattice skirting is also visible. However, the metal handrails have been replaced with wood handrails by this point.
