**STAFF REPORT:** FEBRUARY 12, 2025 MEETING  
**APPLICATION NUMBER:** HDC2024-00594 (garage), HDC2024-00709 (doors)  
**ADDRESS:** 19410 WARRINGTON  
**HISTORIC DISTRICT:** SHERWOOD FOREST  
**APPLICANT:** DEJUAN MCCLENDON  
**PROPERTY OWNER:** DEJUAN MCCLENDON  
**DATE OF PROVISIONALLY COMPLETE APPLICATION:** JANUARY 21, 2025  
**DATE OF STAFF SITE VISIT:** JANUARY 24, 2025

**SCOPE:** EXPAND/ALTER GARAGE, REPLACE FRENCH DOORS

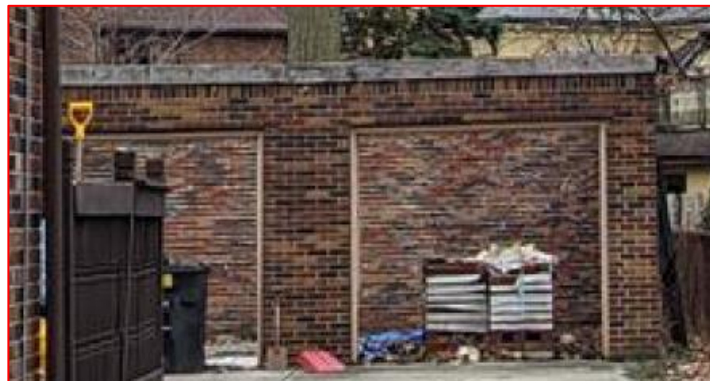
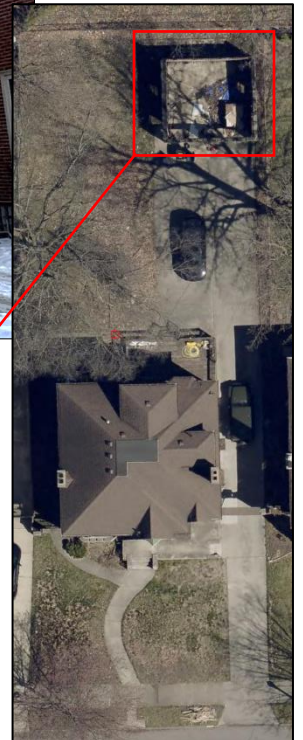
The freestanding two-car garage is located at the northeast corner of the lot; the roof and overhead garage doors have been removed.

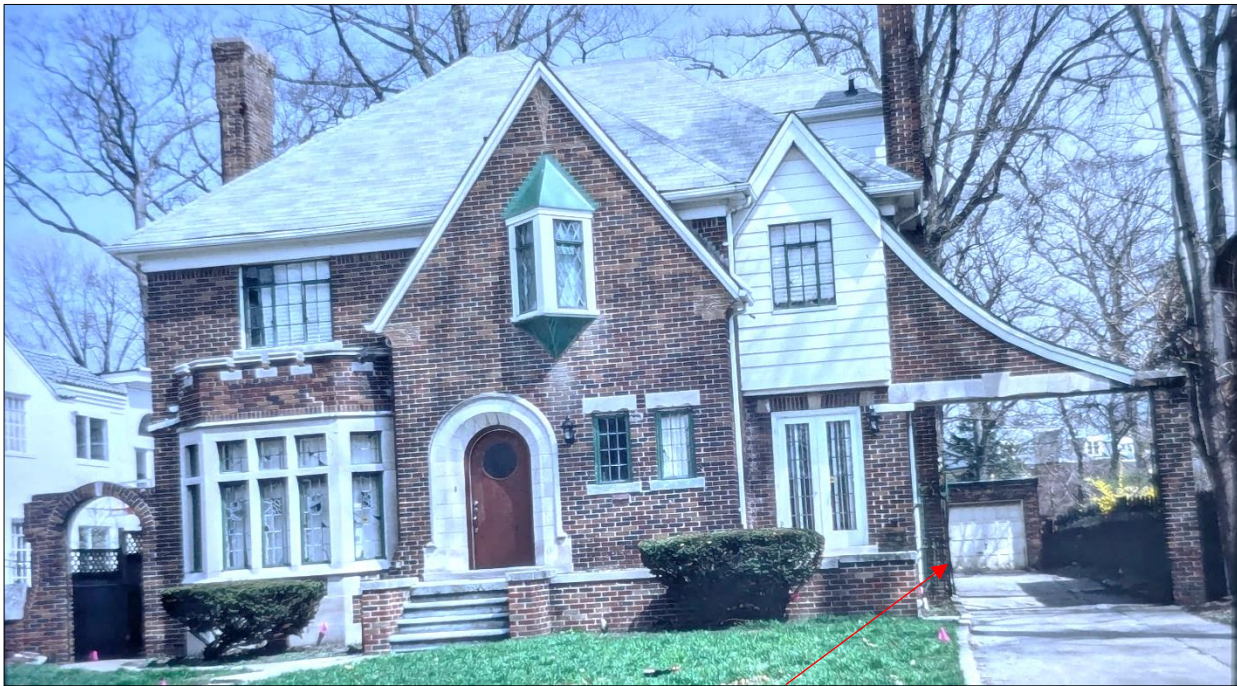
Designation photo, 2002. HDAB. This view shows a portion of the garage, which had a flat roof and wood paneled doors.

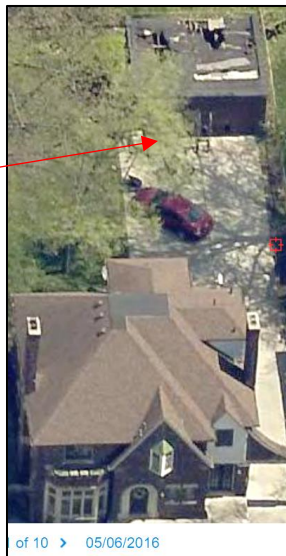
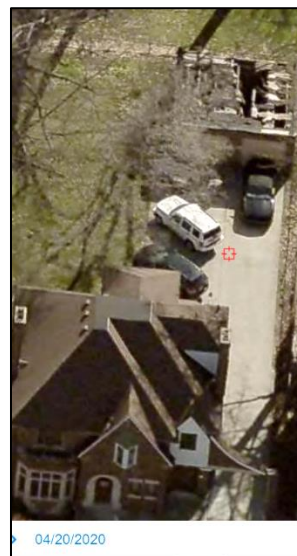
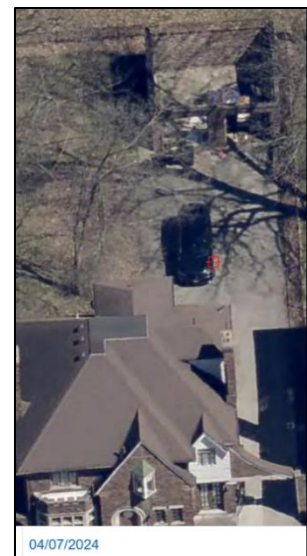
Right: Aerial views – 2016, 2020 and 2024. EagleView.

- The garage has brick veneer that matches the main house, but that is the only material and design component connecting the garage to the house. The (original) flat roof and lack of applied architectural details are a sharp contrast to the house’s steeply pitched and multiple gabled roof and highly ornamented facade.
- These aerial views show the garage roof was highly deteriorated by 2016; and a hole in one of the overhead doors is visible in the photo. By 2020 the roof had mostly collapsed. It was fully removed, along with the overhead doors, by 2024.

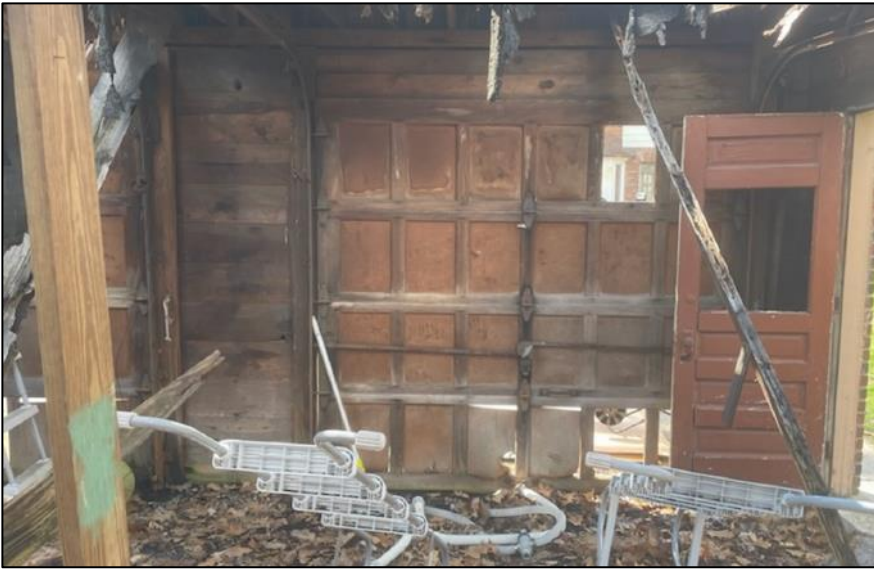
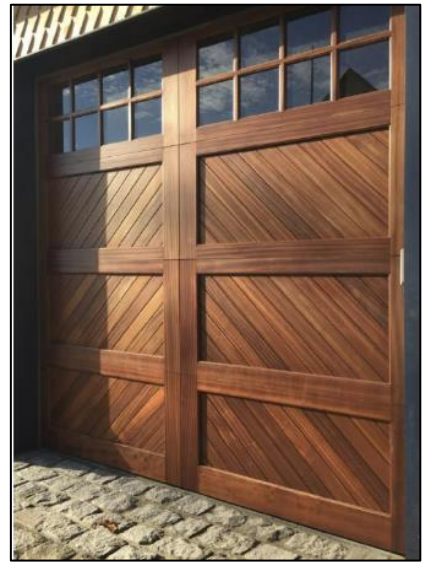
*Applicant photos*

- Above is an interior image of one of the deteriorated overhead garage doors prior to its removal.
- It is staff's opinion that the removal of the paneled doors and flat roof did not alter the features and spaces that characterize the property.

- While the garage has lost some of its integrity, the retention of the masonry-clad walls and individual garage door openings are distinctive features that allow the structure to remain relatable to the house and property.

- The applicant proposes installing new wood, stained finish, overhead doors. Staff believes the doors are compatible with the garage's design and date of construction, however historically these doors have been painted to match the wall's clapboard siding and/or trim.

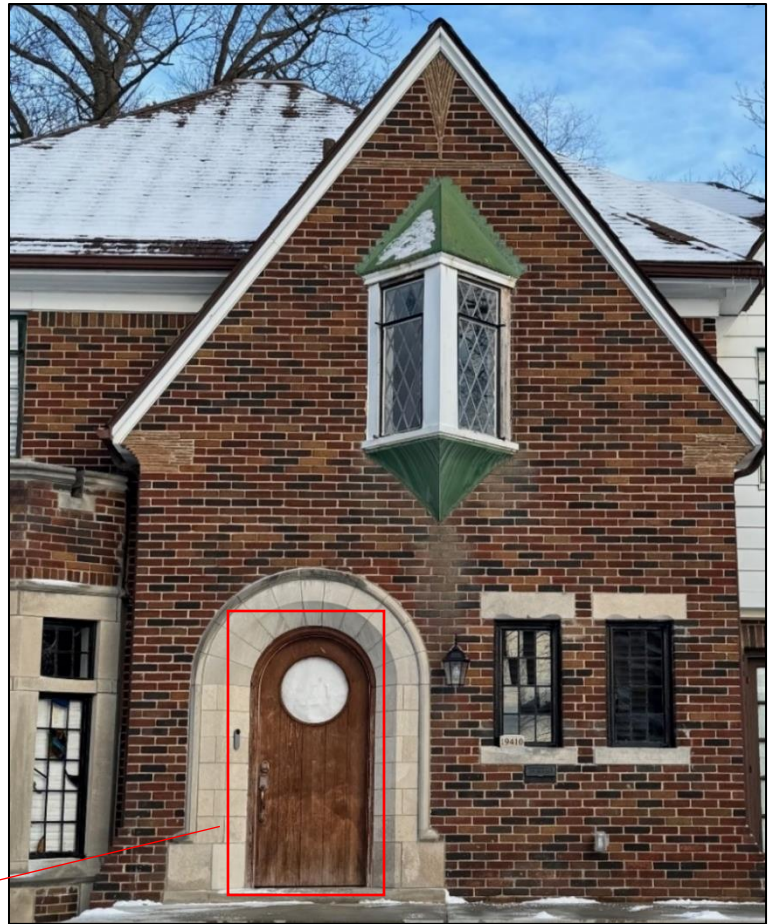
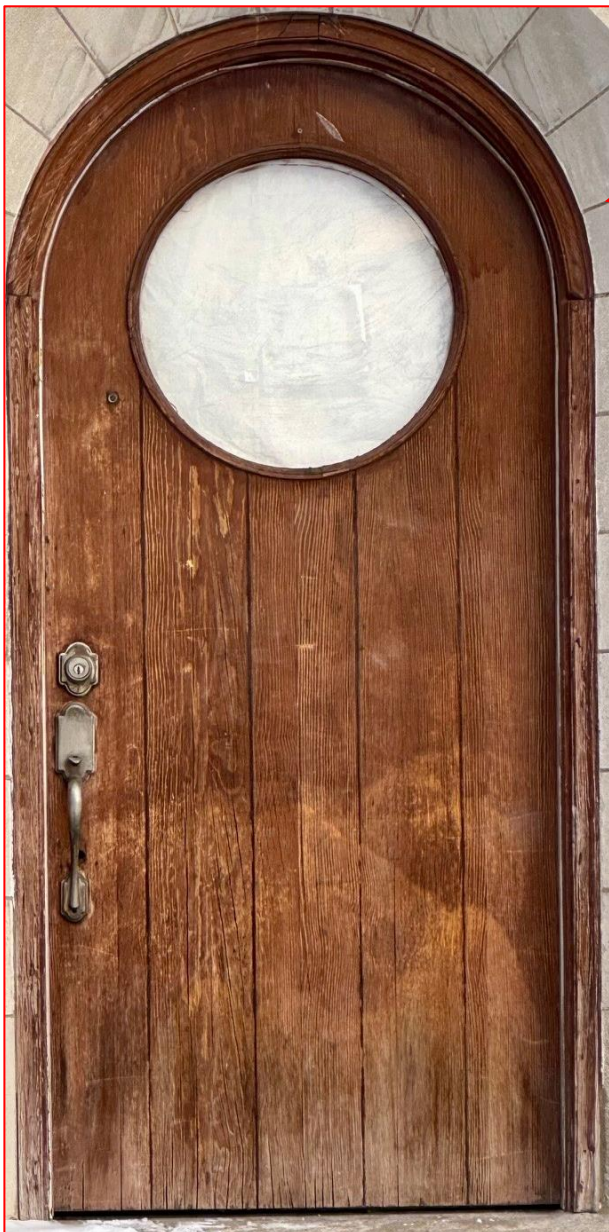
- It is staff's opinion that the existing entry door might not be the original historic door due to its texture and visual appearance:
  - Clear glass in the round opening (staff does not know if it ever contained decorative glass, this glass was in place at the time of designation).
  - No evidence of a mail slot, a common feature on many early 20<sup>th</sup>-century front doors.
  - The materiality and finish of the wood door and lock and handle appear to mimic historic components, but don't match the patina of aged early 20<sup>th</sup>-century doors and hardware.
- Staff reviewed the selected replacement doors submitted by the applicant. Staff believes the one included on this page (door only – not the wood trim/surround) is a compatible option, as it is consistent with the general characteristics of this house and its period of construction.

*Above and left: Staff photos of the existing door.*

- Smooth-faced clapboard siding is used on the garage's gable walls.
- The garage doors will be painted; the color will be submitted for review by HDC staff.
- The front door will be the stained wood door with arched leaded glass opening. Should another door be considered by the applicant, it will be submitted to staff for review.

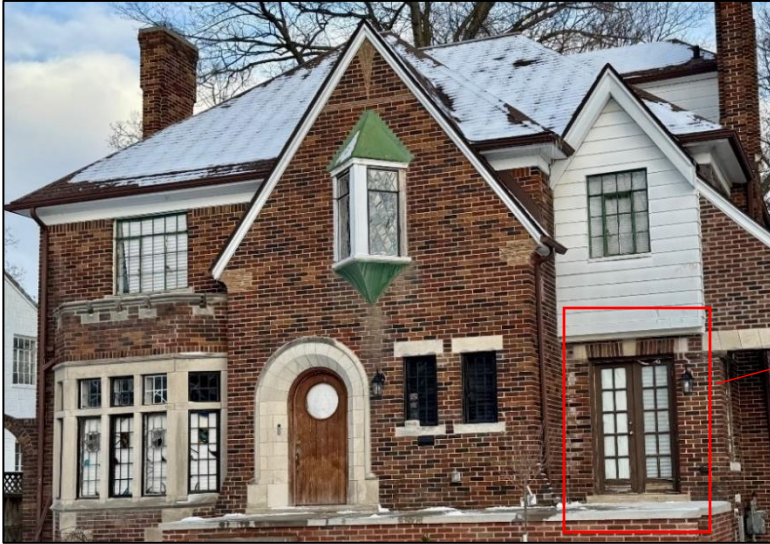
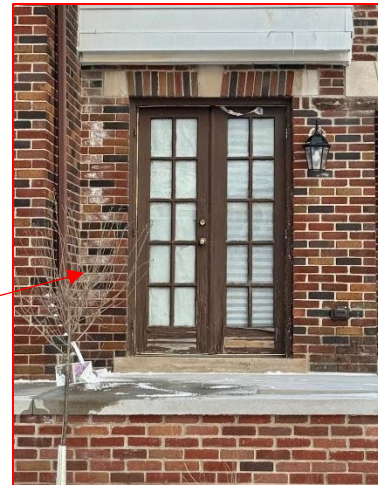
*Staff photos.*

- The existing wood French doors have wood muntins that create a glass pattern that is 2-wide by 5-high.

- Staff didn't find record of an application/approval for the replacement of the original French doors, which were a distinctive character-defining feature of the house. Therefore, the scope of work that would meet the requirements of the historic ordinance (Section 21-2-59(e)) is the fabrication of new wood frame, leaded glass French doors (with an identical pattern) at the first floor of the façade.

- If the Commission considers not requiring wood frame leaded glass French doors at this opening, it is staff's opinion that wood (not aluminum-clad) French doors, with true or simulated divided-light glass that match the existing design and pattern of the wood French doors, would be the most compatible solution.

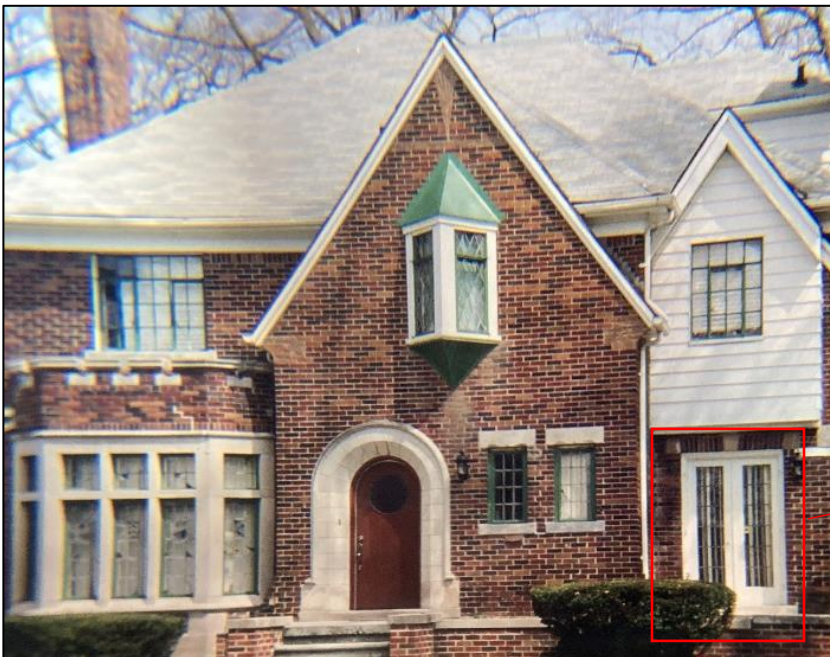
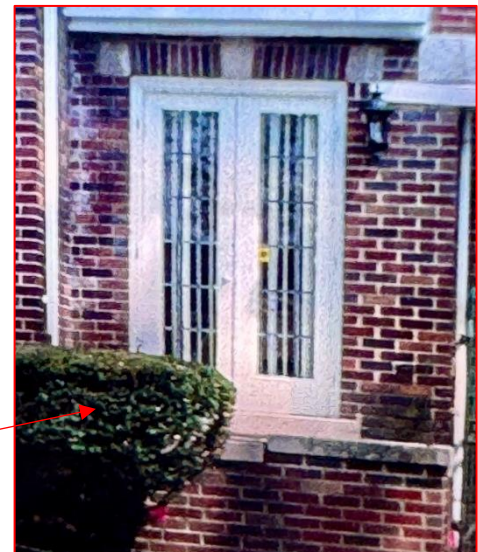
*Designation photo.*

- Staff identified different doors in place at the time of designation. Looking at the thinness of the muntins and different number of glass panels (2-wide by 6-high), it is staff's opinion the doors featured leaded glass.

- The historic wood French doors were a distinctive character-defining feature of the house, and their removal and replacement were not approved by the Commission. Therefore, the scope of work that would meet the requirements of the historic ordinance (Section 21-2-59(e)) is the fabrication of new wood frame leaded glass French doors with an identical pattern as seen in the designation photo.
- The French doors proposed by the applicant are a contemporary design and not consistent with the general characteristic of doors of this type and period and are not compatible with the overall historic character of the dwelling.
