STAFF REPORT: FEBRUARY 12, 2025 MEETING

APPLICATION NUMBER: HDC2025-00027

ADDRESS: 2277 LONGFELLOW

SCOPE: INSTALL BETWEEN-THE-GLASS GRILLES WITHIN WOOD ALUMINUM-CLAD WINDOWS AT FRONT ELEVATION (WORK COMPLETED WITHOUT APPROVAL)

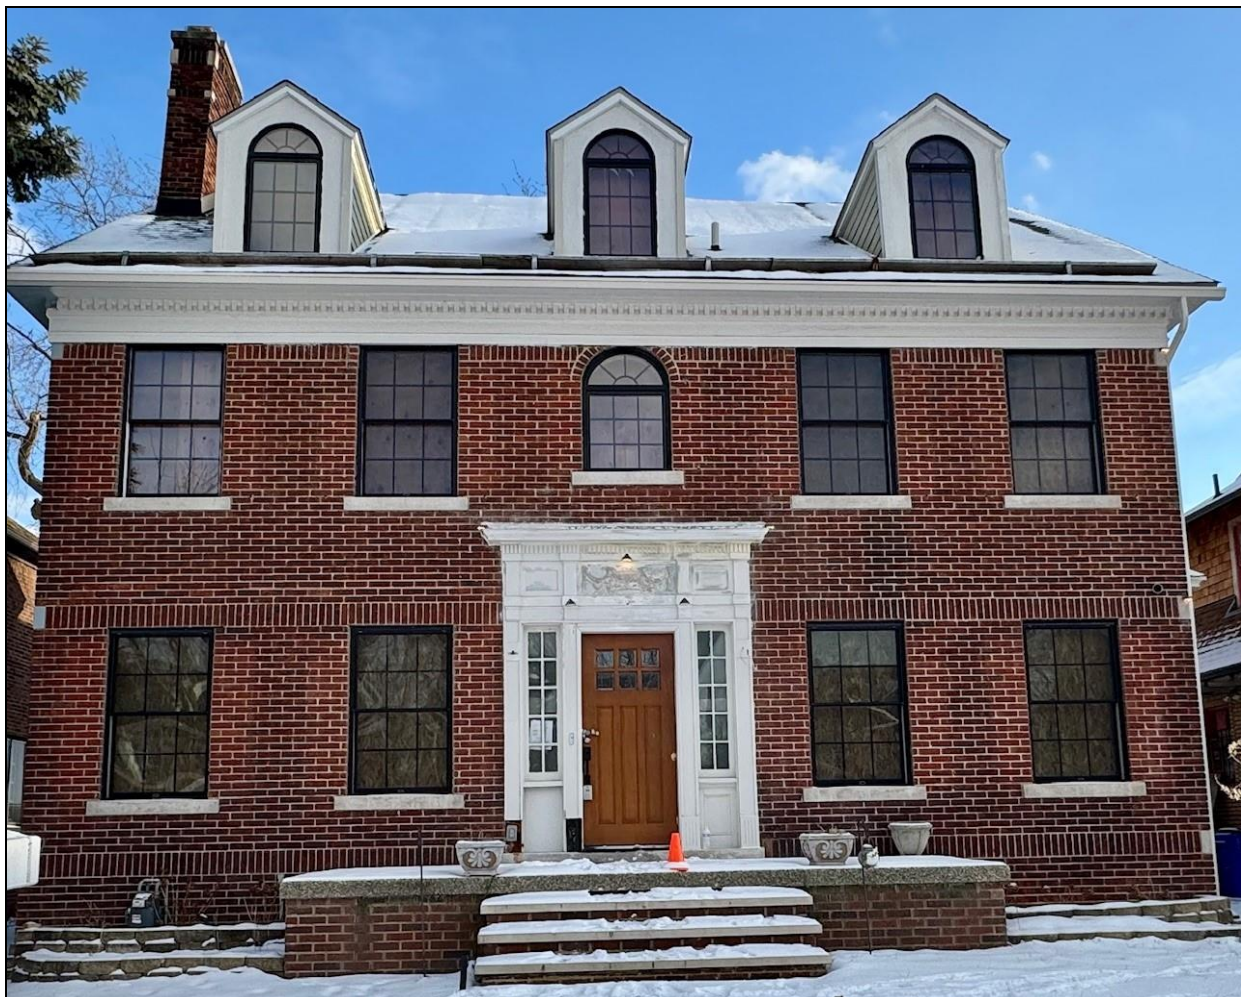
Staff photo, January 24, 2025.

The replacement windows within the first and second floor openings are black, aluminum-clad wood double-hung units with a six-over-six, between-the-glass muntin, pattern. The central window opening over the entrance, along with the three dormer openings, are each comprised of a fixed half-circle unit (with radiant grille pattern) above a (three-over-three) casement unit.

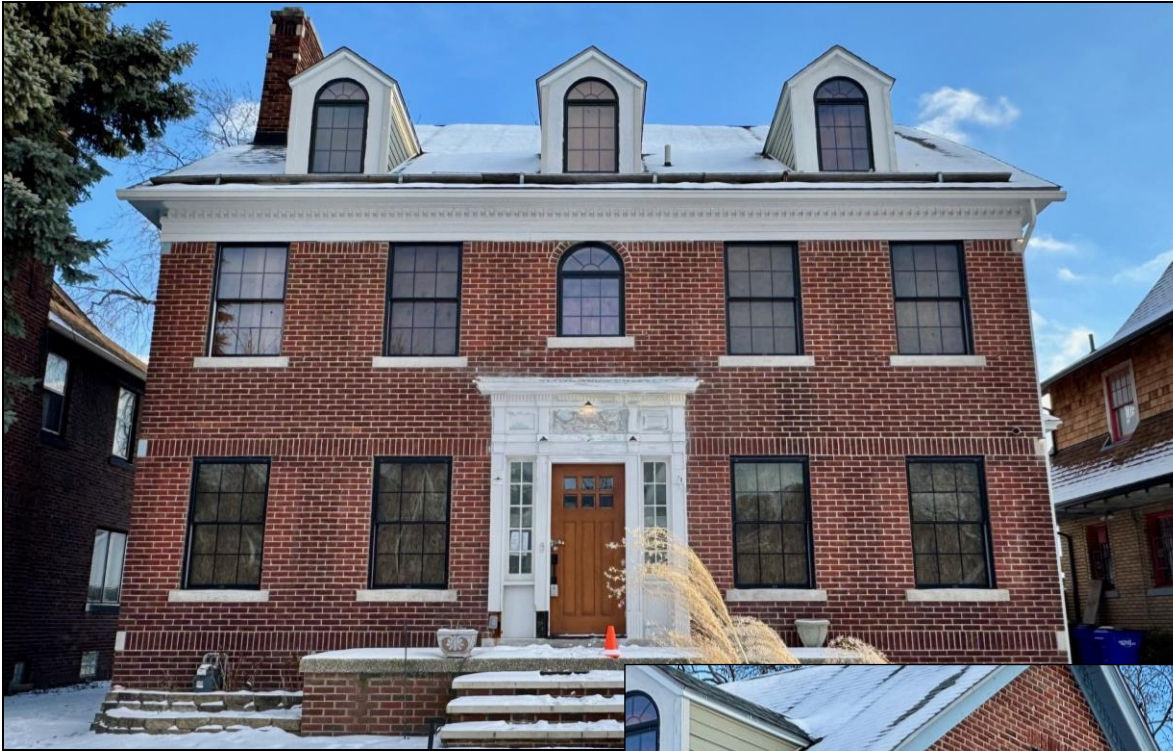
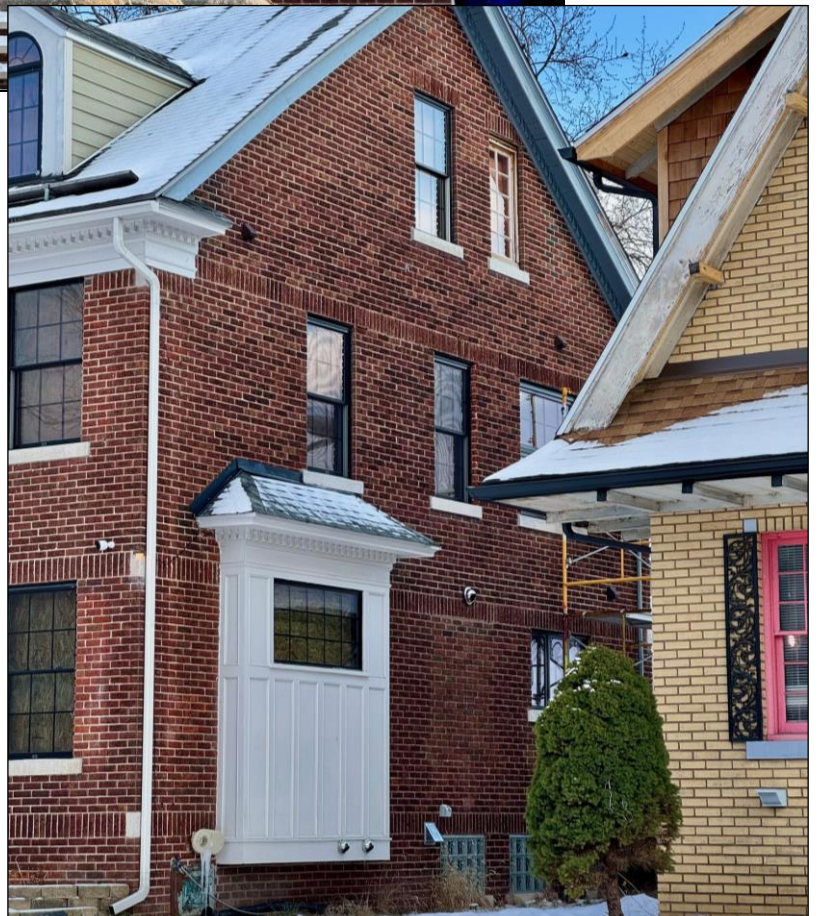
*Above: Façade
Left: right-west elevation.
Staff photos, January 2025.*

- As the Commission approved the replacement windows with the condition the grilles be removed at the front elevation, the existing windows with grilles remain a violation.
- The Commission’s denial of the existing windows was more than one year ago so the applicant is returning to the Commission with the request for approval of the existing windows with between-the-glass grilles.
- The applicant states in the application that the reason for the request is due to the manufacturer confirming that it is not possible to remove the internal grilles from the existing windows. The only way to satisfy the Commission’s decision is to remove the existing windows and install new one-over-one aluminum-clad wood windows.
