STAFF REPORT: FEBRUARY 12, 2025 MEETING

APPLICATION NUMBER: HDC2024-00661

ADDRESS: 258 ELIOT

SCOPE: REPLACE WOOD WINDOWS WITH VINYL WINDOWS (WORK COMPLETED WITHOUT APPROVAL)

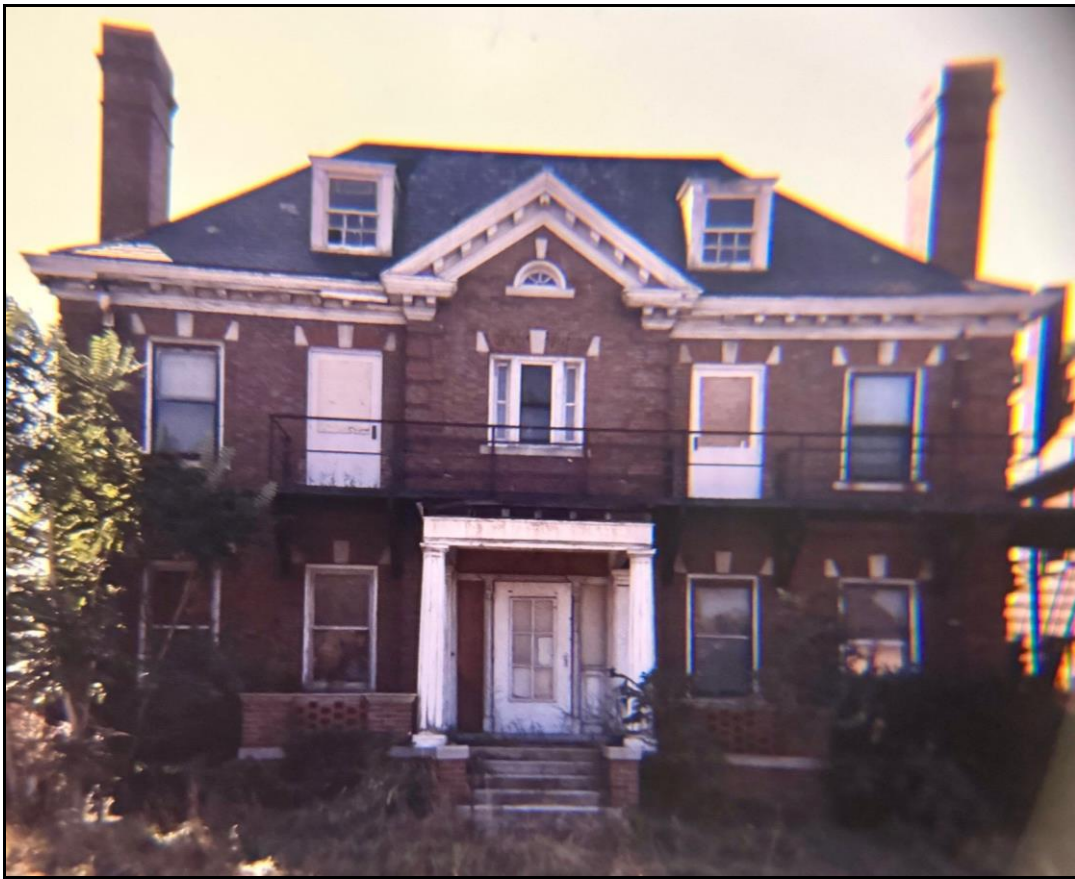
1980 Designation photo, HDAB.

- The designation photo shows several exterior alterations present in 1980, including doors within window openings, a metal balcony/fire escape at the second floor, missing front entry sidelights, and various patterns of double-hung windows.

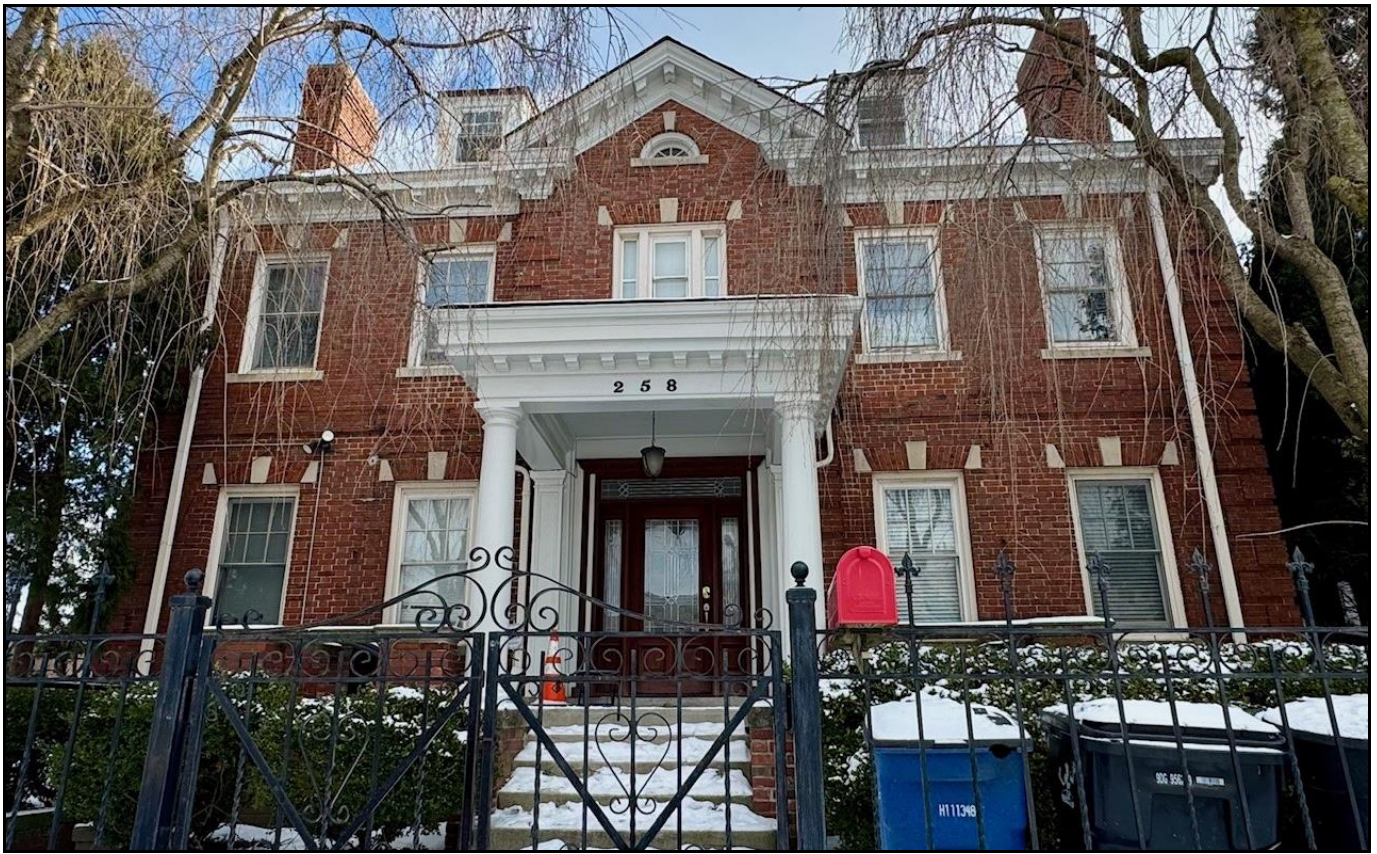
Façade. The windows in the dormers are vinyl replacement units. Staff photo.

- The installed white vinyl windows with between the glass grids, offer a bright white, flat appearance. Additionally, the forward placement of the window sash within the dormers creates an additional flat surface.

Recommendation 1 of 1, Denial: Replace wood windows with vinyl windows

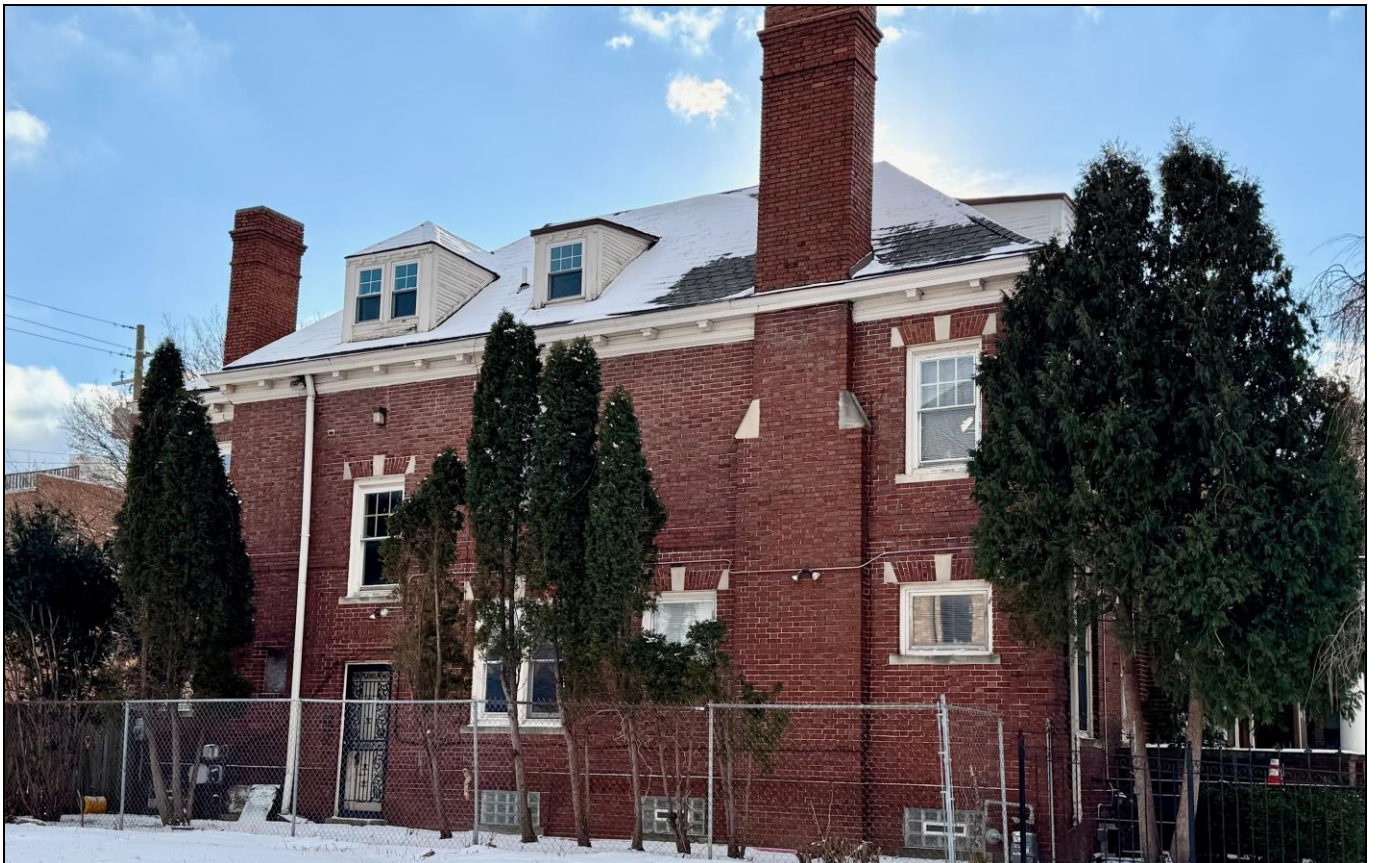
East – side wall. The three windows within the two dormers are vinyl replacement units. Staff photo.

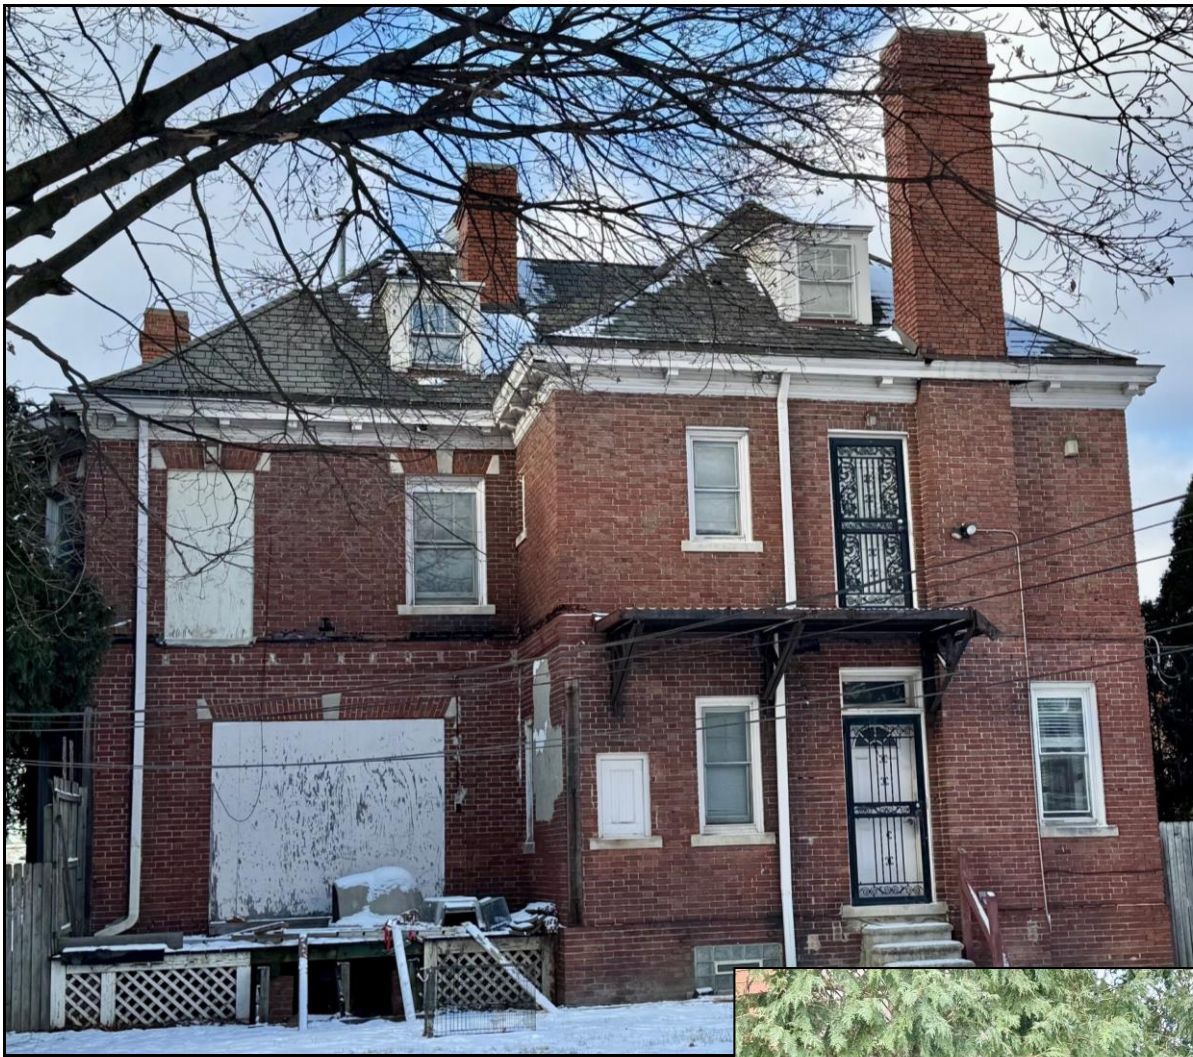
Above: Rear wall of house. The windows in these two dormers appear to be wood. Staff photo, January 24, 2025.

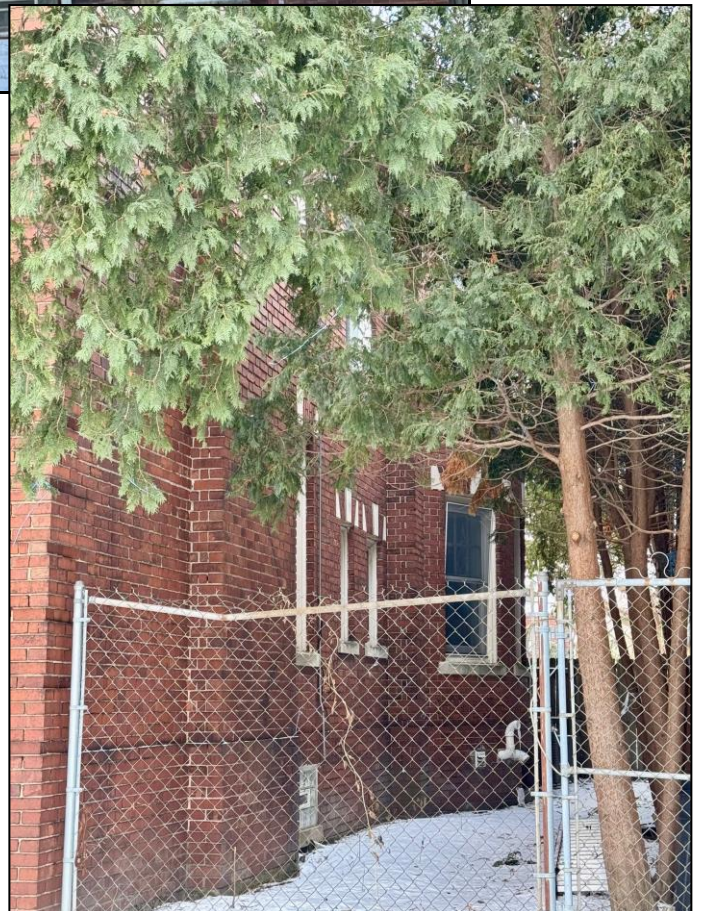
Right: West wall of house is obscured by overgrown trees as well as the adjacent historic house. Staff photo, January 24, 2025.

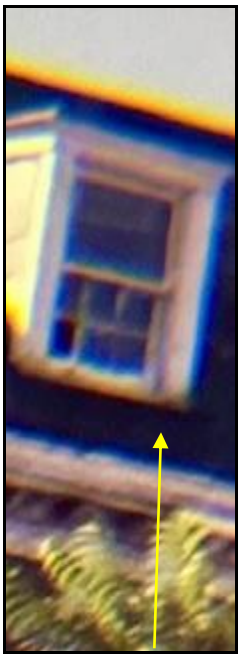
Although blurry, this magnified view of a front-facing dormer at time of designation shows the recessed placement of the window sash. Compare this photo to the one at the far right.

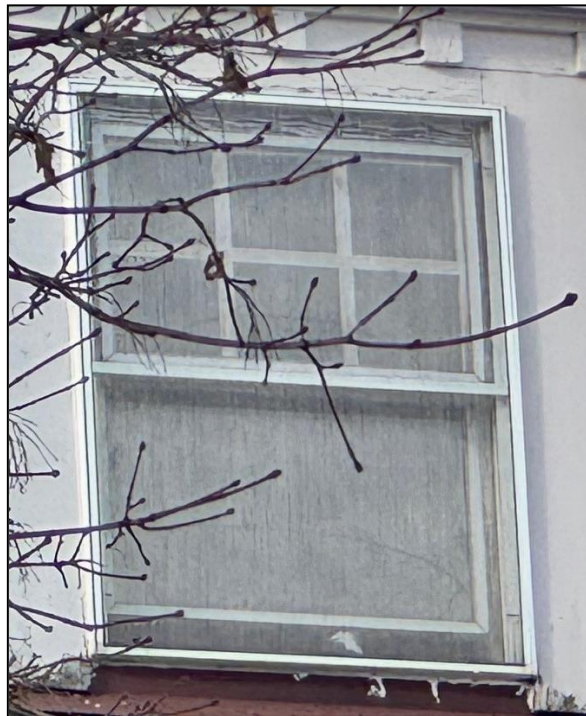
This photo is of a dormer on the rear of the house. The wood sash is recessed within the window opening. (This placement is slightly obscured by the protruding aluminum screen frame.) It also appears that replacement glass/flat grids have been installed within the wood sash frame. Staff photo, January 24, 2025.

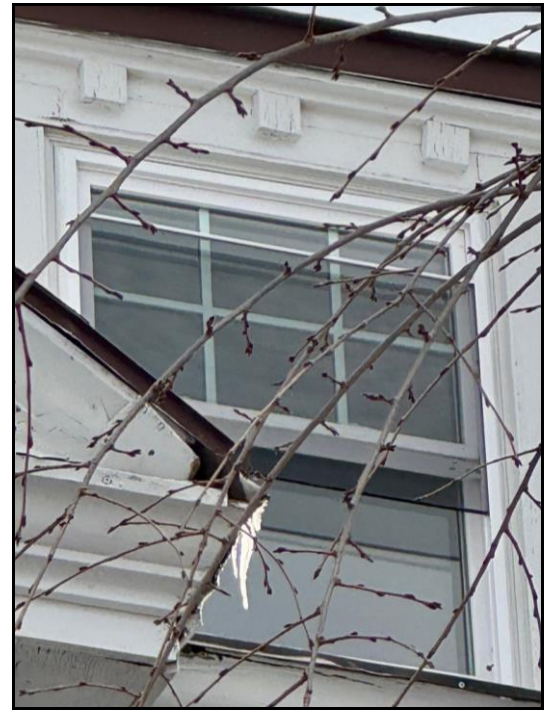
- Placement – Historically, windows are recessed within walls to differing depths, depending on the exterior wall material. Windows within brick clad walls, sit deeply within the window opening, but even with wood framed/clad walls, windows are still recessed from exterior walls. This creates a differential of wall planes, so each element (wall and window) has equal visual impact on an elevation.

This current view of a front-facing dormer clearly shows how the dimensionality of the window and window opening were lost due to the between the glass grids and forward placement of the window sash within the wood-framed dormer. Staff photo, January 24, 2025.
