STAFF REPORT: FEBRUARY 12, 2025 REGULAR MEETING
APPLICATION NUMBER: HDC2025-00015 (VIOLATION #24-835)
ADDRESS: 3774 CORTLAND
HISTORIC DISTRICT: RUSSELL WOODS-SULLIVAN
APPLICANT: KEVIN FUQUA, BLUE WOLVERINE PROPERTIES LLC
PROPERTY OWNER: BLUE WOLVERINE PROPERTIES LLC
DATE OF PROVISIONALLY COMPLETE APPLICATION: JANUARY 16, 2025
DATE OF STAFF SITE VISIT: JANUARY 31, 2025

SCOPE: REPLACE WOOD WINDOWS WITH WOOD AND VINYL OR ALUMINUM-CLAD WOOD WINDOWS (WORK BEGUN WITHOUT APPROVAL)

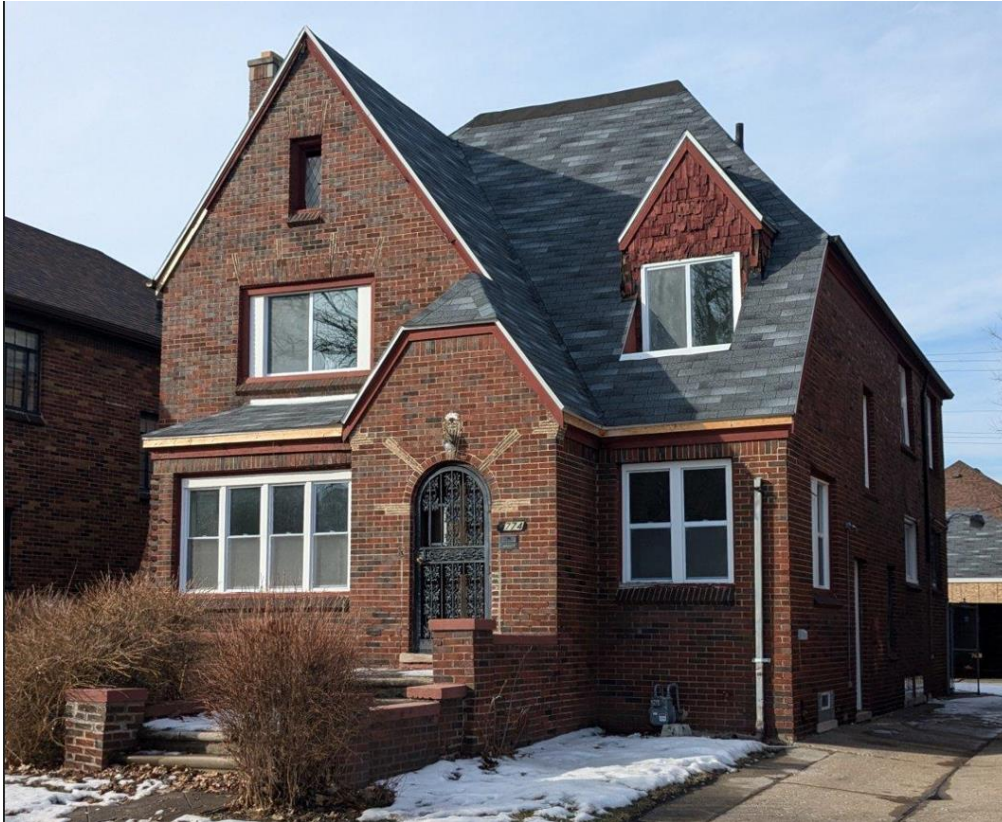
January 2025 photo by staff.

The house at 3774 Cortland is a one-and-one-half-story, red brick, Tudor Revival building built in 1927. Character-defining features include a complex roofline with a subsidiary front gable, a gable dormer, and a clipped-gable entry pavilion, a round-arched entryway with stone-tabbed surround, and one remaining historic window, a quarrel-pane attic window.

The other historic windows, also important to the building's character, have been removed. The second-floor, front-facing windows had already been replaced prior to the establishment of the historic district in 1999. These were again replaced in early 2024, along with all the other windows, other than the attic window mentioned above; this work was done without approval from the Historic District Commission. Staff became aware of this work in February 2024 and the Buildings, Safety Engineering, and Environmental Department promptly issued a Stop Work order.

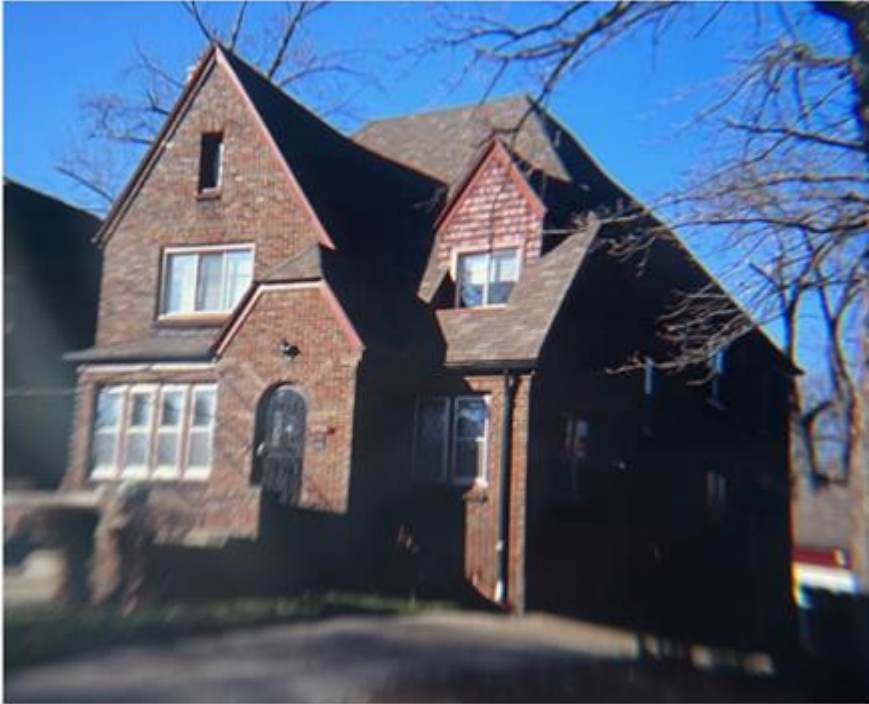
1999 photo by the Historic Designation Advisory Board. Note the windows on the second floor that had been already been replaced prior to the 1999 historic district designation.

- The two, second-story windows on the front of the house had already been replaced when the Russell Woods-Sullivan Historic District was established in 1999. National Park Service guidelines on “replacement windows where no historic windows remain” would apply (See *Replacement Windows that Meet the Standards*, <https://www.nps.gov/subjects/taxincentives/windows-replacement-meet-standards.htm>.) An appropriate window would be “compatible with the overall historic character of the building” and be “consistent with the general characteristics of a historic window of the type and period,” among other concerns. Based on the period of style of the house, and on the Elements of Design quoted above, staff suggests that mullioned groupings of two or three windows would be an appropriate means of filling each opening. These windows may be casement or double-hung sash windows, most likely in wood.

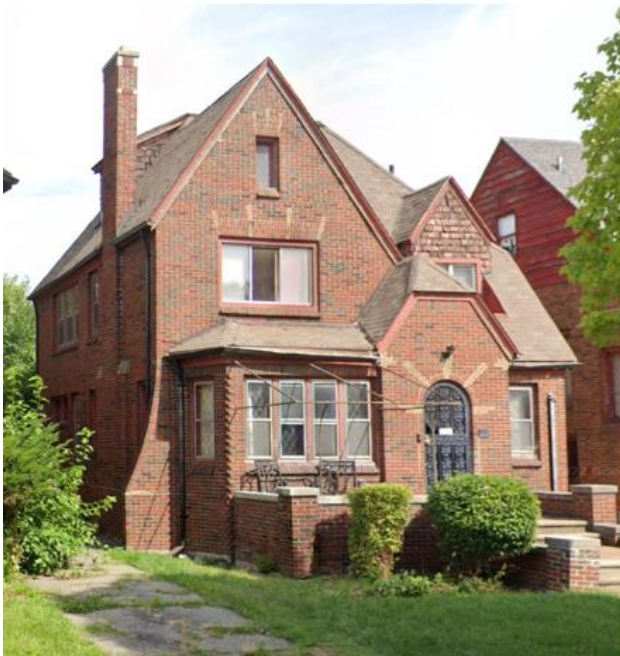
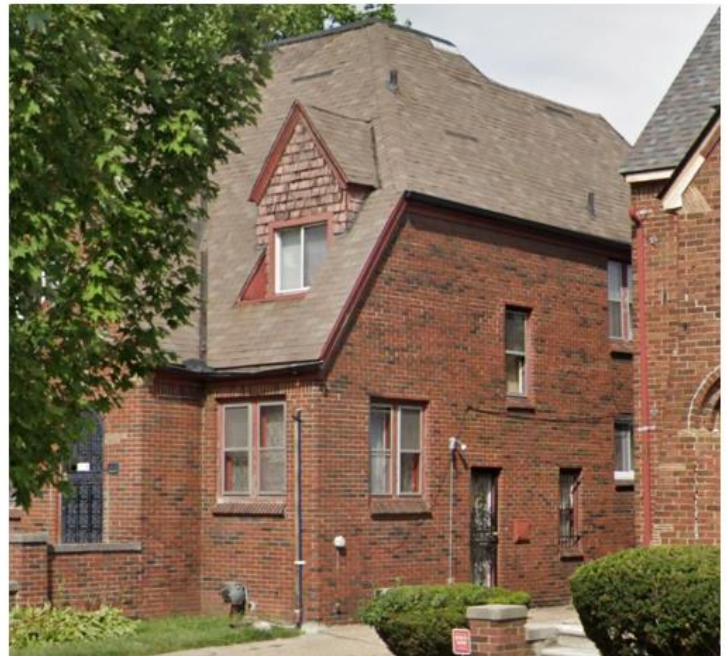
Left: 2018 photo from Google Maps, showing the condition prior to the unapproved work. It appears that there were six diamond-pane windows total: five on the front elevation, first floor, and one on the west face of the first-floor box-bay window.

- The diamond-pane windows on the first floor, front elevation, were distinctive, character-defining features that were removed without approval. The Secretary of the Interior’s Standards for Rehabilitation, particularly Standard #2 and Standard #5 (quoted below) direct that such features be retained. If they had been deteriorated beyond feasible repair, Standard #6 (also quoted below) directs that they should have been replaced with new windows that match as closely as possible in materials and appearance.

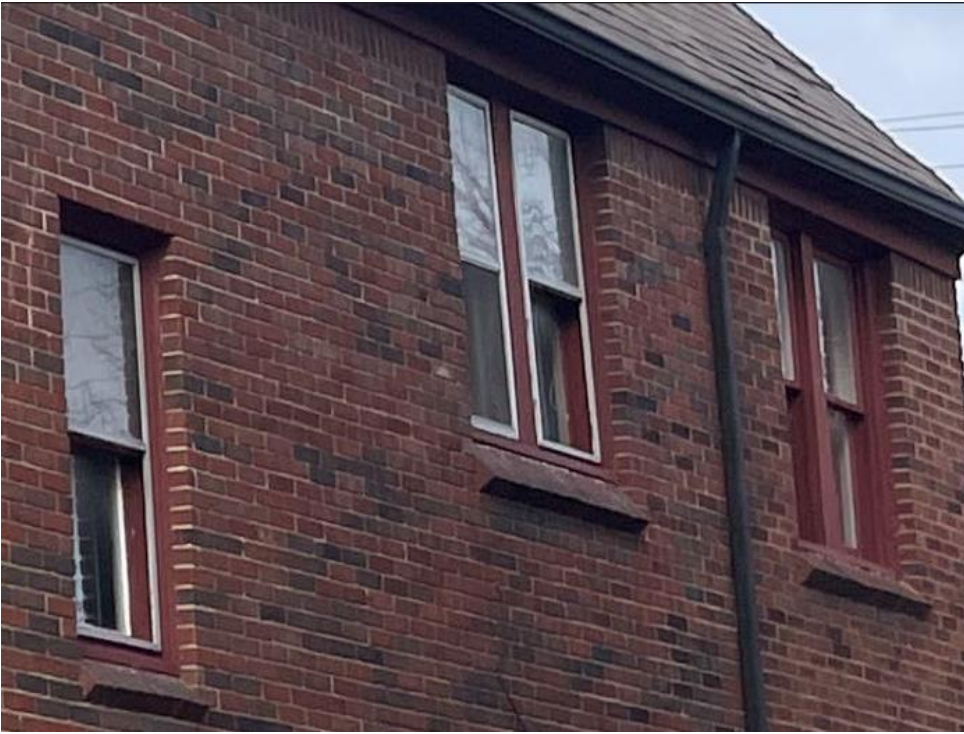
- Based on available photographs, the other windows formerly on the building were a mix of leaded-glass windows in various patterns and, perhaps less distinctive, but still historic, double-hung, wood sash windows. Many of the lost windows have no photographic documentation available, especially on the rear.

West elevation, second floor. February 2024 photo by staff.

- Staff opinion is that the proposed window replacement (other than the two, second-story, front façade windows, described in a separate bullet point below) is not appropriate as the previous windows were not shown to have been deteriorated beyond repair.

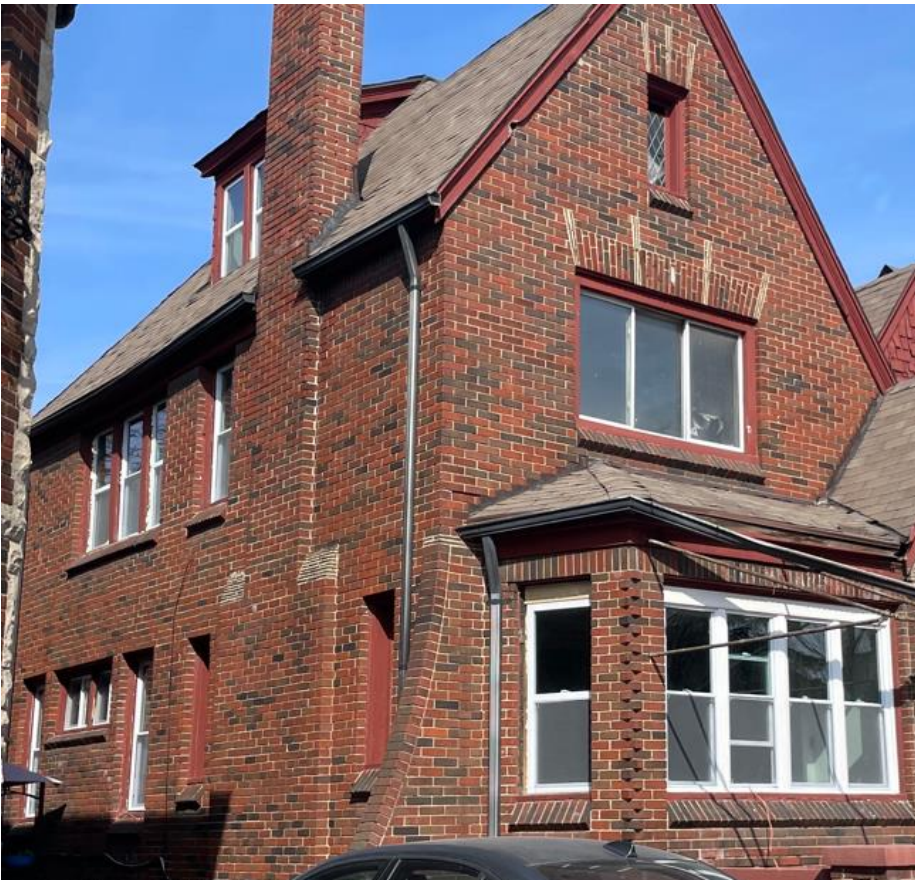
East elevation. February 2024 photo by staff.

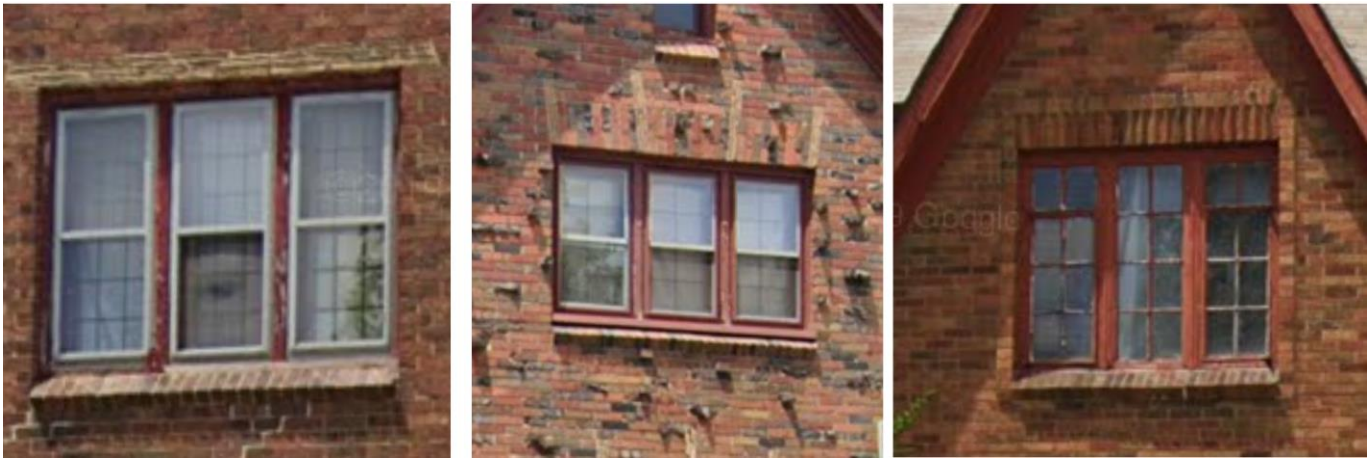
Google Maps images showing examples of mullioned, second-story, wall-gable windows on the same block as the subject property. Such window groupings are very common and are an important part of the district’s character.

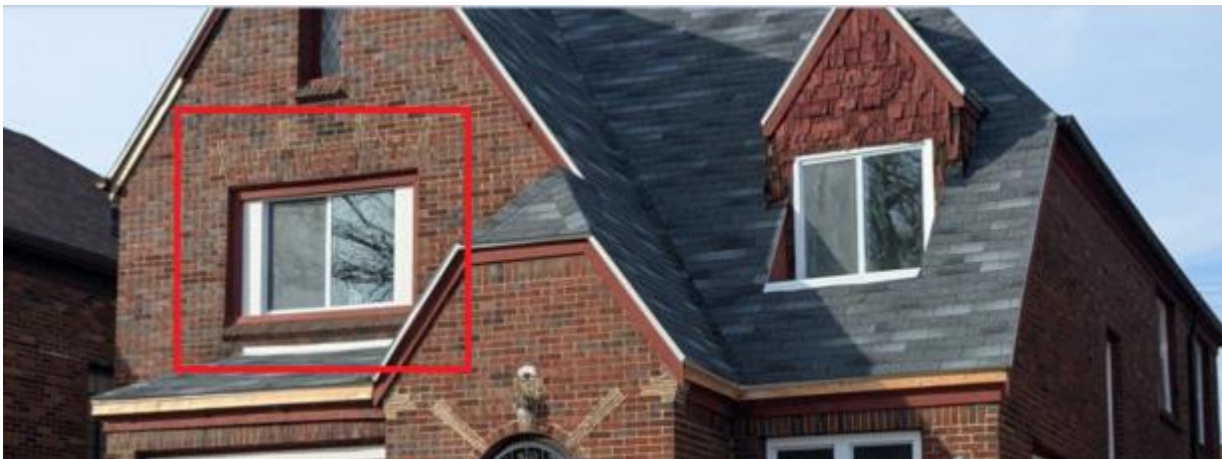
- Staff opinion is that the replacement of the two, second-story, front façade windows, is generally appropriate, but the proposed windows are not appropriate. Per the submitted window schedule, the windows would be “two unit double-hung [sash windows].” However, almost invariably, upper gable areas on Tudor Revival houses in the vicinity are occupied by a rank of three, relatively tall and narrow, windows separated by a wood mullion; this configuration is also alluded to in the Elements of Design quoted above. Filling this area with a double window, lacking a mullion, would not provide the vertical emphasis that would be expected on such a building. For the dormer, two sash windows would be appropriate, but they should be separated by a mullion, the dimensions of which would be based on similar features elsewhere on the building.

Red box indicates the windows that would appropriately be replaced with the three-unit, mullioned windows as depicted above.

- The proposed windows for the second floor, front elevation, do not satisfy Element 3: “It is not uncommon for several windows, which are taller than wide, to fill a single opening, which is wider than tall.”
