STAFF REPORT: FEBRUARY 12, 2025 REGULAR MEETING
APPLICATION NUMBER: HDC2025-00019
ADDRESS: 4218 CORTLAND
HISTORIC DISTRICT: RUSSELL WOODS-SULLIVAN
APPLICANT: JOHN NOVA, NEW CUSTOM HOMES LLC
PROPERTY OWNER: BLOCK & LOT DETROIT LLC
DATE OF PROVISIONALLY COMPLETE APPLICATION: JANUARY 19, 2025
DATE OF STAFF SITE VISIT: JANUARY 30, 2025

SCOPE: REPLACE WOOD WINDOWS WITH WOOD WINDOWS; ALTER STUCCO AND WOOD TRIM
(WORK STARTED WITHOUT APPROVAL)

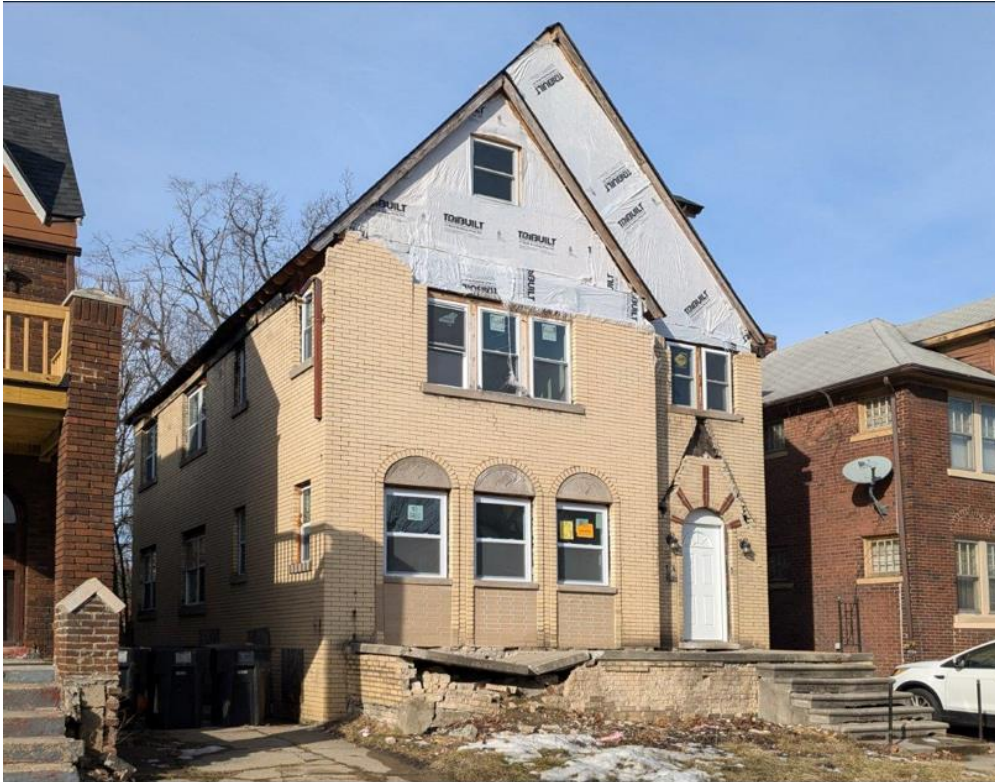
January 2025 photo by staff.

In 2024, staff observed the installation of vinyl windows, the removal of the gable canopy over the front entrance, and the removal of decorative vergeboards (see photo on previous page). This work was done without approval of the Historic District Commission. The area formerly covered in aluminum siding is now covered in house wrap such that its condition is not visible. The property is presently subject to a Stop Work order from the Buildings, Safety Engineering, and Environmental Department.

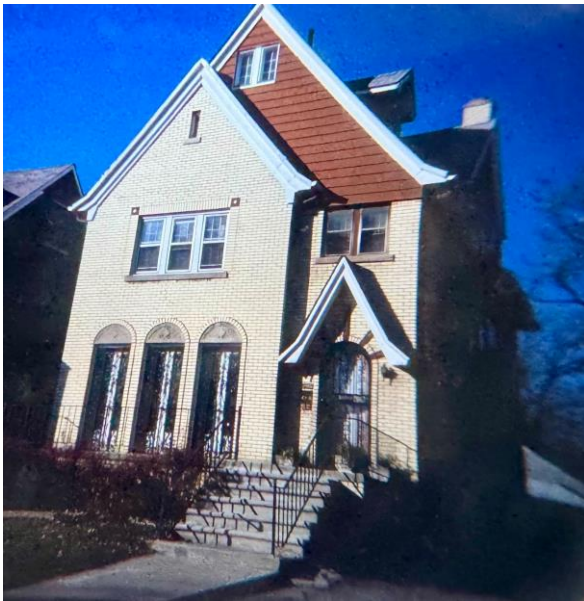
1999 Historic Designation Advisory Board photo.

The proposed scope of work would install new, double-hung wood sash windows by Lincoln Windows, per the submitted window schedule. The application also states that the three French doors that formerly existed on the façade (see the 1999 photo on page 2) would be “put back to original double door style with proper individual light patterns,” although these three units are not shown on the submitted window schedule.

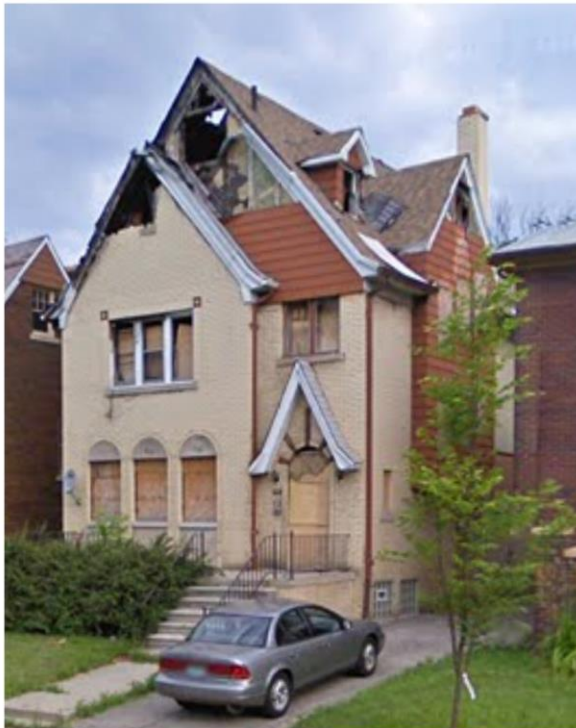
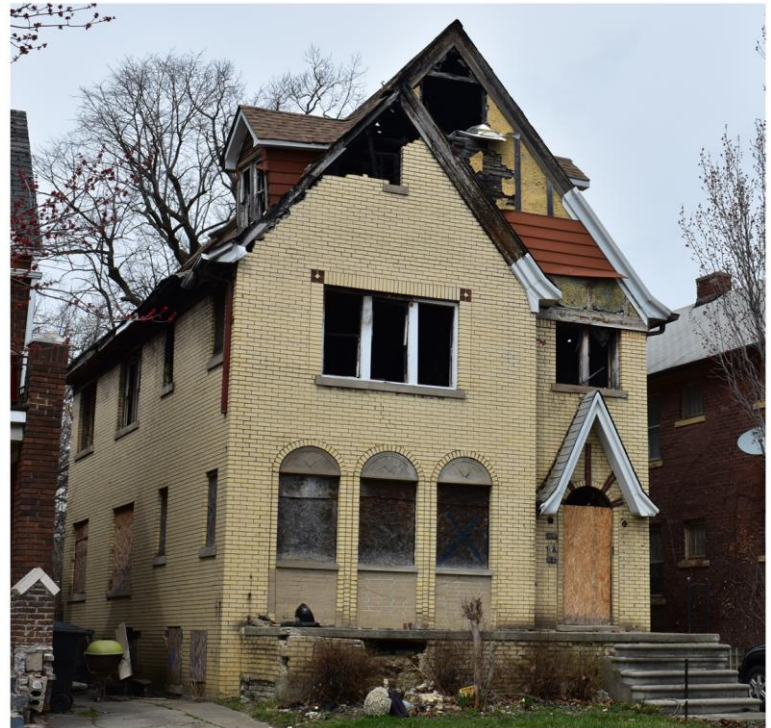
At some point between 2007 and 2009, the house was damaged by fire. Google Maps photos show most or all of the historic windows and doors were lost and the attic story was extensively damaged. The fire also revealed stucco and decorative half timbering that had been covered with aluminum siding at some time prior to the designation of the Russell Woods-Sullivan Historic District in 1999. Much of the stucco and half timbering was damaged by the fire.

Fire damage and exposed stucco and half timbering seen in 2009 Google Maps photo (left) and 2019 staff photo (right).

- The proposed stucco and half-timbering work shall be subject to staff review to ensure that historic materials are retained when possible and to ensure compatible design.
