STAFF REPORT: FEBRUARY 12, 2025 REGULAR MEETING

APPLICATION NUMBER: HDC2025-00020

ADDRESS: 4015 GLENDALE

SCOPE: REPLACE STEEL WINDOWS WITH WOOD WINDOWS

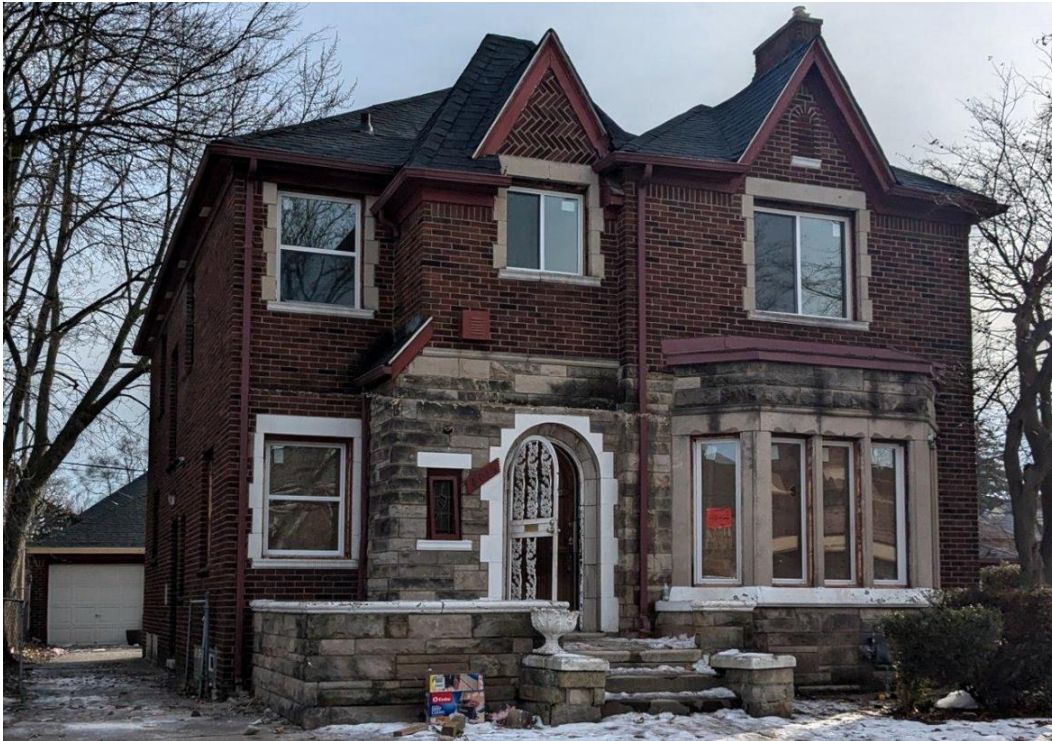
January 2025 photo by staff.

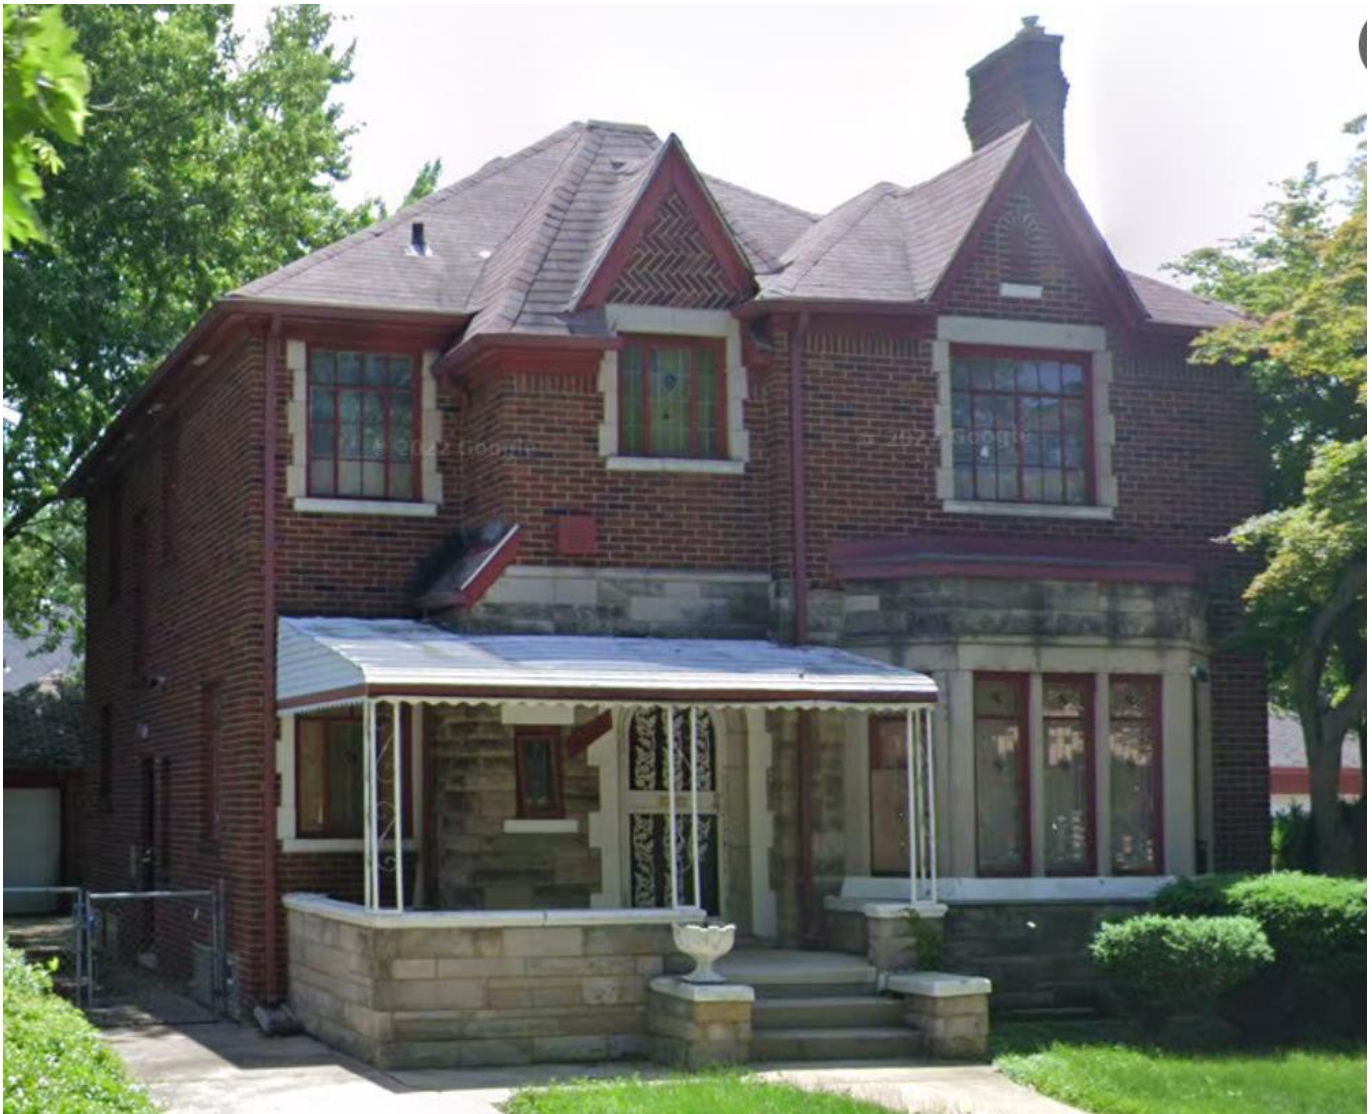
Until recently, rolled steel windows were a distinctive feature. Many of the windows were particularly distinctive and likely irreplaceable as they are leaded-glass windows emblazoned with a stained-glass, multicolored, shield motif. Staff observed these windows being removed without approval on January 14, 2025. At the time of the staff observation, all but one of these windows had been replaced with a vinyl window. The Buildings, Safety Engineering, and Environmental Department promptly issued a Stop Work order.

2022 Google Street View photo showing historic windows.

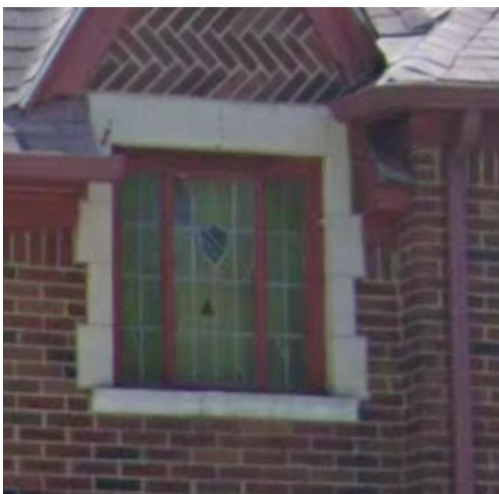
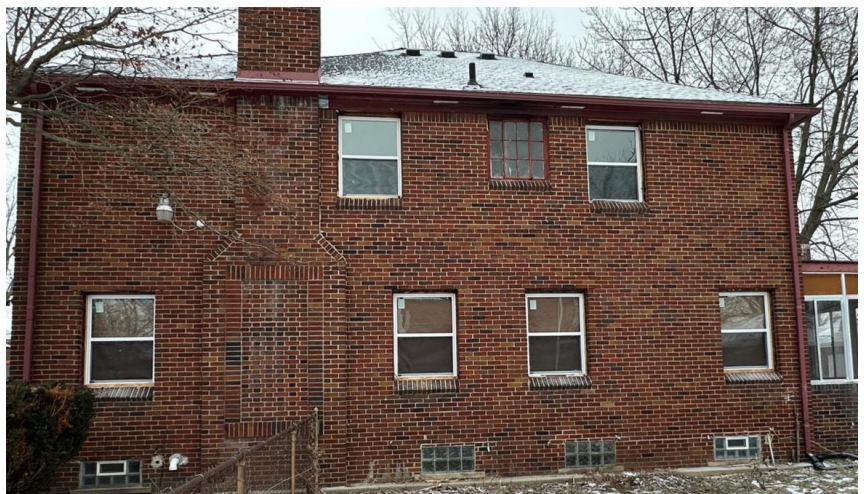
Left: Close-up of same 2022 Google Street View photo. Right: West elevation showing one remaining historic window. Image from application materials.
