STAFF REPORT FEBRUARY 12, 2025, REGULAR MEETING

PREPARED BY: T. BOSCARINO

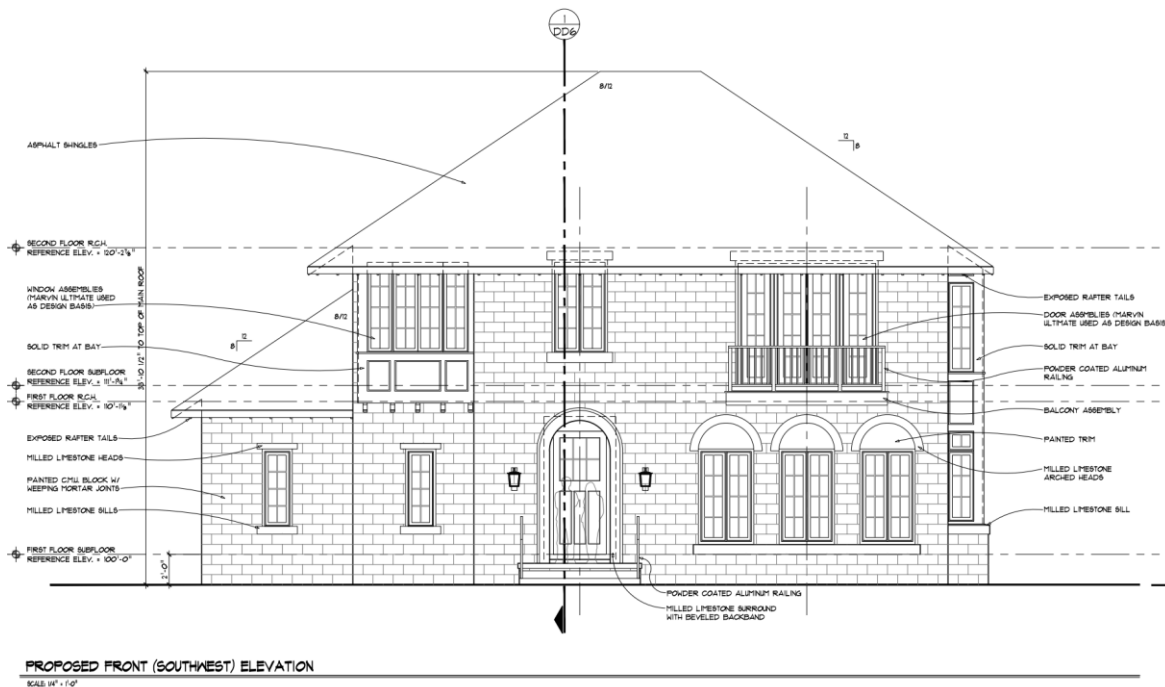
Elevation drawing of proposed building, from application materials.

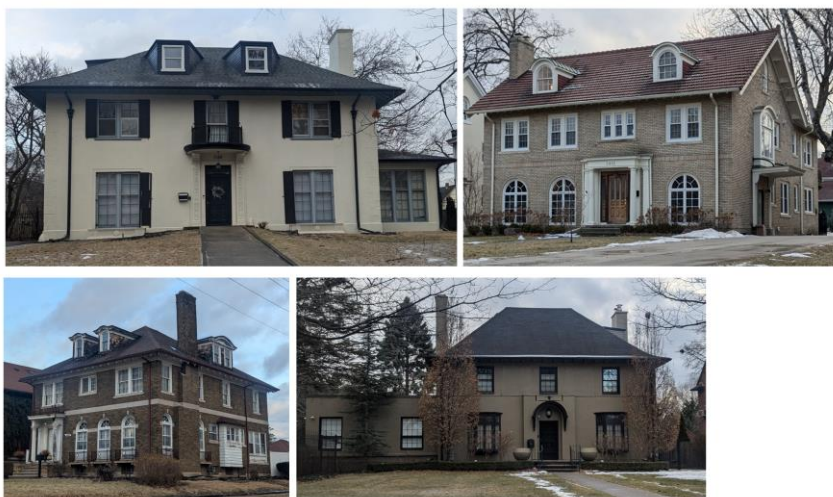
Clockwise from top left: 2168 Burns (similar massing), 3465 Burns (similar style), 3400 Burns (similar massing and style), 2921 Burns (similar massing). February 2025 photos by staff.

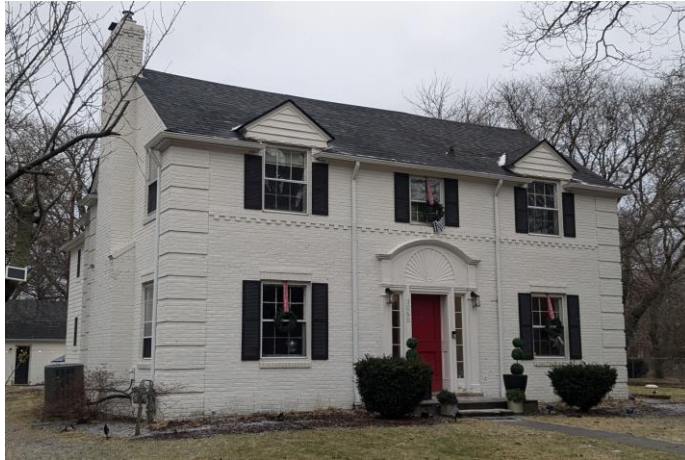
There is one example of painted brick in the vicinity, at 3060 Iroquois. Staff suggests it is unlikely that this is the original condition.

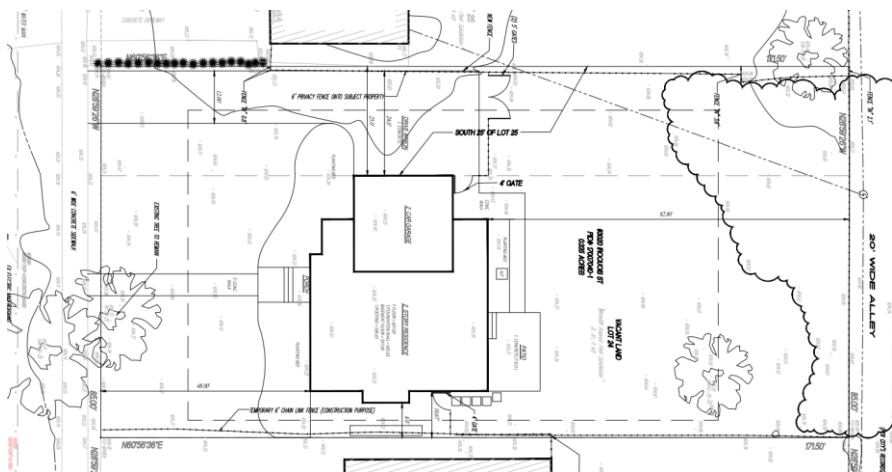
Proposed site plan from application documents (cropped by staff to exclude surrounding areas; please see application materials for complete image). A separate landscape plan, with additional detail, is also provided.

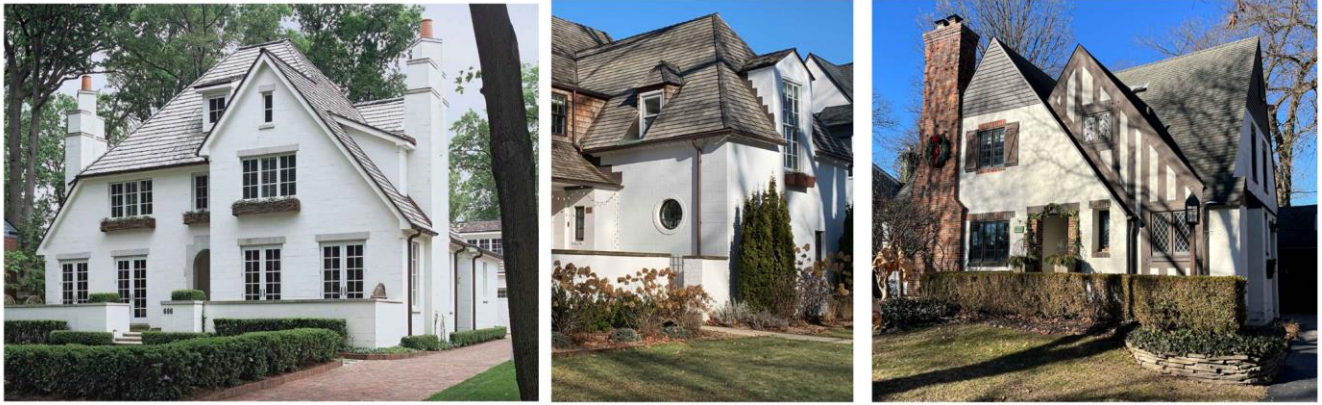
The applicant has provided several images of early-twentieth-century houses (but not in Detroit) that employ a painted CMU wall material. Additional examples are provided in the submitted materials.
