STAFF REPORT: 06/11/2025 MEETING PREPARED BY: J. ROSS

ADDRESS: 2018 11th STREET

APPLICATION NO: HDC2025-00250 **HISTORIC DISTRICT**: CORKTOWN

SCOPE: INSTALL BRICK VENEER AT FOUNDATION, PAINT PORCH, REPLACE PORCH SPINDLES, LANDSCAPING

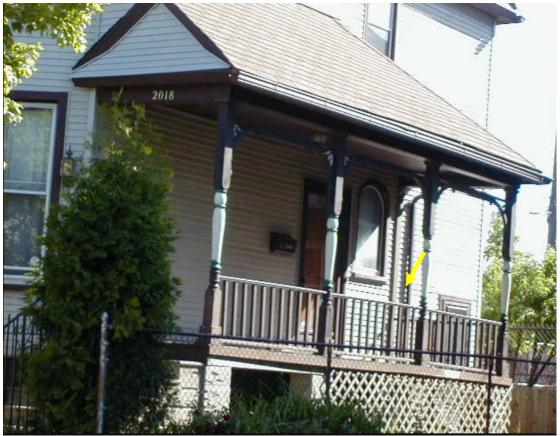
2018 11th, photo by HDC staff in 2001. Note that the railing is approximately 2'-6" in height and features square wood balusters.

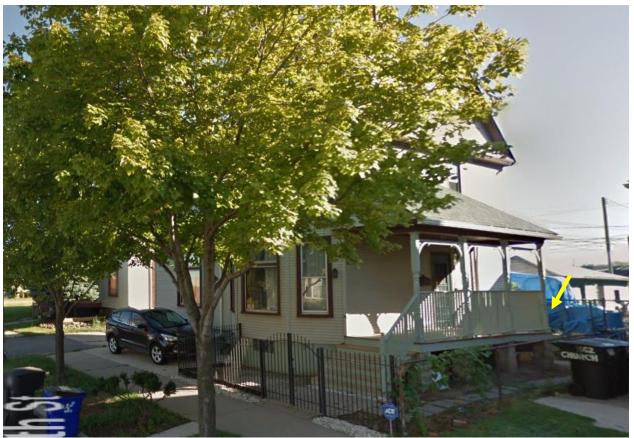
Google Streetview, 2015. Note that the railing visible in 2001 and 2013 has been replaced with the current, high handrail.

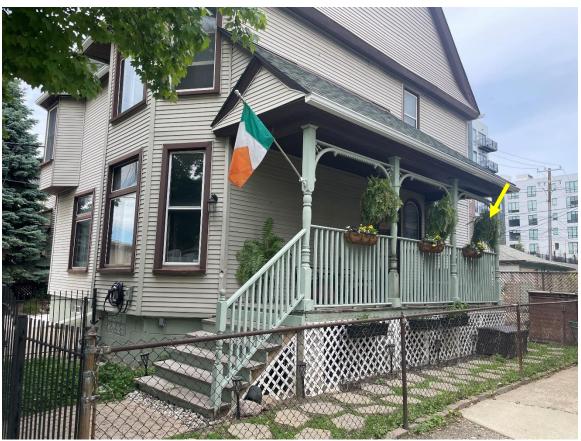
- The current railing appears to be about 42" high (3'-6"), far in excess of compatible railing height for an historic wood porch, which are typically 2-2'-6" (24"-30"). Chapter 12 of the Michigan Rehabilitation Code allows building code officials to approve features that do not meet current code standards on historic properties like this one. Installation of a lower height railing would restore proper balance and proportion to this historic porch.

Current appearance. Photo taken by HDC staff on 5/25/2025. Note square wood balusters and height of the railing, likely 3'-6" (42")

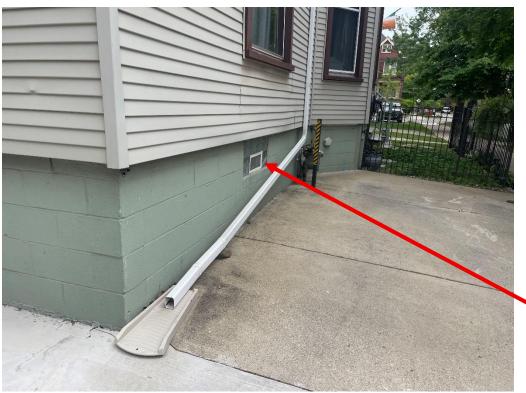
- The current application proposes to install a 2.5" thick brick veneer cladding over the concrete block foundation wall. Note that the walls present a slight projection/stand proud at their junction with the foundation, which is a typical characteristic feature of this type of house. The introduction of the 2.5"-thick brick veneer will eliminate that projection at the wall/foundation junction, thus flattening the appearance of the wall. Additionally, plain square balusters are a typical and character-defining feature of many late 19th century wood houses (see below photo of the proposed brick, taken at the interior of the applicant's house). Staff therefore recommends that the Commission deny these two items.

Current appearance. Note the slight project of the wall at its junction with the foundation. The proposed installation of a 2.5" thick brick veneer will eliminate this projection thus flattening the appearance of the wall

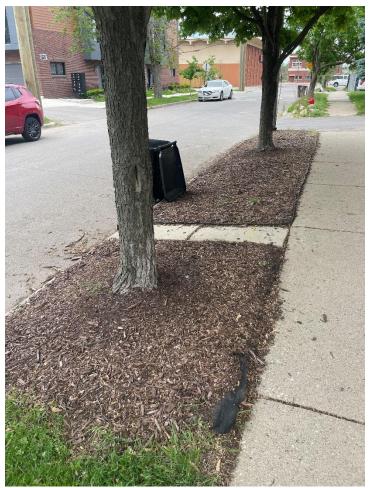
• The application proposes to install brick pavers in the berm area to the west of 2018 11th. See the below photo to note current conditions. Staff visited the site, assessed the public right-of-way in the direct vicinity of the subject property, and noted no existing hardscape in the berm area. Therefore, the proposed addition of pavers would not be consistent with district's historic character, in staff's opinion.

Berm area to the west of 2018 11th. The applicant is seeking to install brick pavers in this area. Photo by HDC staff, 5/25/2025
