REVISED STAFF REPORT: JUNE 11, 2025 MEETING

APPLICATION NUMBER: HDC2025-00264

ADDRESS: 1036 HUBBARD

SCOPE: ERECT CARRIAGE HOUSE, REAR PORCH (WORK COMPLETED WITHOUT APPROVAL)

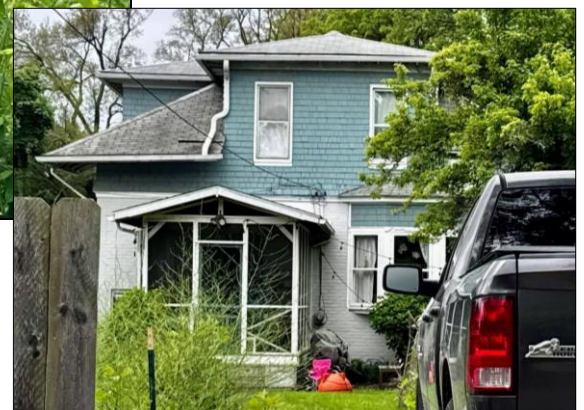
A one-story screened porch extends from the rear wall; staff did not find HDC approval for this porch. At the rear of the lot there are two concrete pads, remnants of previously demolished garages.

Right: Rear of house. Based on Mapillary photos, this porch was erected in 2020. HDC staff photo, May 2025.

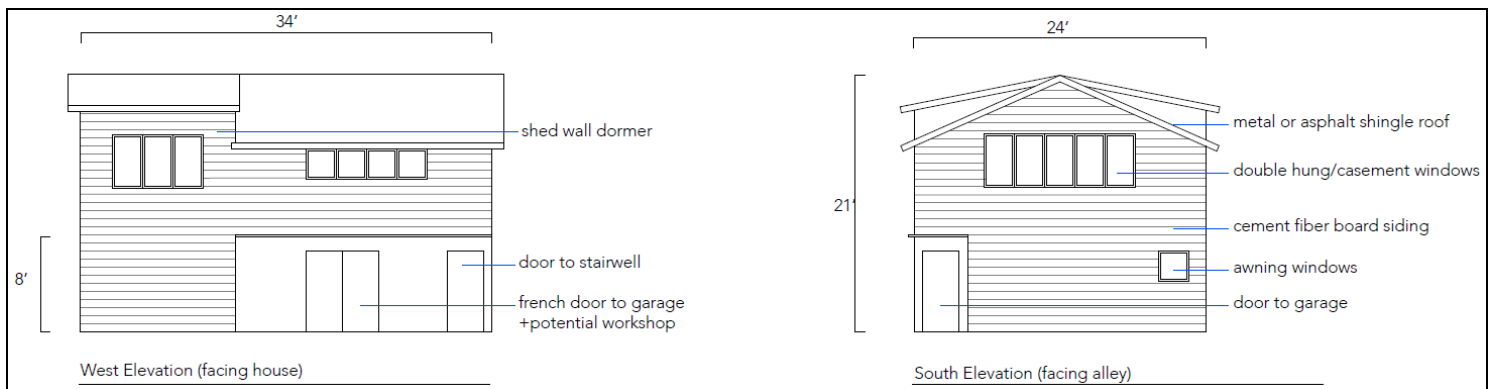
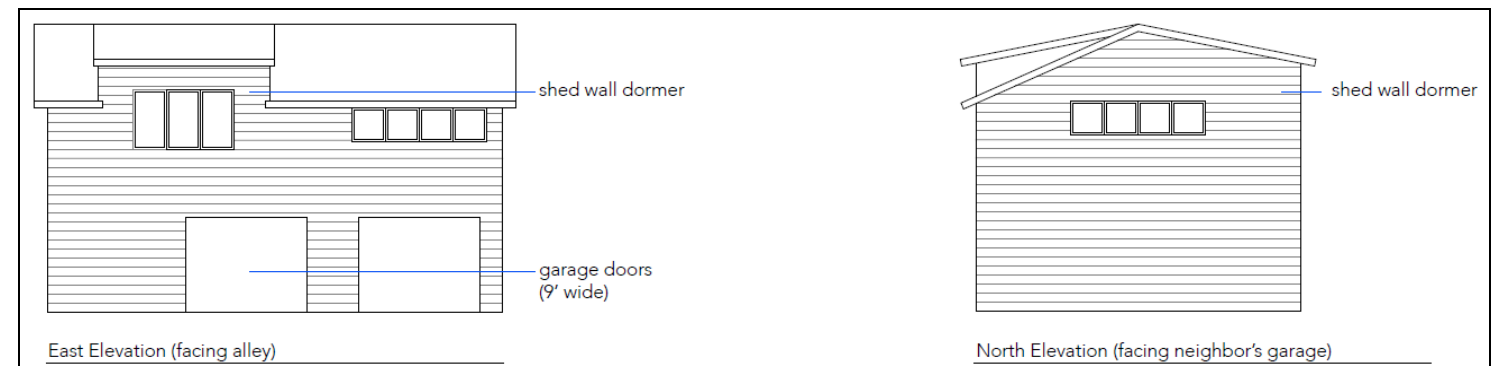
West elevation – faces rear of house

South elevation – faces east-west alley

East elevation – facing north-south alley

North elevation – facing garage at 1044 Hubbard

Regarding the proposed structure, the inset wall and varying eave heights and roof pitches create a uniquely busy design form for the carriage house and is atypical of the historic house and surrounding historic garages.

- The varying roof pitches and eave heights, and a partially recessed first floor wall (creating a garrison-like effect to the structure), create an incompatible shape and massing that is in contrast with the early 20th century house surrounding site and conflicts with Standard 9 which states “new work shall be differentiated from the old and shall be compatible with the massing, size, scale, and architectural features to protect the historic integrity of the property and its environment”.

- The asymmetrical roof includes one section with a more steeply pitched plane and is not compatible with the consistent roof pitches on the historic house nor the surrounding historic gable and hip roofed garages.

Design considerations include the use of a symmetrical gable or hip roof; traditional hip or shed roof dormers inset from the roof edge, similar to adjacent historic garages; one-over-one double-hung and square awning windows, and exterior walls that extend to grade. These suggested design considerations are further supported by the following elements of design.

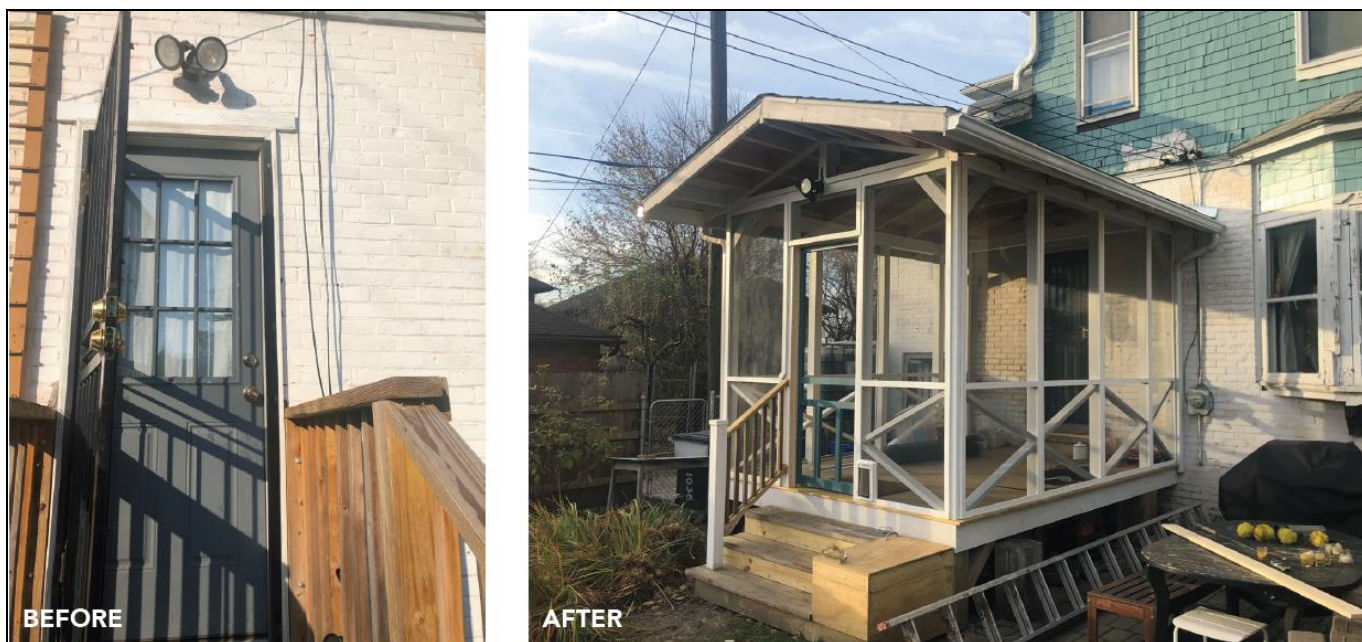
Applicant photos

- Staff notified the applicant that the previously erected rear porch requires HDC approval; the applicant/owner agreed to add it to this application. On June 6, staff received a one-page document explaining the design details and its 2020 erection, as well as photos of the completed work. It is staff's opinion the screen porch is compatible with the house in massing, location and design. However, the remaining unfinished wood elements (balustrade, stairs and wood wing wall) should be painted to match the painted wood porch framing and railing baluster.

- The unpainted elements will be painted to match the existing painted porch framing and railing baluster.
