STAFF REPORT: JULY 9, 2025 MEETING
APPLICATION NUMBER: HDC2025-00295
ADDRESS: 2814 OAKMAN BLVD

HISTORIC DISTRICT: OAKMAN BOULEVARD
APPLICANT: GREG TITTLE, TITTLE BROTHERS CONSTRUCTION
PROPERTY OWNER: VOLNA CLERMONT
DATE OF PROVISIONALLY COMPLETE APPLICATION: JUNE 18, 2025
DATE OF STAFF SITE VISIT: JUNE 23, 2025

SCOPE: REPLACE ROOF; WRAP/COVER FASCIA, SOFFITS, AND FRIEZE BOARD

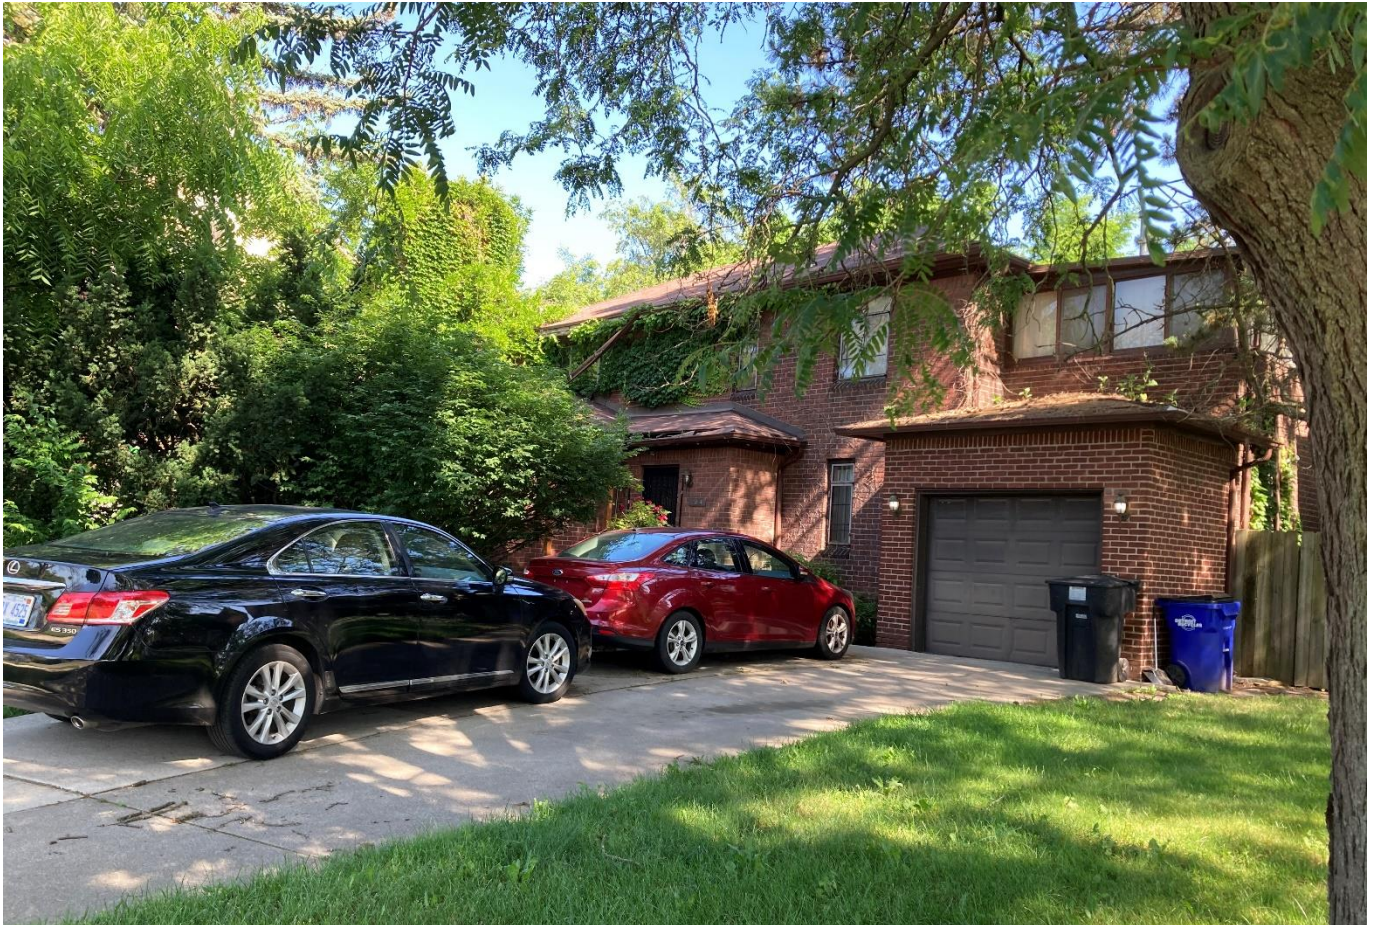
Photo 1, 2814 Oakman Blvd, front (south) elevation, site visit 6/23/25, staff. The projecting volumes for entry and garage, along with the large windows over the garage, can be seen.

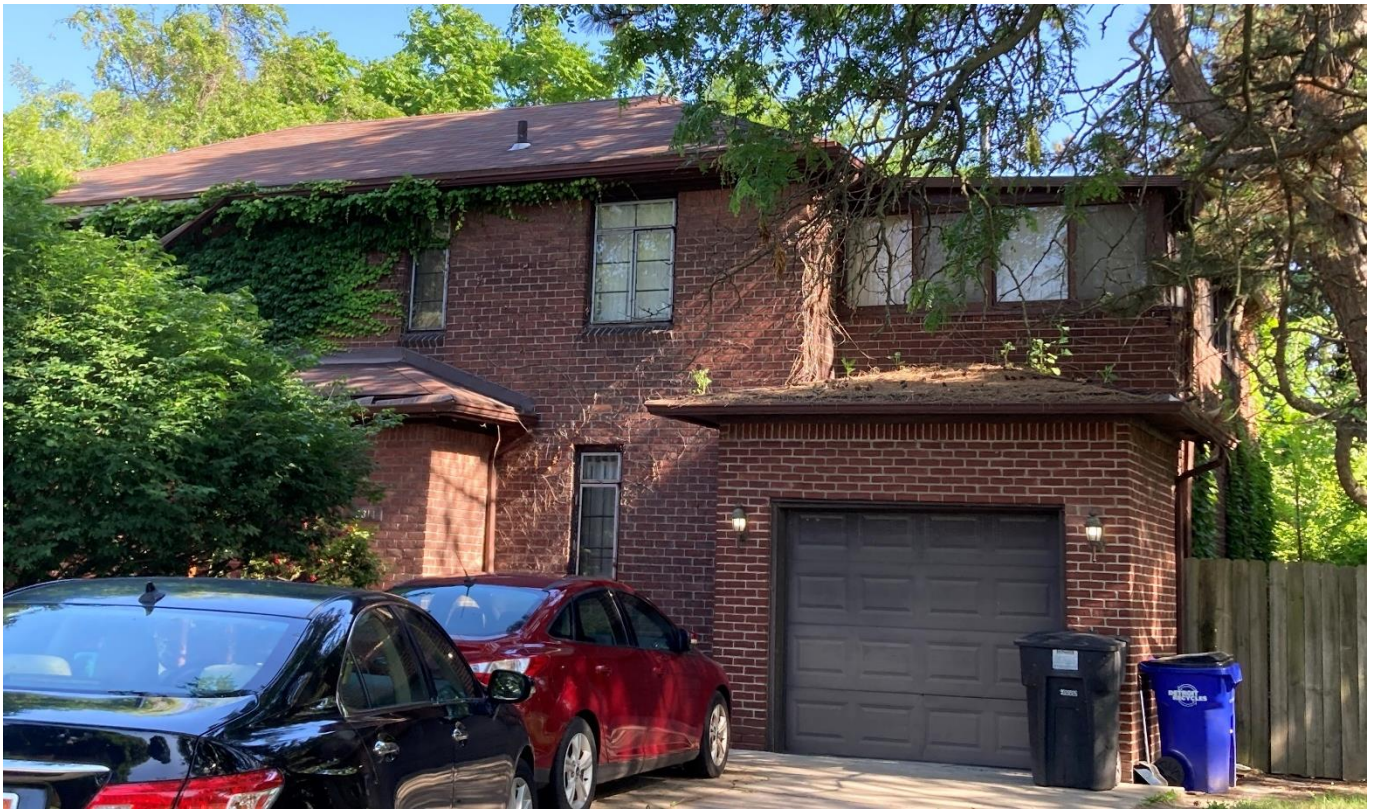
Photo 2, 2814 Oakman Blvd, front (south) elevation, site visit 6/23/25, staff. The character-defining steel windows with divided lights and the original modest garage with deep eaves are visible, along with the shrubs and heavy vine growth toward the western side of this elevation.

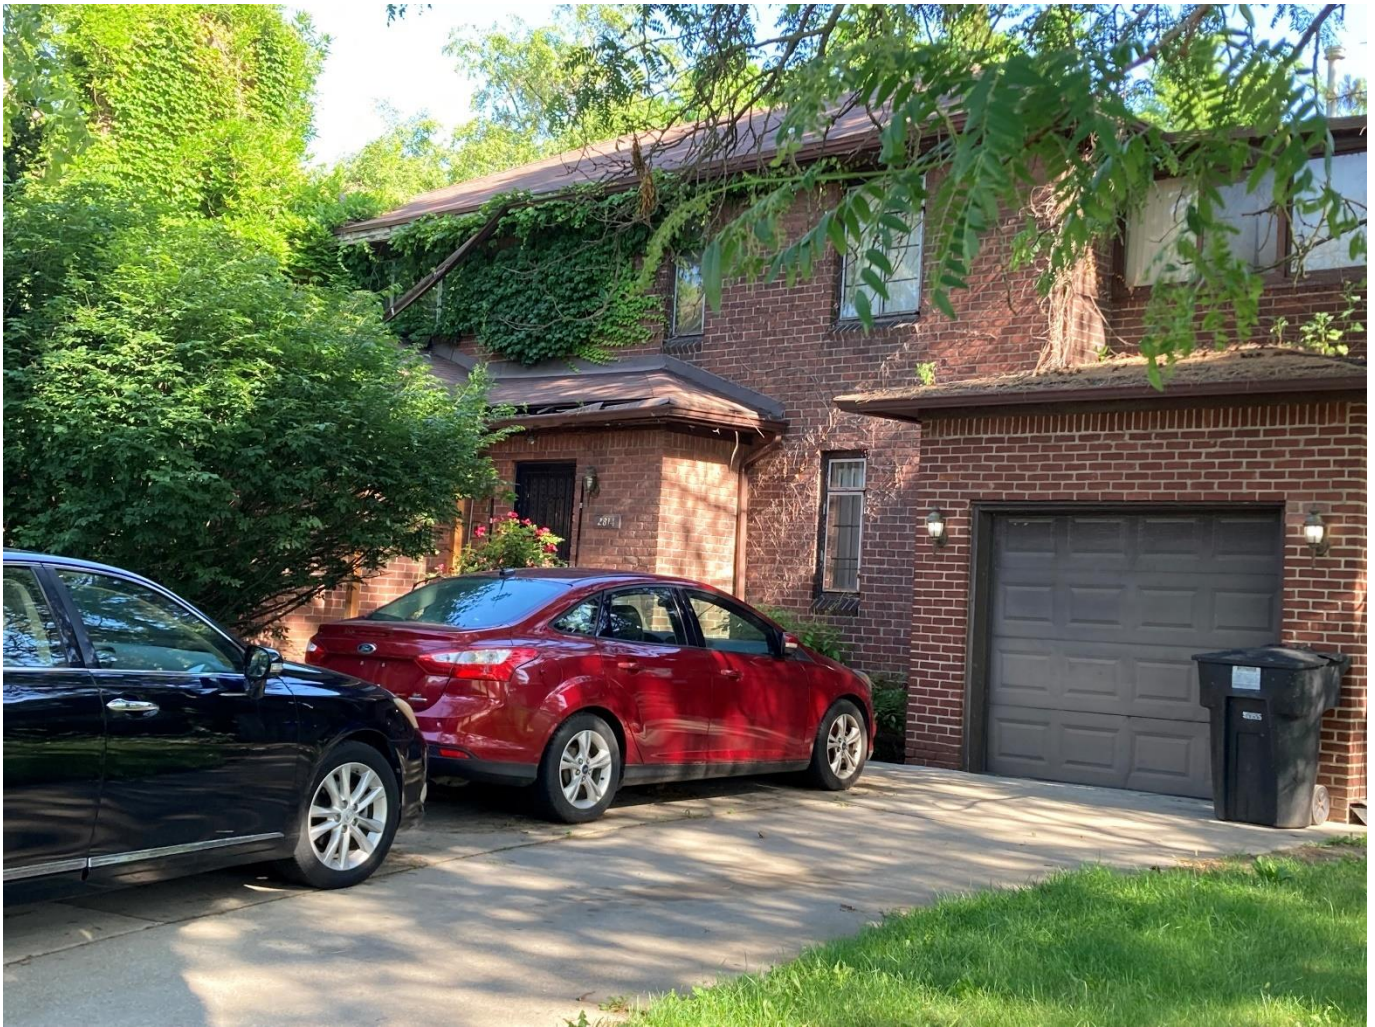
Photo 3, 2814 Oakman Blvd, front (south) elevation, site visit 6/23/25, staff. Closer view of the south elevation shows a broken gutter and heavy vines. The entry volume also appears to have more volume than originally thought. From the sidewalk, staff thought the entry was a small rectangle that balanced the garage, but in this view, it is clear that the entry volume extends forward into the front yard. Because of the shrubs, that more forward extension of the entry was not seen by staff initially.

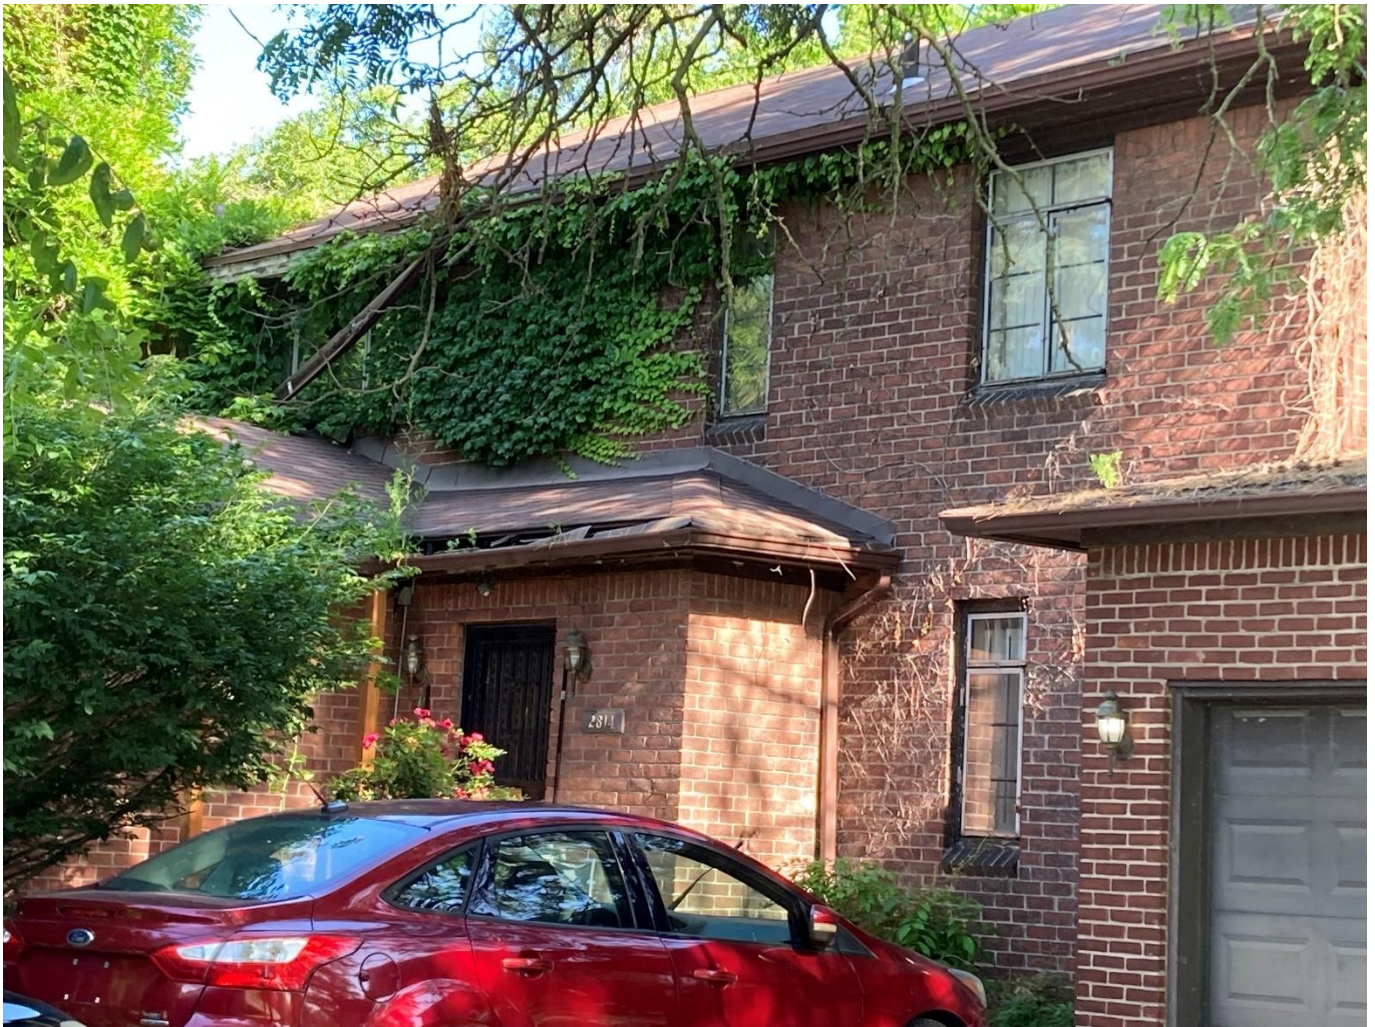
Photo 4, 2814 Oakman Blvd, front (south) elevation, site visit 6/23/25, staff. Closer view shows more of the heavy vine growth, a little more of the entry volume extending forward toward the sidewalk, and the failing gutter on both the main house and the entry volumes. The character-defining steel windows are clear.

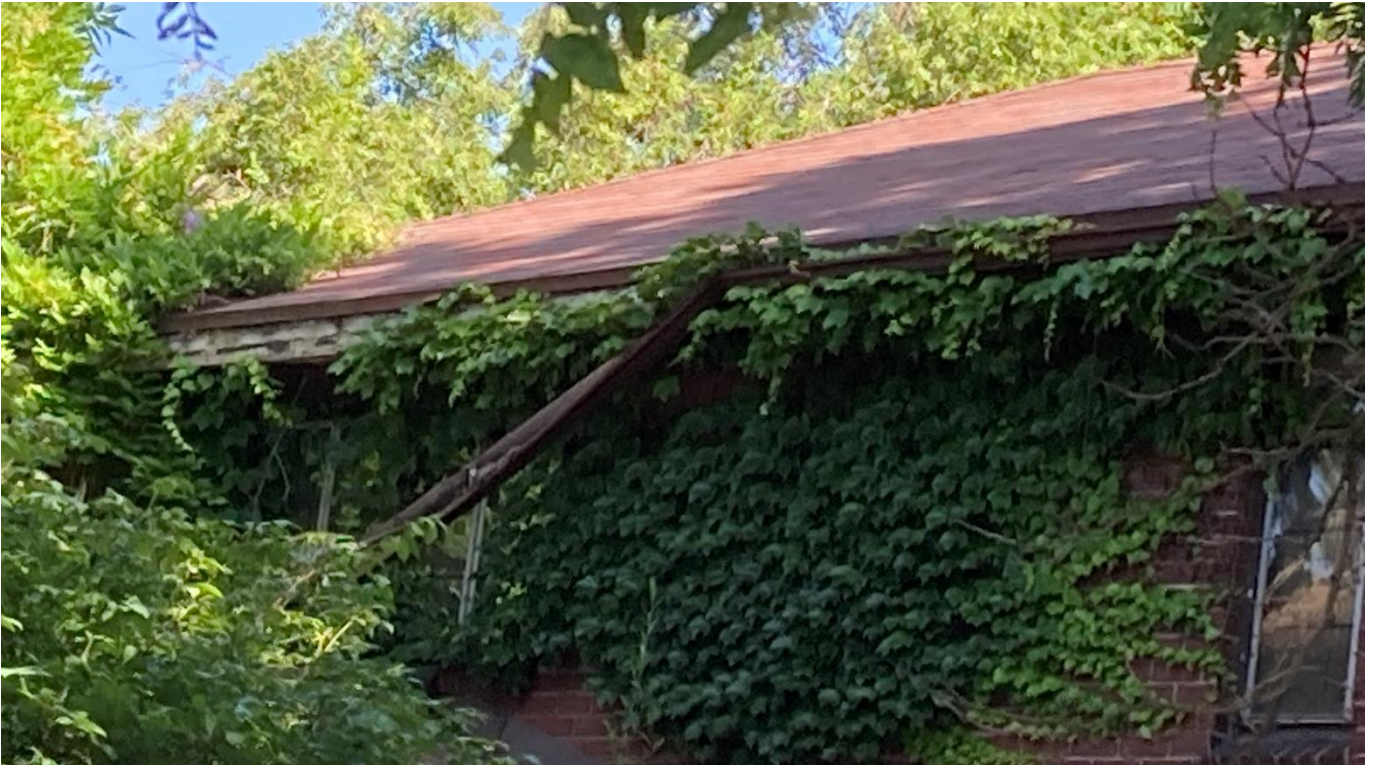
Photo 5, 2814 Oakman Blvd, front (south) elevation, site visit 6/23/25, staff. Detail of the failed gutter and heavy vines.

- The existing roof and gutters are no longer adequately protecting the house.
 - The roof proposed is a brown blend and staff would consider it a like-for-like replacement that meets the Secretary of the Interior's Standards for Rehabilitation and Guidelines for Rehabilitating Historic Buildings.

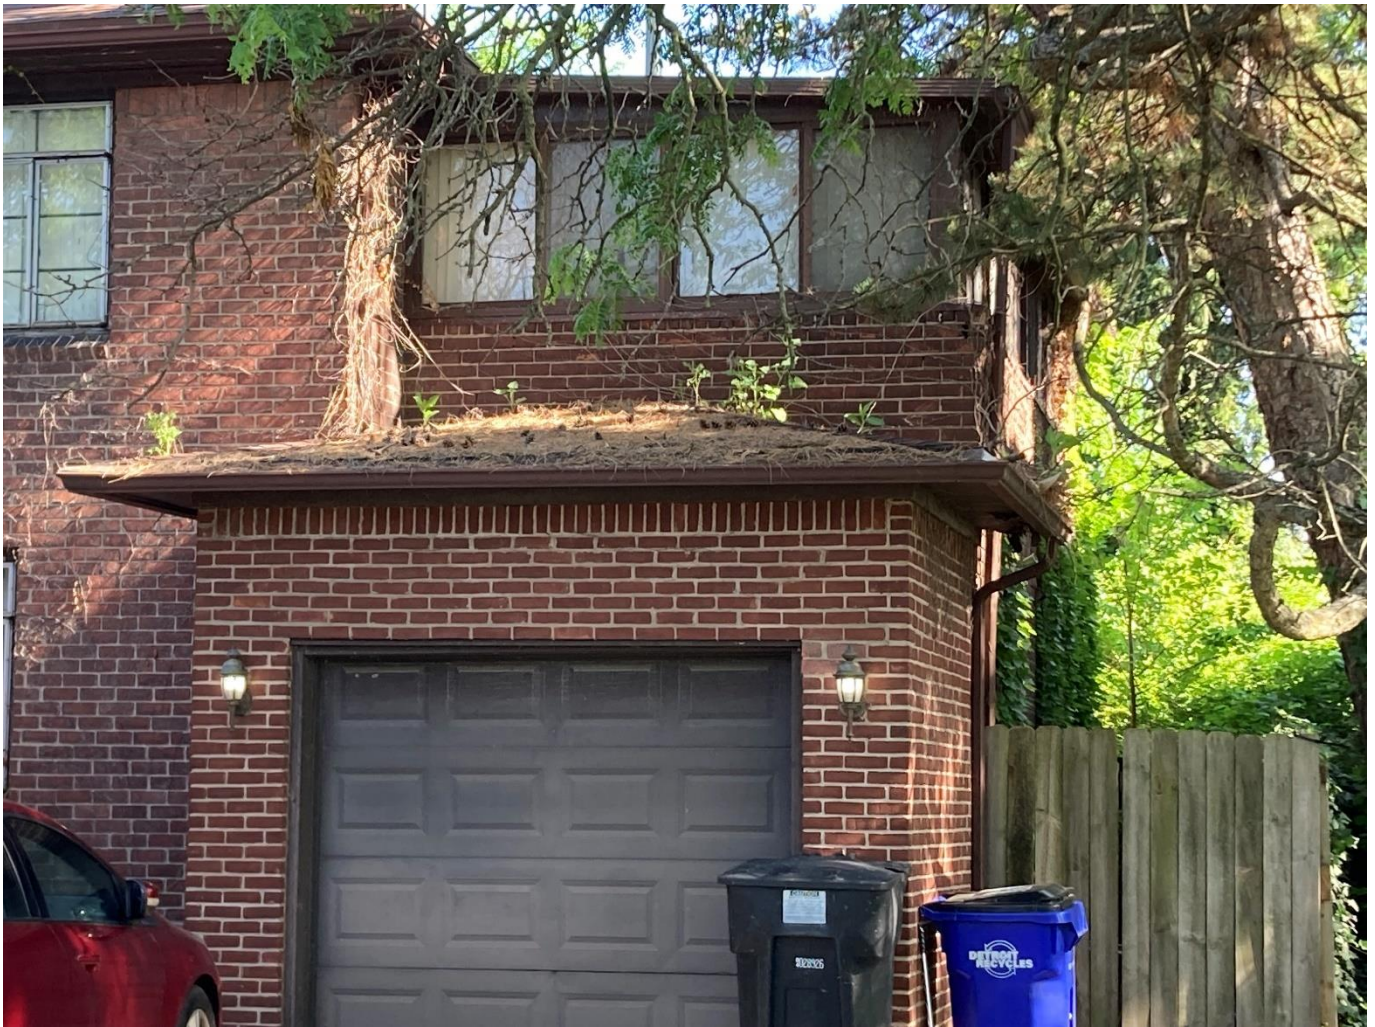
Photo 6, 2814 Oakman Blvd, front (south) elevation, site visit 6/23/25, staff. Detail of attached garage. The 1941 building permit on file notes that the house will have an attached garage. It appears to have dry tree debris, similar to dry evergreen needles, on the roof. The large, fixed windows over the garage look to staff to be part of a 1960s or 1970s addition. A two-story addition was applied for in the building permit files in 1970.

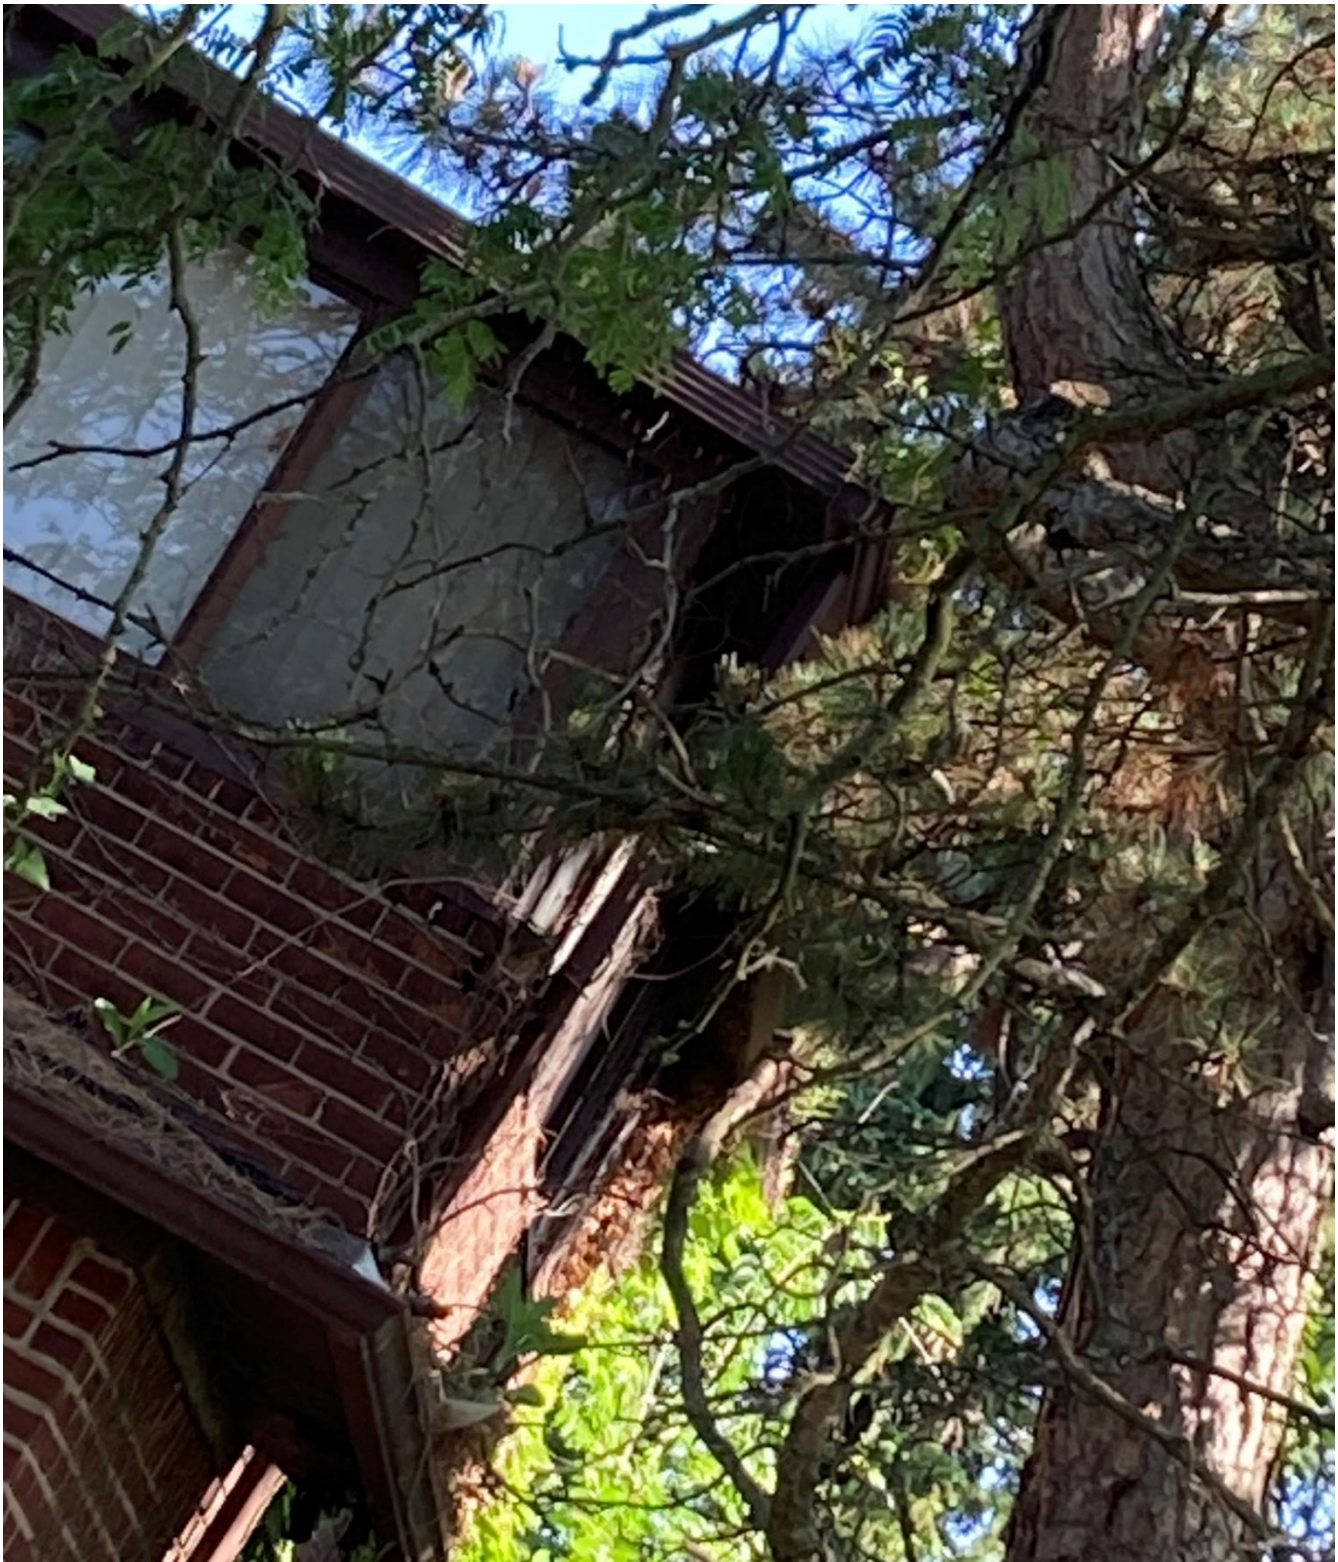
Photo 7, 2814 Oakman Blvd, site visit 6/23/25, staff, east portion of the south elevation and some of the east façade visible. Staff was trying to get a shot through the tree that would show the depth of the eave on the house, and whether there were gutters on this end. Staff appreciated afterward the dimensional fascia covering that is visible here above the large, fixed windows. It appears to be painted aluminum with an interesting profile that staff believes complements the 1970 addition.

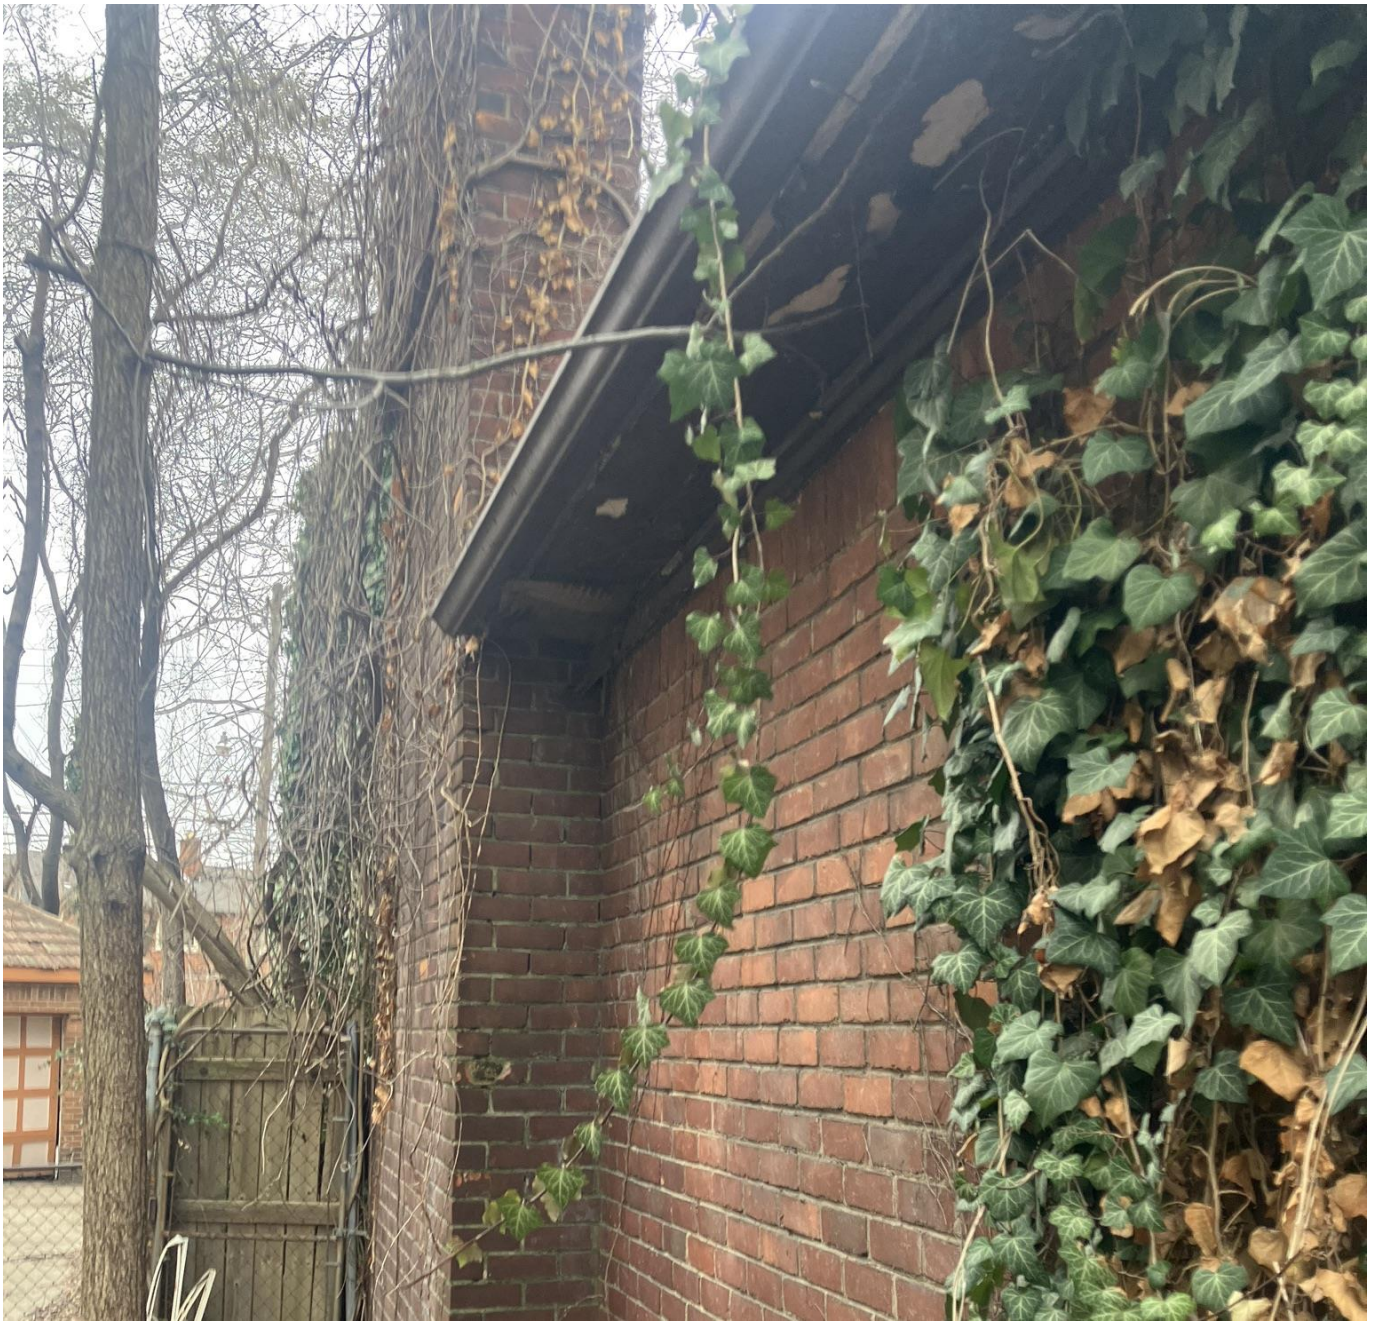
Photo 8. 2814 Oakman Blvd., photo provided by applicant showing condition of soffit and gutter.

- The house currently has wood soffits. The application is to replace the wood soffits with vinyl soffits that ventilate.
 - The Secretary of the Interior's Standards for Rehabilitation require that "deteriorated historic features will be repaired rather than replaced. Where the severity of deterioration requires replacement of a distinctive feature, the new feature will match the old in design, color, texture, and, where possible, materials." It is staff's opinion that the proposed **vinyl soffits** will have a plastic appearance that will not match the existing wood in texture or materials.

- Turbine vents cannot be installed at the property's roof. Rather, flat box or can vents shall be installed at the roof surface. Staff shall have the authority to review and approve the final ventilation plan.
- The existing wood frieze board shall not be wrapped in aluminum. Areas of deteriorated frieze board shall be replaced in kind to match existing.
- The existing wood soffits shall not be replaced with vinyl soffits. Areas of deteriorated soffits shall be replaced in kind to match existing.

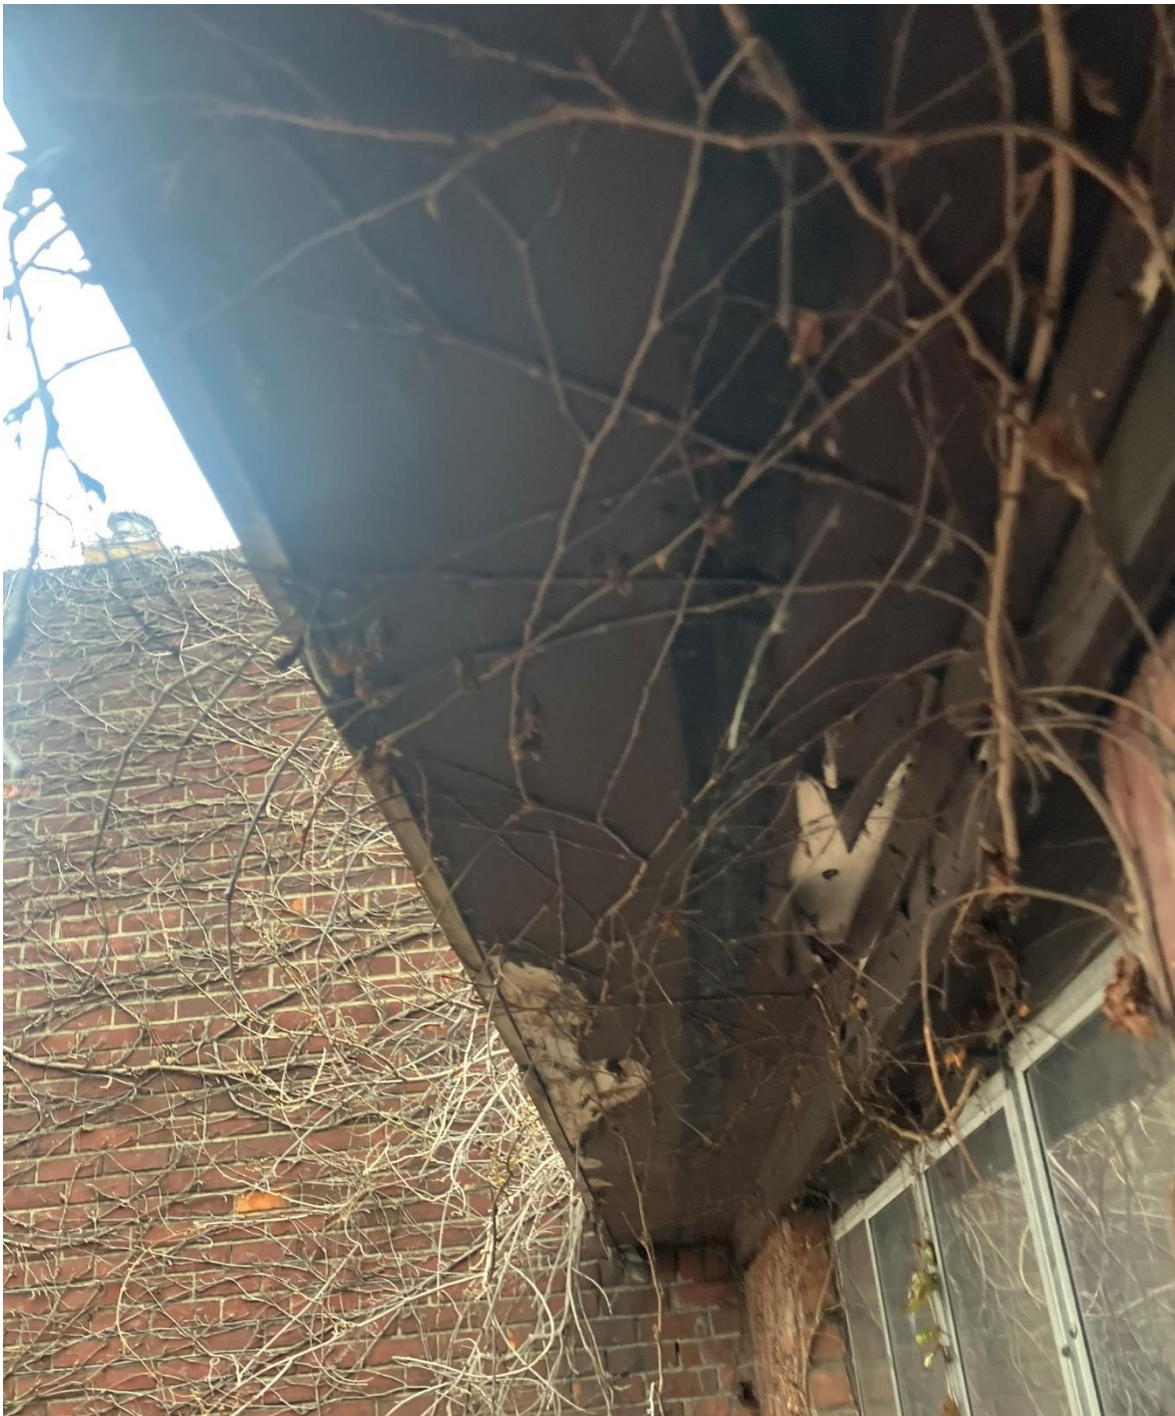
Photo 9. 2814 Oakman Blvd, photo provided by applicant, showing soffit.

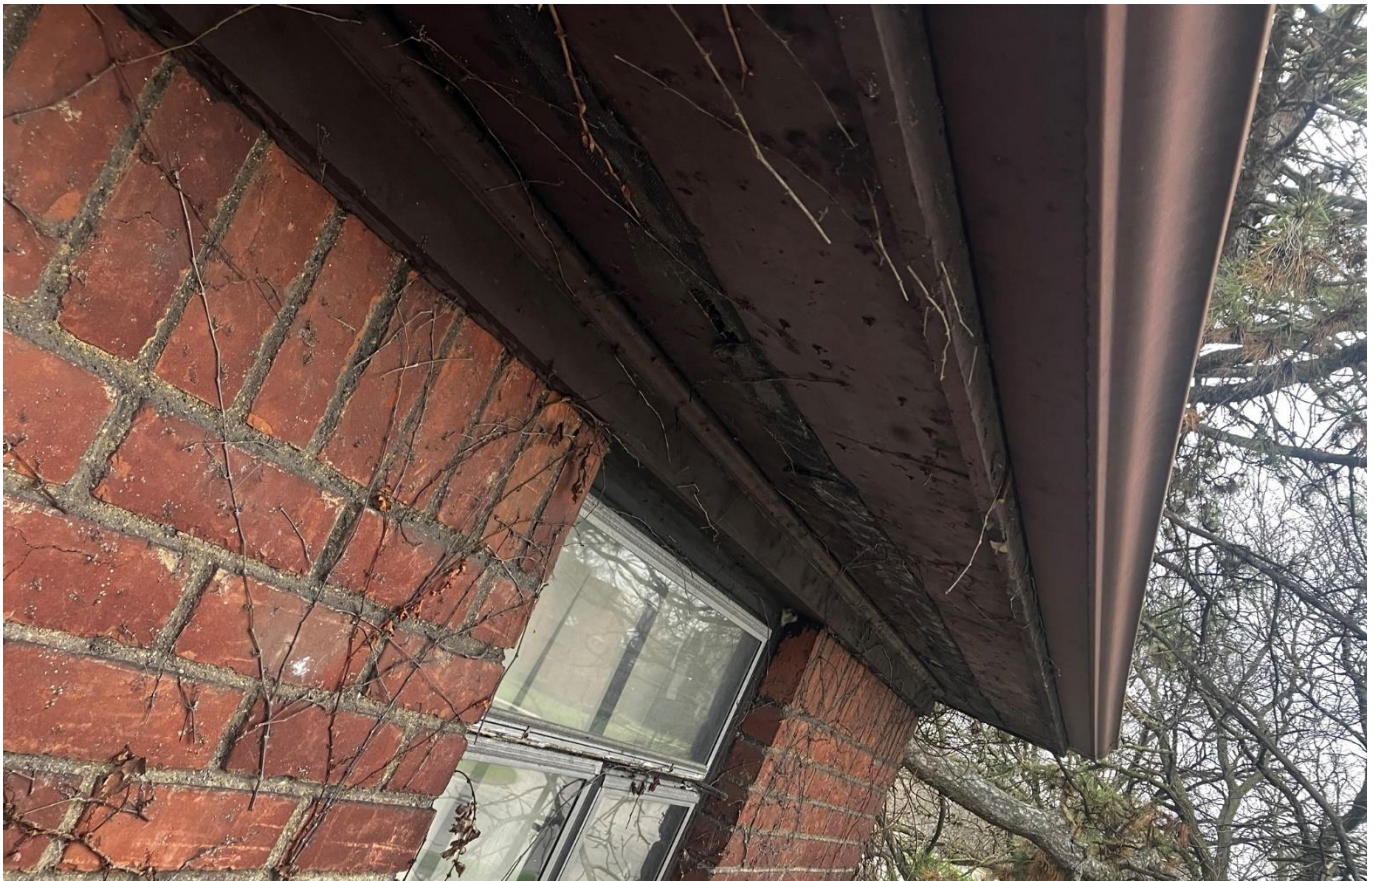
Photo 10. 2814 Oakman Blvd., photo provided by applicant, showing frieze board, soffit, gutter.

- The proposed wrapping of the **frieze board** is not appropriate, however, as it is a decorative historic wood element that is clearly visible from the right-of-way. Aluminum coilstock is not an adequate match for wood as it can warp, dent, or discolor over time. Any deteriorated portion of the existing wood frieze board should be replaced in kind.
