STAFF REPORT: 7/9/2025 REGULAR MEETING
APPLICATION NUMBER: HDC2025-00407-8057
VIOLATION NUMBER: 651
ADDRESS: 691 W. CANFIELD
HISTORIC DISTRICT: WEST CANFIELD
APPLICANT/ PROPERTY OWNER: ROSANNE AND DOUG PATTISON
DATE OF PROVISIONALLY COMPLETE APPLICATION: 6/17/25
DATES OF STAFF SITE VISITS: 6/23/25

SCOPE: MULTIPLE EXTERIOR ALTERATIONS

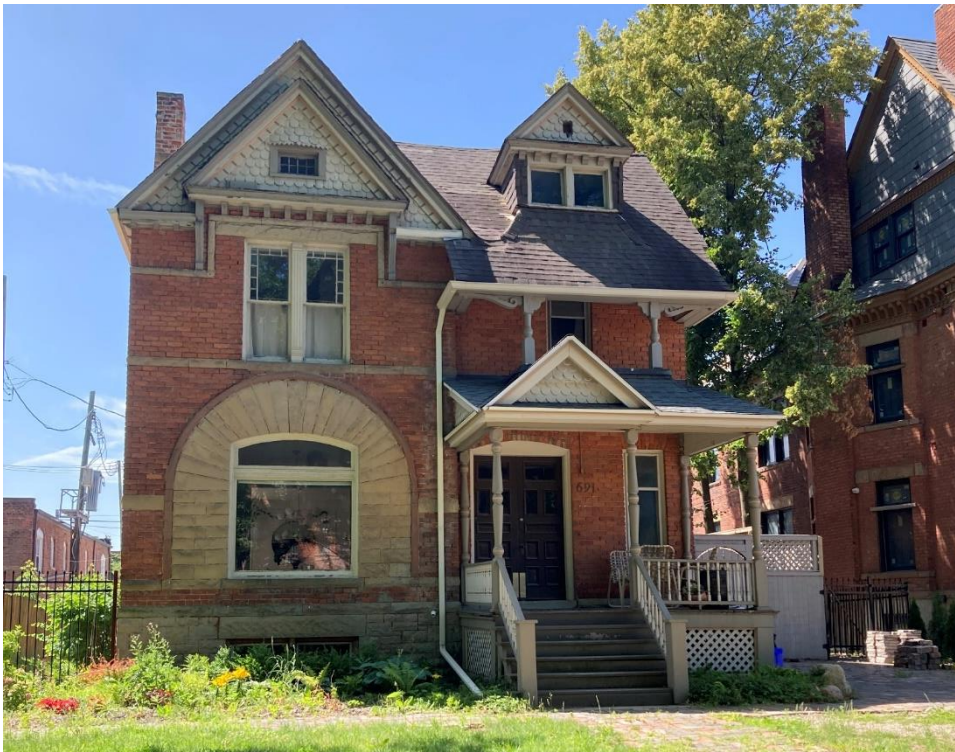
Photo 1. 691 W Canfield, front (north) elevation, staff site visit 6/23/25, staff. The basement windows included in this scope of work are on the front of the house, below the arched rock detail on the east bay. See detail below.

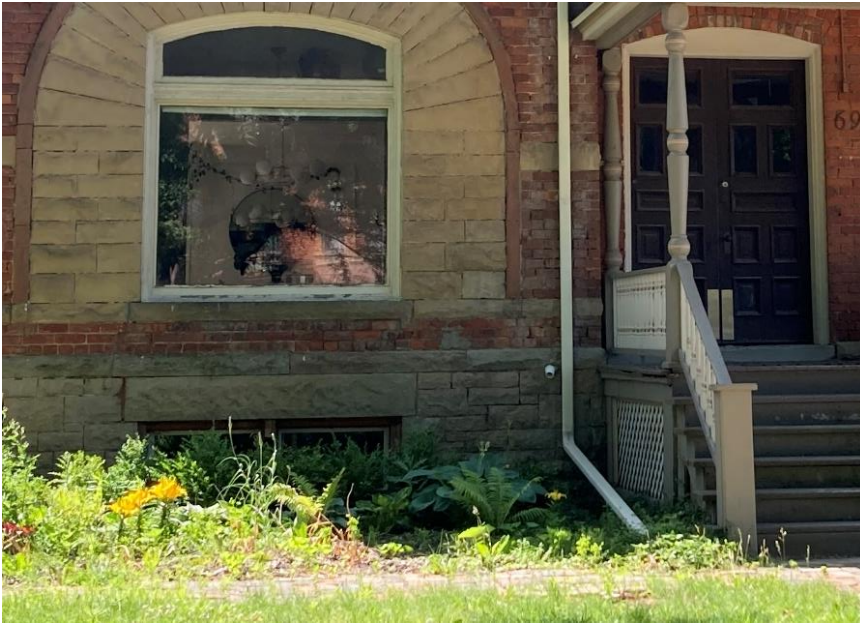
Photo 2. Detail of the above picture from 2025. Proposed is the restoration of the mullion feature with the carved detail.

- The applicant supply staff with a final dimensioned sketch of the front basement windows with the finished mullion in place prior to the issuance of the project's permit

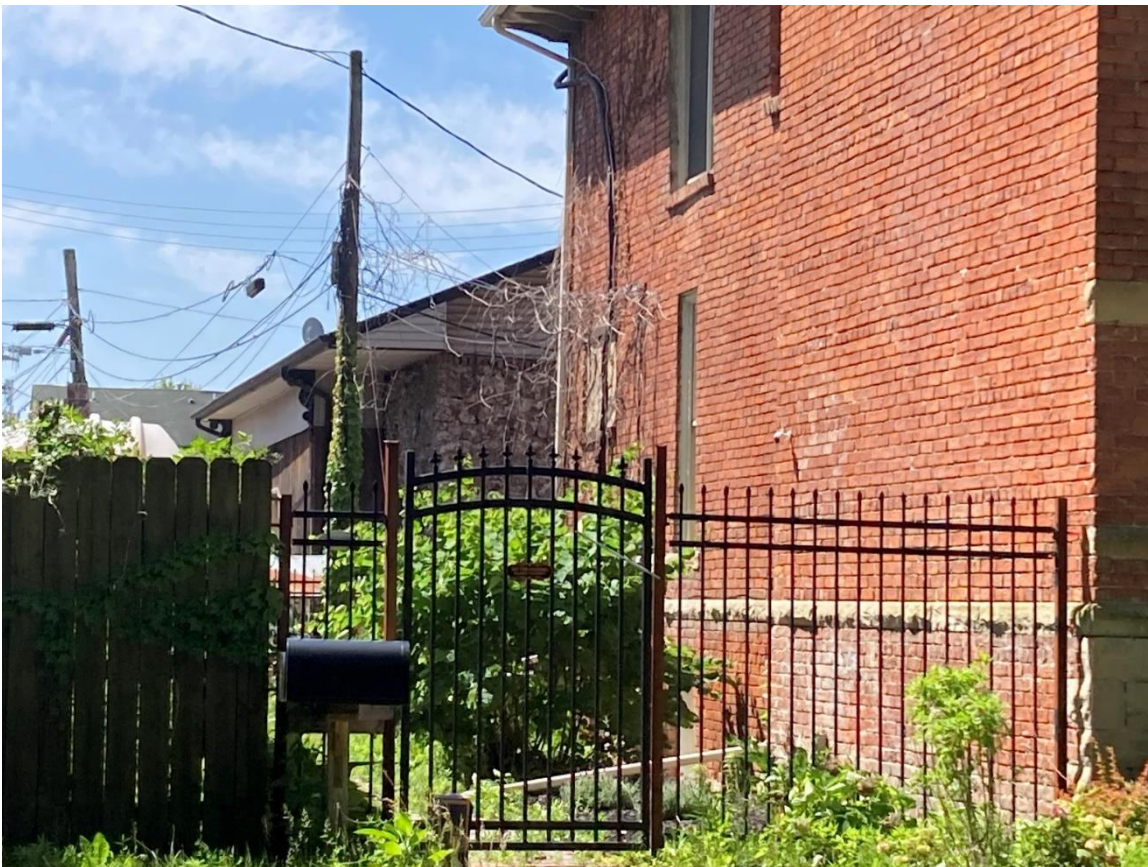
Photo 3. 691 W Canfield, side (east) elevation, staff site visit 6/23/25, staff. On this side of the house, scope of work items included in this proposal include the basement windows and window well, replacement of a vinyl second-story window with an aluminum-clad wood window with repairs to the brick opening, and removing the fishscale siding and transom as infill for a wide door opening to fill it with bricks and a double-hung clad window.

Traveling from the front of the house through the black metal gate to access the east side of the house, two basement windows with a shared window well exist. Vinyl windows were installed in these basement window openings in 2022, but those windows were not approved by the commission, so this application proposes that those basement windows be replaced with aluminum-clad wood windows and window wells. Continuing down the path along the east side of the house, toward the rear of the house, a trench was exposed in 2022 and it remains. The trench exposes the basement at the rear of the east side of the house. Steps lead down from grade to the bottom of the trench and a new door with sidelights leads out from the basement into the bottom of this trench. This portion of the trench has been covered with pavers, creating a sunken patio space from what has become a walk-out basement. The walk-out door with sidelights was proposed in 2022 and denied, but is being proposed again in this application with a new coat of paint.

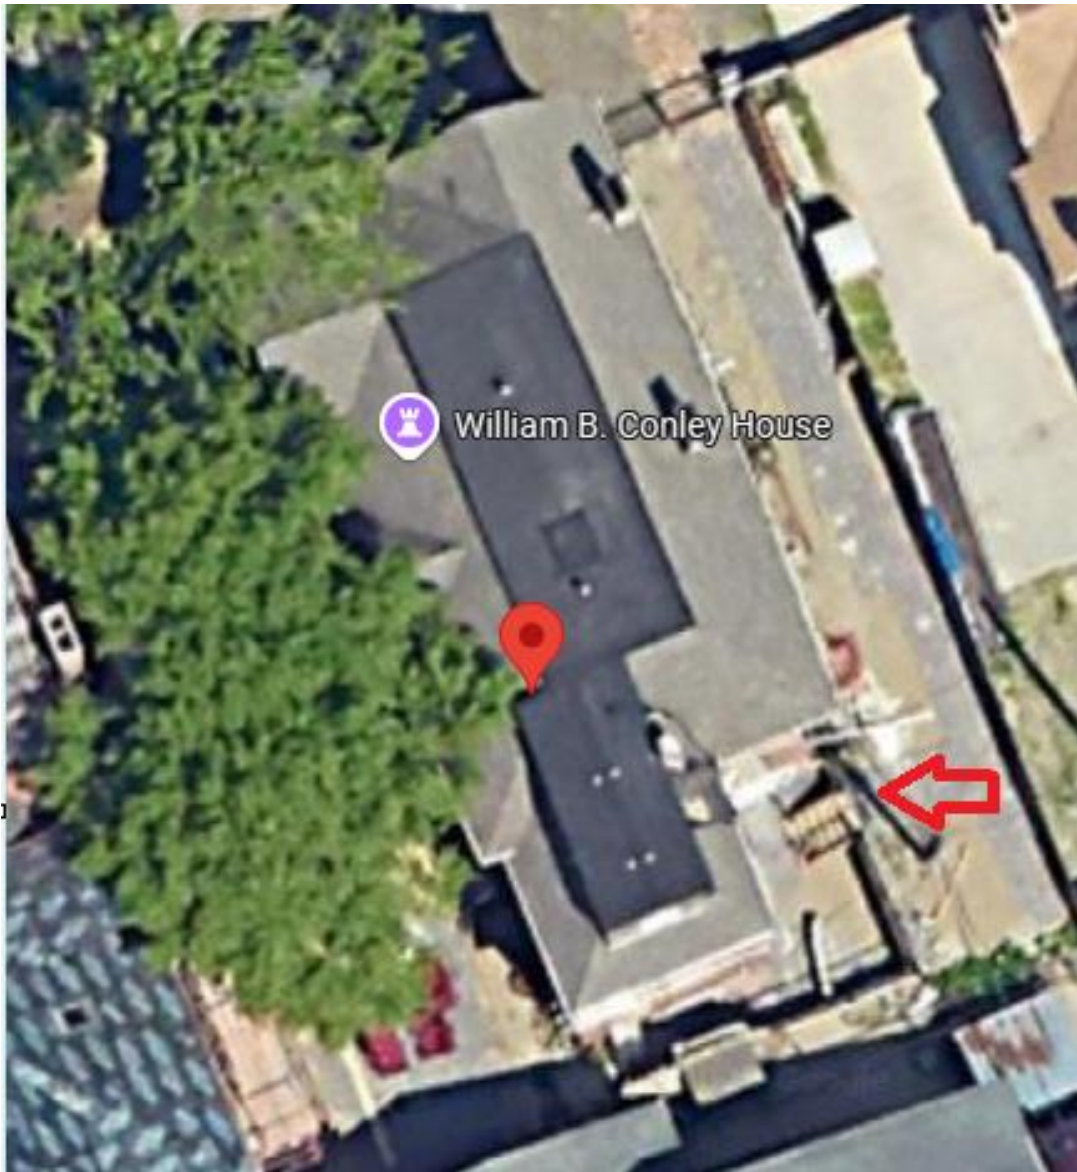
Photo 4. 691 W Canfield, existing conditions, Google map, 2025, exposed trench behind the house is visible. Beginning at the rear of the house on the east side (at the southeast corner) and continuing across the entire rear of the house, the exposed trench is visible. Steps leading down into the trench are visible in this image near the house's southeast corner, at red arrow.

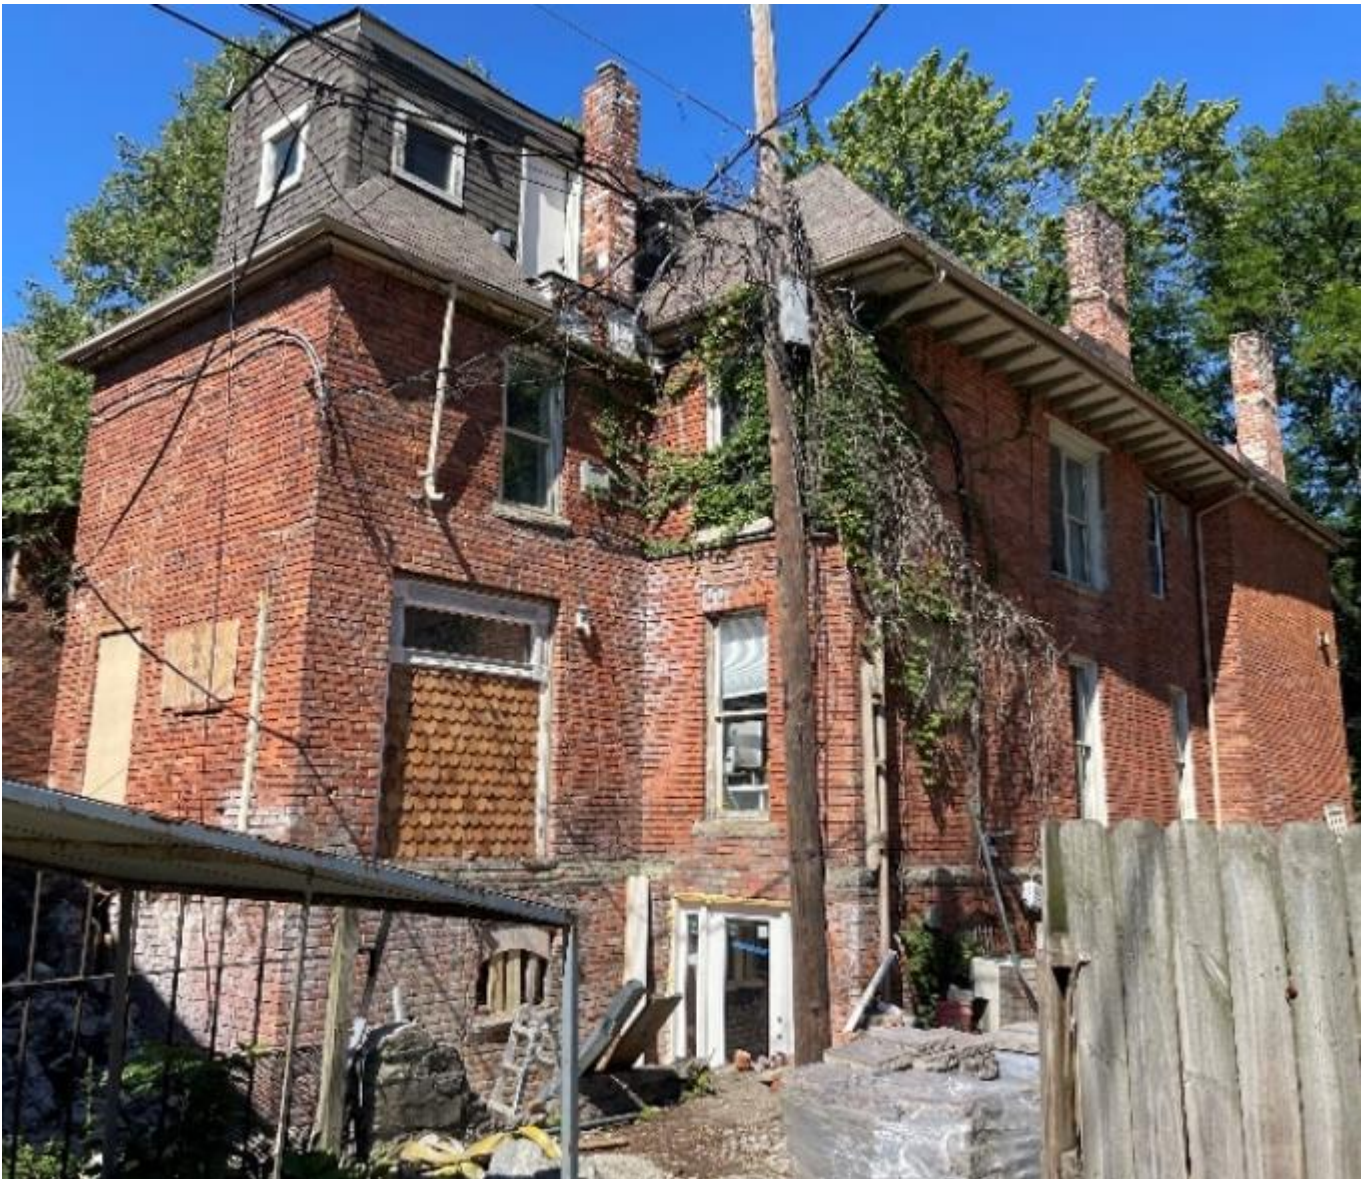
Photo 5. 691 W Canfield, September 2022, staff photo, post unapproved demolition work. The south end of the house still looks much like this in 2025. The south end of the house is shown where a single door and a window opening are boarded up. That door used to step out onto the rubble-and-concrete deck between the house and the retaining wall, and the bricks with white staining below the door and window were not visible because of the former deck. The wide door opening infilled with a transom and fishscale shingles near the house's southeast corner used to be double doors that opened onto the rubble-and-concrete deck. These boarded-up and infilled openings are part of this application. The door with sidelights visible here below grade at the house's southeast corner is the door with sidelights proposed in this application again, but painted a new color. That door would not have been visible either, when the former deck was in place, but the demolition exposed this area and the proposed new deck will not cover this area up. In the applicant's proposal, the door with sidelights would remain exposed and would open to a sunken patio.

This opening is shown in above *Photo 5*; it is the opening that currently is filled in with a transom window and fishscale siding. In 2022, the applicant replaced a set of non-historic French doors with the current fishscale shingles and transom without approval. With the current proposal, the applicant is seeking to install an aluminum-clad wood double-hung window and infill the remaining opening with brick to bring the opening more in line with a historic photo shown in the application. .

- As noted above, the wide opening on the rear of the house was infilled with a transom and fishscale siding in 2022 without HDC approval. The infill replaced a set of non-historic French doors (see the above photo # 10) The Commission denied the work in 2022. The current application is proposing to replace the current unapproved infill with a narrow double-hung, clad wood window and brick to return the opening to its historic/original condition as documented in a historic photo which is included in the submitted application materials. It is staff's opinion that this work item is appropriate with the condition that the bricks and mortar must be suitable matches for adjacent historic brick.

- Anywhere bricks will be used to infill, the bricks need to be a good match for the building both in color but also in hardness/strength, the bricks need to be exterior-grade for use outdoors, and the mortar used must be lime-based, soft mortar.

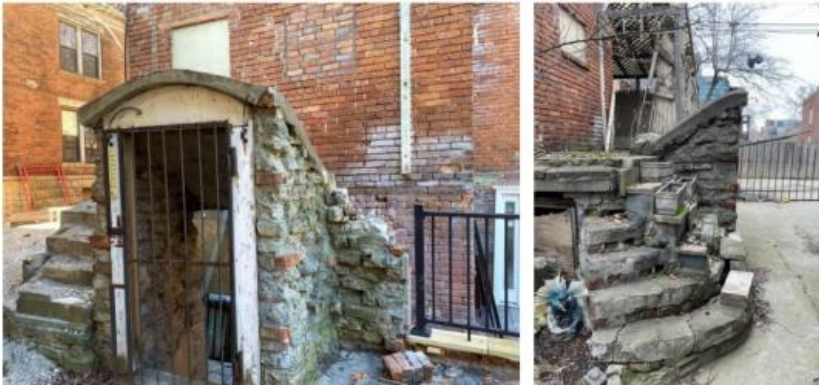
As stated, most of the proposed demolition work has been completed. As late as 2022, there was a stone-and-concrete porch off the south end of the house attached to stone steps leading up to the porch and a curved, vault-like structure that sheltered stone steps leading down to basement level. The vault-like structure remains but the rest of that construction has been demolished.

Photo 6. Photos of the house's south end provided by applicant's consultant in a report that has been included in the application. All of the stone and concrete construction visible here, along with the wood porch/pergola construction further east, are "proposed for demolition." In reality, much of that material has been demolished and only the rubble-and-concrete vault-like structure remains; it, too, is proposed for demolition.

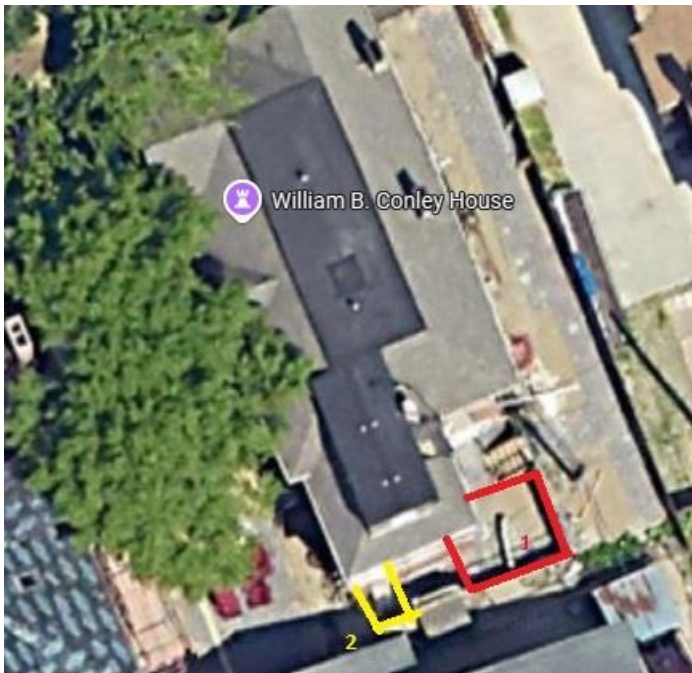
Figure 1. 691 W Canfield, Google aerial view, 2025. Staff drew a red outline showing where one proposed deck will be to cover part of the trench and a yellow line outlining where new rear porch will be erected to cover the exposed trench and lead to the new rear door. Between the two, the trench will remain exposed, the existing set of stairs will lead down to the basement level/areaway, and the rubble-and-concrete, vault-like structure that shelters those stairs will be demolished.

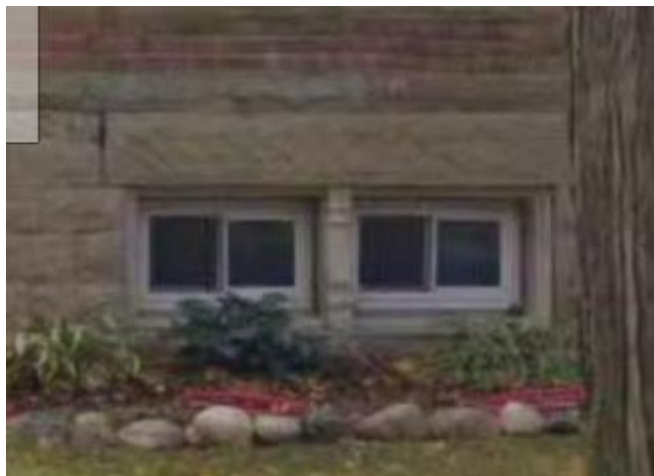
Photo 7. 691 W Canfield, front (north) elevation, basement windows visible below the large stone arch and picture window with transom toward the east side of this elevation, October 2020, Google streetview. The carved mullion between the two windows was visible in 2020 and is proposed to be replicated in 2025.

- In 2022, staff observed that the front basement windows are publicly visible and had bars over the windows from at least as far back as 2015 and before. The color and material of this preceding condition caused the basement windows to recede in the landscape. It is staff's opinion that the modesty of this original condition of the basement windows is a distinctive character-defining feature. In 2016, these bars were removed, and vinyl slider windows were installed, which were replaced with larger vinyl windows and a window well which staff found created a larger, louder presence on the building and in the landscape. Proposed now are wood aluminum-clad windows to replace the larger vinyl windows. Landscaping has been introduced to try to camouflage the window well. Staff's initial/2022 recommendation re: this scope was that the vinyl material, the scale of the windows, and the presence of the window well at this location introduced a material, scale, color and expansion of a modest element into a more dominant element that altered and therefore substantially detracted from the historic appearance of the building. Now, upon second review, with the revisions being proposed, staff finds that these objections have largely been overcome. The landscaping hides the window well successfully, at least from the sidewalk, and the aluminum cladding (instead of vinyl) will help these front basement windows meet the Standards in terms of color and texture. Also, the carved, character-defining wood mullion that was removed without HDC approval will be reproduced to match the historic element. However, because the new windows are taller than the original, the applicant must take care to ensure that the new mullion matches both the proportion of the windows and the appearance of the historic mullion that was removed without HDC approval.

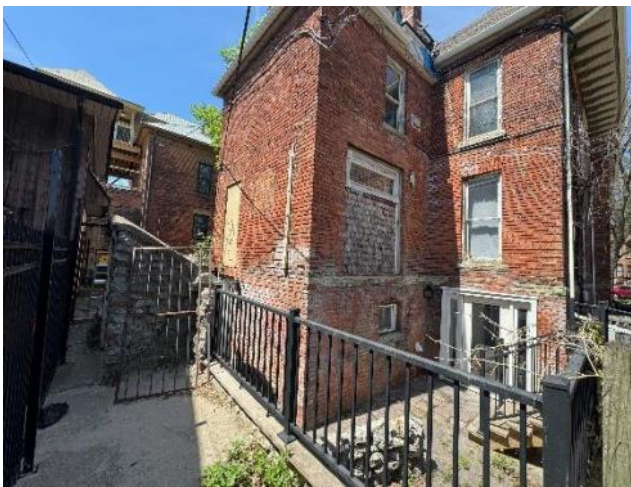
*Photo 8 from the application
showing current conditions at
rear yard/proposed location of
rear deck and porch.*

- the proposed deck surface be painted or stained to help blend in more with historic materials
 - there be no unpainted pressure-treated wood left visible above ground, and that

- the skirting proposed below the new porch should be less horizontal in emphasis and more compatible with historic screening methods.
 - a different railing type be selected for the deck that has a slightly more traditional appearance and is wood painted to match the house's trim, or possibly wood composite that matches the trim. The current proposed railing is modern and thin black aluminum and would match the current railing (see the above) that was installed without HDC approval.

- The new rear deck and patio will either be painted or stained; no unpainted pressure-treated wood will be visible above ground. Also, applicant shall propose a new skirting design for the new rear patio which is more compatible with historic building and the railing for the new deck shall be wood, rather than the proposed aluminum. The final railing design shall be submitted to staff for review and approval.

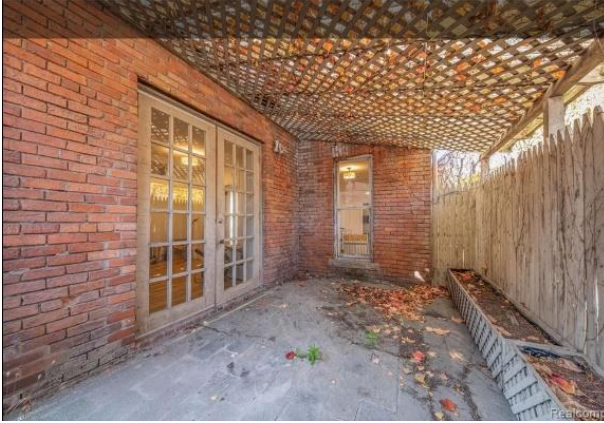
Site Photo 10 by Real Estate.com, listing date, October 2021: (South) rear, east-facing elevation showing French doors, rear porch covering, patio, planter bed and fence over the boiler room below.

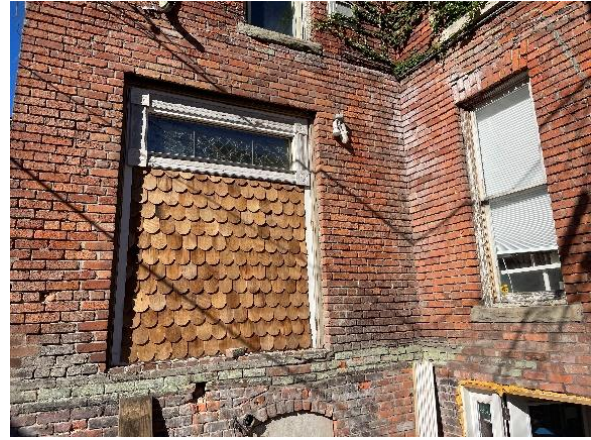
Site Photo 11 by staff, September 1, 2022 : (South) rear, east-facing elevation showing location of removed French doors and infill with fish-scale siding and stained glass transom from another building installed in the opening.
