STAFF REPORT: 7/09/2025 REGULAR MEETING

APPLICATION NUMBER: HDC2025-00260

ADDRESS: 14943 GREENVIEW

SCOPE: DEMOLISH GARAGE, ERECT NEW GARAGE (WORK STARTED WITHOUT APPROVAL)

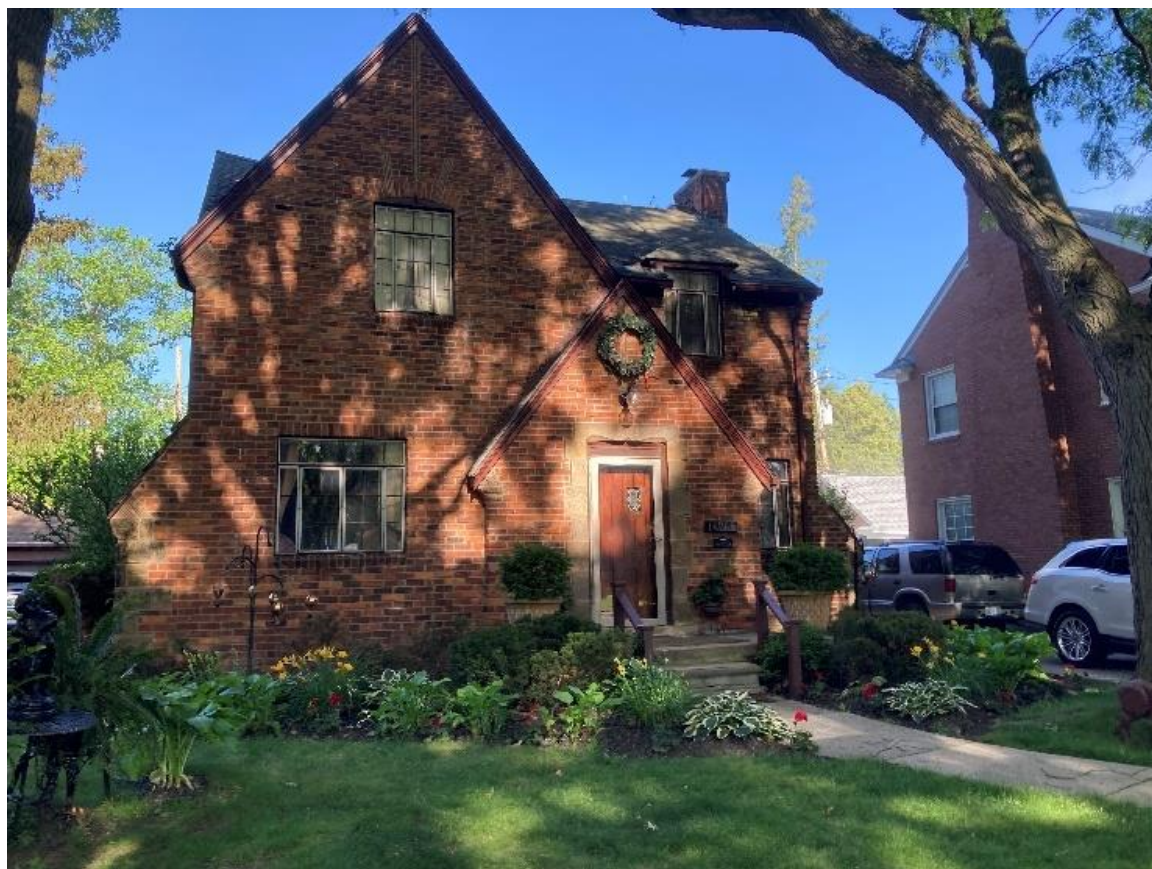
Site Photo 1, by Staff, June 23, 2025: (East) front elevation

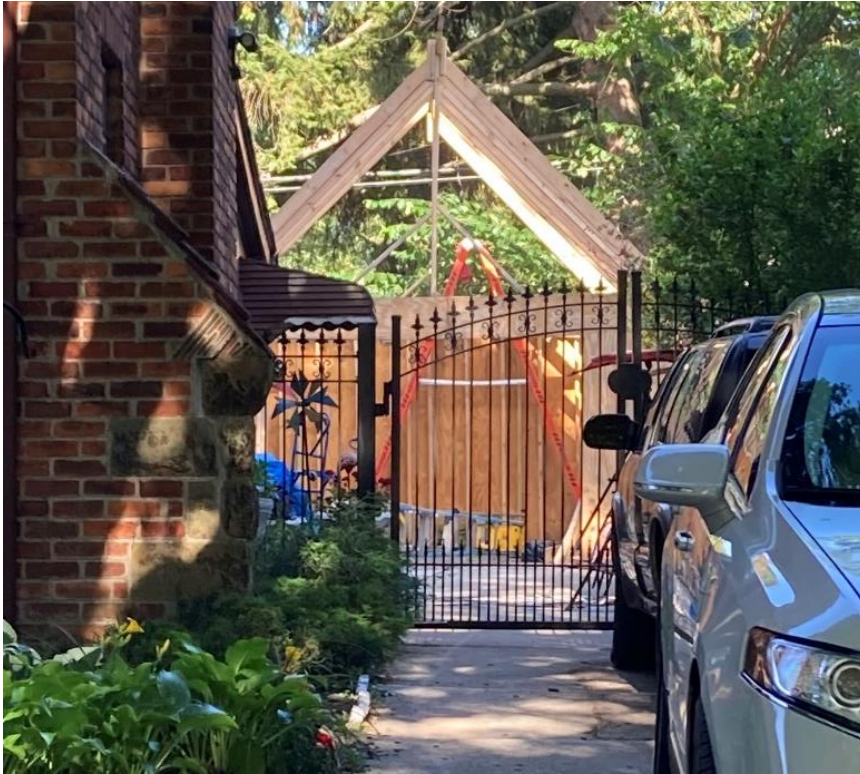
A driveway is along the house's north side and at the end of the drive behind the house's northwest corner, a garage has been started. It appears that there is a concrete pad. Framing that will form the north and south sides of the garage, along with the framing for the garage's gable roof, have been erected.

Site photo 2 by staff, 6/23/25, beginning of rebuild.

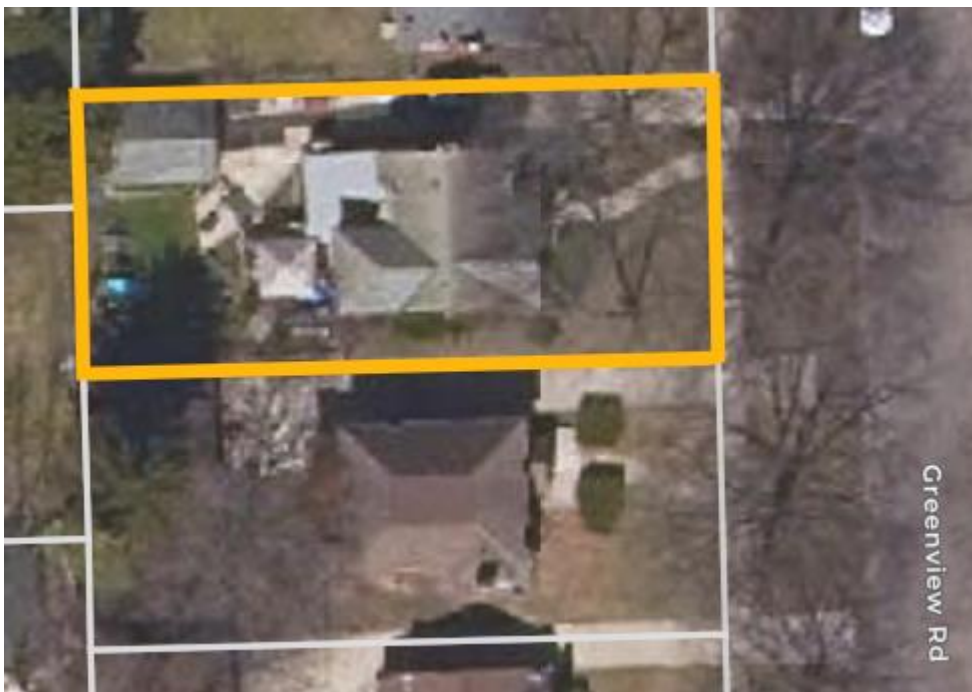
Detroit Parcel Viewer. Aerial view of Parcel 22080384, 14943 Greenview (outlined in yellow), with the old garage visible in the northwest corner of the lot

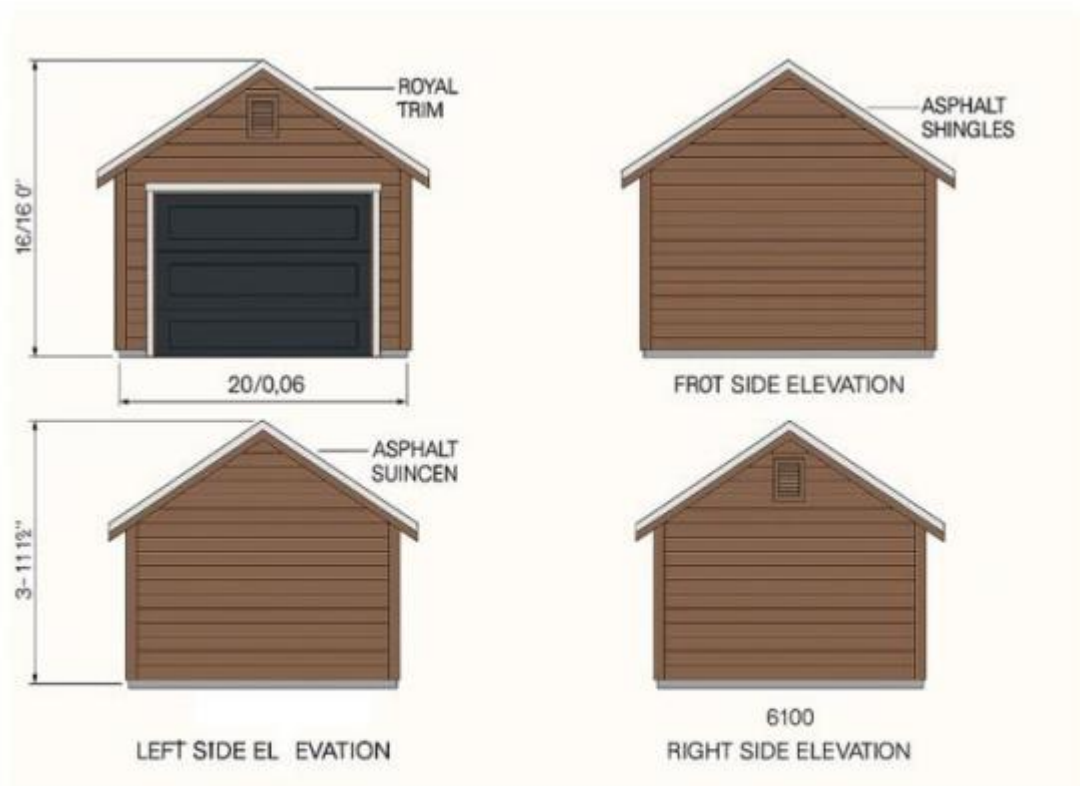
Elevation drawings, submitted by applicant

- While the application is generally complete, staff did note a small number of missing/incorrect details including:
 - Submitted drawings incorrectly depict the non-gabled (north and south) sides
 - The paint color for the walls and the color of the asphalt roofing has not been indicated
 - The soffit and fascia material has not been indicated
 - Complete dimensions of the garage have not been indicated/confirmed. (Applicant describes the "width" as 16'.)
 - The foundation material has not been indicated

- **How will the non-gabled (north and south) sides look?** If the project proposes a simple and modest building and 13' remains the maximum height at peak, staff would say that the design meets both the Standards for Rehabilitation and the Elements of Design.

- The applicant shall submit final dimensioned drawings of the garage which outline paint color(s) and materials to staff for review and approval prior to the issuance of the permit

- Vinyl shall not be used on the new construction and all trim shall be made of wood or a cementitious material (with a smooth finish)
- The garage's walls, asphalt roofing, soffits, fascia, and exterior doors shall be finished with colors that are compatible with those found at the property's historic house.

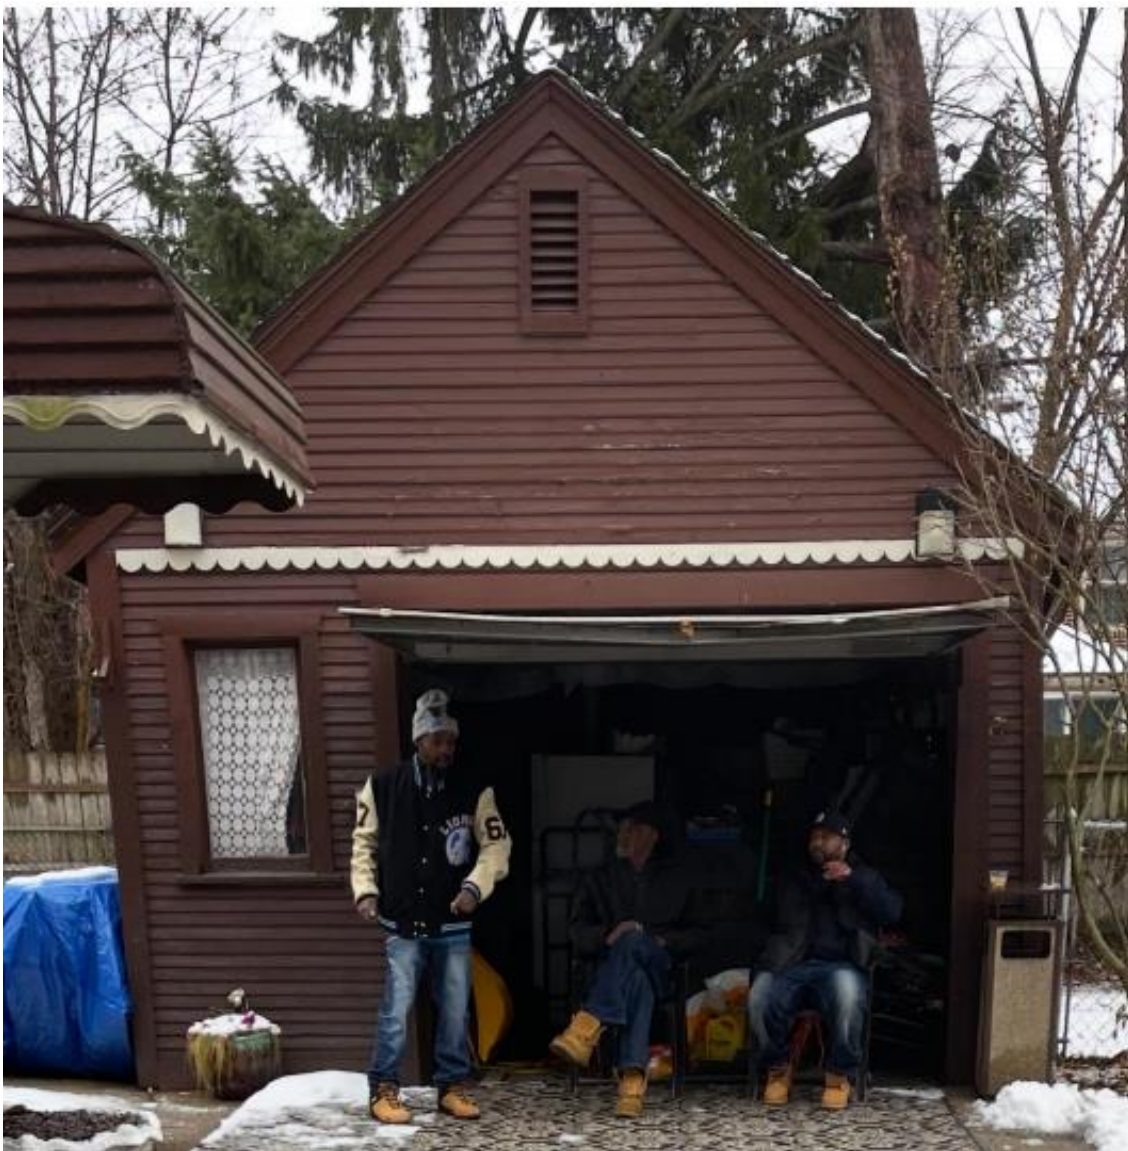
Applicant photo from before the fire.

- The garage before the fire was of historic age and would have been considered contributing to the district because it helped tell the story of early garages in suburban developments at this time. The period of significance for Rosedale Park is 1917-about 1955, according to the City's Rosedale Park Historic District Final Report, and that report states that one of the reasons the district is significant is "its association with streetcar and automobile suburban development in relation to early twentieth century transportation corridors..." The district's final report describes how, along with buyers in the district selecting their homes' architectural styles with care, garages "also figured prominently in the building tastes of Rosedale Park homebuilders and homebuyers...[T]he automobile played an increasingly important role in the lives of Rosedale Park residents....The majority of builders and homeowners tended to select modest, utilitarian designs, 'settling for the simple box garage with a gable or hipped roof, double doors, and perhaps a stock window or two.'" (City of Detroit City Council Historic Designation Advisory Board Proposed Rosedale Park Historic District Final Report, page 10, available at <https://detroitmi.gov/sites/detroitmi.localhost/files/2018-08/Rosedale%20Park%20HD%20Final%20Report.pdf>)

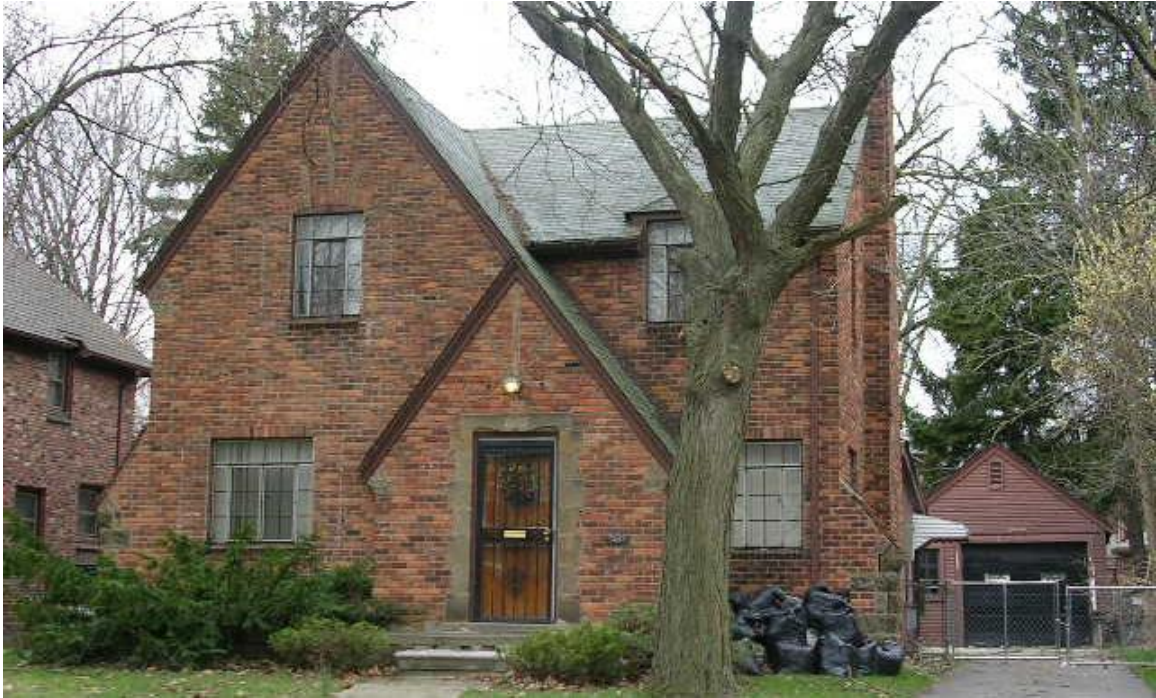
Undated Photo, city files. East elevations, former garage visible. Photo by HDC staff.

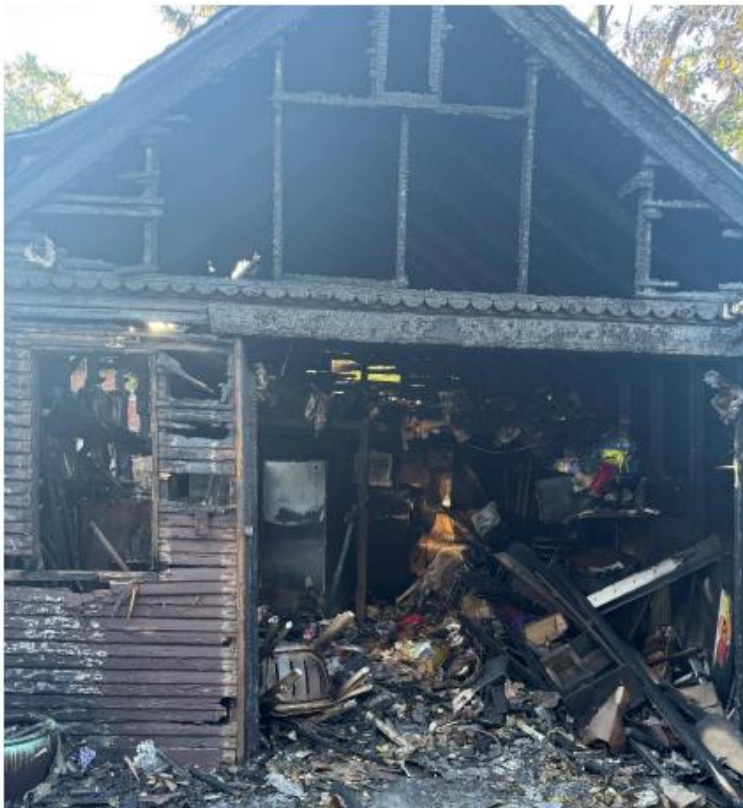
Applicant photo from after the fire.

- The fact that the garage at 14943 Greenview was of historic age and related to the historic context and period of significance for the district helped make the case for the garage to be considered historic or contributing to the district. However, in order for the garage to be considered historic or contributing to the district, in addition to being significant, the resource also needs to have enough historic integrity to *convey* its significance. In other words, if the building lost its essential character-defining features to rehabilitation or removal, the resource could not be considered historic even if it was of the right age and part of an important context. It is staff's opinion that even though this garage was of historic age and was related to an important historic context, the fire the building experienced caused it to lose its key exterior materials dating from the district's period of significance. The garage would have been considered contributing or historic before the fire because it was built during the period of significance, it was related to a key historic context for the district, and it retained all or most of its historic materials to convey its significance. After the fire, however, much of its historic material was lost and it no longer retained enough material to convey its significance. As a result, post fire, the garage lost its contributing or historic status.
